This report is published by the Rail Accident Investigation Branch, Department for Transport.

# Container train accident near Althorpe Park, Northamptonshire, 18 July 2011

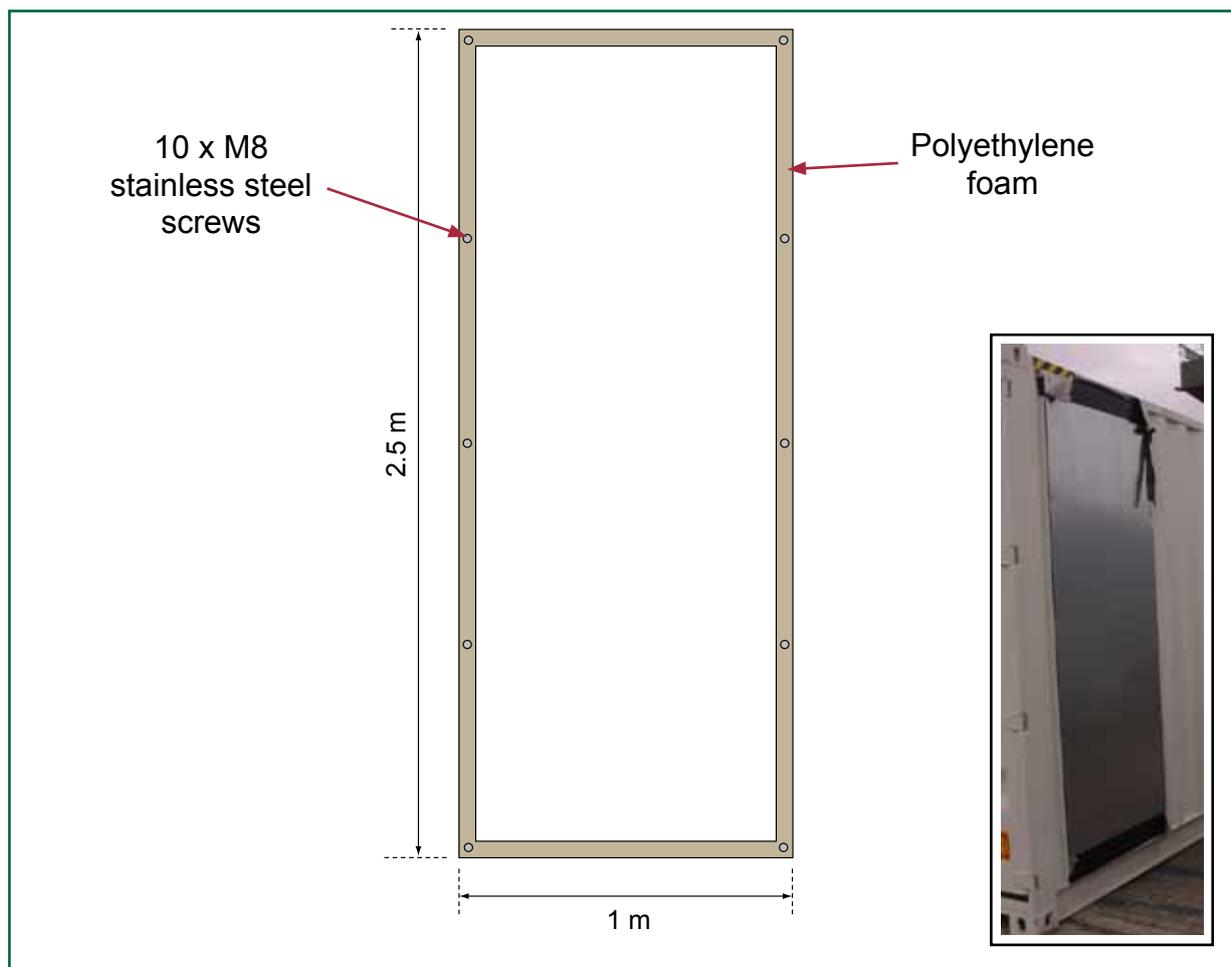
- 23 The transit plates were fixed to the container side by two vertical columns of five near-equally-spaced bolted joints<sup>3</sup>, each comprising an M8 stainless steel screw screwed into a *threaded insert*. Figure 5 shows a diagram of the arrangement, and also a photograph of a plate that remained attached. The threaded inserts, essentially threaded metal tubes, were secured into holes in the container sidewall by a special tool. This tool was used to pull the far end of the tube and *cold form* it tight against the rear surface of the container sidewall (figure 6). The screws had a button head with a special hexagonal socket to make them resistant to tampering (figure 6 inset). To improve sealing, a 50 mm wide strip of 6 mm thick polyethylene foam was fixed around the perimeter of the plate. Tightening the screws made the transit plates compress the foam against the container side.

Figure 5: Transit plate attachment arrangement. Inset shows the transit plate that remained attached to container CPIU 9006609 (the black adhesive tape was applied after the accident)

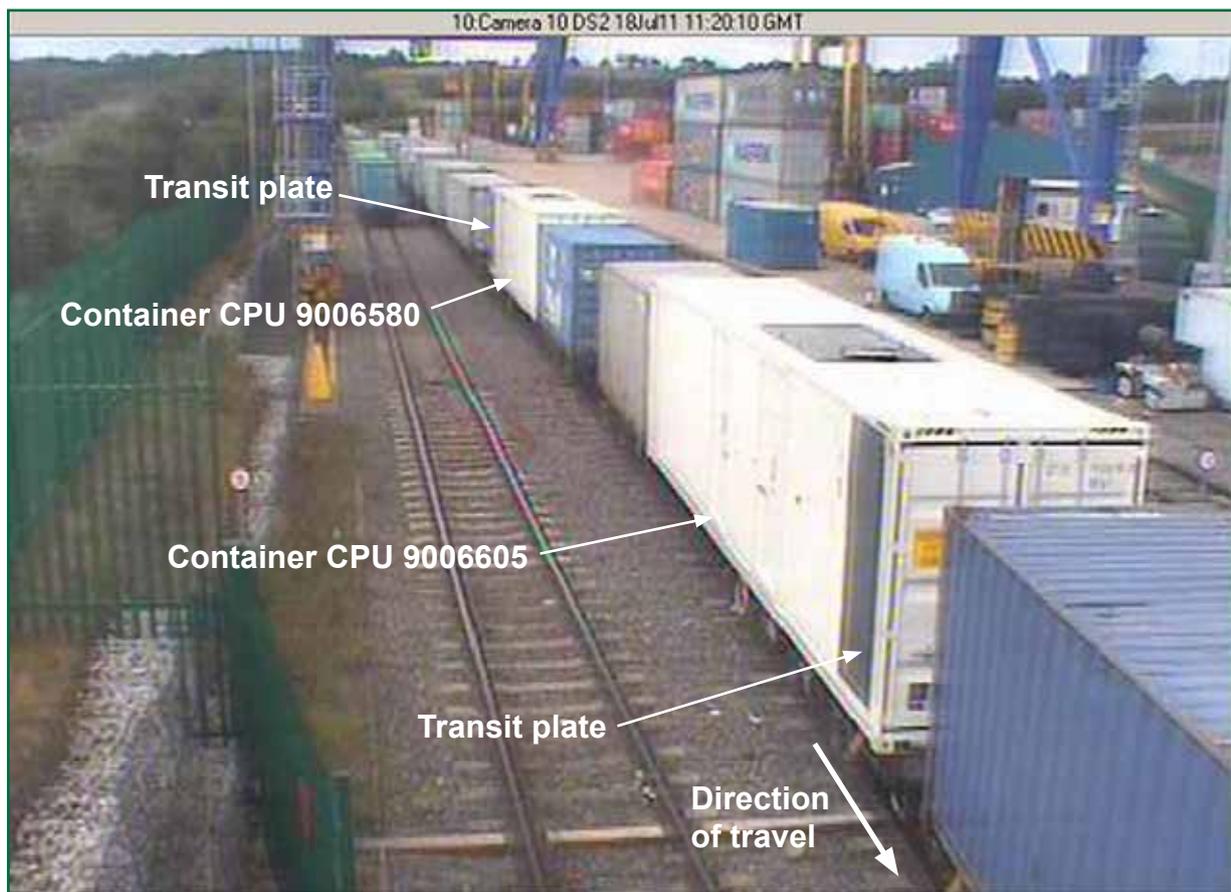
- 28 Part of the pre-departure examination includes checking for container defects<sup>4</sup>. The shift supervisor stated that he specifically remembered seeing both transit plates and side personnel doors on the containers and, from what he could tell, considered them to be securely attached. He signed the *train document* and the *certificate of readiness* for the driver of train 4L68 that confirmed that the train had been prepared and checked in accordance with Railway Group standards and Freightliner procedures.

Figure 7: CCTV image of the right-hand (six-foot) side of train 4L68 departing BIFT (image courtesy of Roadways)

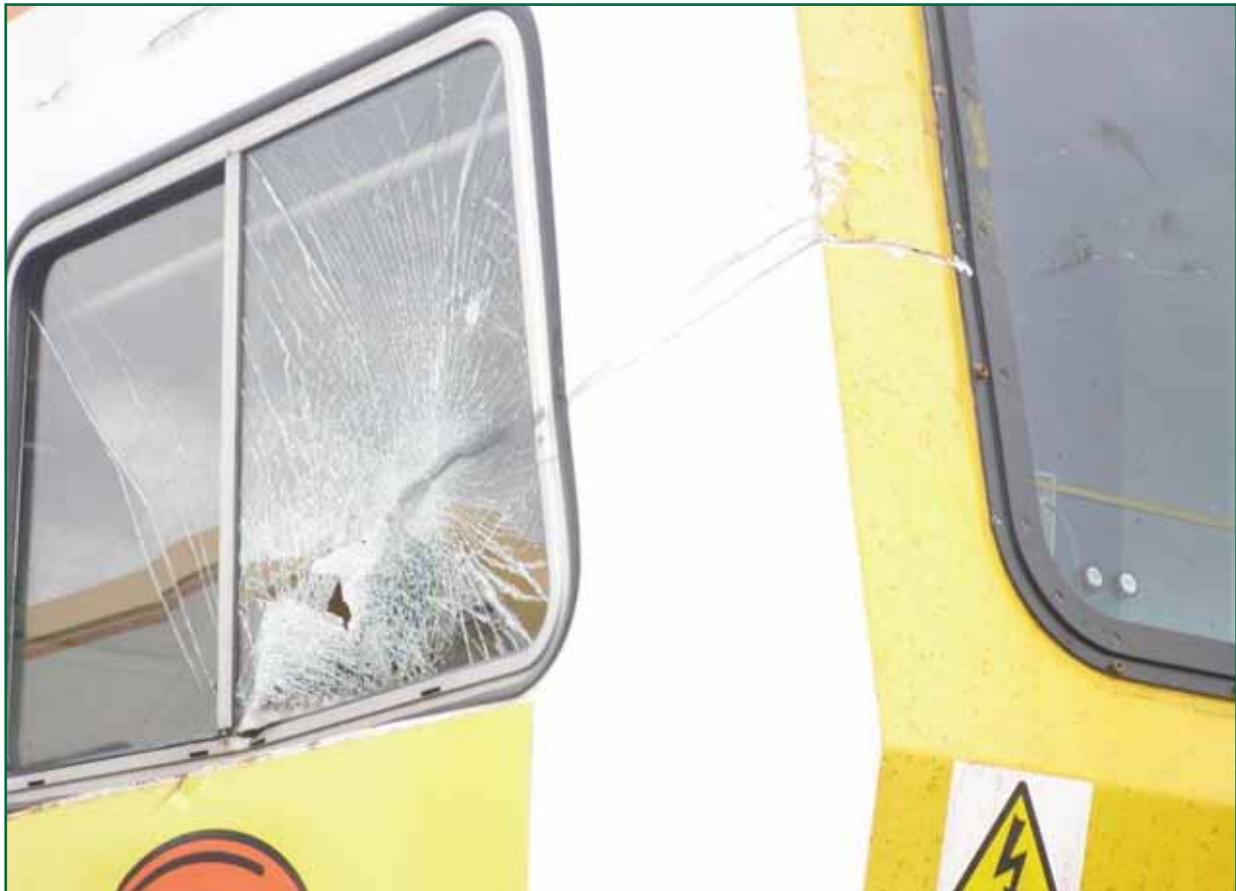
- 35 The tamper driver was uninjured, but his cab was damaged by the impact and the side window was smashed (figure 9). The impact also caused some damage to other parts of the tamper. After starting to drive the tamper forward to Rugby, he stopped again to report that there was debris in the up Northampton cess that looked similar to the metal that had earlier struck his machine.

Figure 9: Damage done to the driving cab of the tamper (photograph courtesy of Colas Rail)

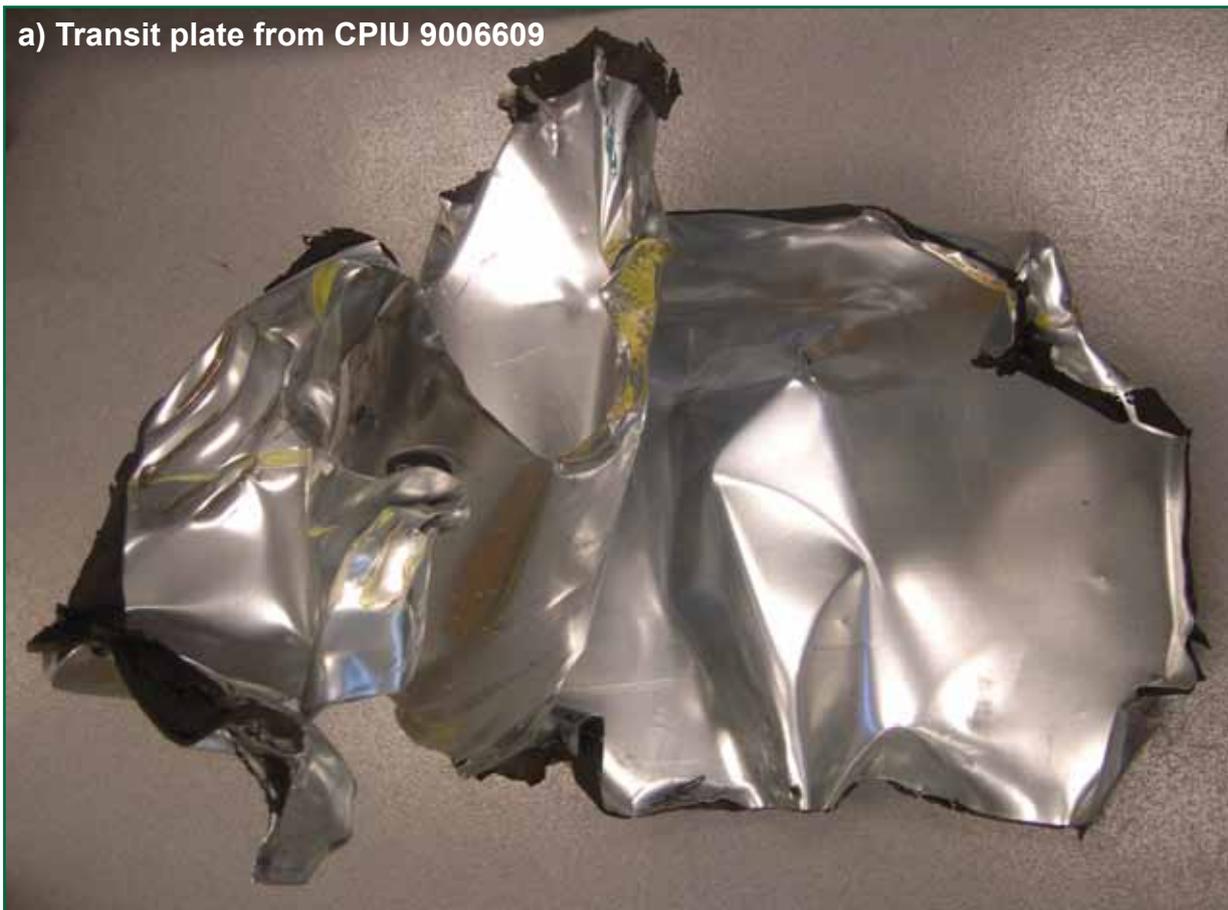
a) Transit plate from CPIU 9006609

- 61 The following evidence supports this:
- the six uppermost screws used to secure the transit plate were missing when the RAIB examined the container after the accident;
  - the six uppermost threaded inserts remained in place and in good condition; there were no broken screw parts in any of them; and
  - the distressed state of the lower screws, and their threaded inserts, and the evidence of pull-through distortion around the lower holes on the transit plate.
- 62 The above evidence is consistent with the tamper driver's account of the upper part of the transit plate 'flapping' as he approached train 4L68 (paragraph 33). It was then torn from the lower screws in the impact.

Figure 11: The transit plates that detached from containers CPIU 9006580 and 9006609 on train 4L68

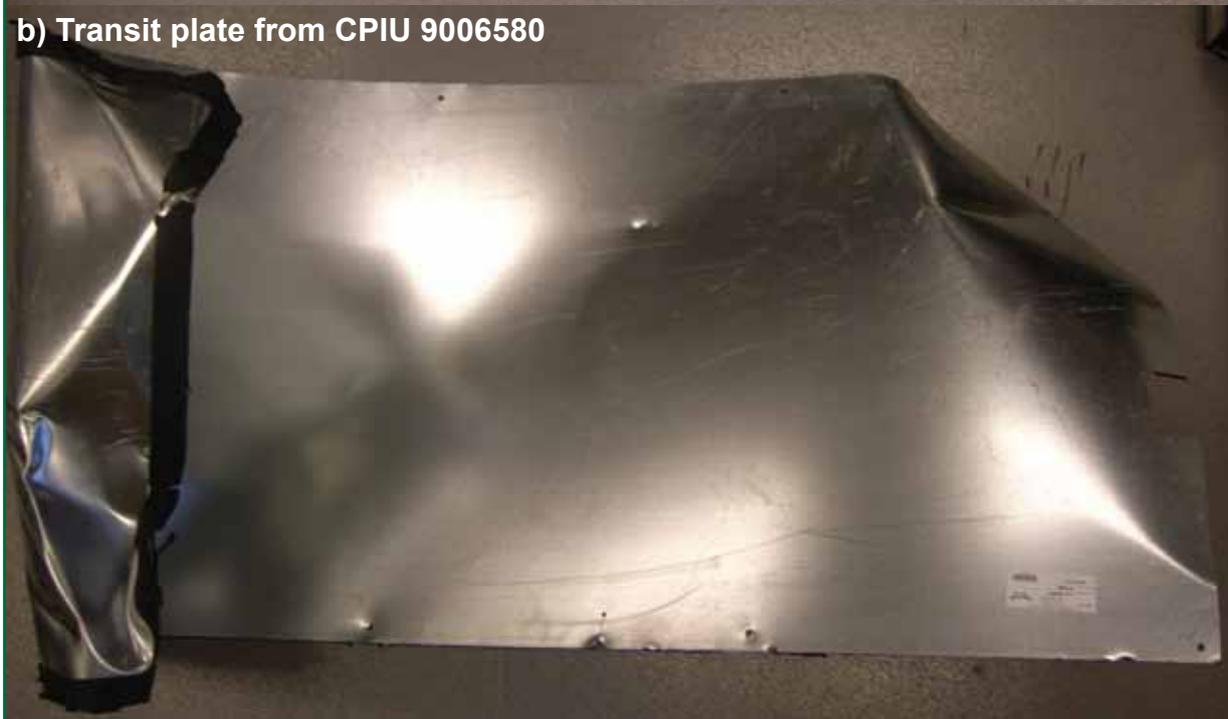
b) Transit plate from CPIU 9006580

- 37 A member of Freightliner's ground staff examined the train when it arrived. He found that the transit plate on the right-hand side of container CPIU 9006580 was loosely attached and flapping. He also found that there was no transit plate on the left-hand side. On container CPIU 9006609 he found that the transit plate was in place on the left-hand side, but with missing screws, and that there was no transit plate on the right-hand side.

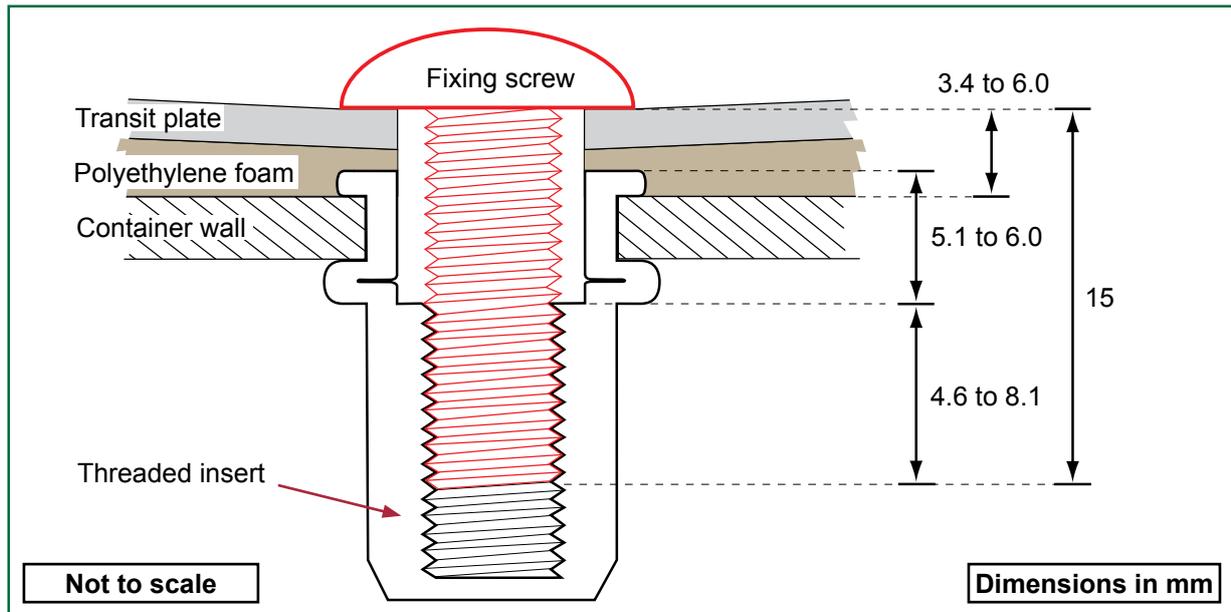
Figure 12: Cross-section through a typical bolted joint used on CPIU 9006609

- 63 **The loosening of the screws securing the transit plate was initiated by a loss of *preload* in the bolted joints as a result of continued compression of the polyethylene foam after tightening. This was a causal factor.**

- 67 While this loss of preload is itself unlikely to have directly led to the loss of the screws, it would have left the screws in a condition where they were prone to self-loosening under foreseeable external loads. The self-loosening that then occurred was most probably due to a combination of two effects:

The Health and Safety Executive should issue a safety bulletin to make manufacturers and users of converted freight containers aware of the need for a competent assessment of the adequacy of bolted joints, which are used to secure exterior attachments, when designing, modifying or repairing containers. It should also ask the organisations authorised to approve containers to cascade this information to their clients (paragraphs 102a and 102b).
