Rail Accident Investigation Branch

Rail Accident Report

Track worker struck by a train at Stoats Nest Junction 12 June 2011

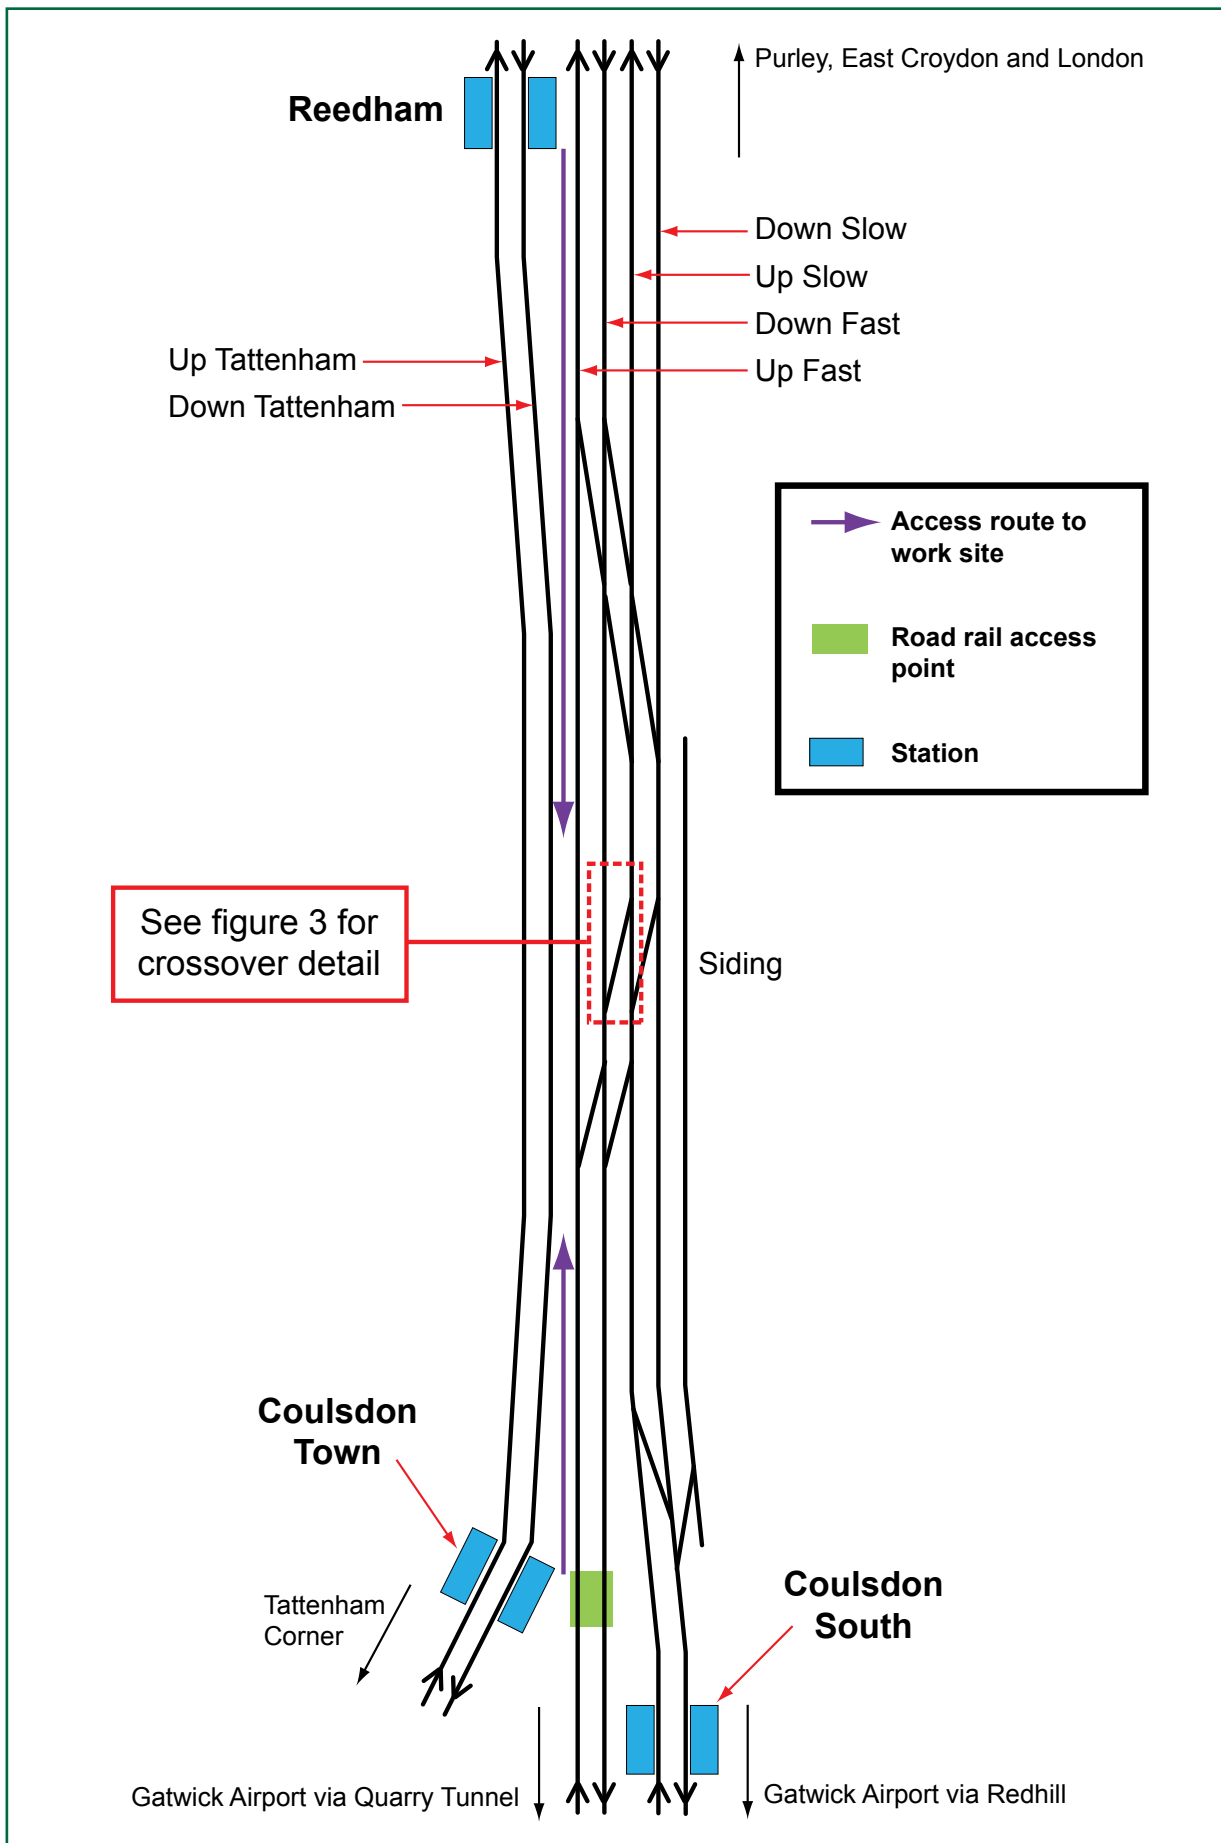
Figure 2: Track layout at Stoats Nest Junction

- 17 The route through Stoats Nest Junction is *quadruple track*, consisting of a pair of fast lines and a pair of slow lines. A series of *crossovers* connect the fast and the slow lines. There are also an additional two adjacent tracks, on the route to Tattenham Corner (figure 2).

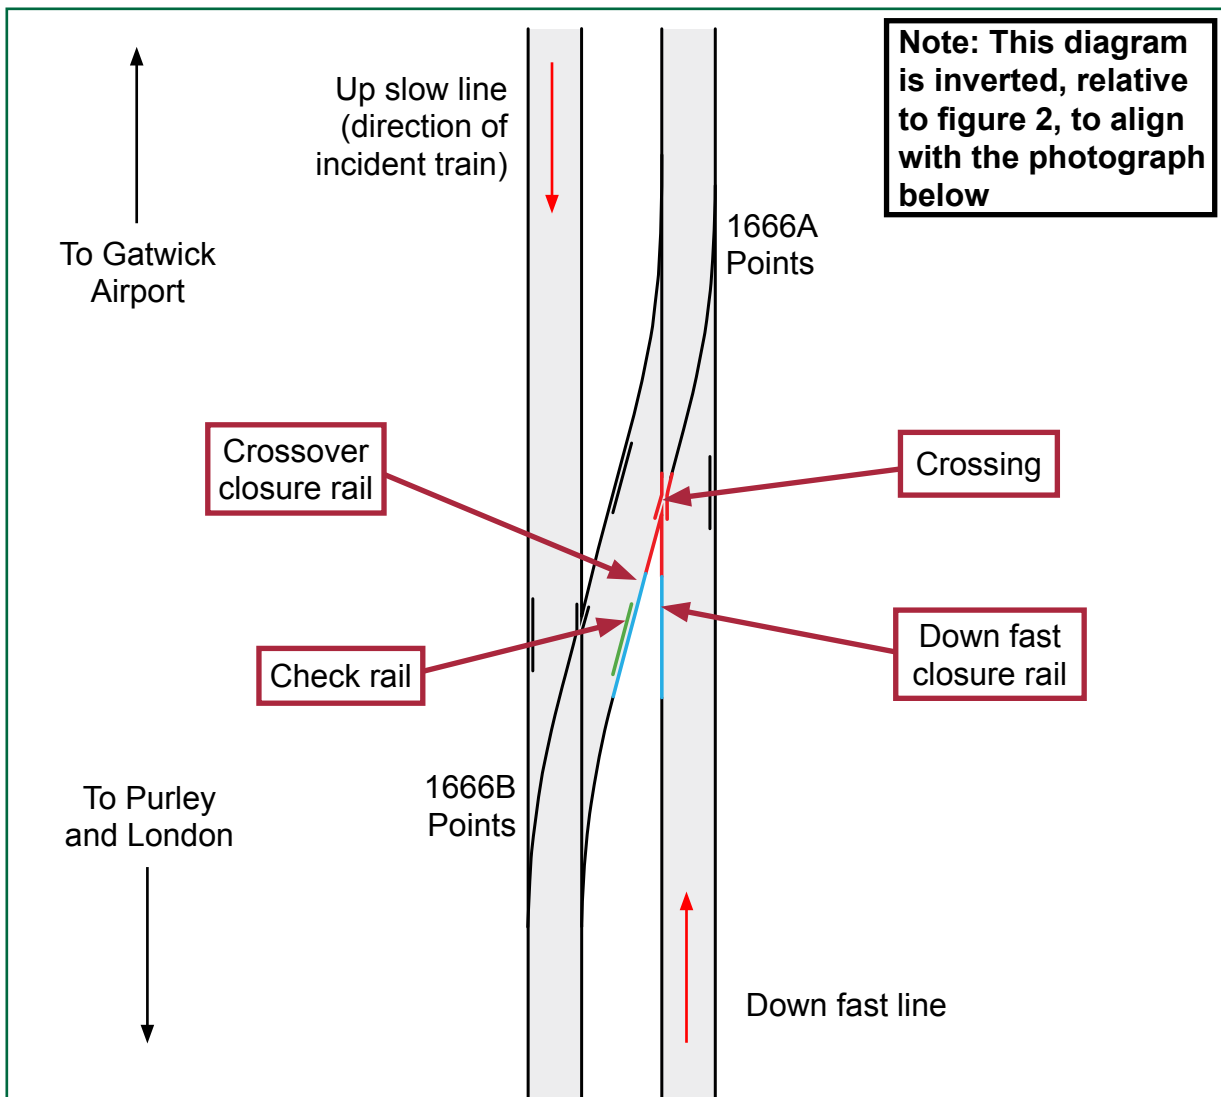
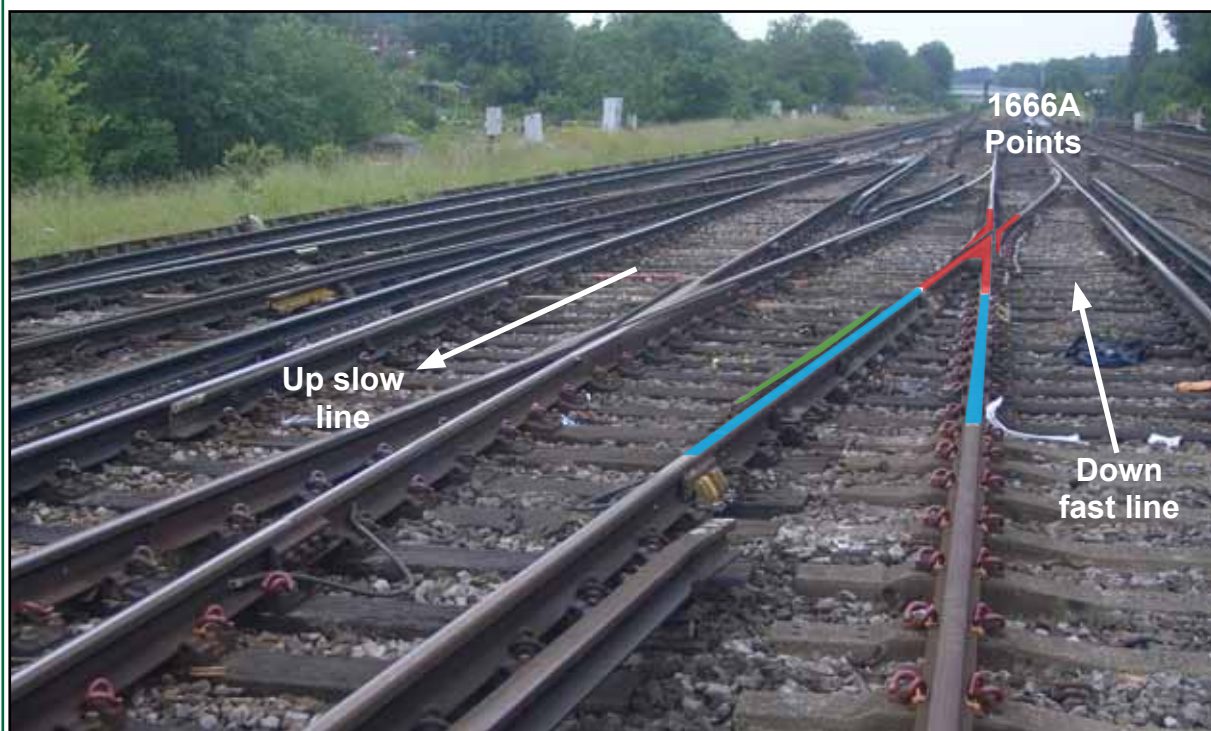
Figure 3: Crossover detail at Stoats Nest Junction

- 39 Initially, the gang removed the rail fixings and cut out the cracked crossing section, in preparation for lifting out and replacement.
- 40 Two RRVs were used to bring the replacement crossing piece to site, from near Purley, along with two lengths of *closure rail* that had been cut to length to accommodate the new crossing assembly (figure 3).

- 85 By this time the welds on the down fast line closure rail (figure 3) were under way, and the track workers were preparing to clamp the crossover closure rail into position so that the up slow line could be handed back on schedule. Although this meant that the crossover would only be able to be used at low speed, the fact that it normally had a 25 mph (40 km/h) speed restriction meant that this would cause no disruption.

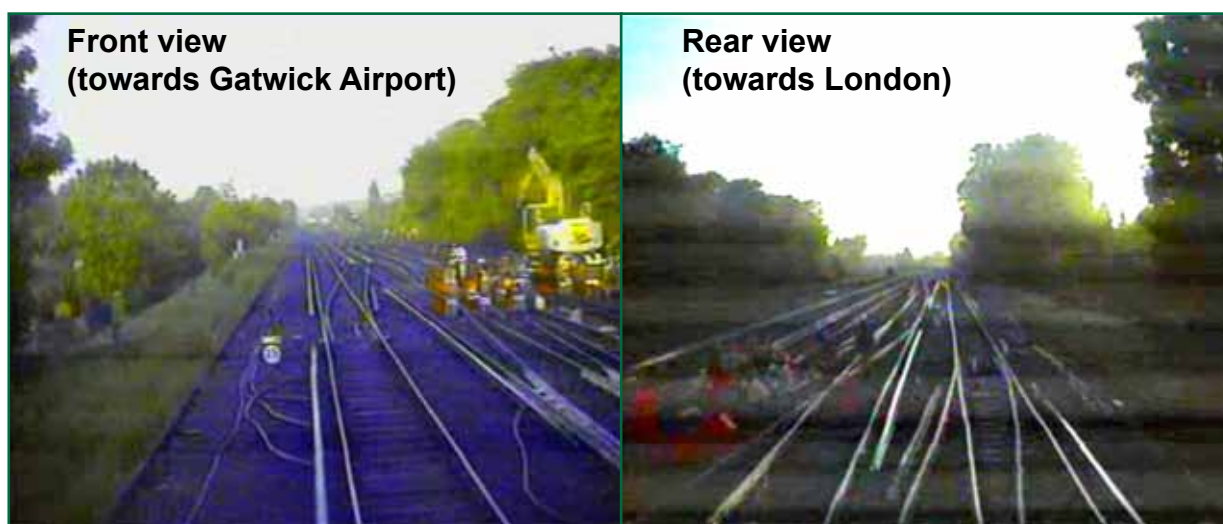
Figure 4: CCTV images of the work site at 05:24 hrs

- 49 At 05:17 hrs the PICOP contacted the Three Bridges signaller to hand back the up slow line for traffic.
- 50 A recording of the forward (and rear) facing CCTV of a passing train, on the down slow line, shows that work was still ongoing on the crossover closure rail, at 05:24 hrs. Personnel were still present in the space between the up slow line, which was now returned to traffic, and the down fast line, which was still blocked. One person was in the *four-foot* of the up slow line, which was open to traffic (figure 4).

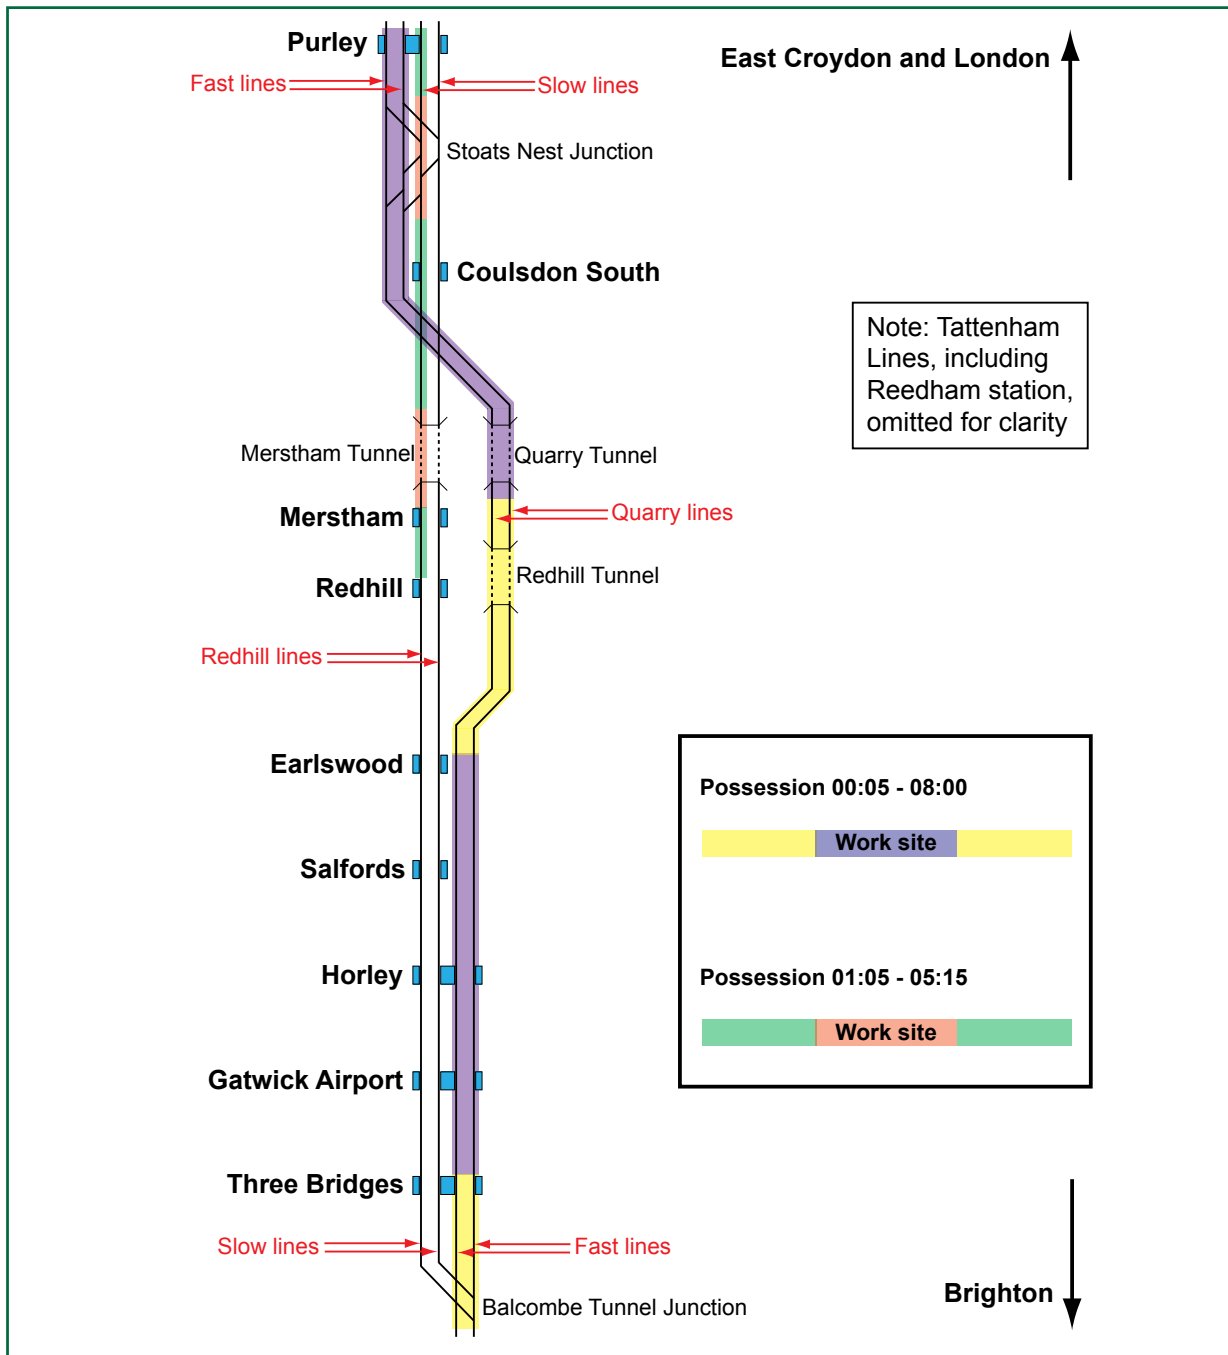
Figure 6: Simplified layout of the possessions

69 The work at Stoats Nest Junction on the night of 11-12 June 2011 was being carried out under a three part² possession of the lines between Purley and Balcombe Tunnel Junction (figure 6).

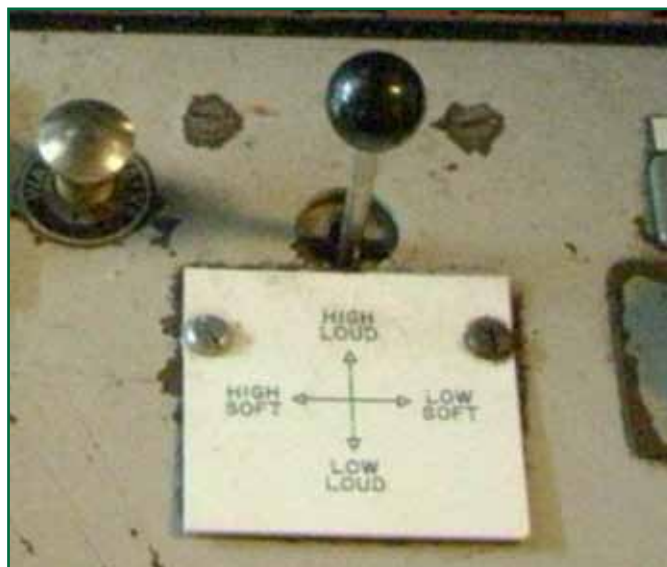
Figure 7: Train horn lever

- 138 The class 442 units are fitted with a four-way horn lever (figure 7). This allows the driver to sound two different horn tones in the loud volume setting, by moving the lever forwards and backwards. A further two tones in the soft volume setting can be sounded by moving the horn lever left and right.

- 139 The train driver believes that he sounded the horn using the soft volume level, when he sighted the track gang close to the line. The driver stated that he used the soft volume level because he was close to the track workers at the time, and believed that they were clear of the train. However, because the OTDR on the train does not record horn use (paragraph 135), there is no evidence to confirm whether the horn was sounded, the timing of any horn use or its volume.

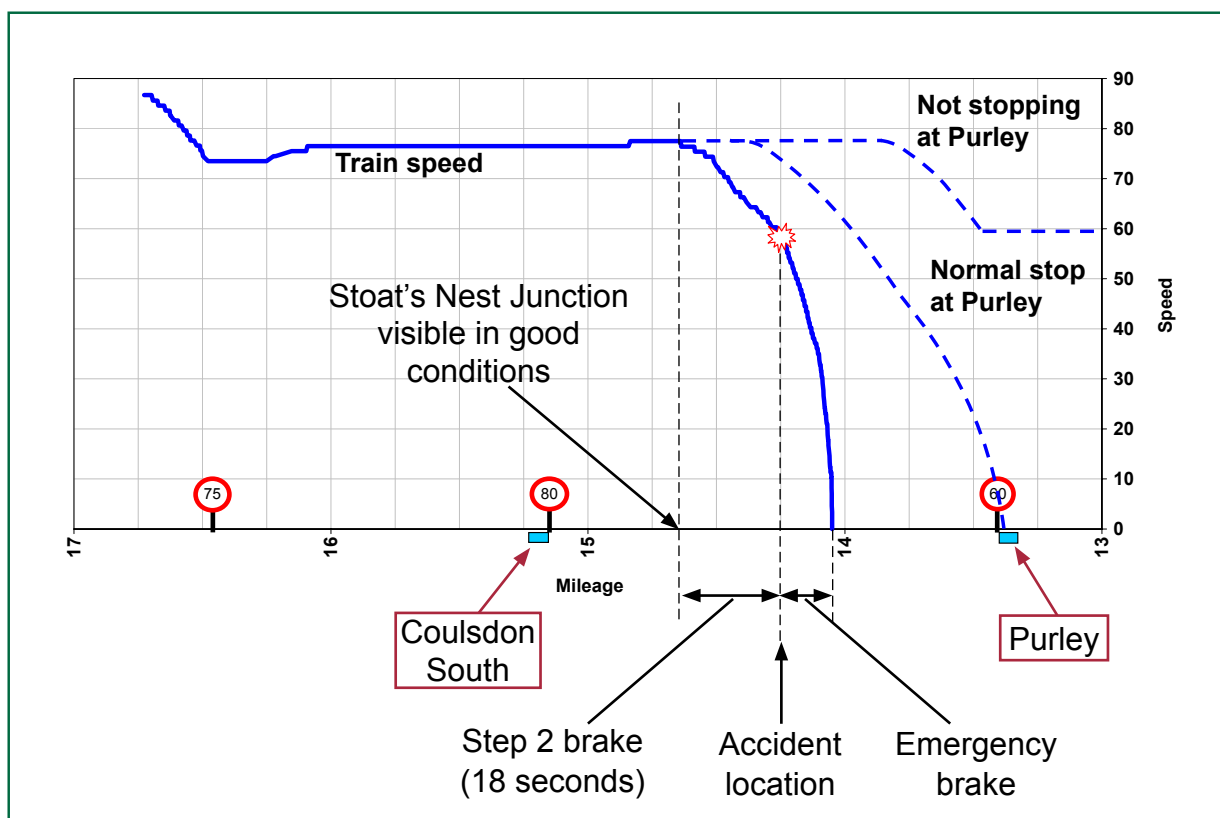
Figure 8: Train speed and line speeds

- 148 Approximately 550 metres (18 seconds) before the impact, the driver applied the brakes, bringing the speed down ahead of the 60 mph (96 km/h) restriction at Purley. This brake application was about 50 metres after the first opportunity at which the driver would have had a clear view towards Stoats Nest Junction (in ideal conditions). Evidence from a driver trainer indicates that the brake application was approximately 350 metres earlier than the normal braking point required to stop the train at Purley, and 1250 metres earlier than would have been required to slow the train to pass through Purley without stopping. Figure 8 shows the train's speed profile on the approach to Stoats Nest Junction as well as the speed profiles for normal services stopping at, or passing through, Purley.
