Rail Accident Investigation Branch

Rail Accident Report

Fatal accident at Piccadilly Gardens, Manchester, 5 June 2011

Report 08/2012
May 2012

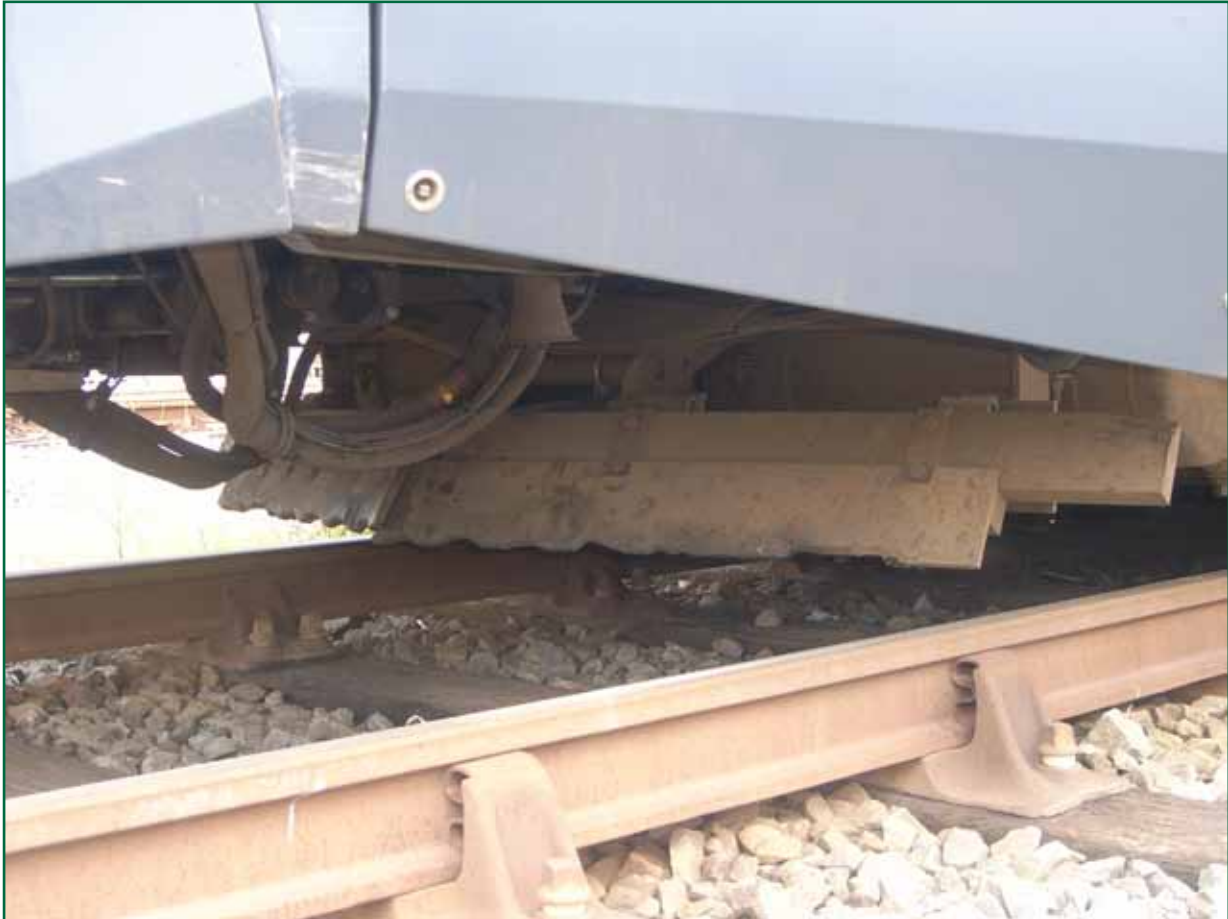
Figure 4: The under-run protector on the 'A'-end of tram 1002 (not at accident site); the notches in the rubber edge are caused by occasional contact with rail heads

- 17 The under-run protector on the leading end of the tram was mounted on the bogie frame (the metal frame equipped with the wheelsets), 1.4 metres back from the front of the tram. It consisted of two wooden sections fixed to metal support brackets and it spanned the full width of the bogie. On the leading end of tram 1002, the clearance between the lower edge of the wooden section and the road surface was 115 mm. Metrolink's design and maintenance instructions specify that this clearance should be 115 mm, with a tolerance of +/- 5 mm. Some clearance (ground clearance) is necessary between the underside of the protector and the paved highway to prevent contact between the protector and the rails and road surface when the tram meets changes in vertical curvature in the track.

- 18 On the lower edges of the wooden sections were 10 mm thick rubber strips. The rubber strips projected below the wooden sections giving a clearance of 80 mm between their lower edges and the road surface when on level track.

- 76 The chest injury sustained by the pedestrian after he came into contact with the under-run protector was rated by the AIS severity scale as 'life threatening'. The injury graphs suggest that this would almost certainly be the case irrespective of age.

- 78 To evaluate some of the design aspects of the protector, a model section of it was made. This recreated the ground clearance and rake angle of the tram's under-run protector. This allowed static tests with crash test dummies and a human volunteer to evaluate contact points with the chest. Both the human volunteer and one of the crash test dummies were representative in chest depth to the pedestrian involved in the accident. This showed that the smaller the ground clearance, the more likely a given size of person will be pushed forwards or rolled by the under-run protector, rather than it coming into contact with the chest region.

- 79 A comparative test was done with the rake angle removed, ie the under-run protector mounted vertically with the ground clearance maintained at 115 mm. In this case, although the protector passed up the arm, it did not override the shoulder to the same extent as when raked.

- a. The pedestrian's stumbling position when the initial collision occurred (**paragraph 86, no recommendation**).
- b. The ground clearance and rake angle of the under-run protector (**paragraph 80, Recommendation 2**).
- c. The age of the pedestrian (**paragraph 75, no recommendation**).

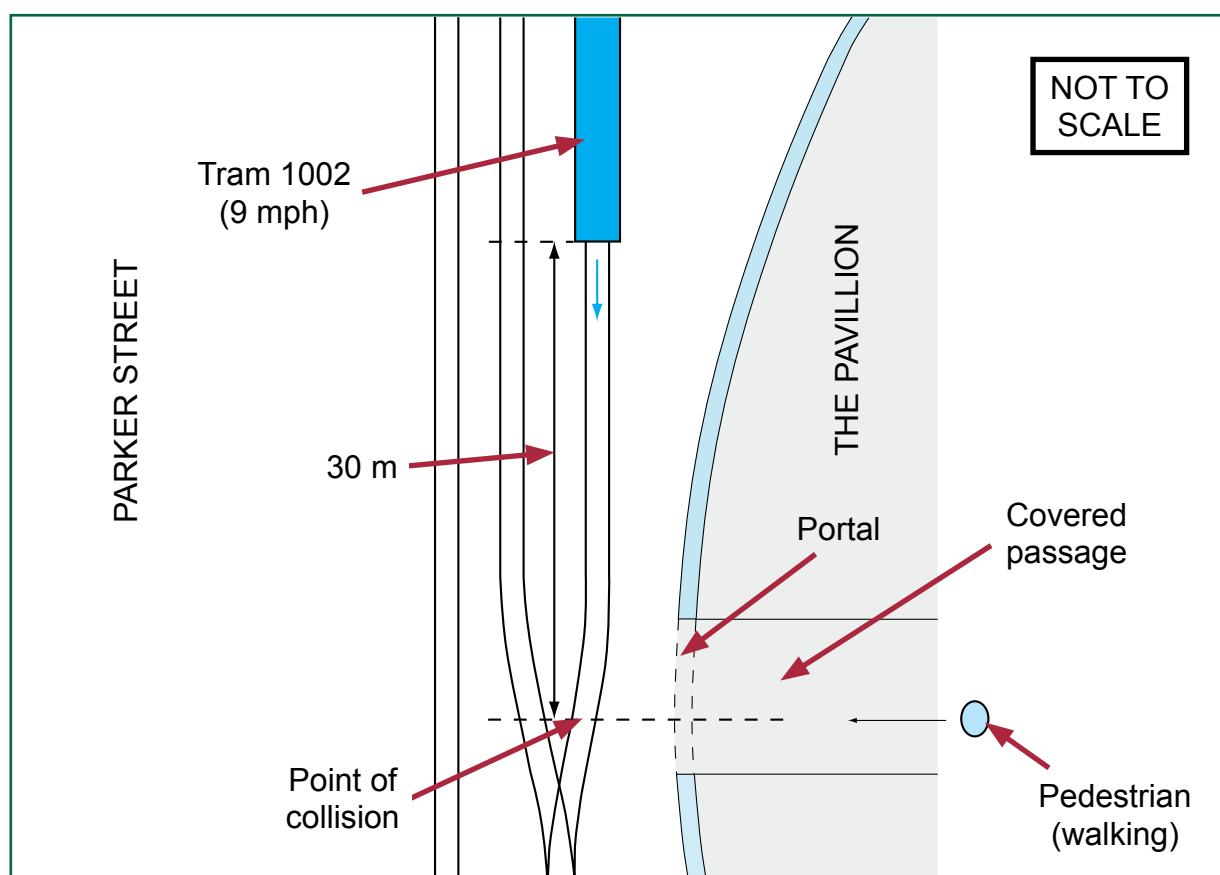
Figure 5: Positions of tram and pedestrian 8 to 9 seconds before the accident

- 28 The pedestrian walked into the covered passage of the Pavillion 8 to 9 seconds prior to the accident. He was within the central half of the passage's width. At this time the tram had turned into Parker Street and was about 30 metres from the point of collision (figure 5).

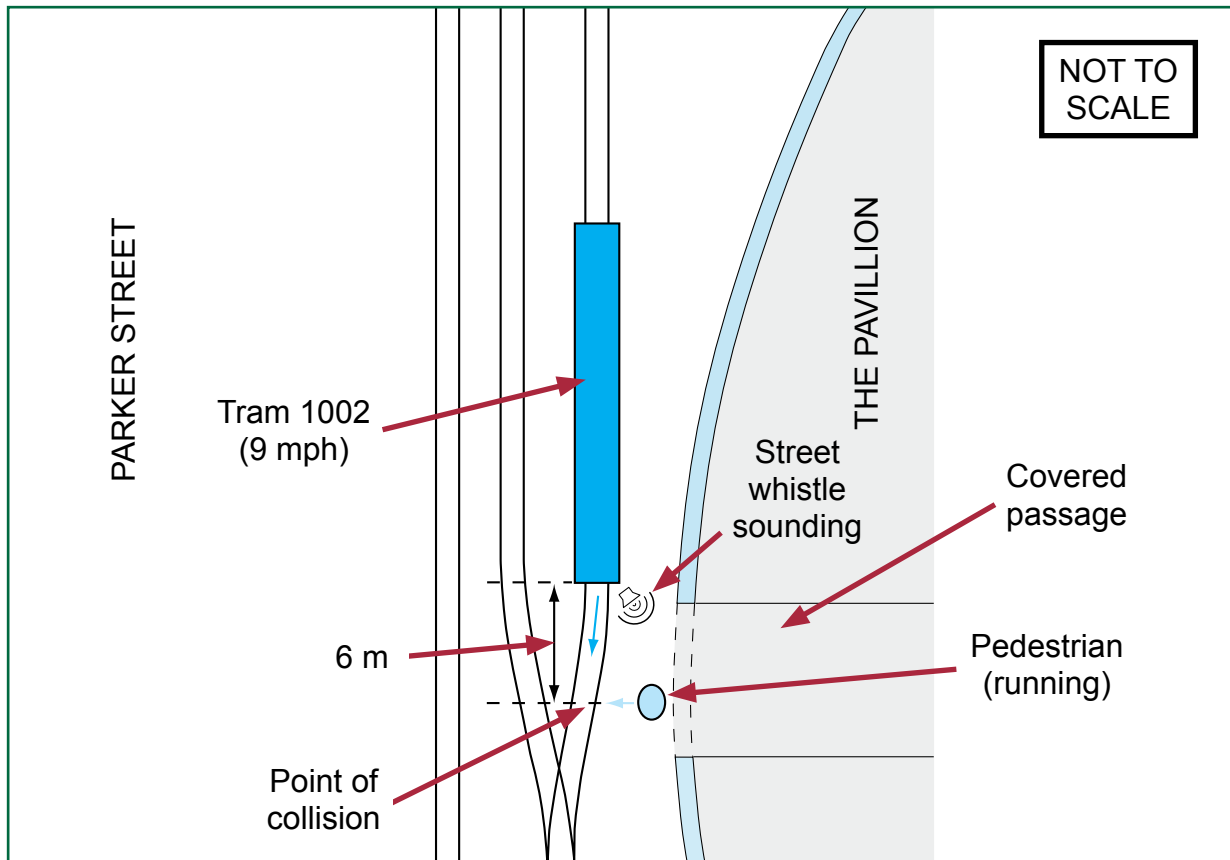
Figure 6: Positions of tram and pedestrian 1.5 to 2 seconds before the accident

- 30 The data recorder shows that the driver sounded his street whistle between 1.5 and 2 seconds before the collision, when the tram was approximately 6 metres away (figure 6).

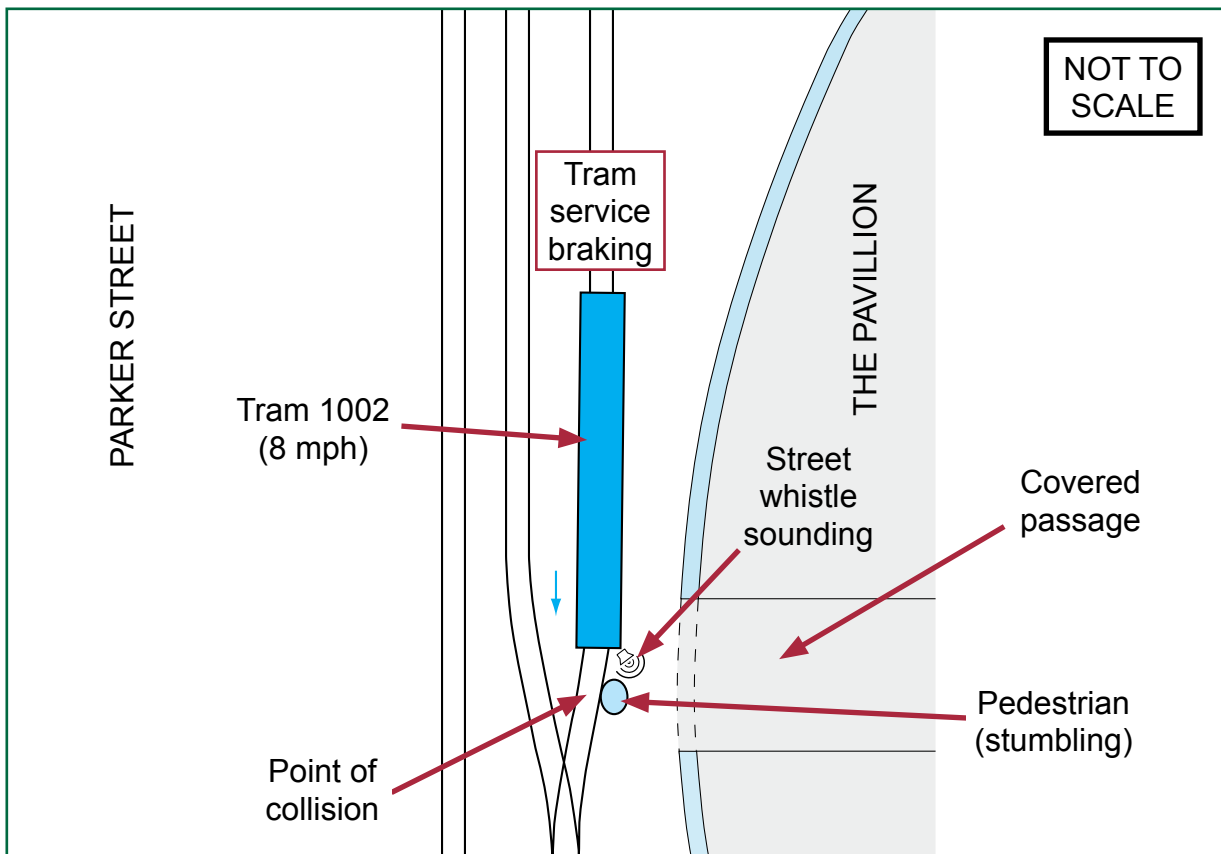
Figure 7: Positions of tram and pedestrian approximately 1 second before the accident

- 32 The CCTV footage shows the pedestrian attempting to stop immediately before crossing in front of the tram then stumbling (figure 7). The tram at this time was continuing to brake and sound its street whistle. The data recorder indicates that the speed of the tram was 8 mph (13 km/h) when the pedestrian was struck.

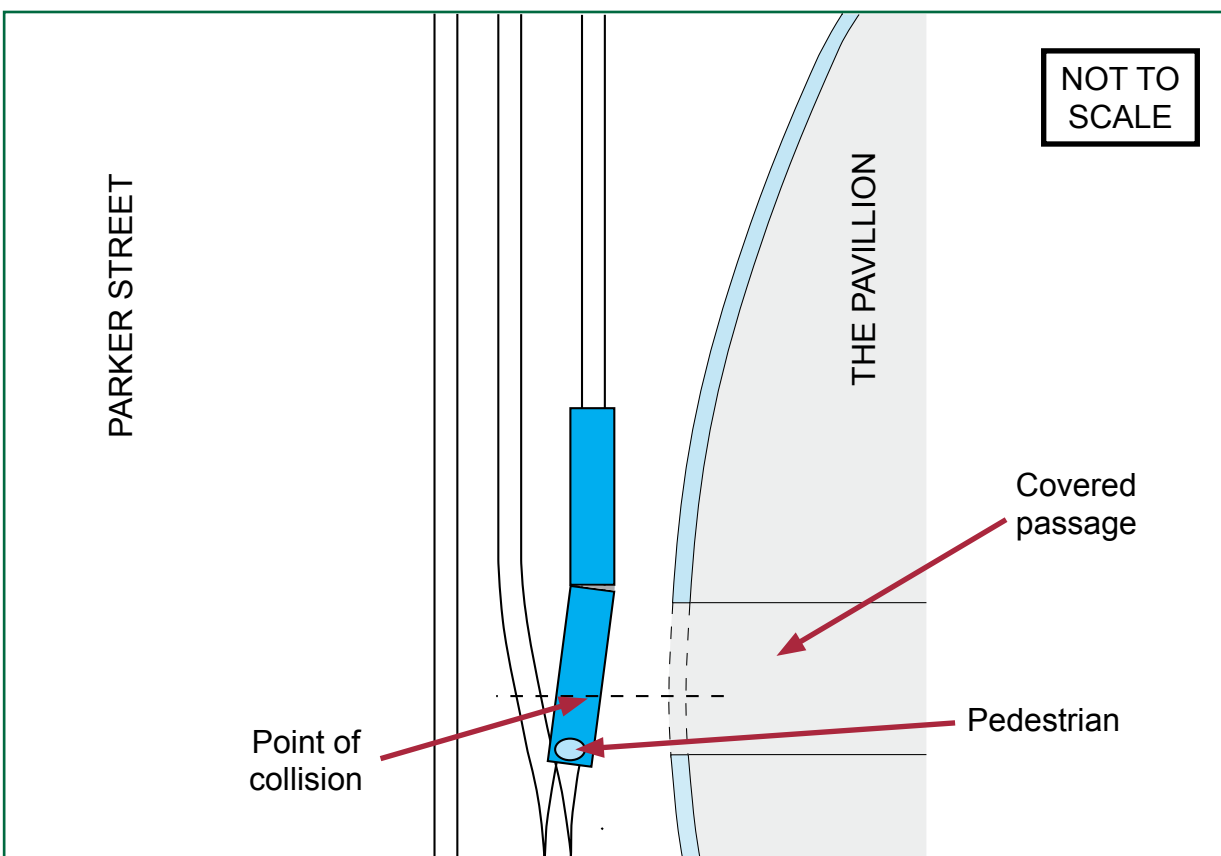
Figure 8: Positions of tram and pedestrian following the accident

- 33 The driver stopped sounding the tram whistle and applied the hazard brake (figure 8). This was within 2 seconds after the collision and when the tram was travelling at 7 mph (11 km/h).

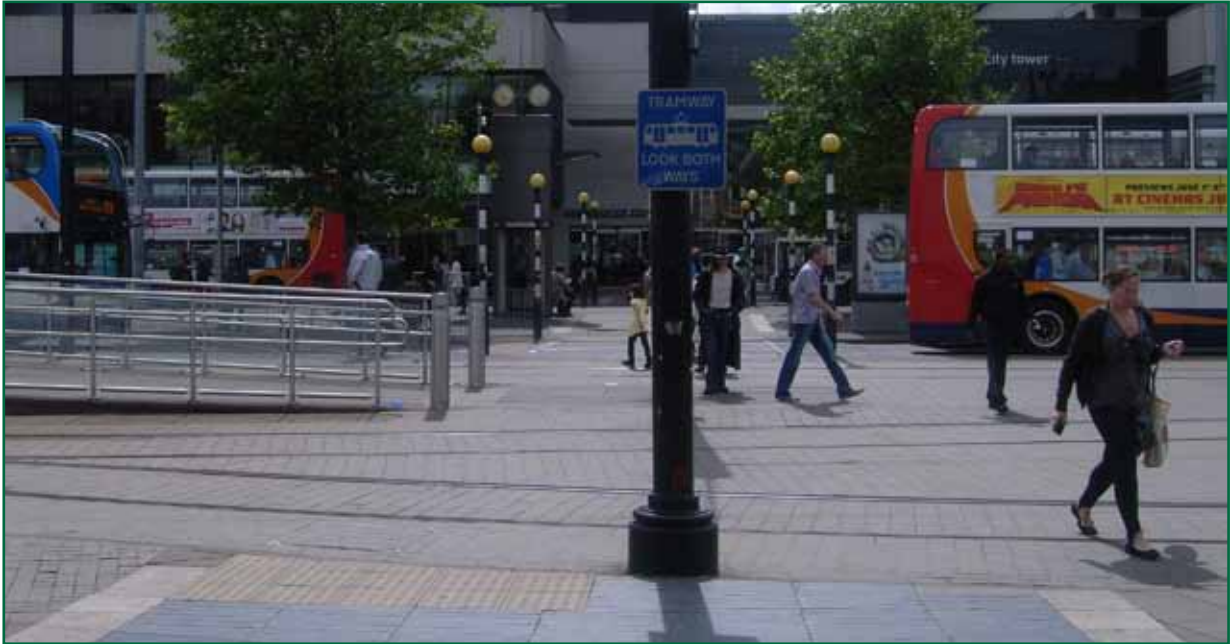
Figure 9: The approach to the tram lines from the covered passage

- 68 There are visual prompts present alerting pedestrians of the presence of the tram lines (paragraph 52). The visual prompt provided by the change of paving begins approximately 4 metres before reaching the passage exit. At this point pedestrians walking at a typical speed of 3 mph (5 km/h) have approximately 5 seconds to look for an approaching tram before reaching the first tram line. Beyond this point moving towards the tram lines, the distance visible to pedestrians increases to the full length of the Pavillion to the north of the covered passage, ie the full length of the tram lines in Parker Street. The street layout possibly contributed to the accident by reducing the available sighting, and consequent reaction times available, for both the pedestrian and the tram driver. However, in this case, these times were reduced substantially because the pedestrian was running.

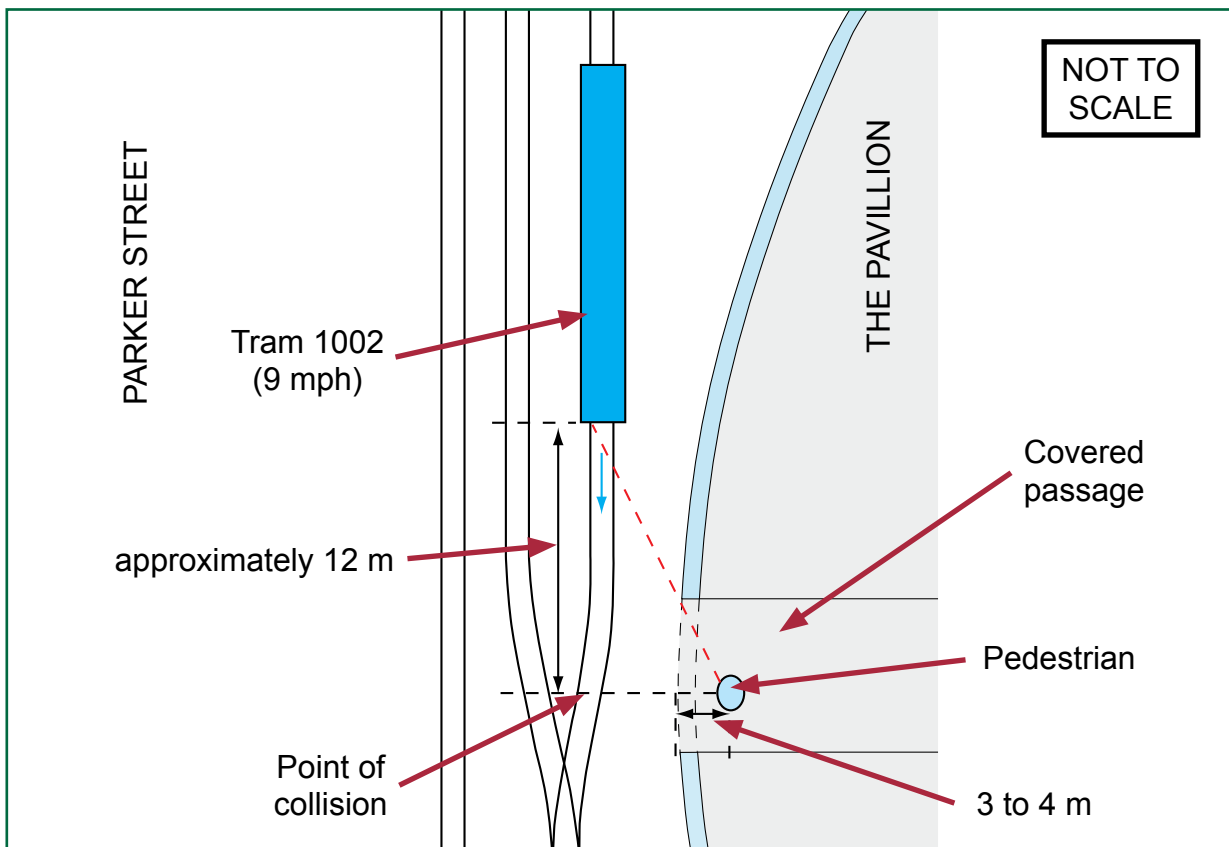
Figure 10: Relative positions of tram 1002 and pedestrian when the tram was visible

- 53 From analysis of the positions of the tram and the pedestrian, based upon the CCTV footage, the tram would have been visible to the pedestrian when he was 6 to 7 metres from the nearest running rail. At this point the pedestrian was 3 to 4 metres from leaving the covered passage and corresponds to a time when the tram was approximately 12 metres from the crossing. For the running pedestrian, based upon his approximate speed measured from the CCTV footage, this was about 3 seconds before reaching the tram lines (figure 10).
