RAIB Bulletin 04/2011

Derailment on the Bure Valley Railway, Norfolk 30 May 2011

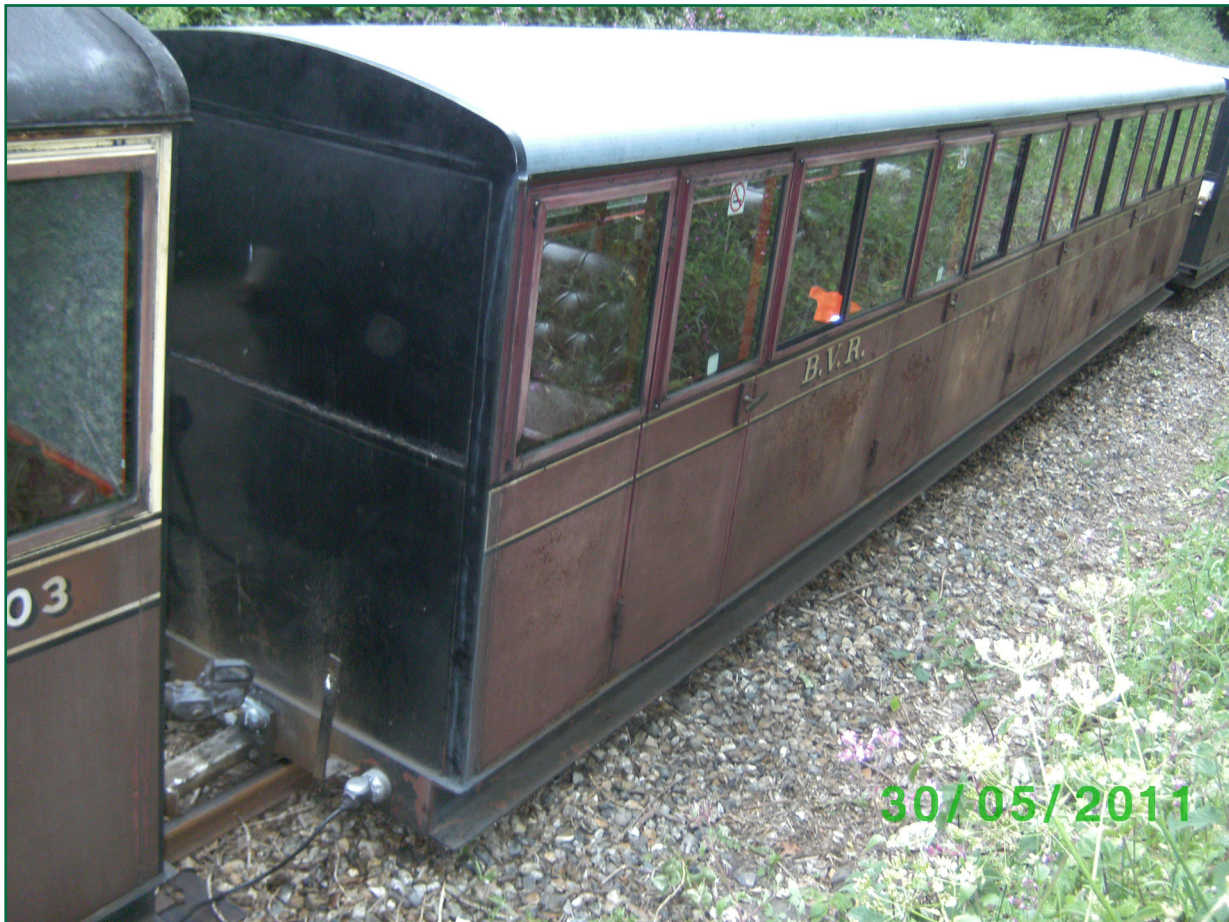
- 2 At approximately 15:25 hrs on 30 May 2011, the leading bogie of the second coach of the 14:40 hrs train from Wroxham derailed close to the village of Bampton, about two miles (3.2 km) from Aylsham (figure 2). The train was formed of nine coaches and was hauled by a steam locomotive.
- 3 When the derailment occurred, the train was running at about 16 mph (26 km/h). The driver became aware of jerking and stopped the train. No-one was injured as a result of the derailment. Most of the 61 passengers on the train completed their journeys by walking to Aylsham; a few were transported by road.

Figure 2: Derailed second coach (courtesy of the Bure Valley Railway)

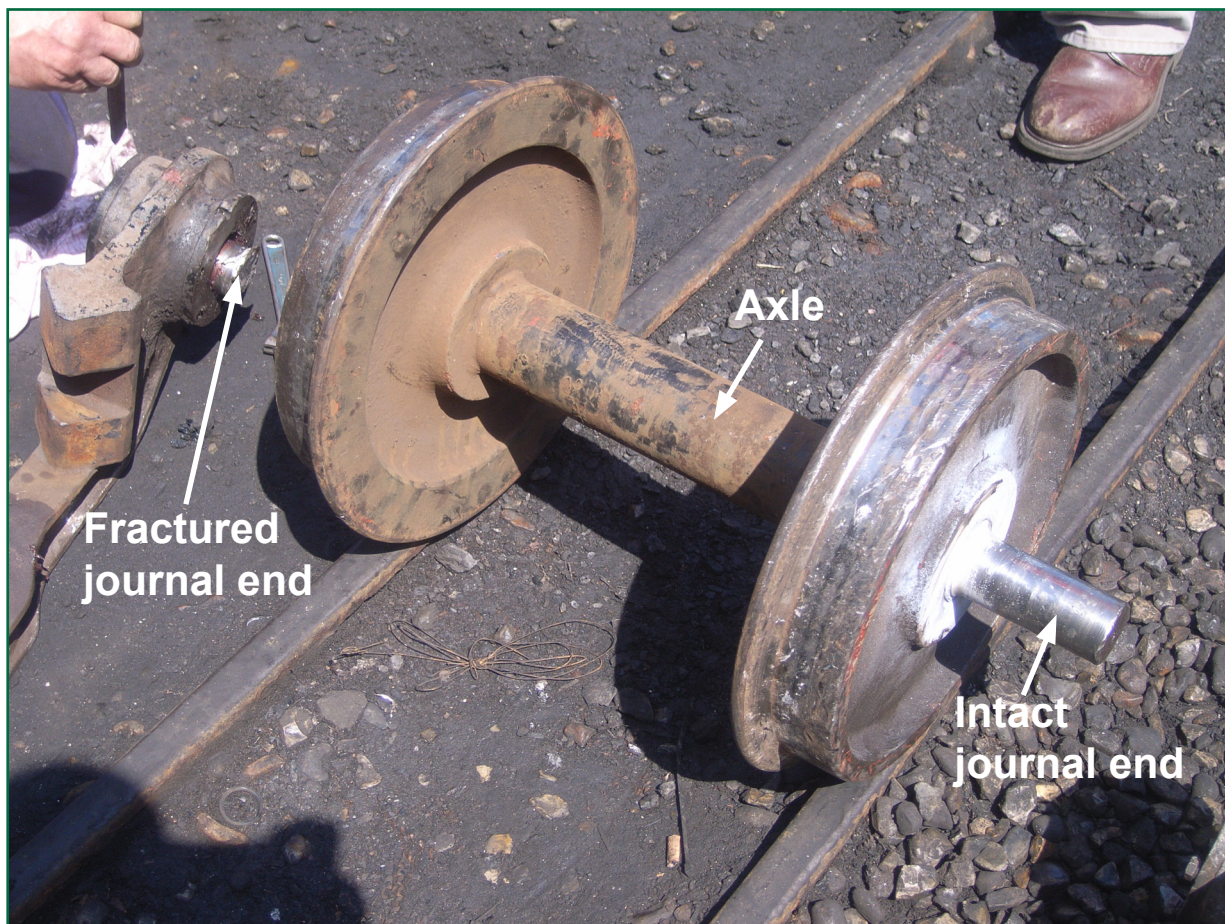
- 4 The BVR quickly established that the derailment was caused by the failure of an axle fitted to the derailed coach; one of the journal ends¹ had fractured from the remainder of the axle adjacent to one of the wheels (figures 3 and 4).

Figure 3: The failed wheelset (showing the unbroken journal end)

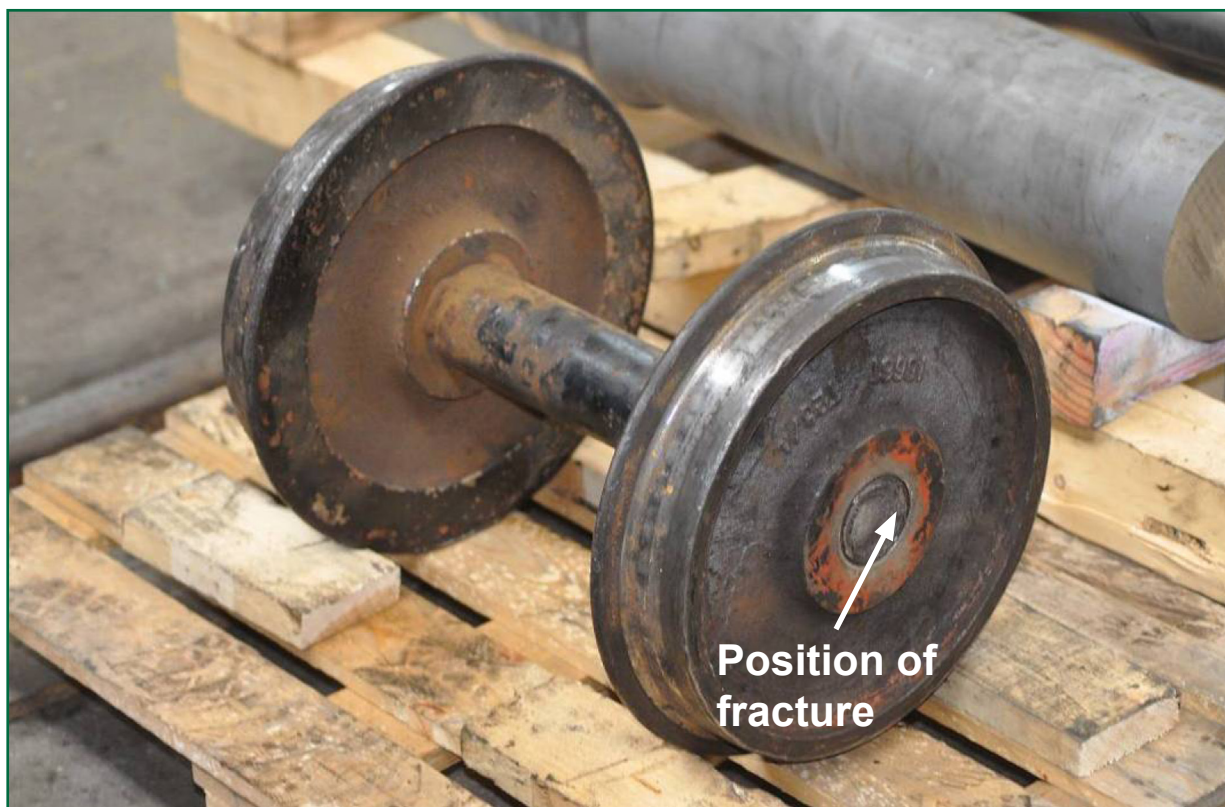
Figure 4: Wheelset showing the position of the fracture (courtesy of Serco Technical Consulting Services)

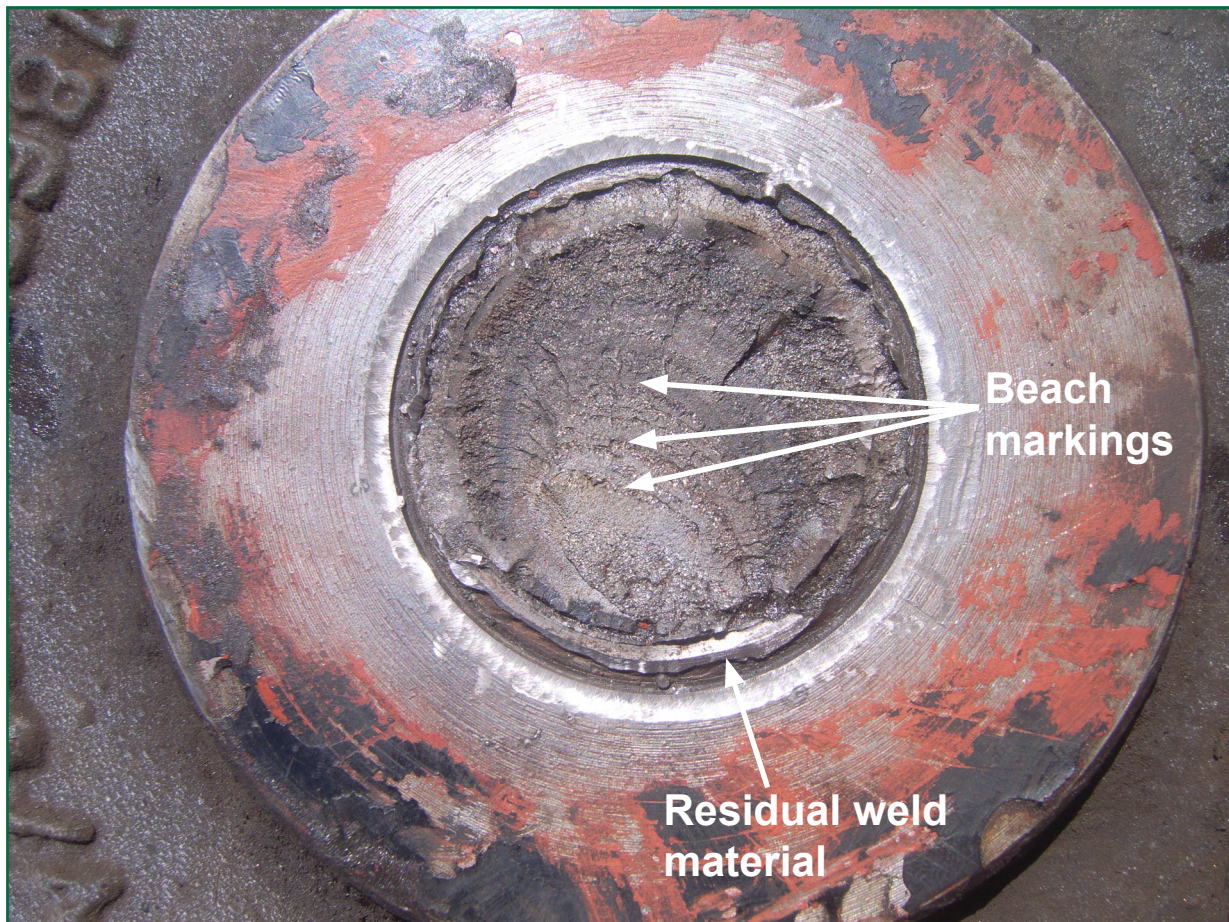
Figure 5: Fracture face of the axle

- 8 The metallurgical examination concluded that the fatigue forces in the axle caused the growth of cracks, which were produced when the axle journal end was built up with weld metal. This ultimately led to the axle's failure.

- 9 The beach markings, which are characteristic of fatigue failures, (figure 5) were very coarse and appeared to have some narrow bands of brittle failure between them. This indicated that the crack propagation was fairly rapid.

- 10 The measured hardness values of the material suggest that the welding was carried out without pre-heating³ of the journal end causing hard brittle areas (known as martensite) to form in the material.

- 11 The tendency for cracks to form in the martensite is greatly increased if hydrogen is present in the weld metal. Hydrogen content can be minimised by ensuring that the weld electrodes are dry before use; the wide crack opening that was observed during the metallurgical examination suggests that high hydrogen content was present and so may have been caused by the use of damp electrodes.

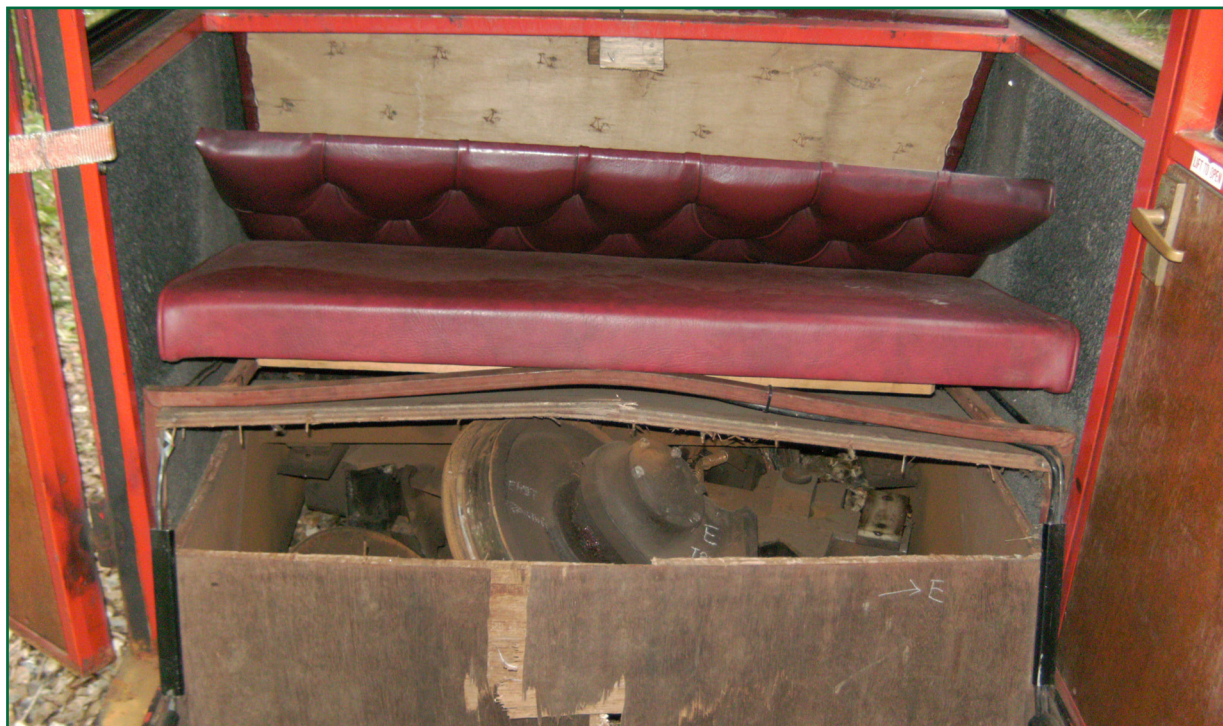
- 21 The potential consequences of the accident were increased because when the axle failed, and the derailment occurred, the other wheelset on the same bogie forced its way through the plywood floor of the coach into the passenger accommodation (figure 6). Fortunately, this did not injure any passengers.

Figure 6: Incursion of the derailed bogie into the passenger accommodation (courtesy of the Bure Valley Railway)

- 22 The BVR started a programme in 2005 to refurbish its coaching stock that was delivered in 1990, when the railway opened. The refurbishment includes replacing the plywood panels over the bogies with steel panels. The coach that derailed was waiting to be refurbished. Had the failed axle been fitted to a refurbished coach, it is unlikely that the passenger accommodation would have been penetrated.
