Rail Accident Investigation Branch

Rail Accident Report

**Collapse of the overhead line near to Jewellery
Quarter Tram Stop, Midland Metro
20 April 2011**

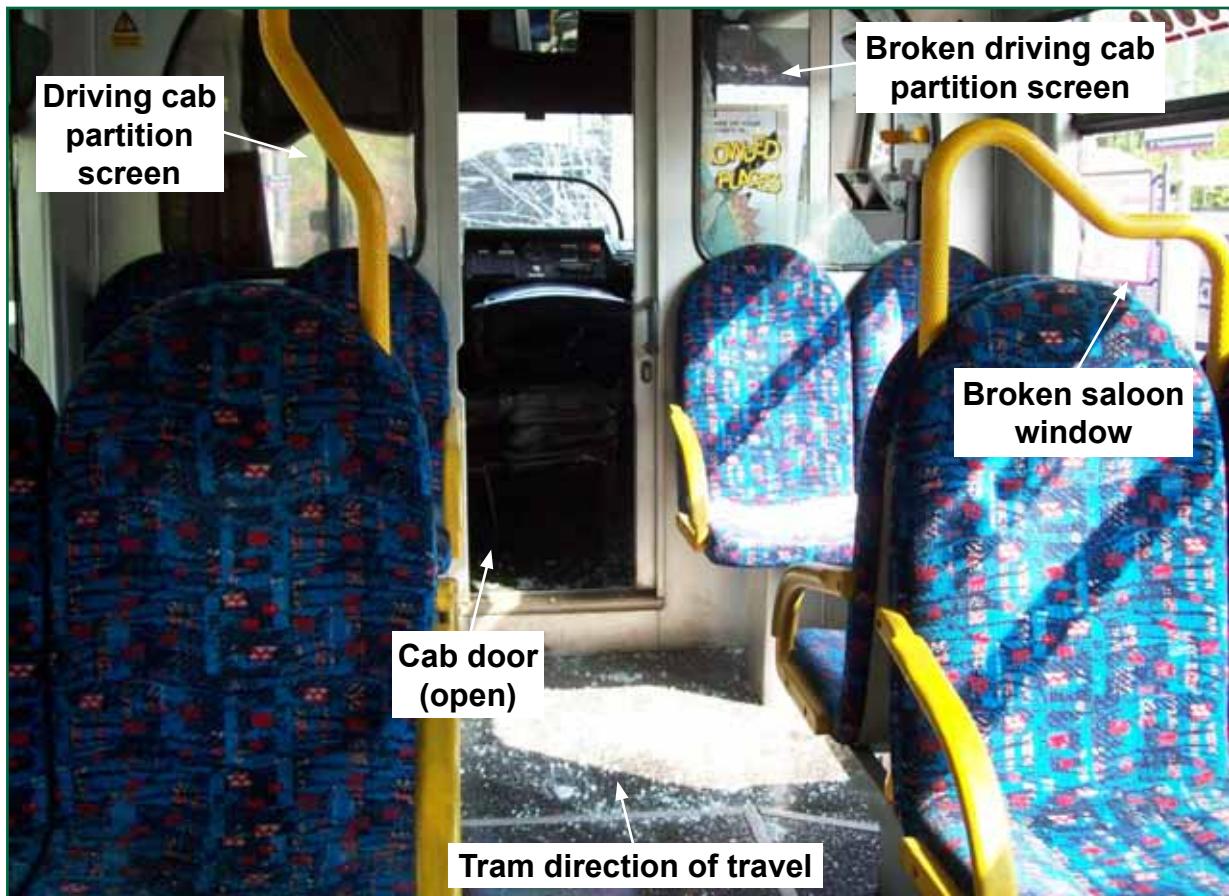
Figure 4: Damage to the saloon interior at the leading end of Tram 13 - the cab door is shown in the open position (image courtesy of National Express Midland Metro)

- 44 By 13:25:02 hrs the tram CCTV system recorded the right-hand side saloon doors sustaining damage. It also shows that the OLE collapse had now overtaken the tram, with the cantilever at 18606 pole having detached and dropped in front of the windscreen of the tram's leading cab, which it then struck. Immediately afterwards the front-most right-hand side saloon window and the right-hand side driving cab partition screen both shattered, showering the passenger saloon with glass.

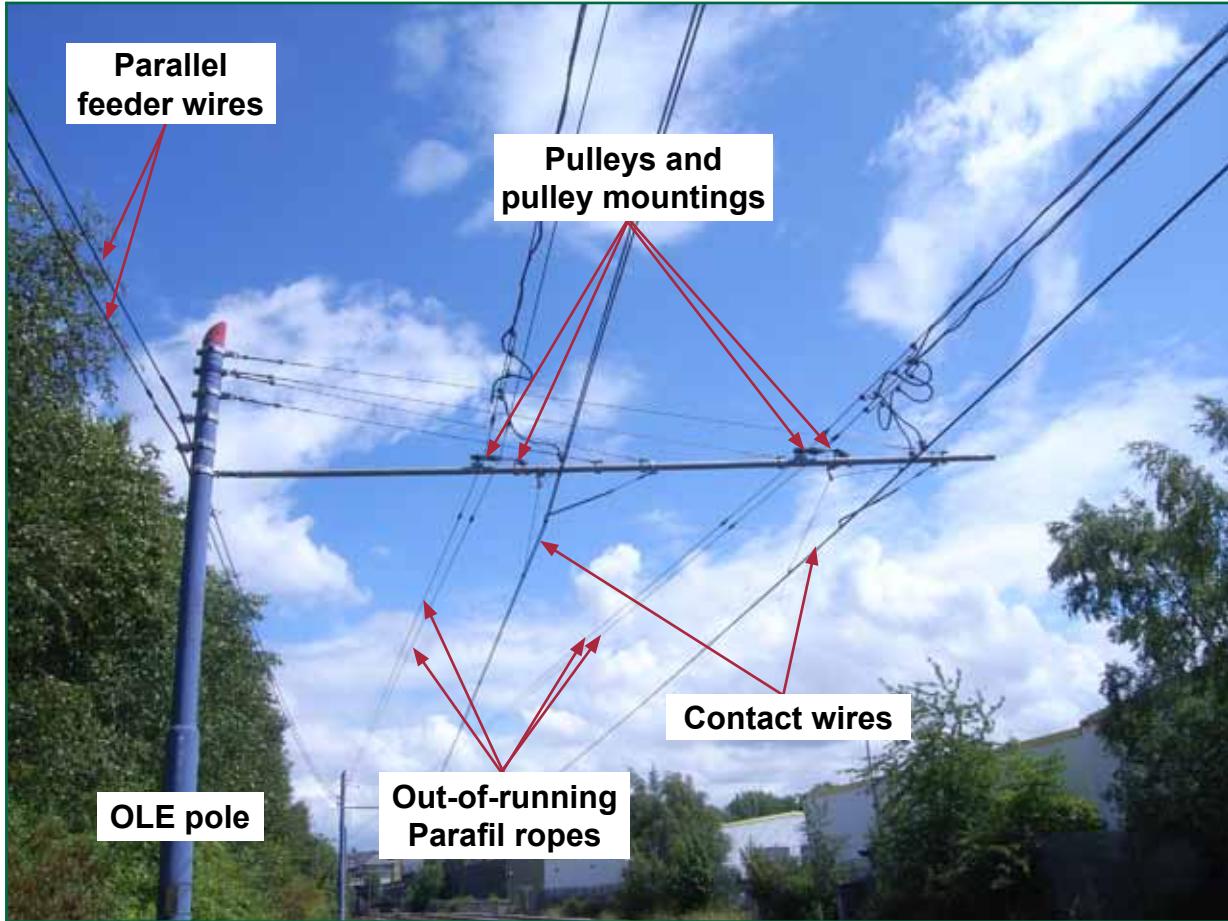
Figure 11: Post-incident photograph of overlap equipment at 18512 pole

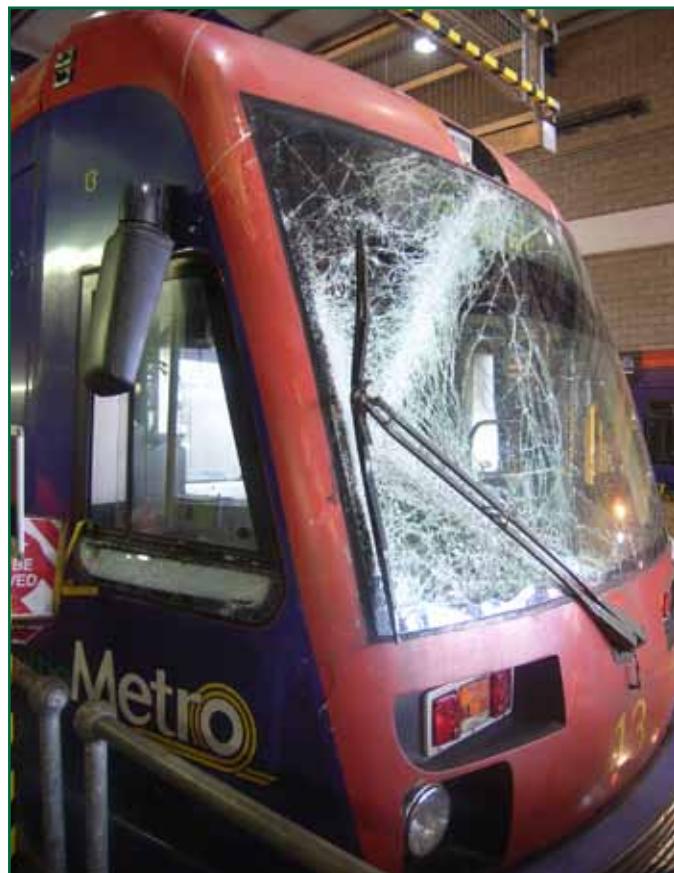
Figure 12: Damage to front windscreens and cab side window of Tram 13

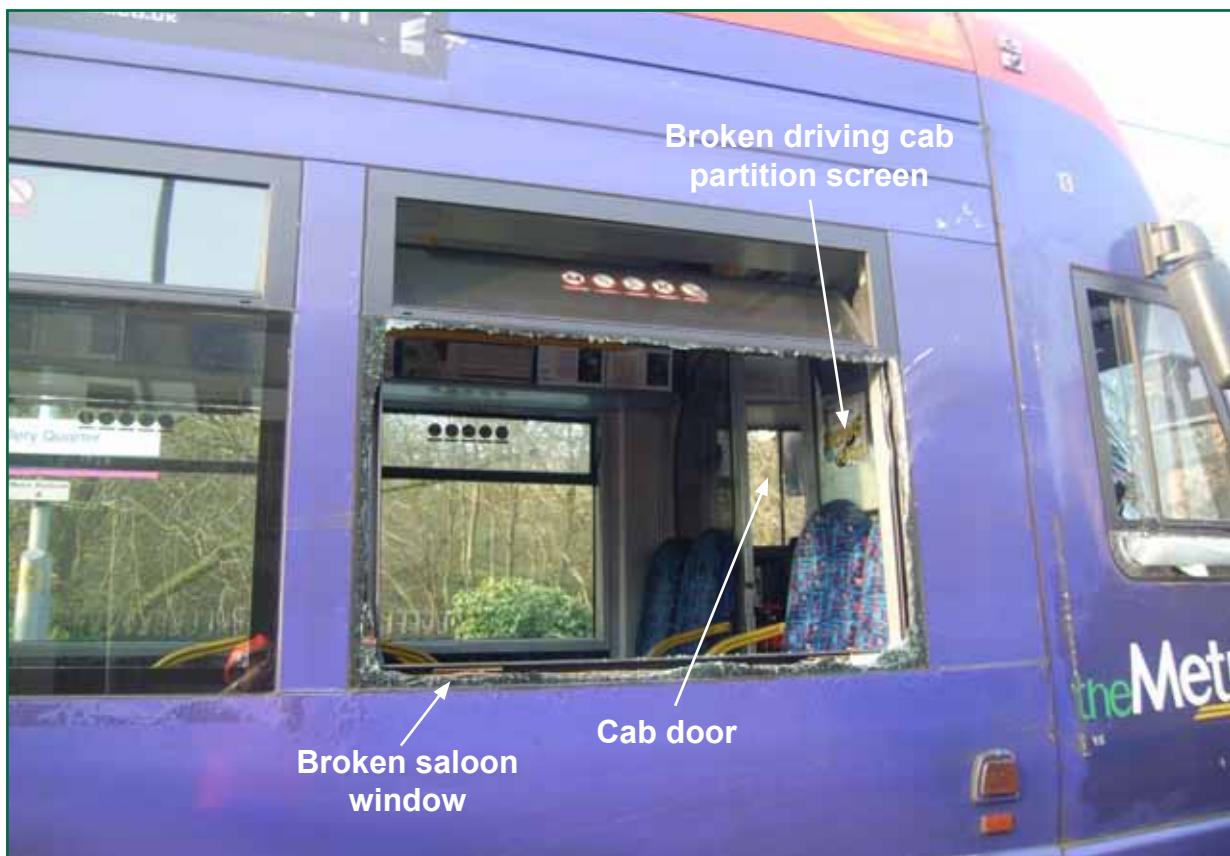
Figure 13: Damage to saloon window and driver's screen glass on the right-hand side leading end of Tram 13

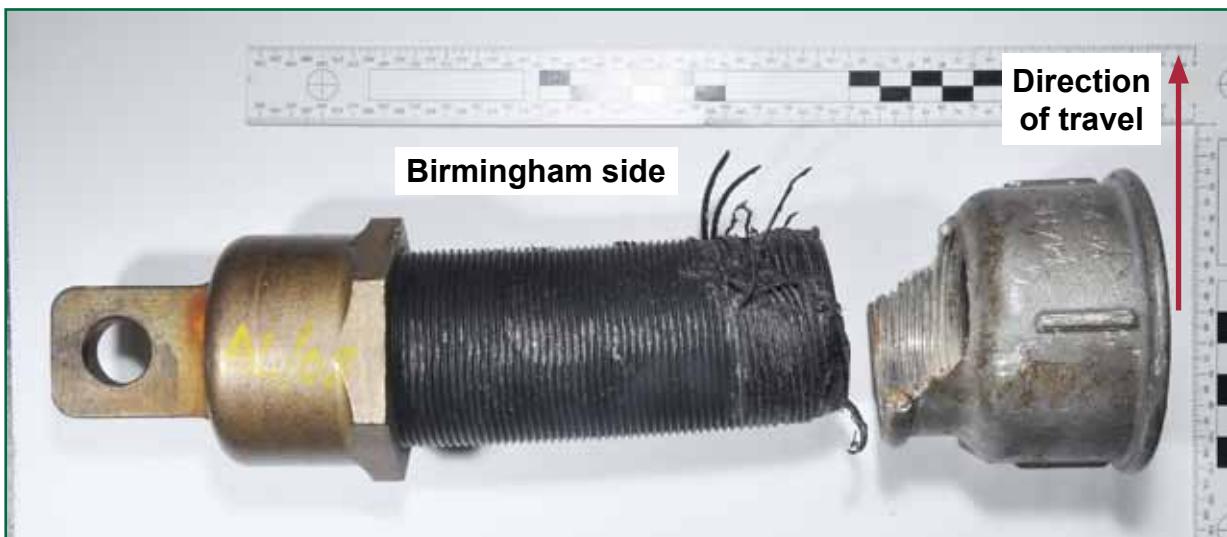
- 61 **The partial detachment of the cantilever at 18512 pole was due to the fracturing of the reducing sleeve.**
- 62 Examination of the bracket arm showed that the bracket foot assembly (figure 14) had parted at the point where the nylon insulator threads into the reducing sleeve, leaving both items damaged. The clevis cover and insulator remained attached to the pole bracket by the clevis pin, with the main body of the reducing sleeve remaining with the cantilever. The examination also found that the delta suspension connecting to the contact wire on the Wolverhampton line had been ripped from the clamp connecting it to the cantilever (figure 15) and that the register arm on this line was also disconnected. The Wolverhampton out-of-running pulleys had become separated from the cantilever at 18512 pole, although the out-of-running ropes and contact wires remained intact.

Figure 14: Damage to the bracket foot assembly of 18512 pole

- 67 The nylon insulator was deformed in the direction of Birmingham and slightly upwards (figure 14). The thread at the reducing sleeve end of the insulator was damaged, with many threads being deformed or stripped on both sides. Taken together with the distortion of the reducing sleeve segments this clearly indicates that the overload force was applied in the direction of Birmingham.
- 68 There are two credible sources of this overload, namely;
- the way in which *operating loads* were able to act (the less likely cause - see paragraph 69); and
 - the introduction of an *abnormal load* following the parting of a Parafil rope (the most likely cause - see paragraph 103).

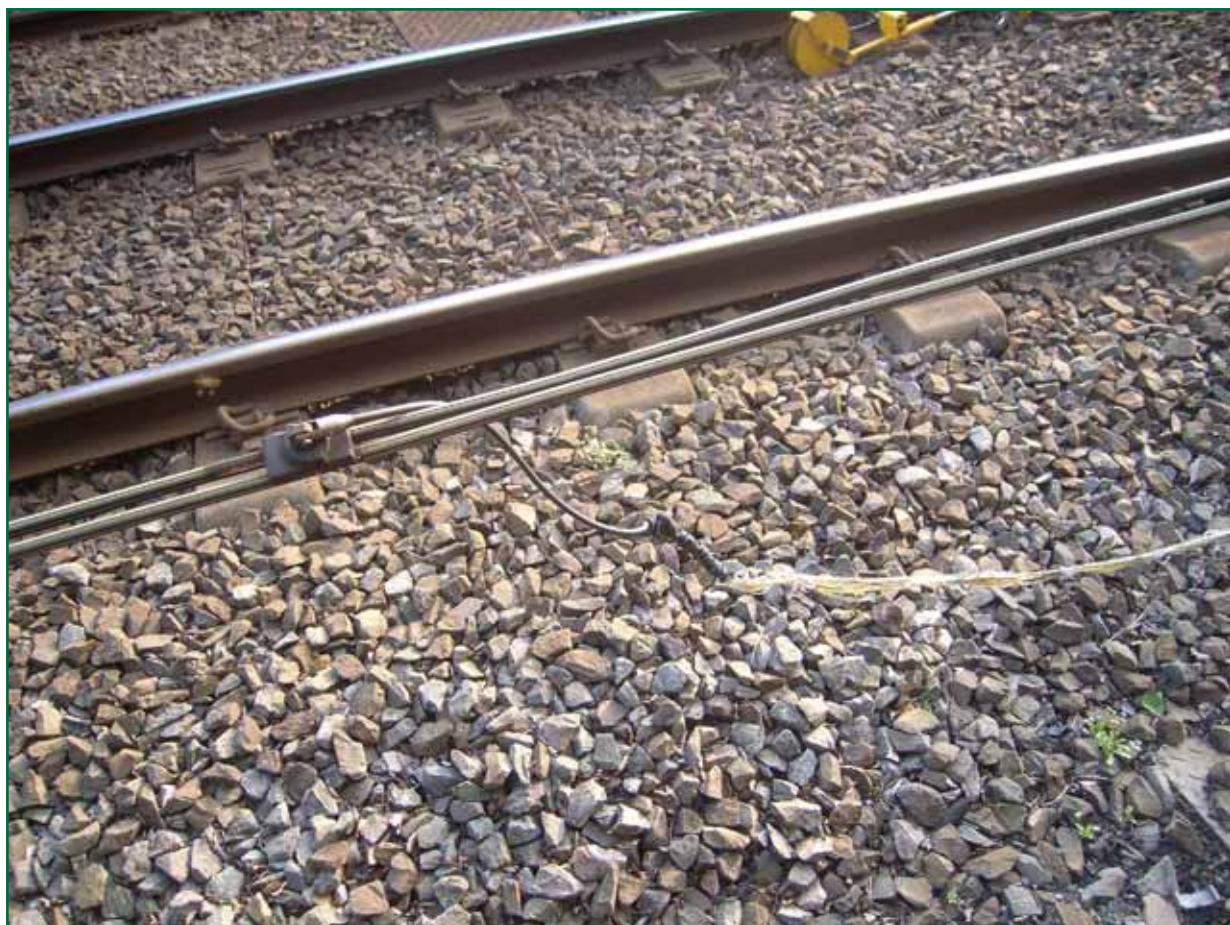
Figure 15: Damage to the delta suspension of the Wolverhampton contact wire

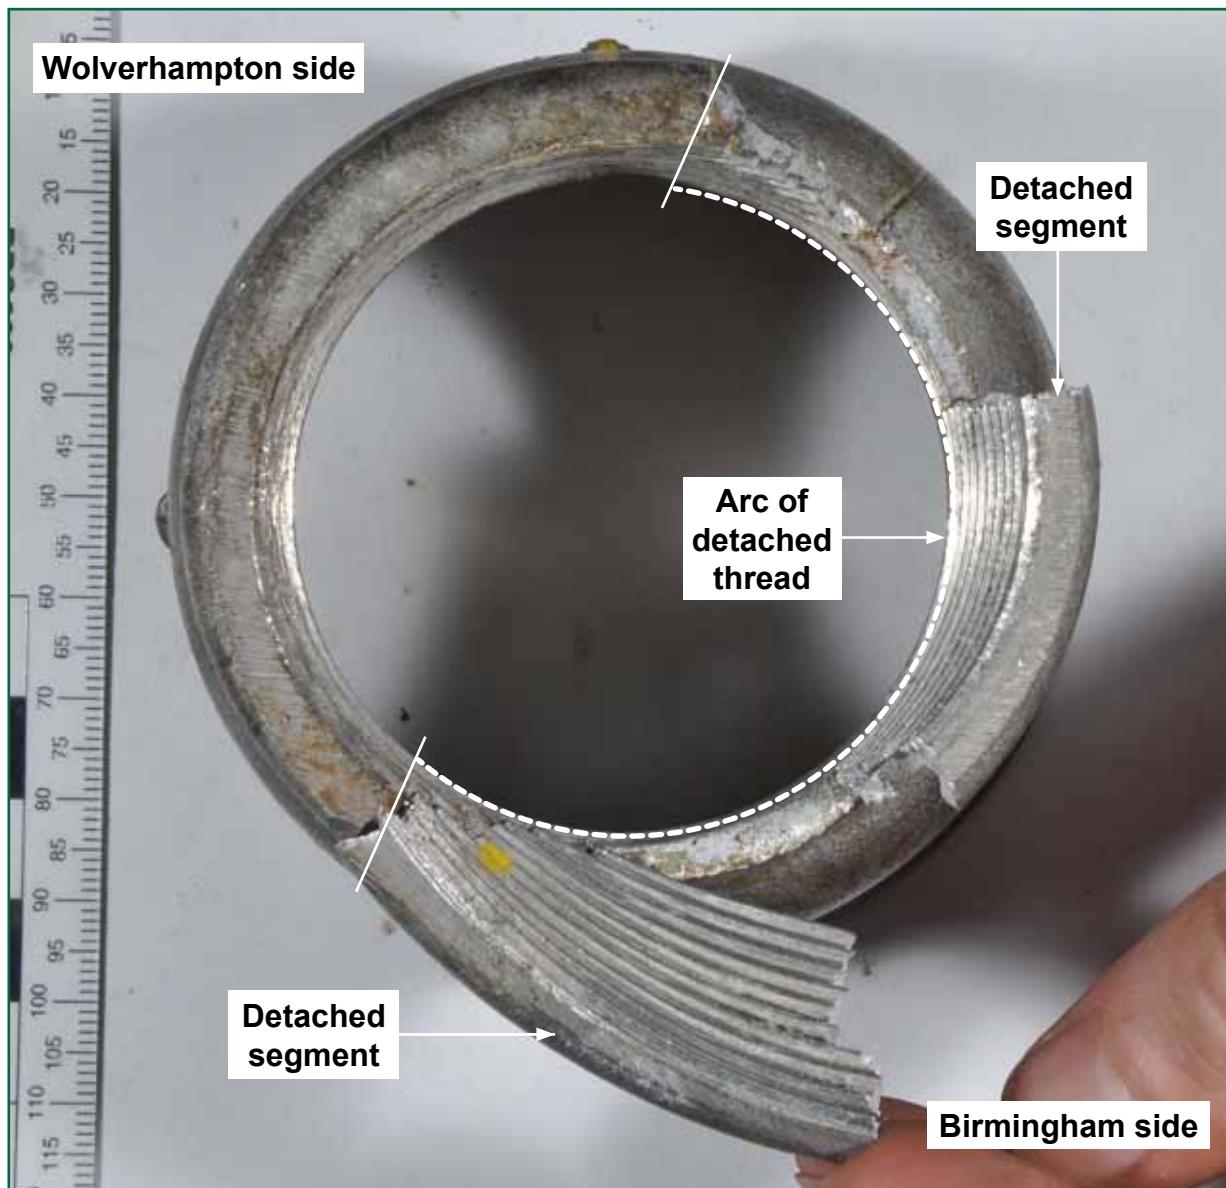
- 65 Metallurgical examination indicated that the reducing sleeve failed in a brittle manner due to mechanical overload. There was no evidence of significant impact damage, fatigue or significant casting defects. Although there was evidence of superficial corrosion, this had not caused significant material loss.

- 66 The reducing sleeve was cracked around the thread run out of the smaller diameter thread (ie where it meets the insulator), with the crack extending approximately 180° around the thickness of the sleeve and then longitudinally through this thread (figure 16). This caused the detachment of segments on the Birmingham side, from approximately the 1 to 7 o'clock positions. These segments were distorted in the direction of Birmingham as they separated from the sleeve.

Figure 16: Damage to the reducing sleeve - two of the detached pieces of the smaller diameter thread have been re-positioned for photographic purposes

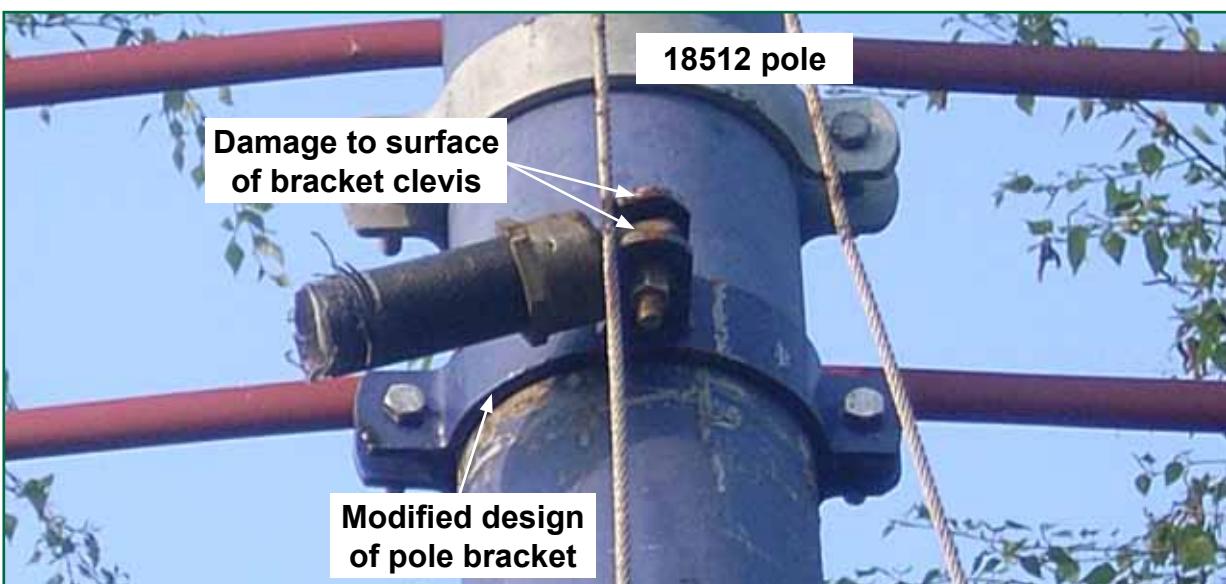
- 90 Post-incident inspection showed evidence of contact between the bracket clevis and the clevis cover of the bracket foot assembly recovered from 18512 pole. The bracket clevis had either a rough or damaged face (figure 21) whilst the clevis cover showed both wear marks and evidence of rust (figure 22). This rust could only have resulted from contact with a steel item, such as the pole bracket (the clevis cover is made from aluminium bronze and would not produce rust).

Figure 21: Modified design of pole bracket in-situ at 18512 pole following the accident

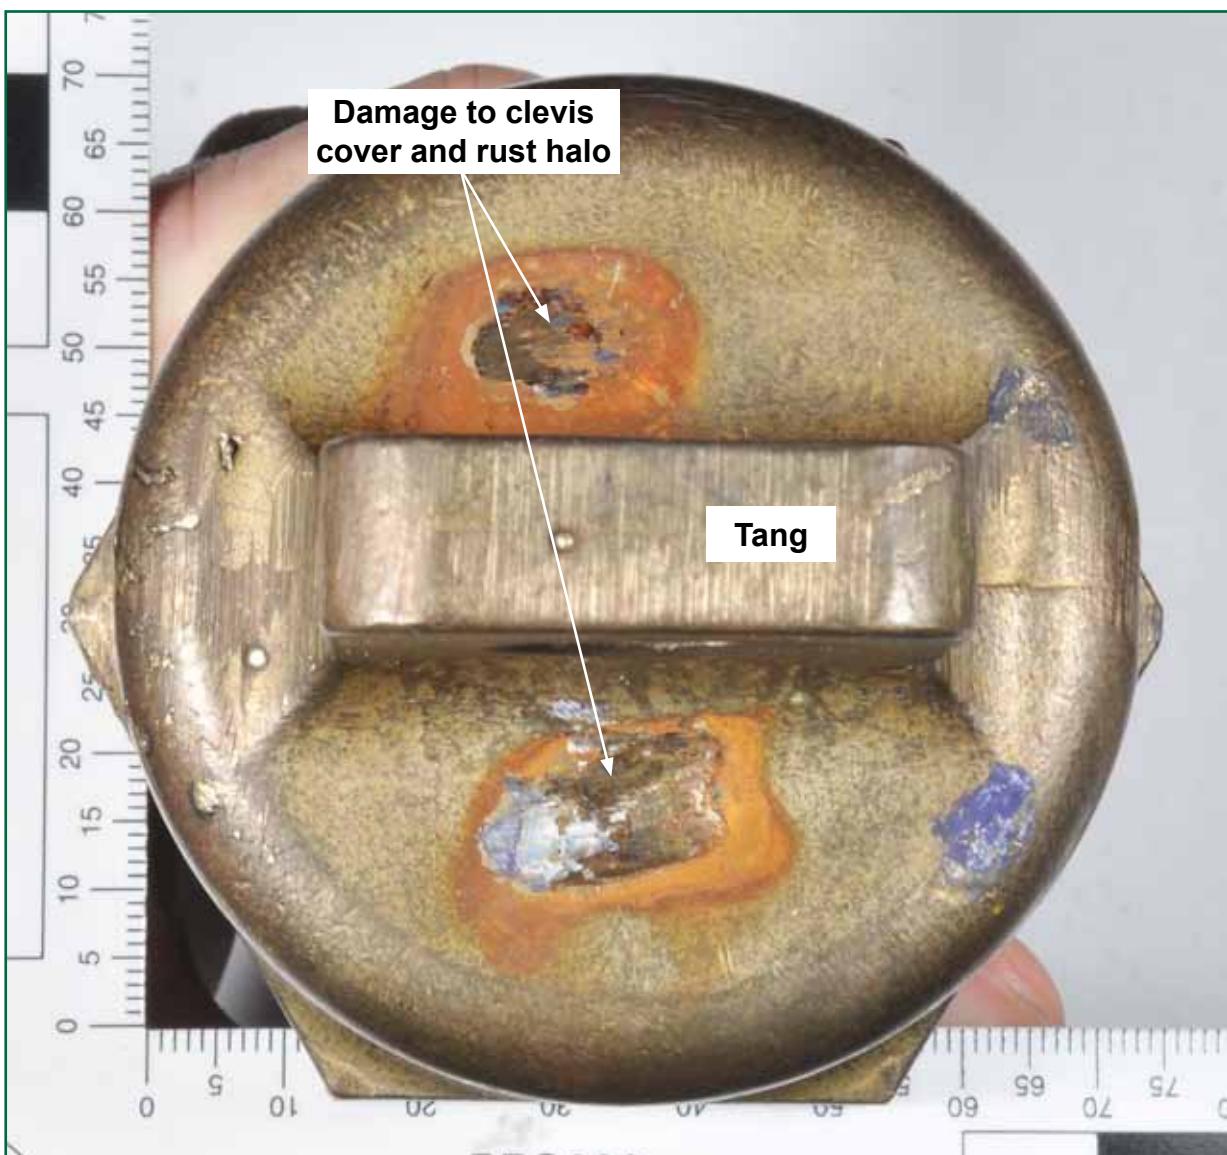
Figure 22: Marks on the clevis cover of the bracket foot assembly taken from 18512 pole

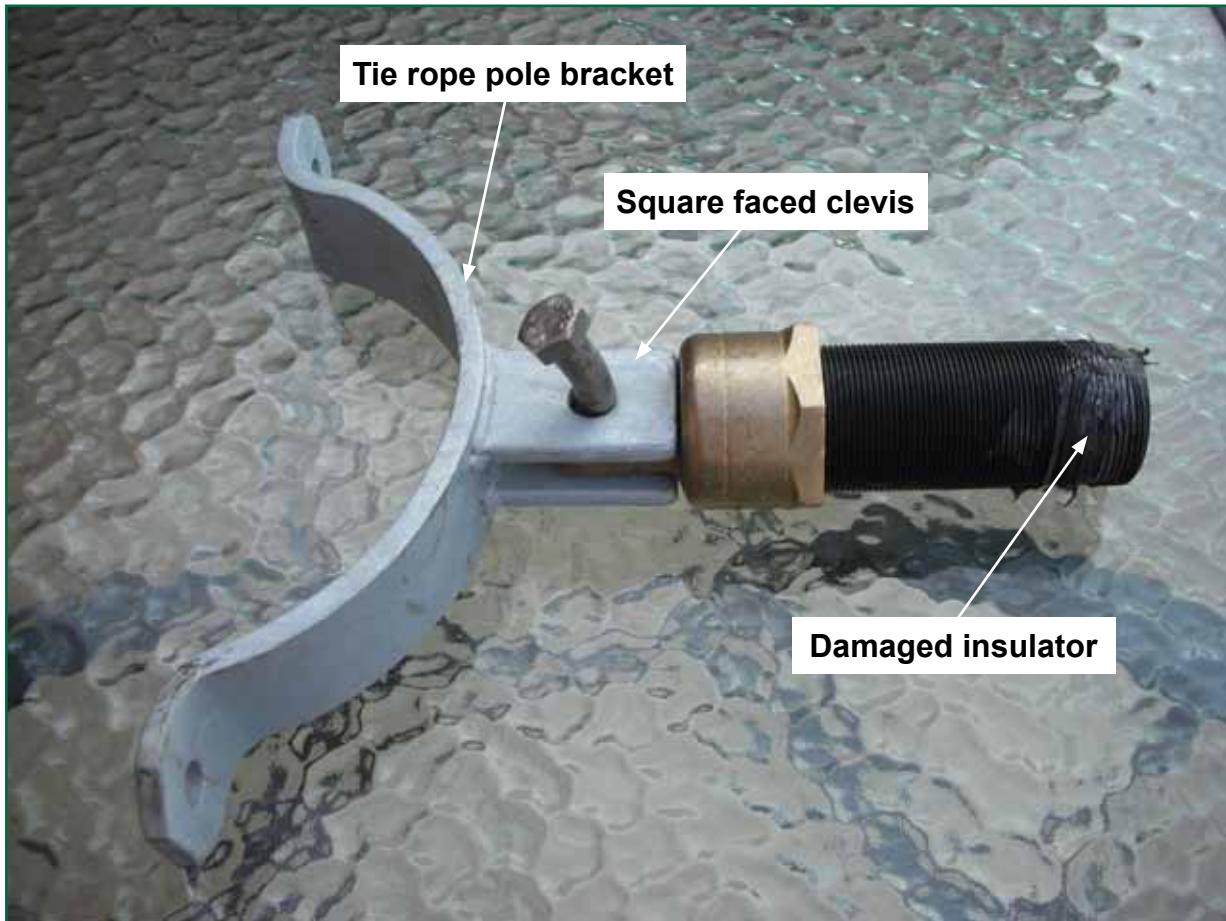
- 91 It is also of note that, during recovery operations following the accident, there was a comparable failure of a reducing sleeve on another pole whilst the contact wires were being connected. In this second failure, the bracket foot was unable to rotate because it had been fitted in error to a tie rope pole bracket (figure 23) which had a square-faced profile.
- 92 Despite there being evidence of contact between the bracket clevis and clevis cover at 18512 pole, analysis showed that, whilst this may have caused some restriction of movement, the friction created would have been insufficient to react the magnitude of bending moment required to yield the reducing sleeve ie the clevis cover would slip across the face of the bracket clevis before the reducing sleeve started to yield.

Figure 23: Bracket foot assembly which failed post incident, connected to a tie rope pole bracket featuring a square faced clevis (image courtesy of National Express Midland Metro)

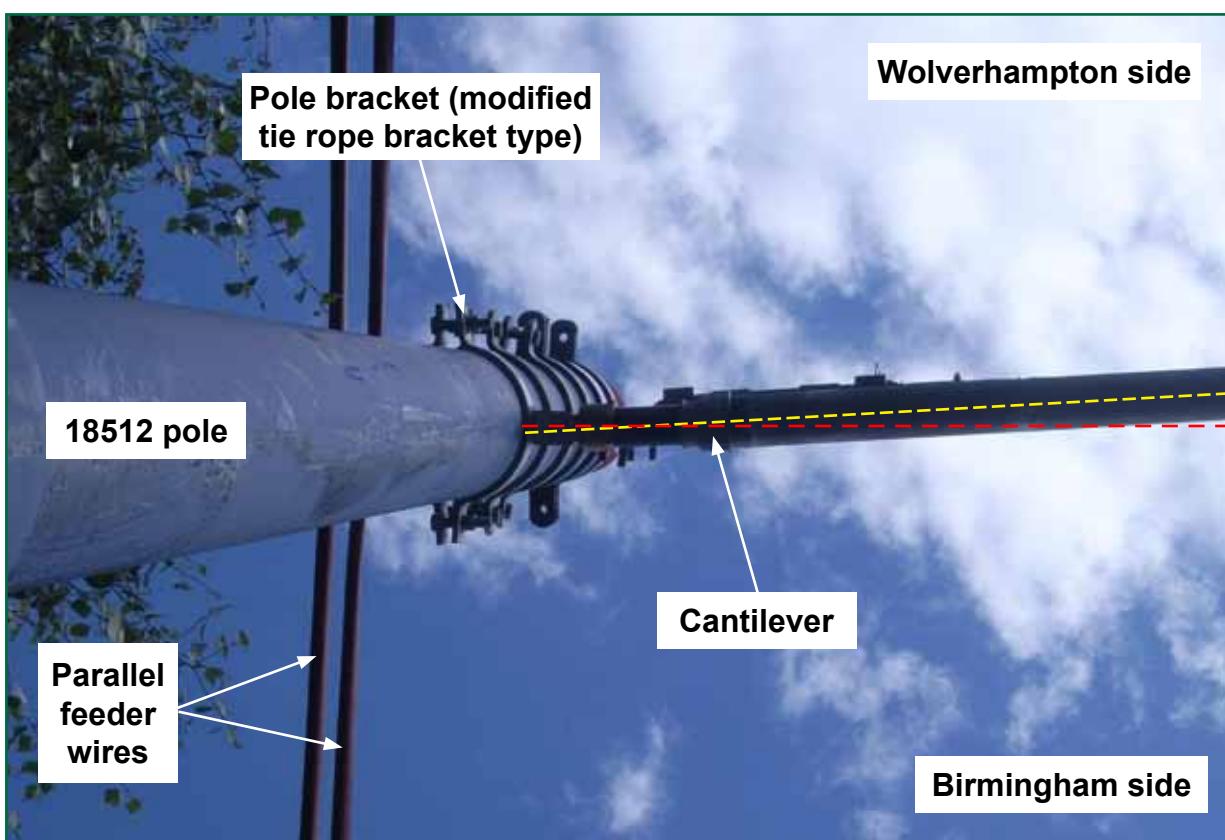
- 76 The distortion of the reducing sleeve segments and the deformation of the nylon insulator indicate that the cantilever was deflected towards Birmingham prior to the sleeve failing. Measuring the angle of deformation of the insulator (some of which may have been caused as a result of the dewirement) and extrapolating it over the typical cantilever length (7.97 metres) indicates that the end of the cantilever at 18512 pole was deflected by no more than approximately 550 mm from its position when perpendicular to the centre line of the track.

Figure 24: Photograph of 18512 pole taken in July 2011 showing insulator deformation

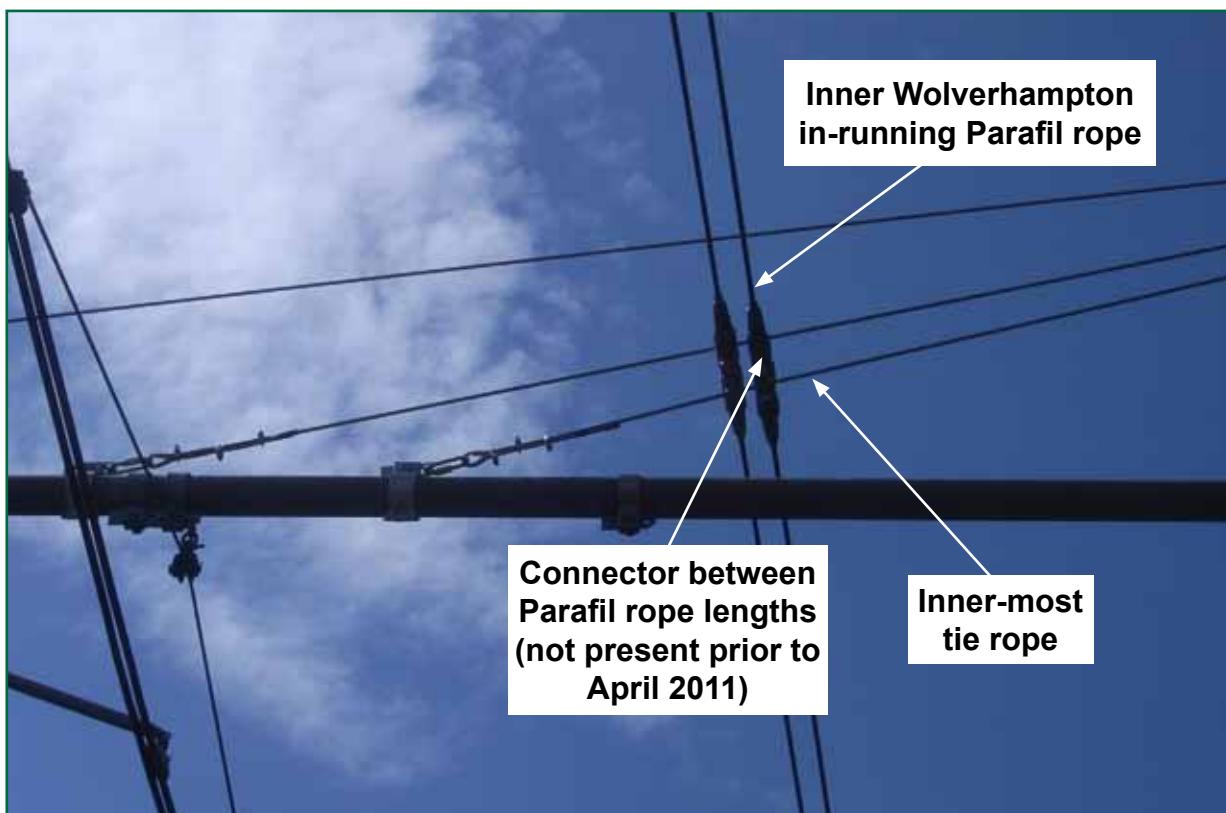
110 The damage to this rope could have occurred either prior to the accident or as part of the collapse of the OLE which followed it, although it is significant that the Parafil seems to have parted where it ran in close proximity to the tie ropes supporting the cantilever at 18432 pole. The evidence available to the RAIB is that the parted tie rope ran between the inner-most and middle tie ropes, although it is inconclusive as to whether the Parafil rope was able to touch these tie ropes prior to April 2011. However a post-incident inspection of 18432 pole in July 2011 showed that the inner of the two Wolverhampton in-running Parafil ropes was touching the inner-most steel tie rope as it passed over the cantilever (figure 25).

Figure 25: Inner Wolverhampton in-running Parafil rope touching a tie rope at 18432 pole – photograph taken in July 2011
