Rail Accident Investigation Branch

# Rail Accident Report

**Train passed over Lydney level crossing with  
crossing barriers raised  
23 March 2011**

# Train passed over Lydney level crossing with crossing barriers raised, 23 March 2011

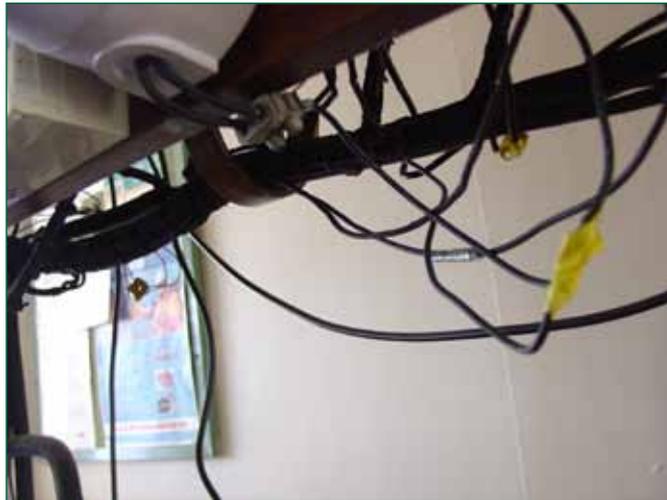
- 52 Network Rail undertook full functional testing of the crossing after the incident. This testing was undertaken after the defective contacts on the barrier pedestal were replaced, and before RAIB attended site (RAIB did not attend immediately after the incident because, although a serious incident<sup>9</sup>, Network Rail did not report it to RAIB until the following day). Network Rail's testing did not reveal a fault which would explain why the annunciator failed to sound when expected. Possible reasons include a temporary high resistance electrical contact (ie a dirty electrical contact), or poor connections in the disorganised wiring seen beneath the instrument shelf (figure 8).

Figure 8: Disorganised wiring beneath the instrument shelf on 7 April 2011

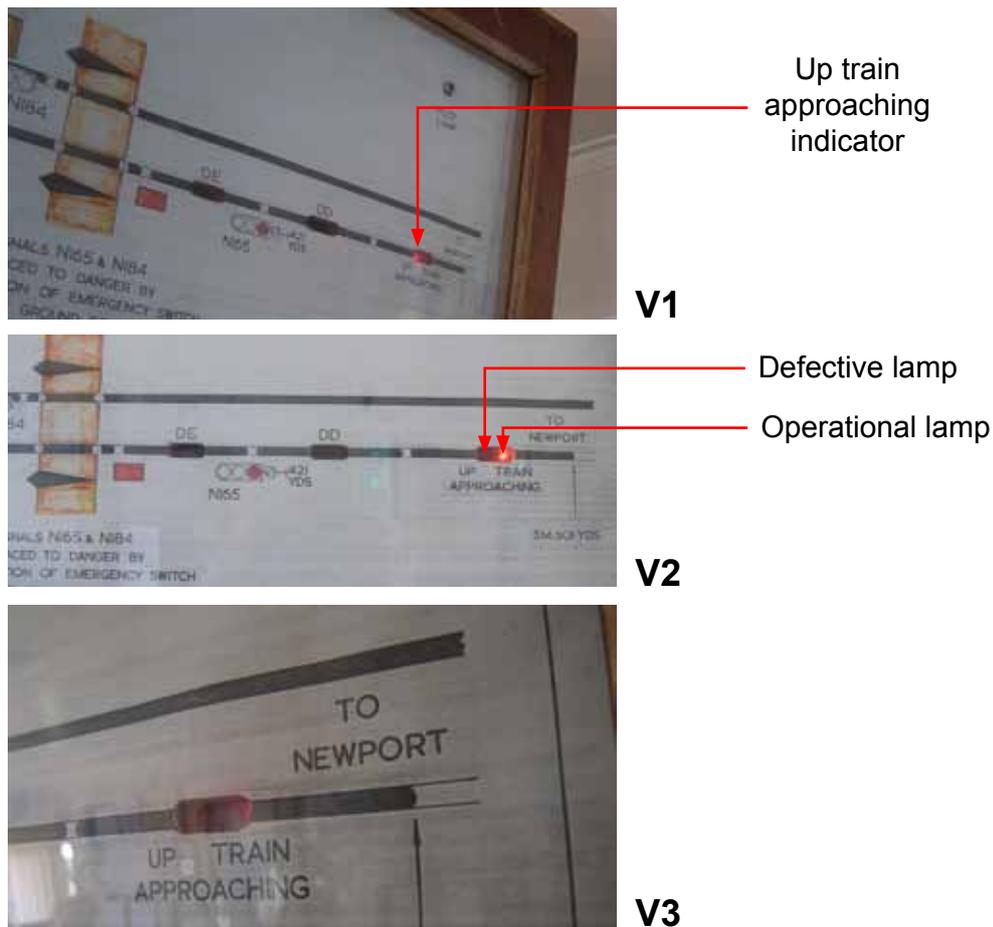
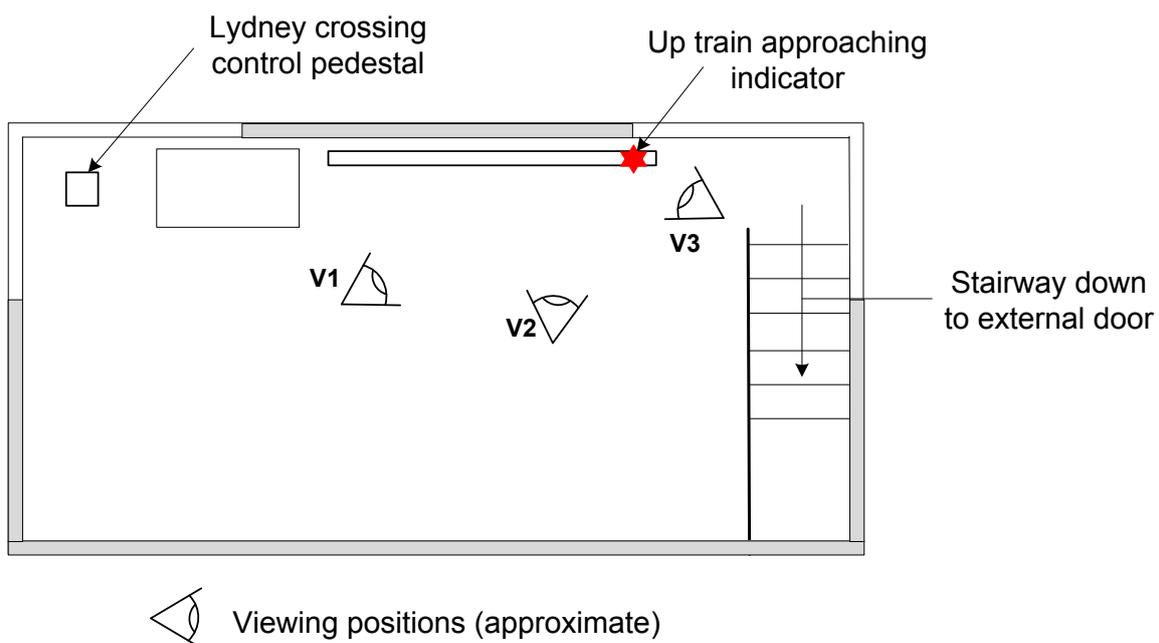
Figure 9: Visibility of up train approaching indicator

- the crossing keeper did not properly examine the diagram.
- 58 Post-incident examination by the RAIB showed that one of the two lamps in the up train approaching indicator was defective (figure 9) and the surface layer of the diagram was detached from the backboard around this indicator.

- 59 When the crossing keeper was deciding whether to raise the barriers manually, train 1M68 was occupying track circuit 1137 and this would have illuminated the up train approaching indicator. Post-incident testing by RAIB showed that, when viewed from directly in front, this indication was easily seen although the left-hand lamp was defective (figure 9, view V2). Viewed from the left (view V1), conspicuity of the indication was poor because the detached surface layer partially obscured the illuminated lamp. Viewed from the right (view V3), the defective lamp and the detached surface layer meant that it was difficult to see that the indicator was illuminated.

- 60 The crossing keeper was standing at the control pedestal when the barriers did not respond to the raise button. He then moved towards the stairway in order to leave the box and raise the barriers manually. It is possible that, while doing this, he viewed the diagram and, due to the diagram and indicator defects, gained the impression that the indicator was not lit.

- 151 RAIB wrote to Network Rail, on 18 April 2011, giving the preliminary findings of the RAIB's investigation. On 12 May 2011, following a further visit to Lydney, the RAIB advised Network Rail that the Lydney diagram was defective.
