# RAIB Bulletin 03/2011

## Derailment at Dalchalm level crossing, Highland, Scotland 23 February 2011

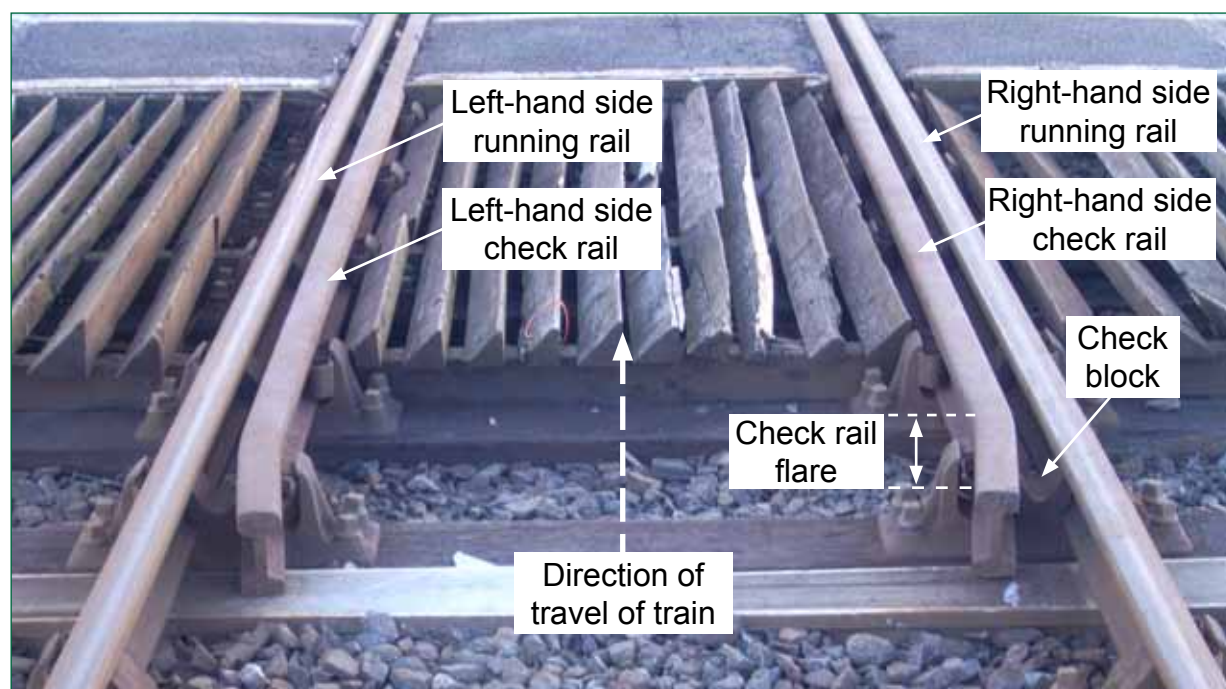
Figure 3: Arrangement of check rails at Dalchalm level crossing

- 24 An examination of Dalchalm level crossing showed single wheel derailment marks on the left-hand side running rail (towards the cess) and the right-hand side check rail (towards the four foot). These marks started just past the check rail flare and continued through the crossing surface and onto the railway beyond. Bright metal marks were found on the first right-hand side check block, whose check chair was fractured.

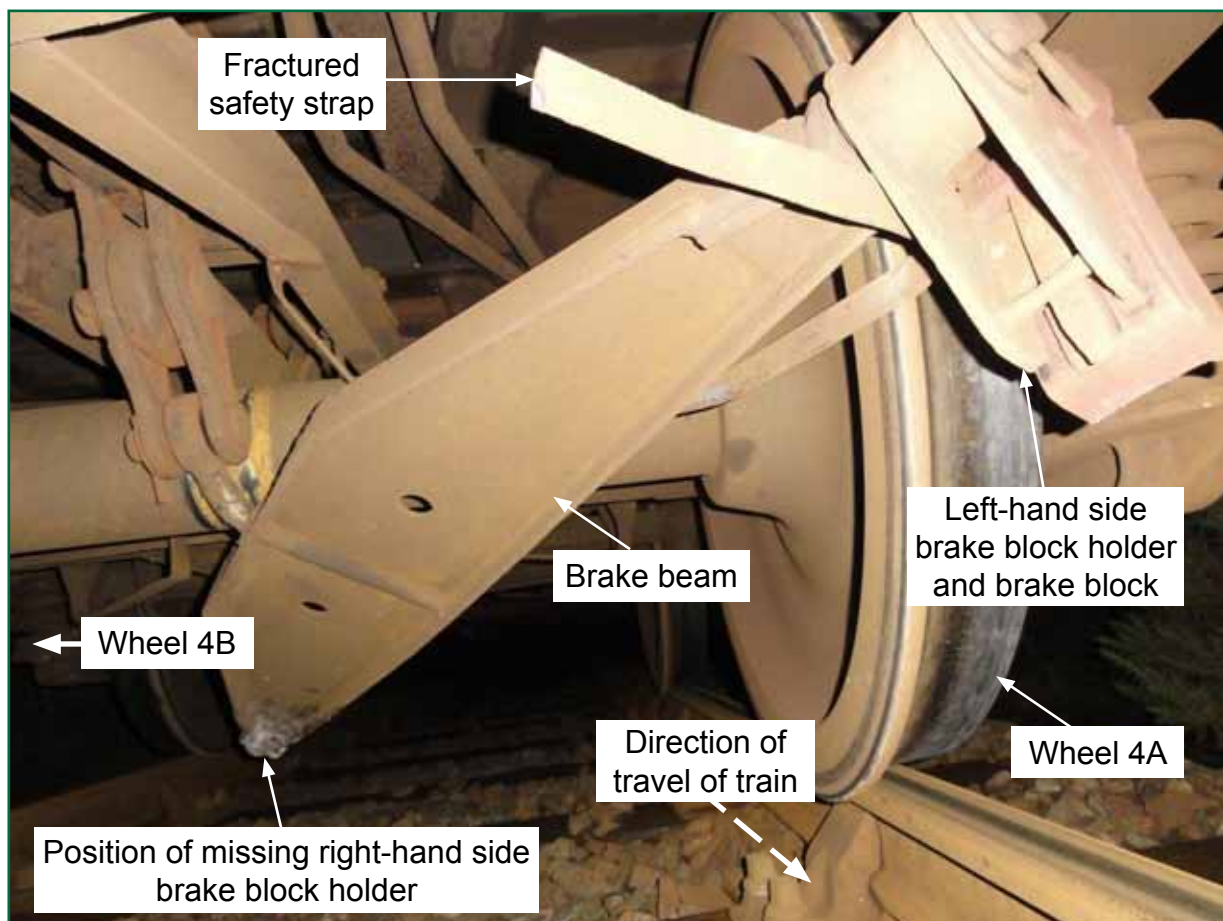
20 As a result of this report, the signaller instructed the driver of 6E69 to stop and examine the train. The train came to a stand between Golspie and Rogart, around 10 miles (16 km) beyond the point of derailment. On inspecting wagon 950544, the driver found that the brake block holder and brake hanger were missing from the leading face of wheel 4B and that the leading brake beam of wheelset 4A/4B was dragging in the four foot (see figure 4). He also noticed that wheels 1B and 1A had sustained some sort of damage.

Figure 4: The brake rigging on the leading face on wheelset 4A/4B following the derailment (photograph courtesy of DB Schenker)

- 23 This inspection confirmed the driver's findings regarding the missing brake components on wheel 4B. Examination of the brake beam at wheelset 4A/4B showed that the safety strap on the 4A side of the loose beam was fractured and that the strap on the 4B side was missing entirely. It could be seen that the fractured safety strap at the 4A side had recently broken at one end, just below its front fixing bolts, and that the strap had also been repaired by welding at the rear fixing at some point in the past. It was evident from the build-up of dirt on the bogie frame surface that the missing safety strap at the 4B side had probably been absent for some time. Although not causal to the accident, it was noted that one of the safety straps of the trailing brake beam on wheelset 1A/1B was also missing.

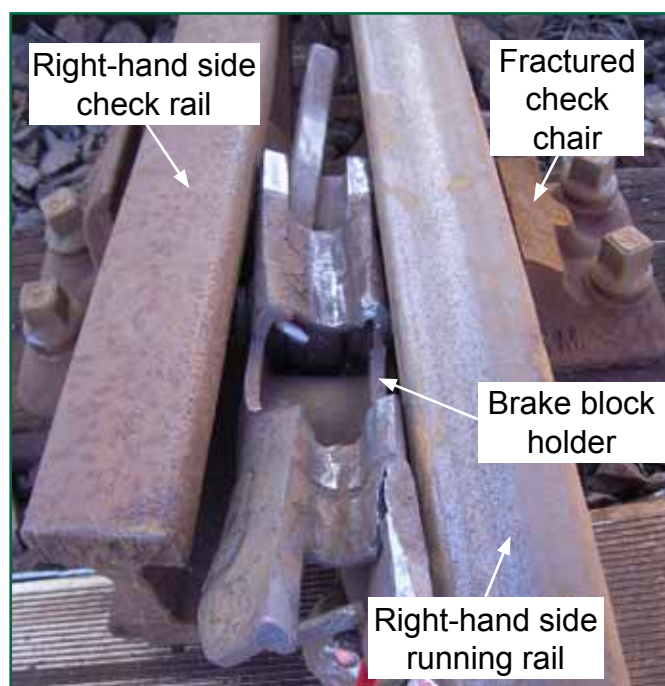
- 25 The detached brake block holder and hanger from the leading face of wheel 4B were inspected. The upper brake hanger pin was missing from the brake hanger and both the hanger and the brake block holder (which remained attached to the hanger via the lower pin) had been heavily damaged. This damage was consistent with the brake block holder and hanger having been forced into the right-hand check rail flare at the crossing.

*Figure 5: The detached brake block holder and the check rail flangeway – the brake block holder has been replaced into this position post-incident for photographic purposes*

- 28 On the immediate approach to Dalchalm level crossing the brake block holder and hanger were able to enter into the gap between the right-hand check and running rails. This caused the split pin on the brake head pin to shear, allowing the brake block holder and hanger to detach from the brake beam and become lodged in the flangeway.

- 29 In this position the brake block holder was probably struck by the following wheels on right-hand side of the wagon, which would have driven it further into the flangeway, against the first check block. At some point, wheel 1B also struck the block holder; this caused the wheel to run onto the head of the right-hand side check rail, before it derailed into the four foot. This would also have forced wheel 1A on the opposite side of the wheelset to ride up onto the head of the left-hand side running rail before derailing towards the cess.
