RAIB Bulletin 02/2011

Near miss incident at Seaburn station platform 29 November 2010

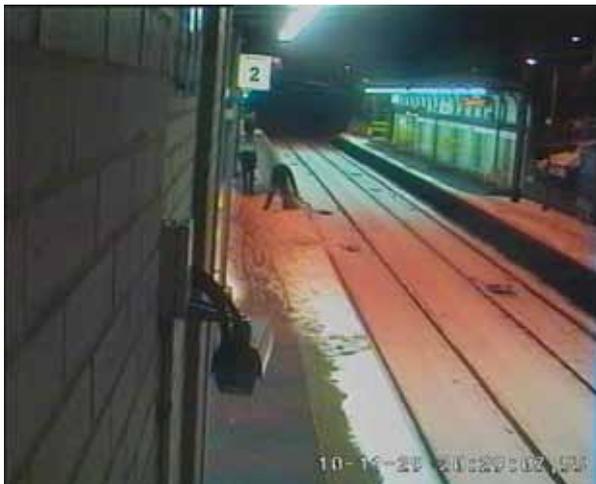
- 2 Cleaner A and a colleague were working along the platform facing the direction of approaching trains. The method of work used by cleaner A was to clear a strip from the edge of the platform by shovelling snow on to the running line and then standing at the cleared edge, to shovel snow from the adjacent area behind towards the back of the platform.
- 3 Neither worker was wearing their company issued high visibility clothing.

Figure 1: Cleaner A working close to platform edge 2.5 s before arrival of train (Image courtesy of DB Regio Tyne and Wear Limited)

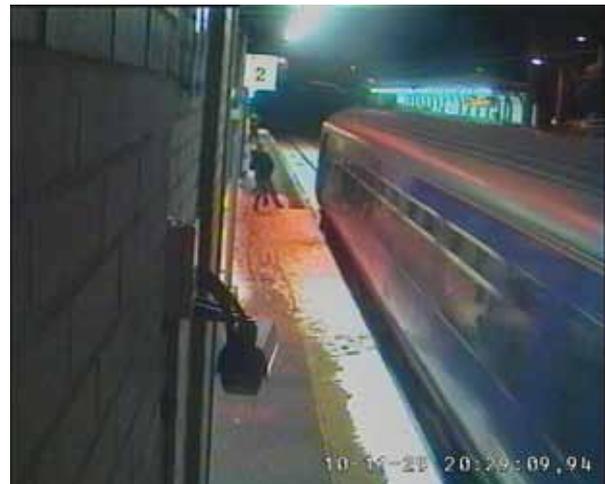
Figure 2: Cleaner A taking evasive action on approach of train (Image courtesy of DB Regio Tyne and Wear Limited)

- 4 When cleaner A was standing close to the edge of the platform, a train travelled through the station at a speed of around 60 mph (97 km/h). He saw the train when it was approximately one second's running time away and quickly moved from the platform edge.

- 23 The immediate cause of this incident was that the method of work adopted for clearing snow was not safe. Underlying this were failures of management to put in place a system of work to control the risks, to train and instruct workers in how to clear snow safely, to adequately supervise their work and to ensure that appropriate personal protective equipment was worn.

- There is a need for station operators to review (or if necessary, prepare) their winter weather plans for their stations to ensure that the risks from clearing snow from the edge of station platforms are adequately controlled. Such reviews should take into account factors such as reduced sighting times, non-stopping trains, and other risks such as bi-directional working and maximum line speeds.
