# Rail Accident Report

## **Station overrun at Stonegate, East Sussex 8 November 2010**

Report 18/2011  
November 2011

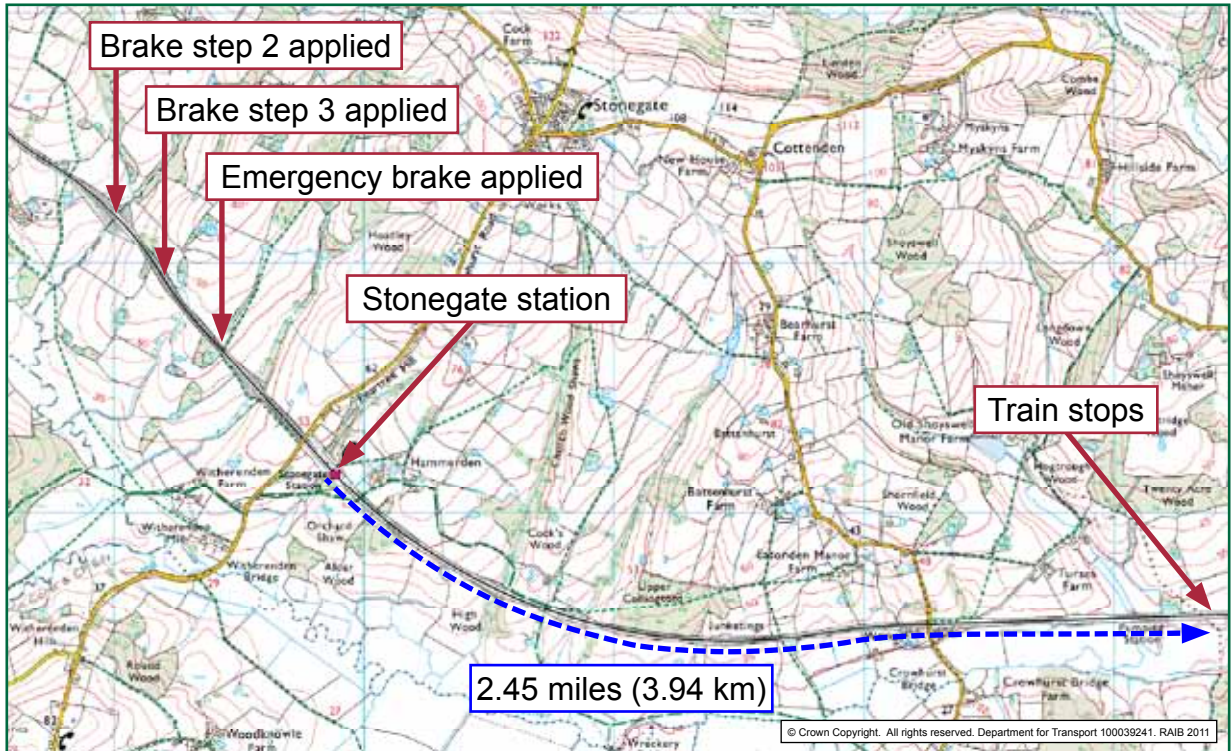
Figure 2: Overview of incident

Shortly after 08:00 hrs on Monday 8 November 2010, a passenger train running from London Charing Cross to Hastings failed to stop at Stonegate station in East Sussex. The train ran for a further 2.45 miles (3.94 km) with the emergency brake applied, passing the level crossing at Crowhurst Bridge before coming to a stop 3.22 miles (5.18 km) after first applying the brakes.

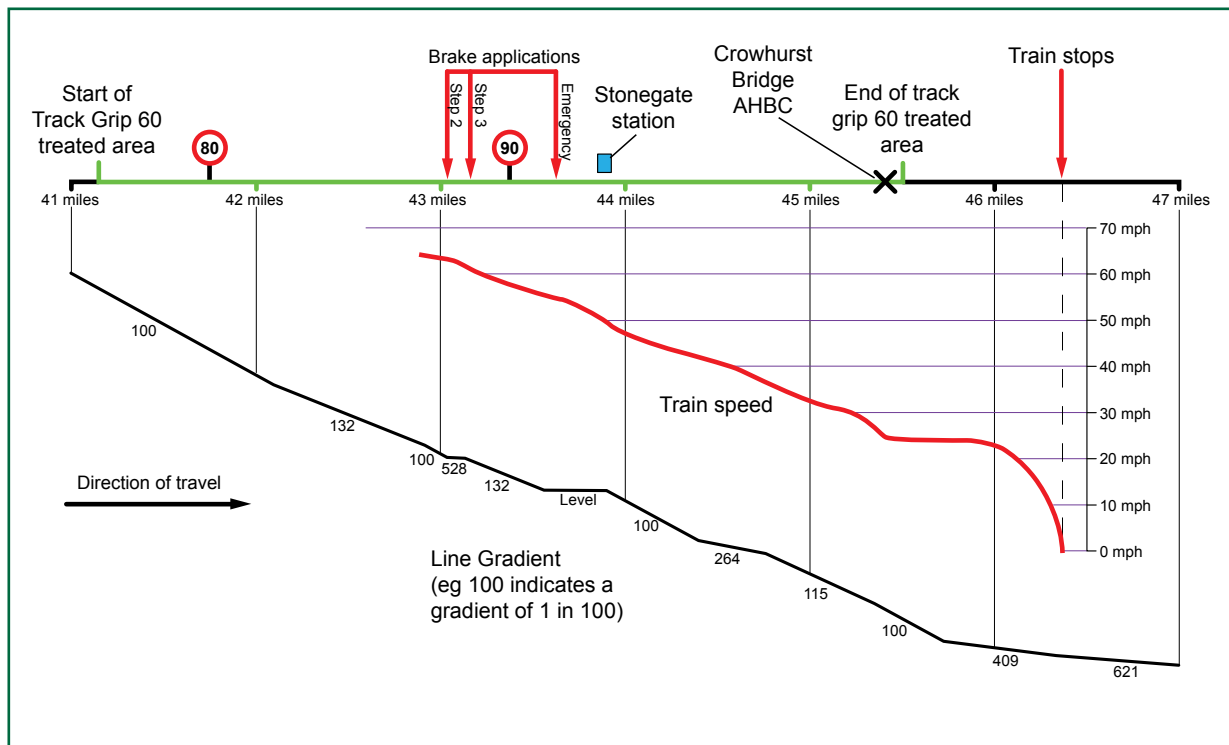
Figure 3: Details of line characteristics and train movement at Stonegate

- 98 **The immediate cause of the incident was that the train did not decelerate at the desired rate on application of the brakes approaching Stonegate station.**
- 99 The driver initially applied the brakes in step two, 1400 metres before Stonegate station. In good adhesion conditions, allowing for the downhill gradient, brake step two should have been able to stop the train from 64 mph (103 km/h) within 800 metres<sup>6</sup>.

- 102 Table 1 shows the *brake retardation* rates (allowing for the gradient) achieved in each of the brake steps applied during the incident.
- 103 When brake step two was applied, the average braking retardation rate achieved was 1.7 %g, instead of 6 %g as would be expected in dry conditions with no rail head contamination. This reduced to 1.3 %g as the brake step applied was increased to emergency.

- 104 Over the 2.4 miles (3.86 km) of line, from where the brakes were applied to the end of the Track Grip 60 treated area, the average braking retardation rate was 1.5 %g. Calculations show that a braking retardation rate of 3.4 %g would have been required for the train to have stopped in the station at Stonegate, with no overrun. This corresponds to an improvement in rail adhesion of 1.9 %g, compared to the 3 %g improvement that sand can normally be expected to provide (paragraph 59). It is possible that the extremely low adhesion conditions on the day of the incident made the expected 3 %g improvement unachievable, and therefore it is possible that the train would still have overrun Stonegate station if sand had been deposited. However, even a small increase in adhesion, due to the use of sand, would have considerably reduced the length of overrun.

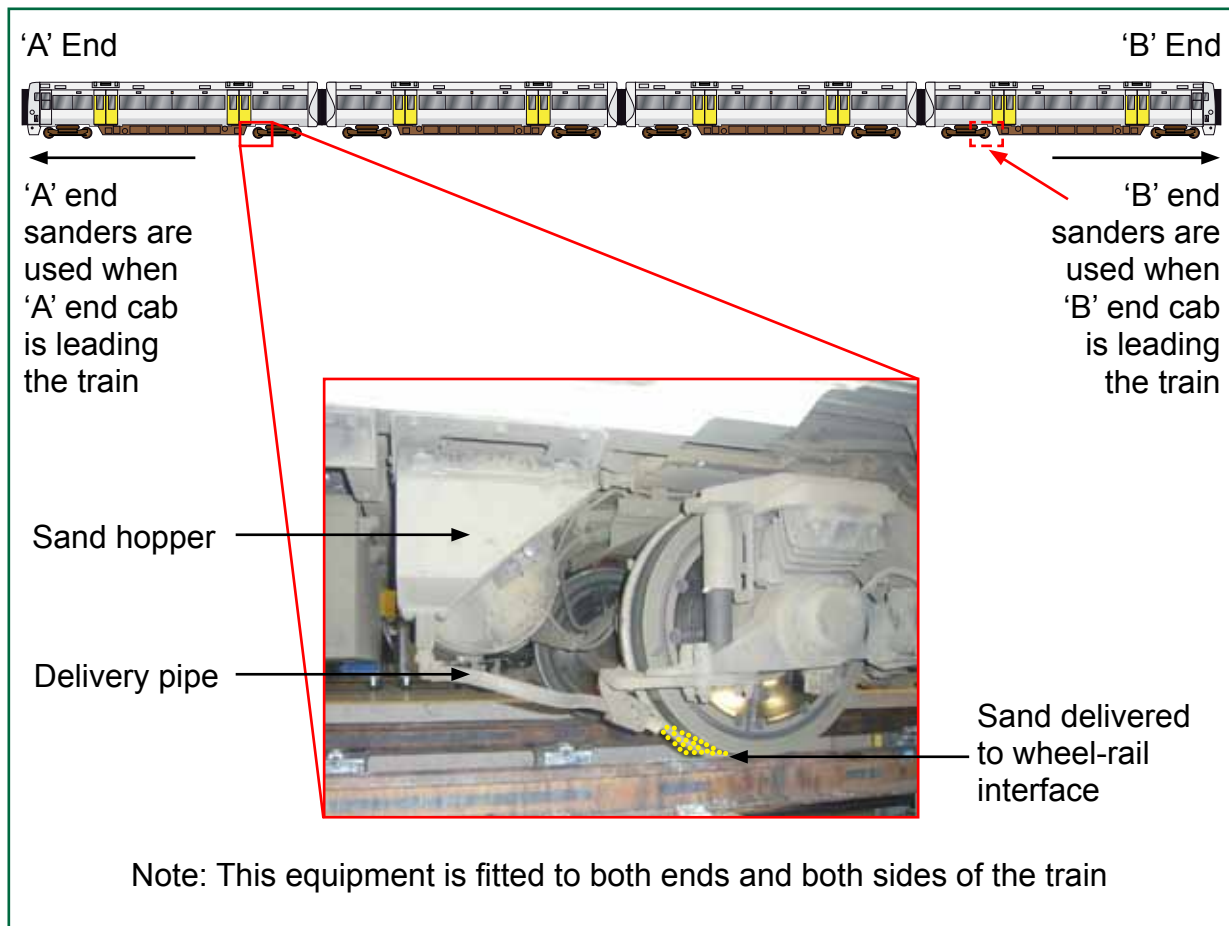
Figure 4: Diagram showing sanding equipment on the train

- 61 The class 375 trains first entered service between 2001 and 2005 (paragraph 158). The design was modified in 2003 so that sand would be applied automatically in brake step two when the WSP system activates because it detects that one or more axles are not rotating at the same speed as the remainder (in addition to step three and emergency as had been originally provided). This was initiated by Connex, the operator of the trains at that time, in response to a number of instances of wheelslide resulting in station overruns in brake step two. The maximum time that the sanding equipment was permitted to apply sand was also increased from 10 seconds to 60 seconds, as experience had shown that 10 seconds of sanding was insufficient in low adhesion conditions.

- 62 The class 375 trains were further modified by Southeastern in autumn 2006 so that the maximum time that the sanding equipment was permitted to apply sand was increased from 60 seconds to 180 seconds. This was in response to further operational experience and an *Adhesion Working Group (AWG)* review of low adhesion incident performance during autumn 2005 (AWG report of 28 April 2006). It also pre-empted recommendations that were made by the RAIB following investigations into a series of low adhesion incidents in 2005 (see RAIB Report 25/2006 Part 3).

- 123 When unit 375711 was examined by Southeastern on the night of 8/9 November, after the incident, one of the sand hoppers on the 'A' end was found to be empty (the other could not be checked, but is likely to have been empty as well). Analysis of the OTDR data enabled the RAIB to estimate that the unit's sand had run out by approximately 18:00 hrs on 5 November. It is therefore almost certain that the sand hoppers had been empty on the morning of 8 November.
- 124 The sequence of events that resulted in the sand hoppers being almost certainly empty on the morning of the incident is described in paragraphs 125 to 145 below.
