RAIB Bulletin 01/2011

Serious injury of a guard on the Foxfield Light Railway, 24 October 2010

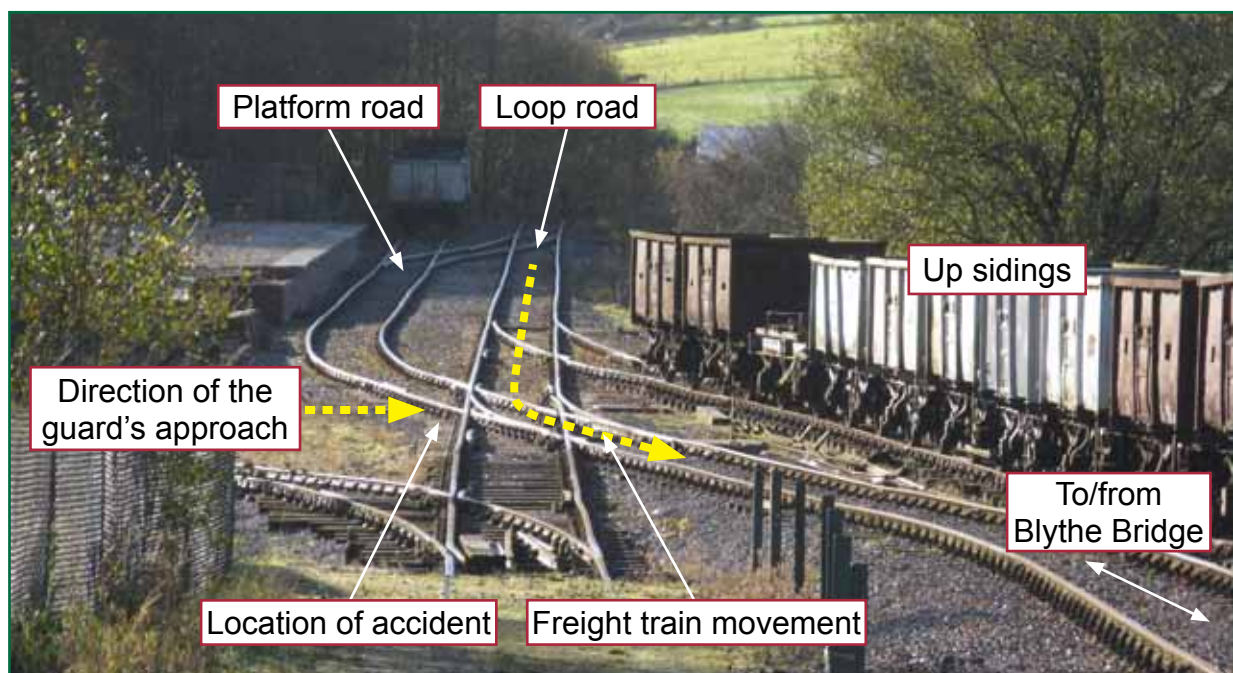
Figure 1: Layout at Foxfield Colliery showing the location of the accident

- 5 The role of a train guard is to instruct drivers to move the train when required and to operate a brake in the brake van.
- 6 The wagons had been brought into the platform road (Figure 1) by another locomotive at 13:25 hrs. They were uncoupled and coupled to the yard locomotive which was subsequently involved in the accident.

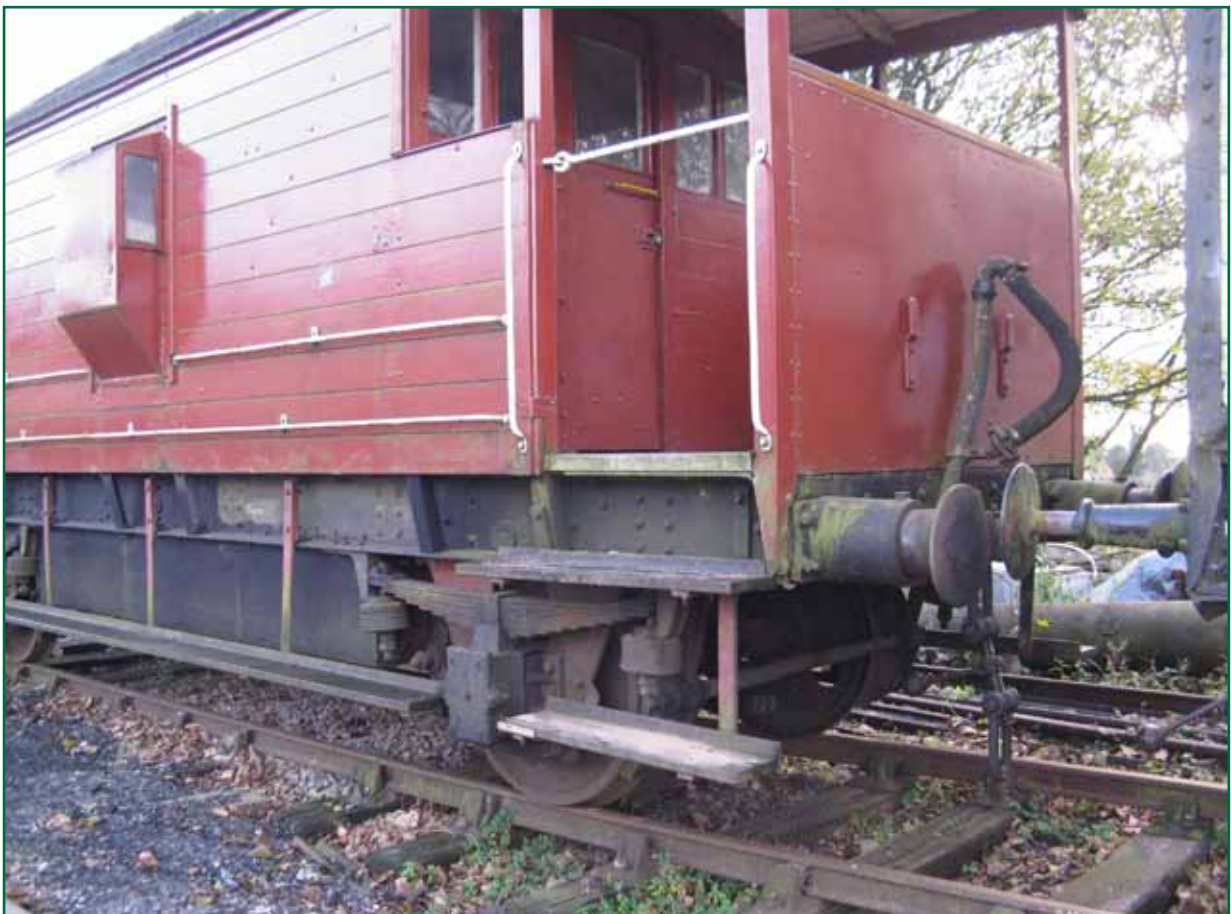
Figure 2: The brake van involved (note: the footstep was sanded after the accident)

- 9 At approximately 14:15 hrs, the guard was returning to the train after his break. The guard reports that he was surprised to see the train moving as he approached it. There is a conflict of evidence as to who gave the footplate crew the instruction for the train to be moved. As the brake van passed over a set of points in front of the guard, he grabbed the handrail of the leading end of the van and placed his foot on the step (Figure 2). His foot slipped and he was dragged along by the train until he let go. The estimated speed of the vehicle was between 3 to 5 mph (5 to 8 km/h).
