Rail Accident Investigation Branch

Rail Accident Report

Runaway and collision of a road-rail vehicle near Raigmore, Inverness 20 July 2010

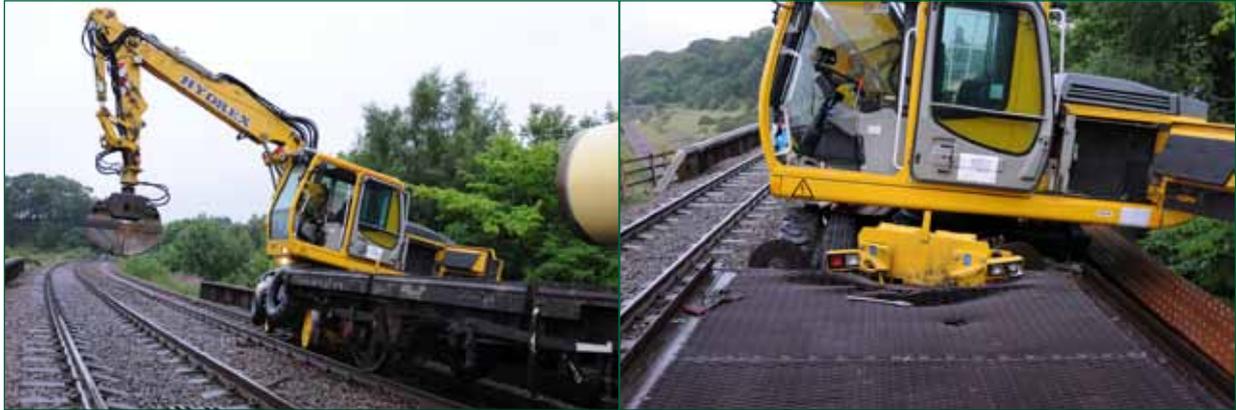
Figure 2: The accident site showing the RRV and the rear wagon of the freight train

- 12 In the collision, the machine operator was thrown out of the RRV cab and landed on top of the rear wagon of the freight train, sustaining serious injuries which required hospital treatment. The RRV was derailed by all wheels and the leading axle of the rear wagon became derailed.
- 13 Both the RRV and the freight wagon sustained damage.

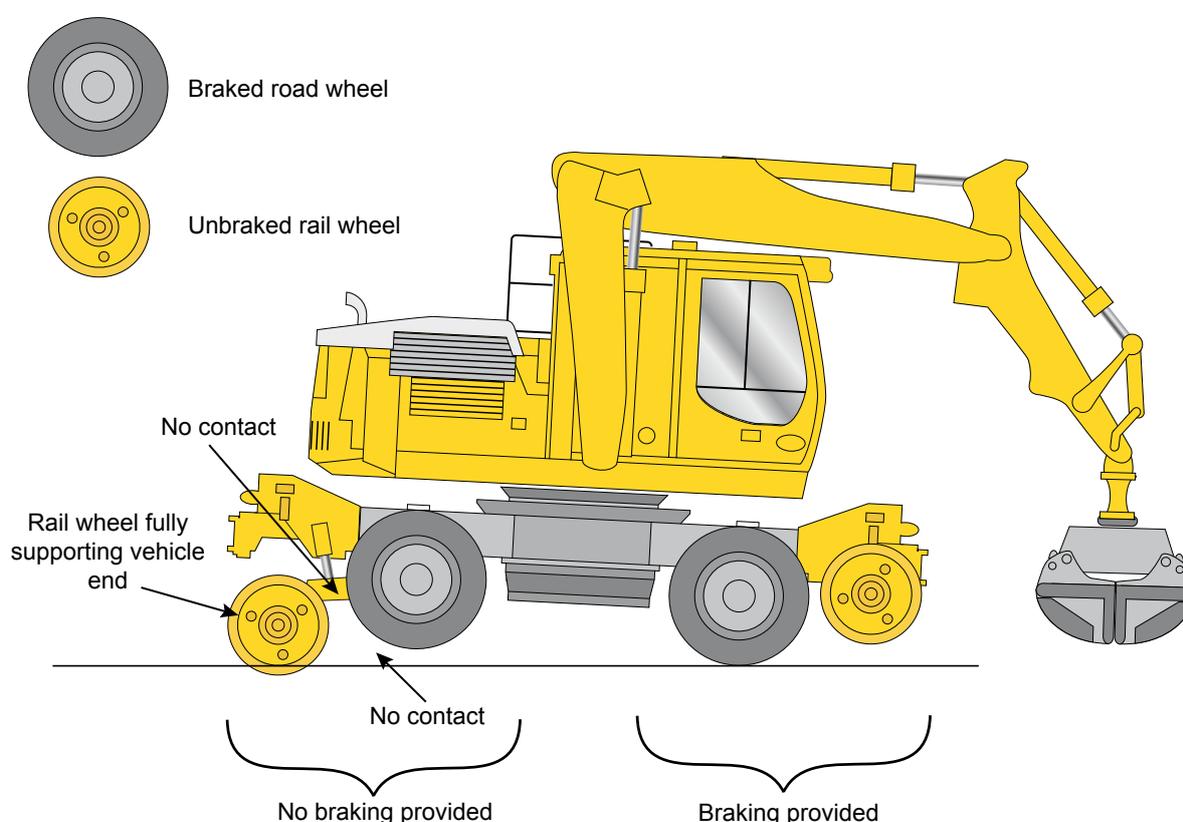
Figure 7: High-ride RRV - transition condition that results in no braking being provided at one end of the machine during on/off-tracking

79 This transient condition is an inherent feature of the high-ride design, if the rail wheels are not independently braked. When the machine is on or off-tracked on an incline, prevention of a runaway relies on there being sufficient braking at the other end of the machine (subsequently referred to as the *holding end*). If there is no brake force at the holding end, a point is reached, as the rail wheels are lowered (or raised), when all braking is lost and, even on a modest gradient, the RRV will start to run away.

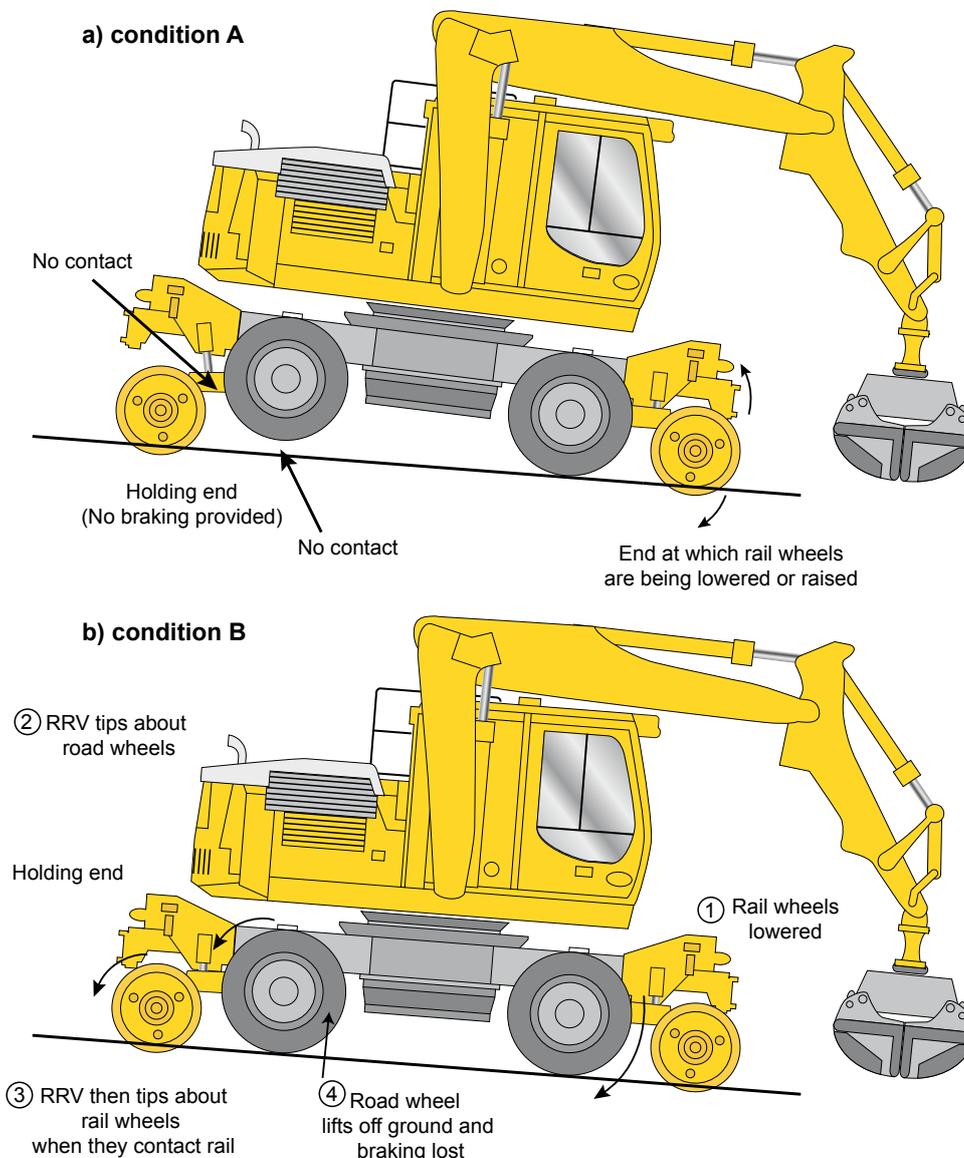
Figures 8a and 8b: High-rise RRV - on/off-tracking runaway conditions

The holding end is left in the transient condition with no braking provided (road wheels lifted off the ground, rail wheels not sufficiently in contact with the road wheels) when the rail wheels at the opposite end are lowered (or raised) (figure 8(a)).

The road wheels at the holding end are on the ground, and carrying their full load, but the rail wheels are left close to (or just touching) the rail. With reference to Figure 8(b), when the rail wheels at the opposite end are lowered (1), the RRV first tips about the road wheels at the holding end (2), but it then tips about the adjacent rail wheels as they come into contact with the rail (3). This lifts the road wheels that were providing the braking off the ground (4)⁹.

- 81 The following control measures can prevent the two conditions occurring during on/off-tracking :
- a check that at the holding end **either** the rail wheels are in full contact with the road wheels, **or** the road wheels are in full contact with the ground and the rail wheels are fully clear of the rail; and

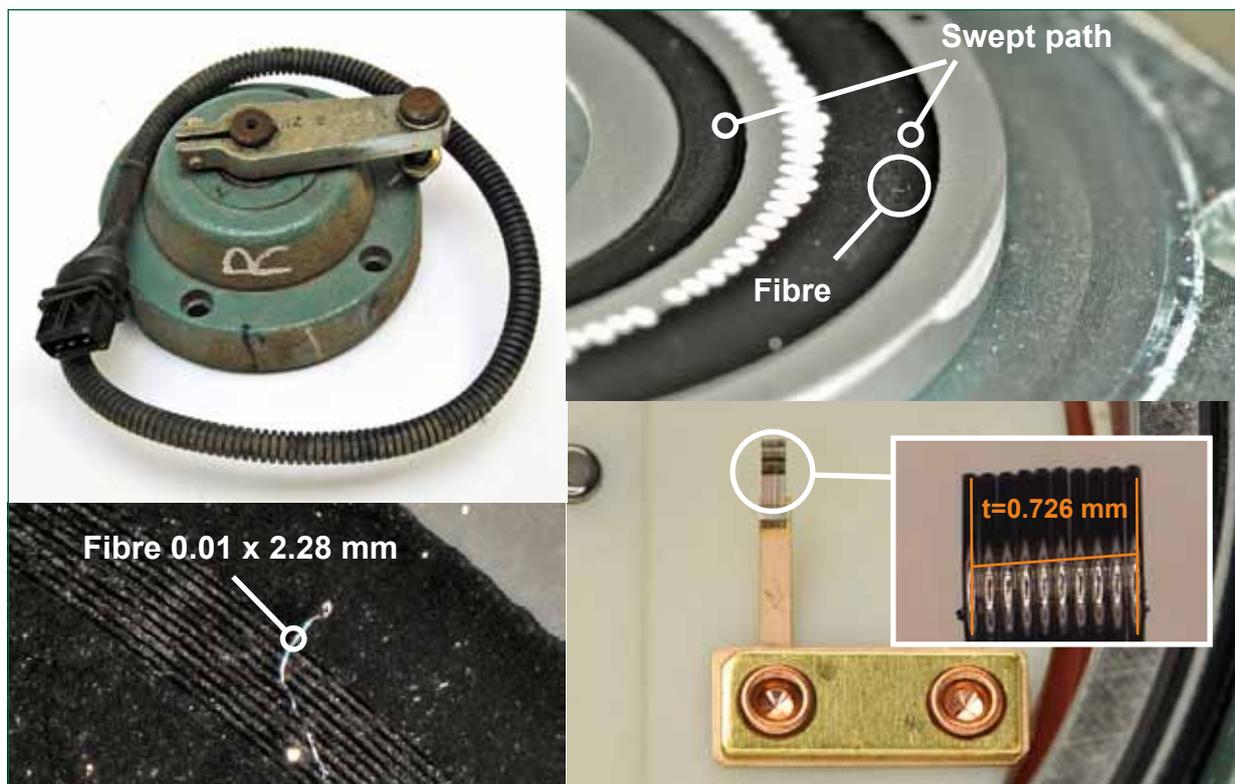
Figure 10: Photographs (clockwise from top left) of the 'third' potentiometer, swept path, wiper arrangement and track and fibre (with dimensions in millimetres)

- 136 In the third potentiometer (which was from the rear end of the incident machine), a loose fibre was observed on the swept area of the potentiometer track (figure 10).

- 137 A dark fibre was also observed on the fourth potentiometer, but this was clear of the swept area, and did not appear to be loose.
- 138 The fibre found in the rear (third) potentiometer was 0.01 mm in diameter and 2.28 mm long (figure 10). It is possible that a fibre of this size could have been trapped under one (or part of one) of the wipers and created a resistive fault in the electrical circuit.

139 The RAIB undertook testing with the third potentiometer using various fibres of a similar size to the one that was found in it. The RAIB found that it was possible to change the resistive output of the potentiometer (and on occasions obtain an open circuit) by the introduction of different fibres across the swept path, under the wiper. The RAIB did not carry out tests with the fibre that was found in potentiometer number three, because its small size meant that it was impractical to place the fibre in position under the wiper. Although a fibre of the dimensions of that found is unlikely to have interfered with the operation of the potentiometer, testing with other fibres has shown the potential for contaminants in the potentiometer to give rise to a single point failure of the control system.

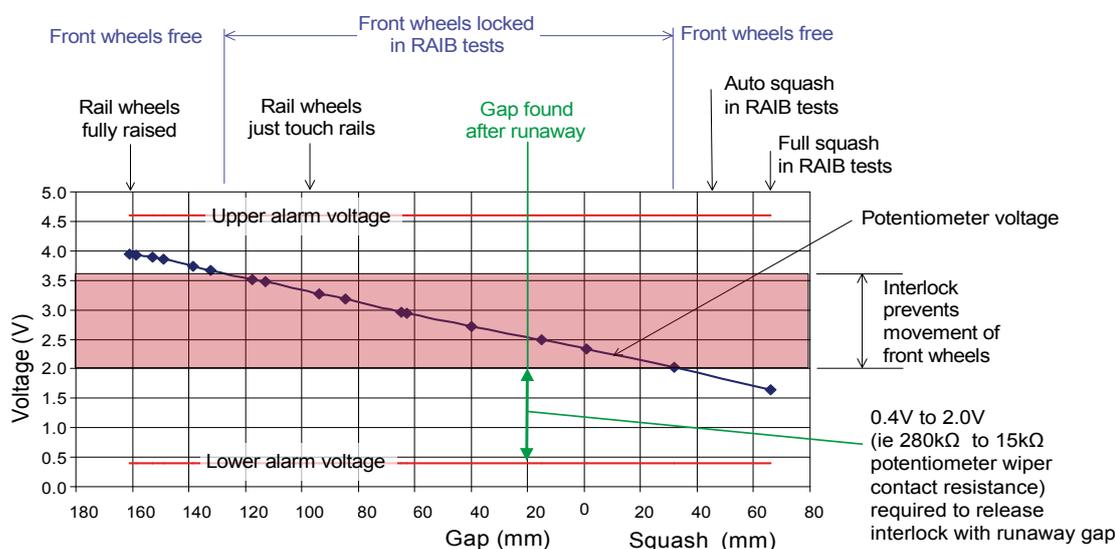
Figure 11: Graph showing relationship between voltage and road/rail wheel air gap

- 144 The green arrow represents the range of voltage values (0.4 to 2.0V) at the input to the control system that will cause a release of the interlock function (allowing the raising or lowering of the other end rail wheels), despite the existence of a 20 mm air gap. Additionally, no fault alarm will be generated by the control system. A range of wiper resistance values (between 280 kΩ and 15 kΩ) will cause this control voltage to move from the red shaded 'interlock area' (figure 11) to within the green arrow area (non-interlock area – rail wheels free to move).

- 145 The evidence suggests that the RRV control system did not prevent the machine getting into an unbraked condition. This is likely to have been as a result of a single point failure. This most probably occurred in the form of a change in the electrical resistance, possibly in the rear potentiometer or in the circuit associated with the rear potentiometer and control system (paragraph 139). The design of the RRV control system was therefore a causal factor in the accident.

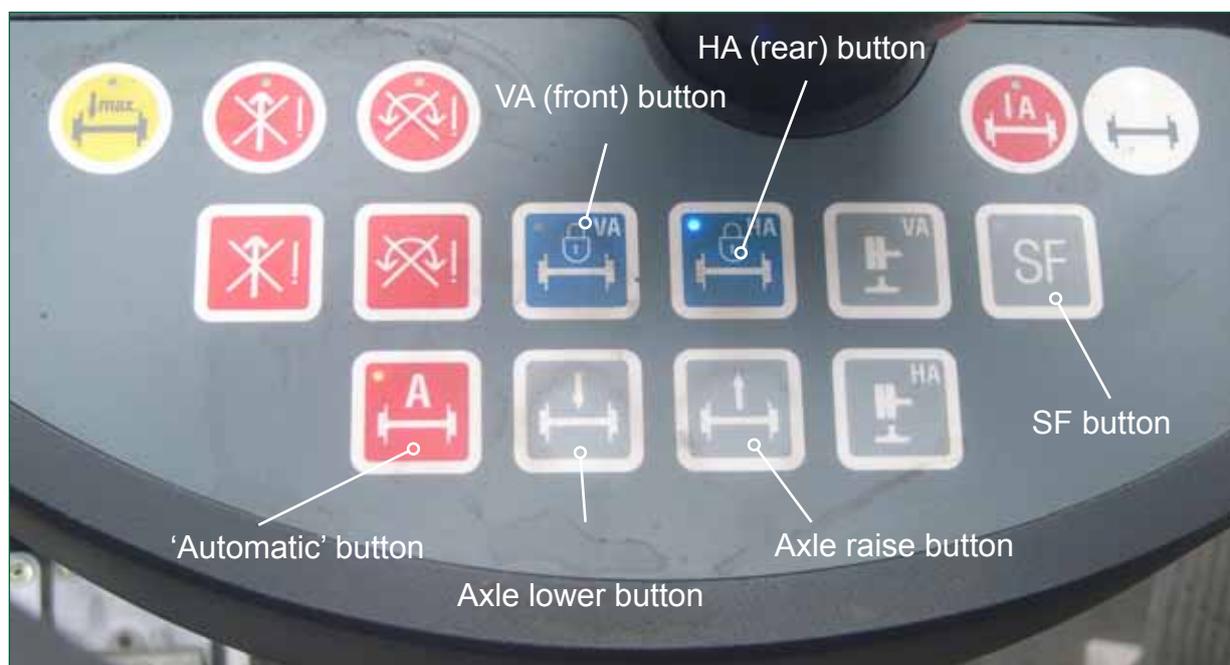
Fig 13: Rail (ZW) control panel indicating axle operation buttons

- 150 Once the operator has locked a front or rear chassis and the respective lock button is illuminated (only one end can be selected at a time), the next step is to press either the 'raise' or 'lower' buttons to command the other rail chassis to move (figure 13). The design of the controls therefore requires the operator to depress the front (VA) button, if he wishes to move the rear rail wheels, and vice versa with the rear (HA) button and the front wheels. The operation of selecting one end in order to move the other end is potentially confusing. This adds to the complication of the buttons being labelled with the letters 'VA' or 'HA' for front and rear. Furthermore, the cab and boom arm are able to rotate through 360°, also making it possible that the operator may become confused between the front and rear of the machine.

- 151 Had the lock buttons been correctly selected, and then operated by the machine operator in the correct sequence, he might have realised that there was a problem with the machine before deploying his front end rail wheels (figure 14 [step k]). The design of the human-machine interface may have confused the operator, and was therefore a possible causal factor in the accident.
