Rail Accident Investigation Branch

Rail Accident Report

**Collision between train 1C84 and a tree at
Lavington, Wiltshire
10 July 2010**

Report 08/2011
April 2011

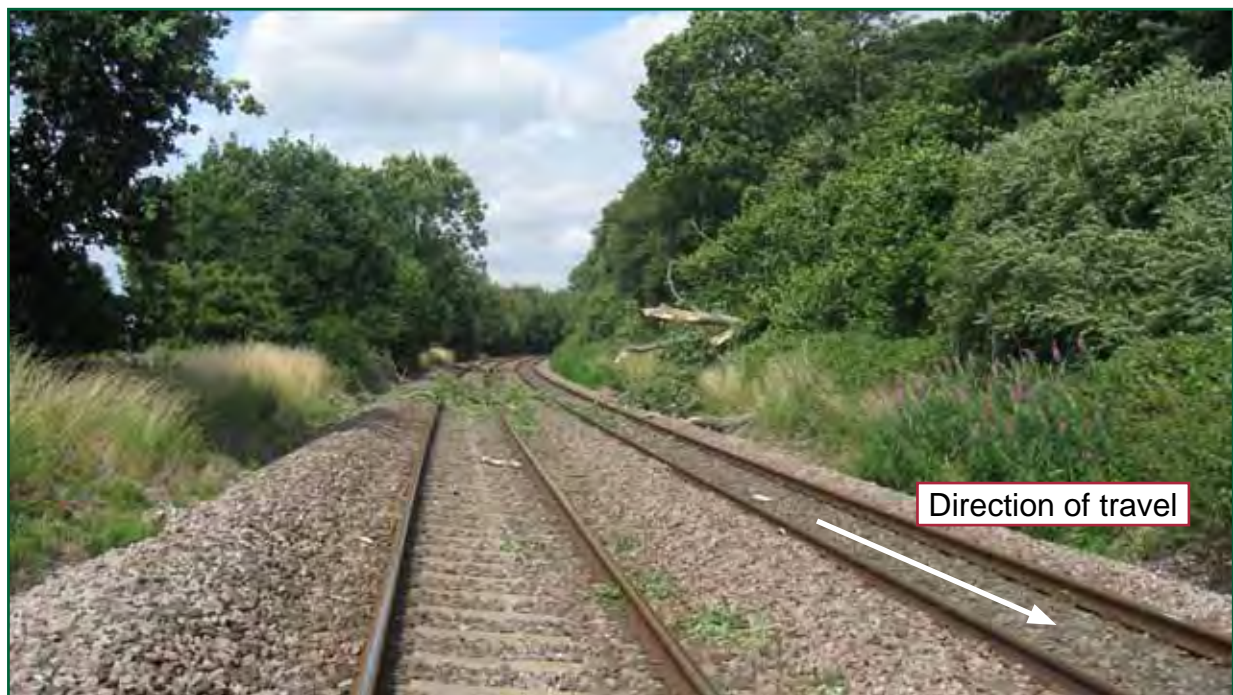
- 28 The tree had fallen across the line at 85 miles and 77 chains, and was obscured from the driver of train 1C84 by a left-hand curve (figure 4). The RAIB estimates that the tree might have been visible to the driver for five to six seconds before the collision occurred. The driver immediately applied the emergency brake using the brake control handle; this was recorded by the *on train data recorder* (OTDR) two to three seconds before the collision, which happened at 14:09:22 hrs.

Figure 4: View of the fallen tree after the collision, looking towards London

- 29 The upper branches of the tree were struck by the cab of the leading power car and entered it through the windscreen. The left-hand half of the windscreen and the upper portion of the windscreen pillar bore the brunt of the impact.
- 30 The main control circuit breaker of the leading power car was tripped as a result of collision damage to the driver's desk. This resulted in a loss of electrical supply to both the *National Radio Network* (NRN) radio and the *wheel slide prevention* (WSP) system, as well as other systems on the train, including the OTDR on the leading power car.

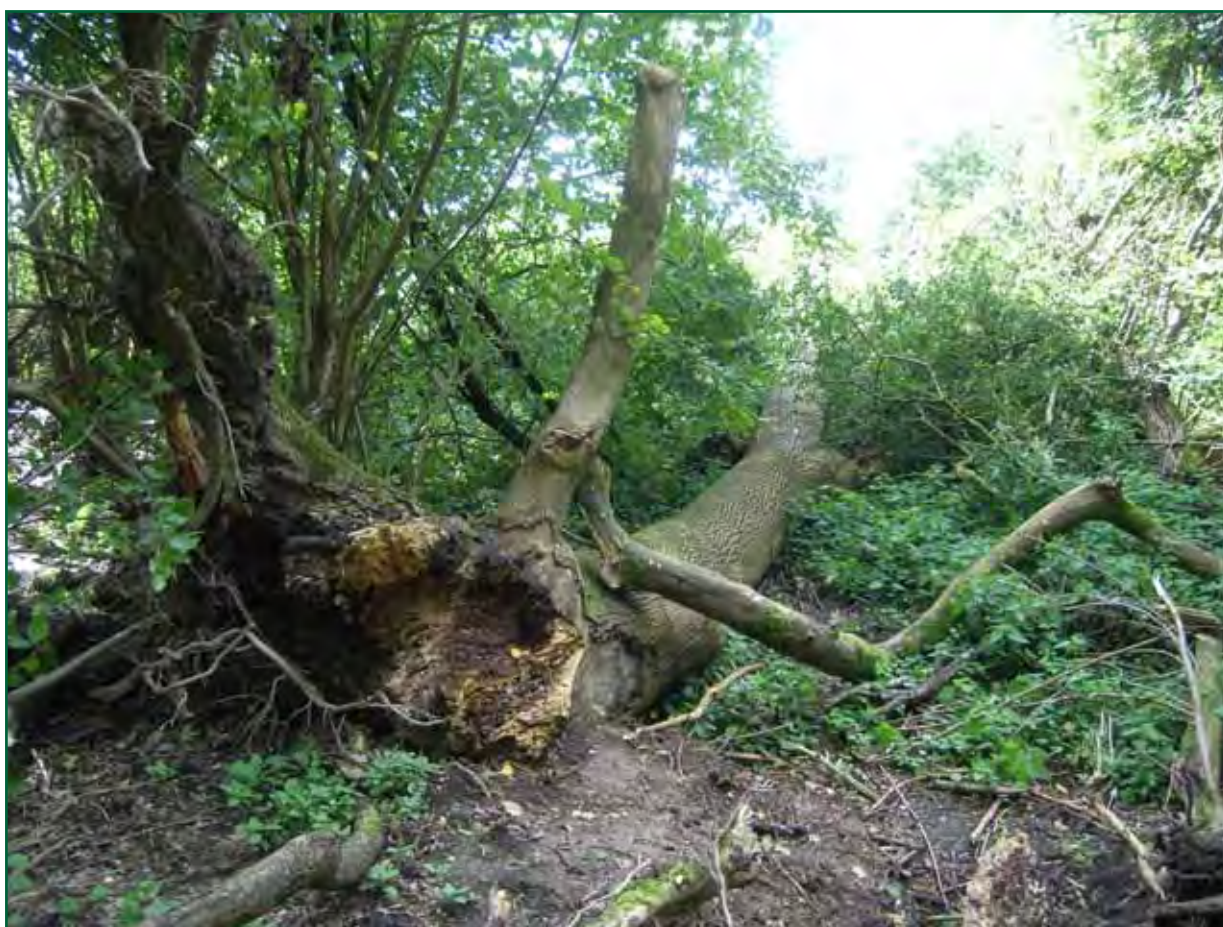
- 47 **Prior to the accident the tree was in a dangerous condition but, as this had not been identified, no action had been taken to remove it before it fell. This was a causal factor in this accident.**
- 48 A specialist, who reported on the condition of the tree after it had fallen, stated that in his opinion, “the severely deteriorating condition of the subject tree’s lower stem would have been readily identifiable on inspection from close at hand (certainly up to 3 m away) for several years prior to its collapse” and that “the decay was seated substantially on the far side of the stem base relative to the railway” (figure 5).
- 49 If the dangerous condition of the tree had been identified, the risk it presented to the railway might have been apparent and steps could have been taken to fell it in a controlled way.

- 52 There are earlier remains which show that some branches and/or trees had fallen across the boundary fence since 1971, possibly in both directions (ie from the railway side of the fence as well as from the adjacent wood). Previous incidents involving trees at the boundary in this location may have been managed by railway maintenance staff, possibly without discussion with the landowner; the RAIB understands that this approach is common practice. However, the RAIB has been unable to establish what action was taken by any party in relation to these previous incidents at Parham Wood. Historically, local maintenance teams have been responsible for managing lineside trees. The local track section manager has worked in this area since 1976; he has had no experience of any similar incident with trees in that time.

Figure 5: Base of the fallen tree, looking towards the railway

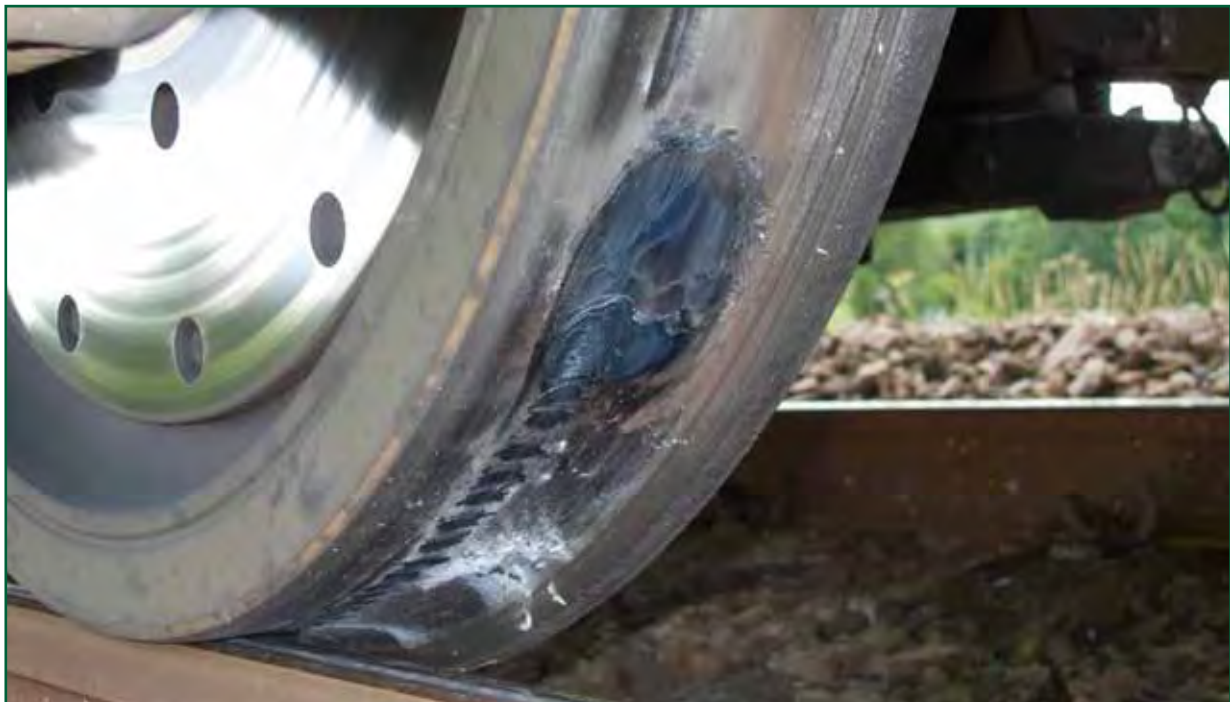
- 31 Data from the OTDR on the trailing power car indicates that both of the recorded axles on this vehicle stopped rotating within 9 seconds of the collision. Damage to the wheels indicates that they all started to slide after the collision (paragraph 68). The RAIB estimates that the overall average braking rate was 7.9% g from the time that the emergency brake was applied⁴. Since HSTs were originally specified to deliver a 9% g braking rate, the actual braking rate achieved indicates that the loss of WSP and the subsequent wheel slide had a minimal effect on braking performance.
- 32 The train did not derail and subsequently travelled for about 1 km before coming to rest, which the RAIB estimates to have been at 14:10:11 hrs, assuming a constant rate of deceleration.

- 67 The driver sustained hairline fractures to his right wrist and the ring finger of his left hand, as well as multiple cuts and bruises in the collision. He was taken to hospital for examination at around 18:00 hrs, and released the same day. No-one else was injured.
- 68 The driving cab was extensively damaged and the train was immobilised. The application of the emergency brake, followed by loss of power to the WSP system and contact with debris from the fallen tree, probably caused all of the axles on the train to lock up and the train subsequently to slide to a stand. This caused severe *wheel flats* to all wheels along the train (figure 6).

Figure 6: Damage to the wheel tread of HST power car 43041

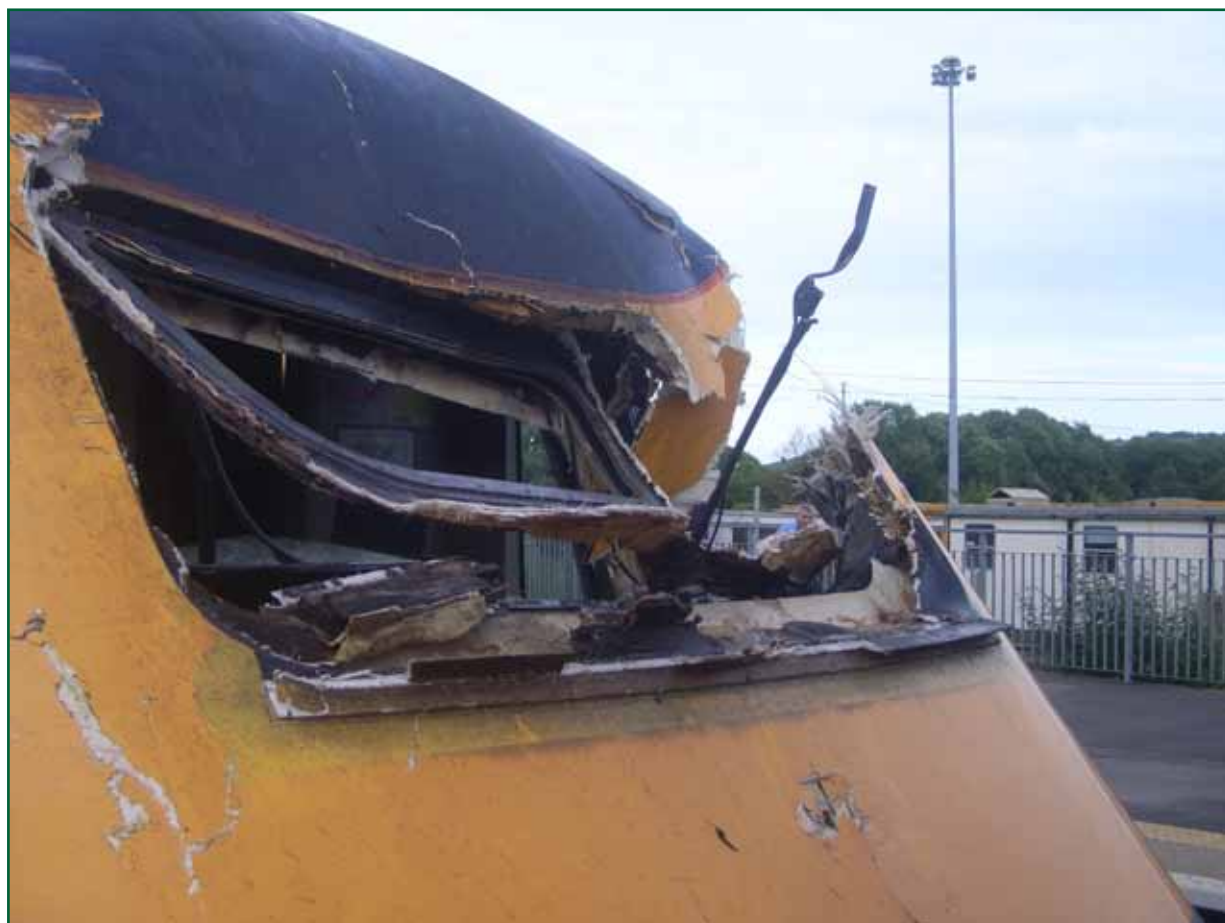
- 70 The cab was struck by the tree at a height of approximately 2.8 m above rail level. The tree penetrated a distance of approximately 1 m through the left side of the cab, starting at the windscreen pillar and extending to the leading edge of the left-hand door pillar (figure 7). The leading left-hand door pillar was cracked but the left-hand driver's side door remained relatively intact. The support provided by the door is likely to have helped the door pillar resist further penetration by the tree. The steel window frame on the left-hand side was distorted and the glass side window had broken and fallen out of its frame.

Figure 7: Damage to the driving cab, photographed on arrival at Westbury

- 71 There was also cracking to the glass reinforced plastic (GRP) cab roof, extending laterally from just above the windscreen centreline to the top of the right-hand side windscreen pillar. The severity of the damage to the upper left-hand portion of the cab was sufficient to distort the aluminium windscreen frame and cause the windscreen to become detached from the GRP structure. The shattered windscreen remained in one piece (held together by the interlayers¹³) and fell into the cab space.

- 74 The RAIB's assessment indicates that, while the ultimate strength of the HST cab pillar is broadly similar to that of a modern cab structure compliant with GM/RT2100 Issue 3, the energy absorption characteristic of a modern cab would be expected to result in less penetration than for an HST cab in a similar impact. However, no recommendations are suggested for the improvement of HST cab crashworthiness for the following reasons:
