Rail Accident Investigation Branch

Rail Accident Report

**Collision between train 1C84 and a tree at
Lavington, Wiltshire
10 July 2010**

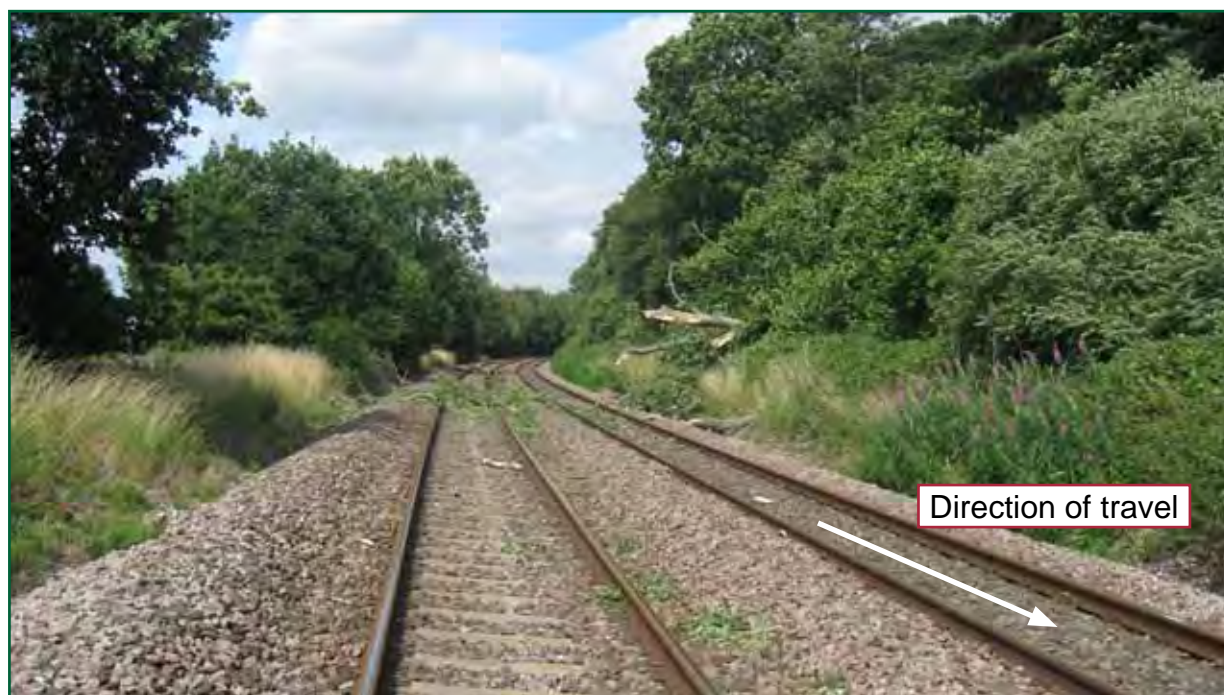
- 28 The tree had fallen across the line at 85 miles and 77 chains, and was obscured from the driver of train 1C84 by a left-hand curve (figure 4). The RAIB estimates that the tree might have been visible to the driver for five to six seconds before the collision occurred. The driver immediately applied the emergency brake using the brake control handle; this was recorded by the *on train data recorder* (OTDR) two to three seconds before the collision, which happened at 14:09:22 hrs.

Figure 4: View of the fallen tree after the collision, looking towards London
