Rail Accident Report

Derailment of an engineering train between Gloucester Road and Earl's Court stations on London Underground 12 May 2010

Report 05/2011
March 2011

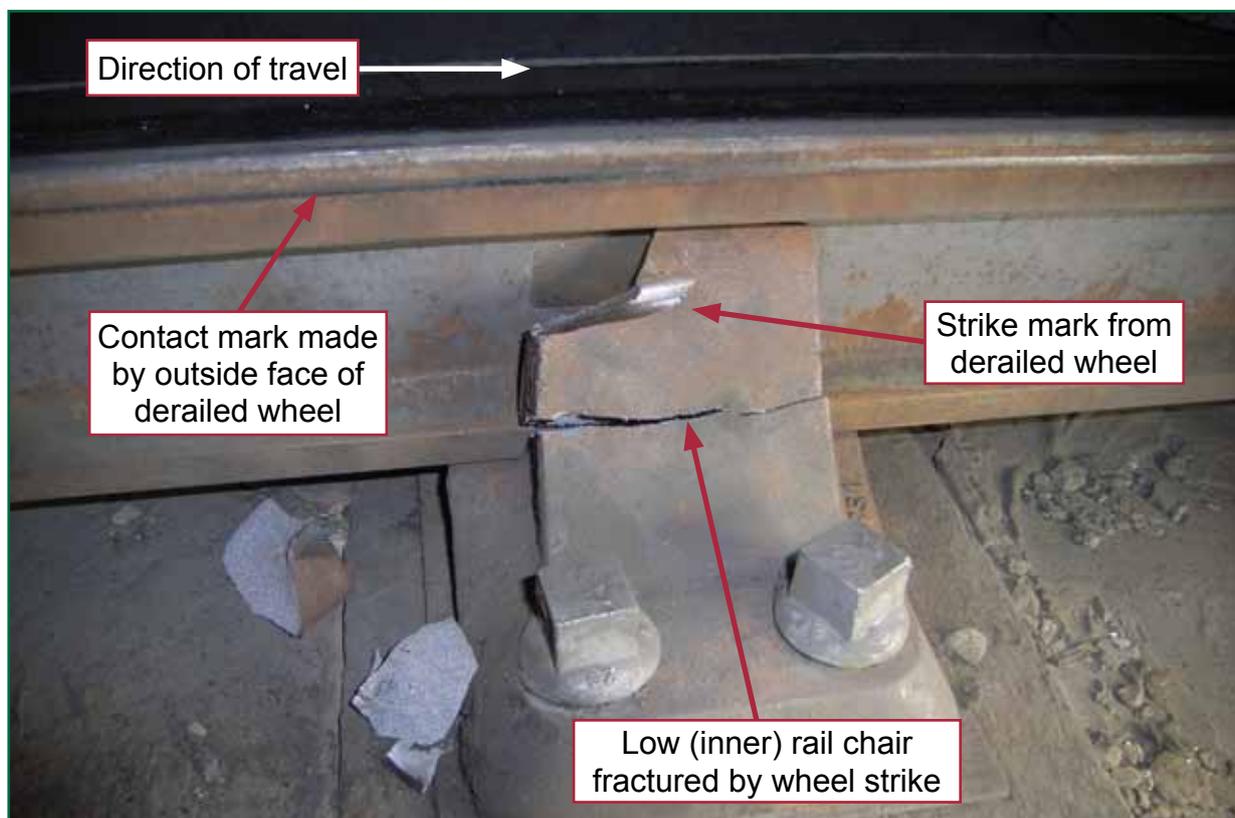
Figure 5: Left-hand wheel tread corner strike mark on low rail chair

35 There was evidence of tread corner strike marks on the low rail chairs at the point of derailment clearly indicating a wide gauge derailment had occurred. The strike marks continued to the point where a second derailment occurred when the leading right-hand wheel flange climbed up and over the high rail. The leading right-hand wheel had been forced to climb over the high rail when the leading wheelset encountered track that was fixed more securely to the sleepers. A sideways force towards the high rail was produced when the derailed low rail wheel encountered track of the correct gauge value with secure track fastenings.

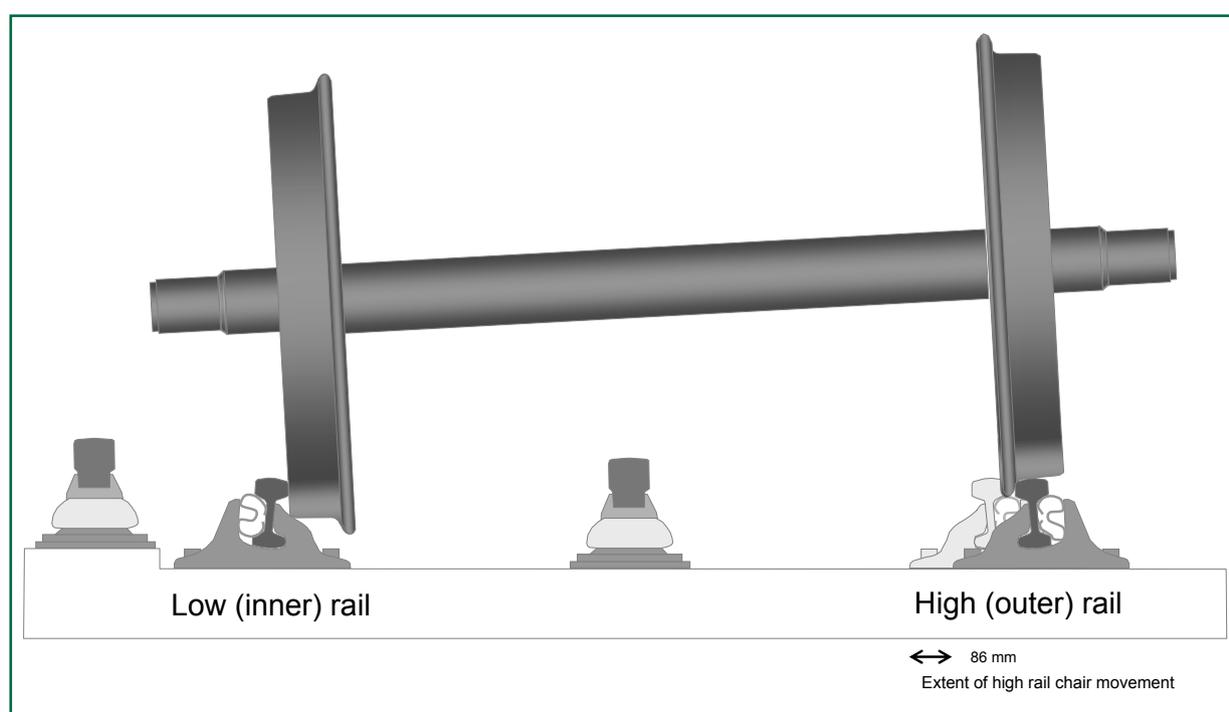
34 Gauge spread derailments occur when the distance between the rails is sufficient to allow at least one *tread corner* of the wheelset to drop into the gap between the rails (figure 6). When a wheelset is traversing a curve a large lateral force can be generated at the tread of the wheel on the inner rail which is reacted by the wheel's flange against the outer rail (*high rail*). Where the track fixings are not effectively securing the rails, sufficient force can be exerted to cause the rail to roll outwards or move out laterally increasing the track gauge beyond safe limits.

Figure 6: High (outer) rail movement, showing normal chair position and subsequent position of an unsecured chair allowing gauge to widen dynamically.

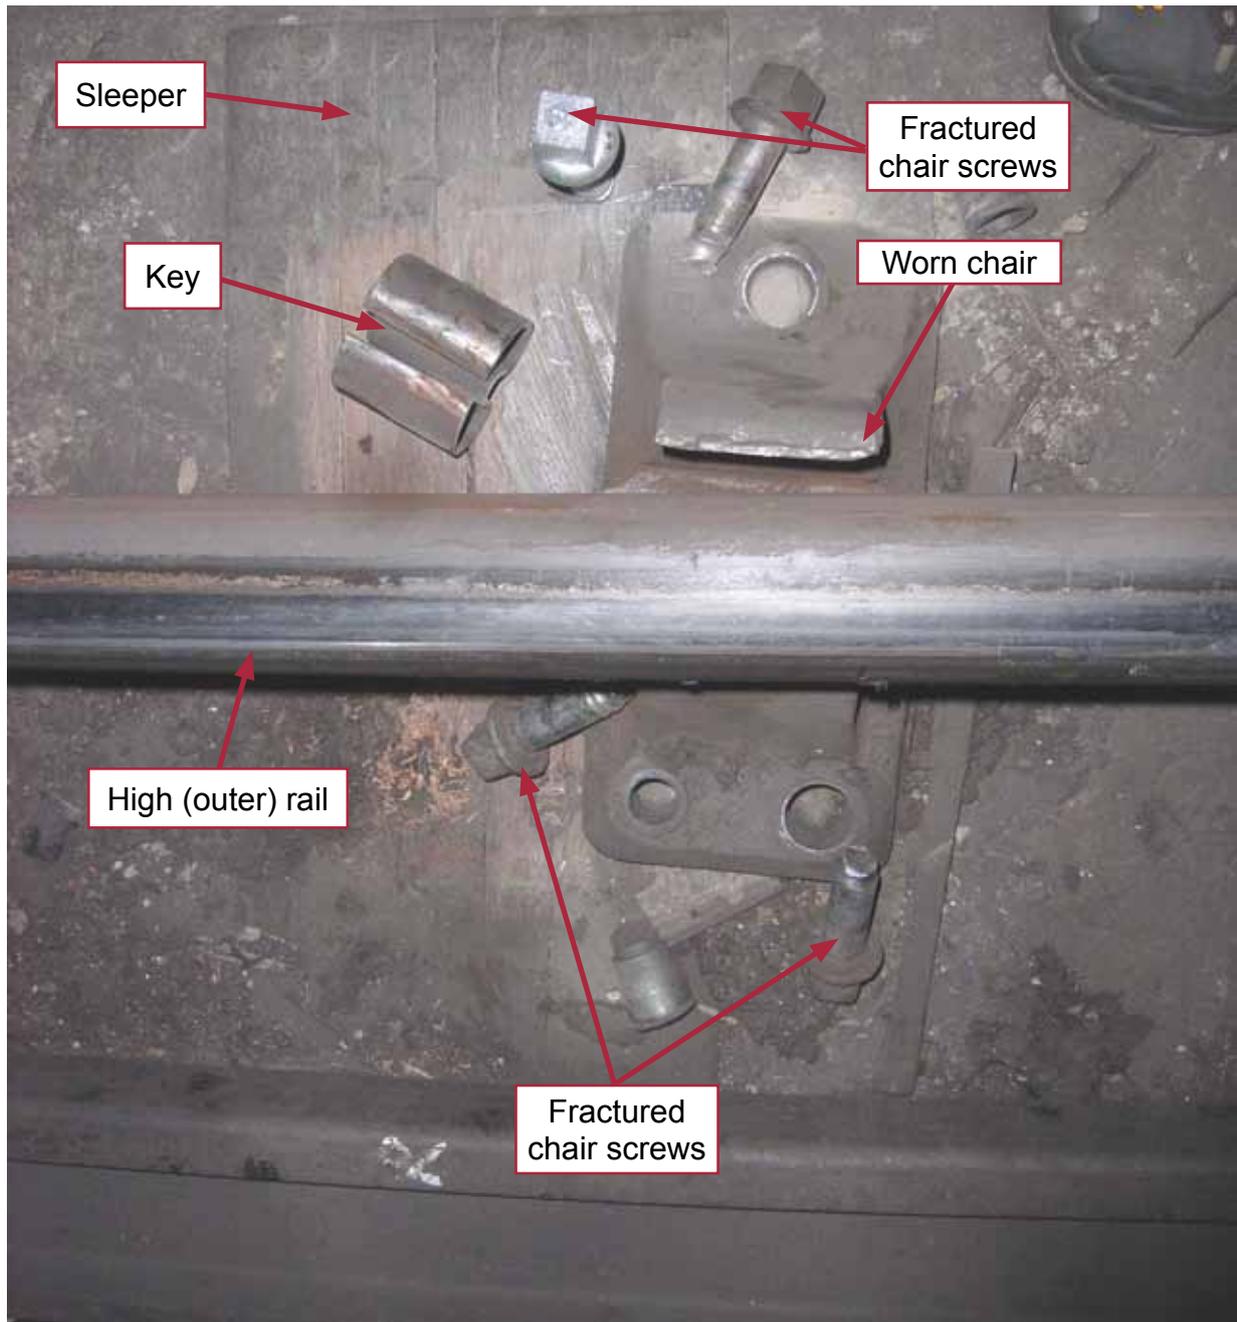
- 36 At the point of derailment the RAIB observed five consecutive chairs on the high rail that were not secured to the wooden sleepers (figure 7). The screws used to secure the chairs to the sleepers had all fractured. A metallurgical analysis of a sample of screws from the derailment site identified that the screws had failed through fatigue as a result of reverse bending. This caused cracks to form on both sides of the screw. The cracks continued until the majority of the cross-section had been compromised, leading to the failure of the remaining material (figure 8). For fatigue failure to occur, the screws must have been subject to repeated bending cycles. Once the screws had failed, the track was no longer securely fastened to the sleepers.

Figure 7: Unsecured chairs at the derailment site

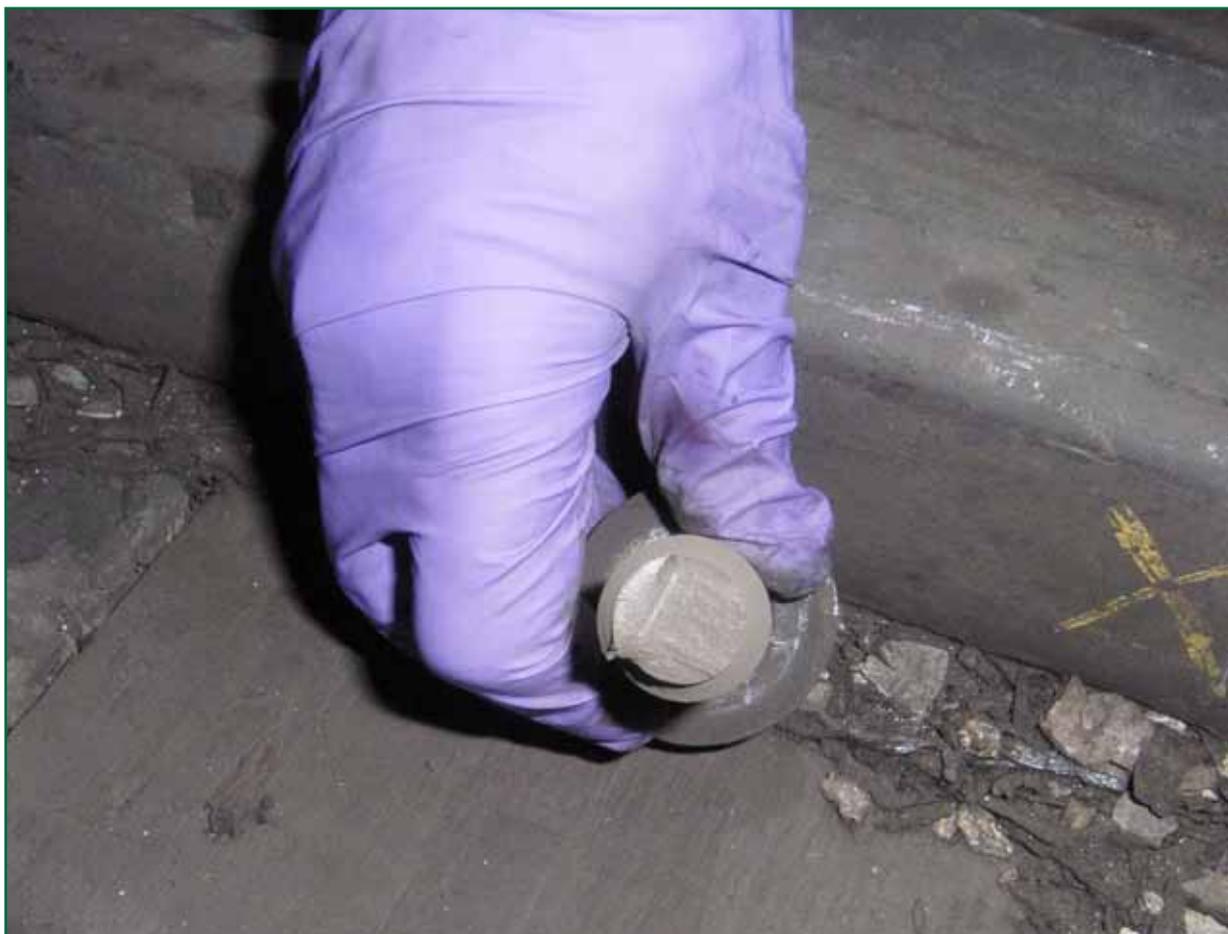
Figure 8: Fractured screws showing signs of fatigue failure

- 37 The majority of the fractured screws analysed showed evidence of polishing to the screw shank. The polishing was most likely to have been caused by repeated movement between the screw and chair due to loose screw fastenings in sleepers of poor condition. The RAIB observed that several of the wooden sleepers were in poor condition, and that several chairs had been repositioned to enable them to be more securely screwed into the sleeper. There was visible evidence that chairs had been moving on the sleepers causing *chair shuffle* (figure 9) as trains passed. *Side-wear* was also present on the high rail at the derailment site which widened the gauge, but was within the safety limit defined by LU standard 1-159 'Track- dimensions and tolerances'.

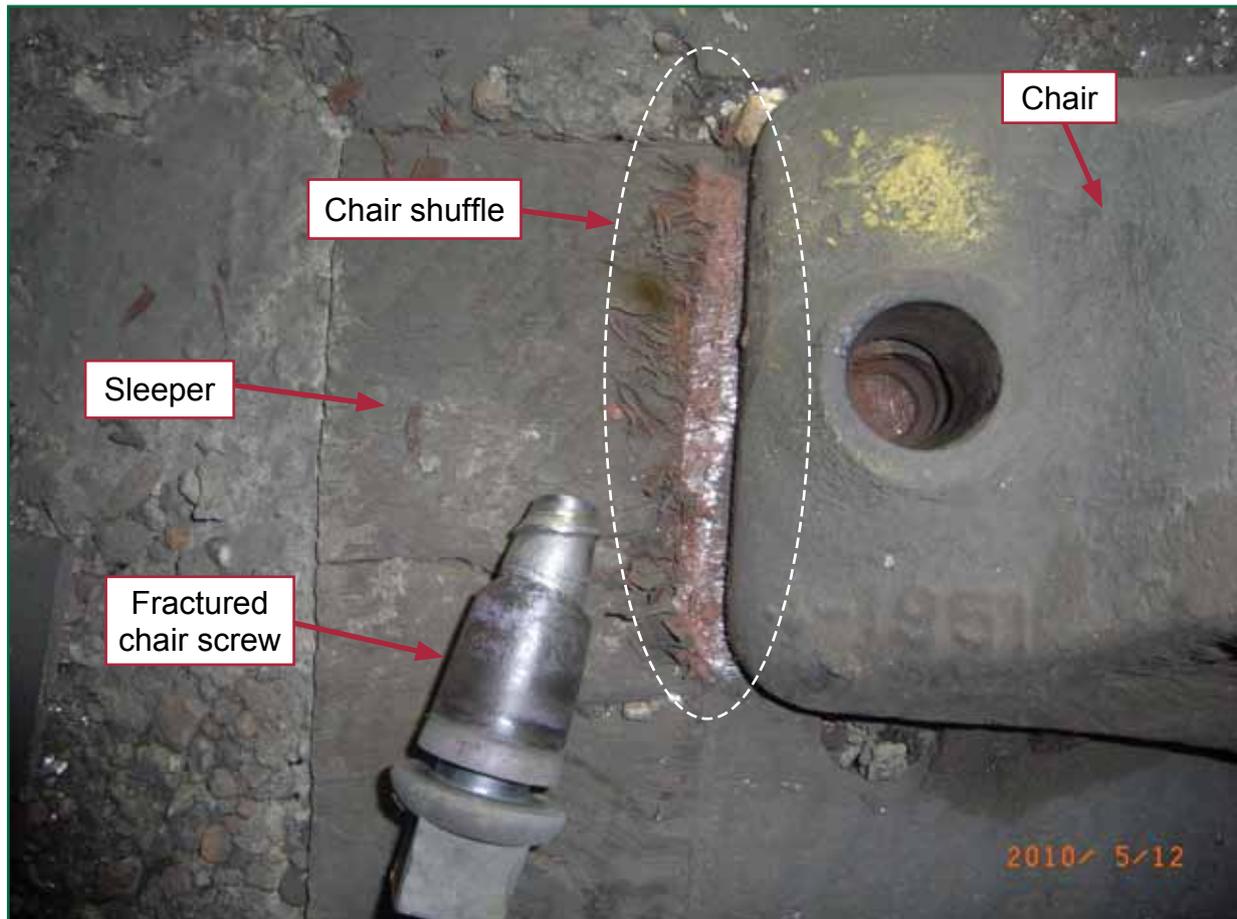
Figure 9: Chair shuffle at derailment site
