Rail Accident Investigation Branch

Rail Accident Report

Track worker struck by a train at Cheshunt Junction 30 March 2010

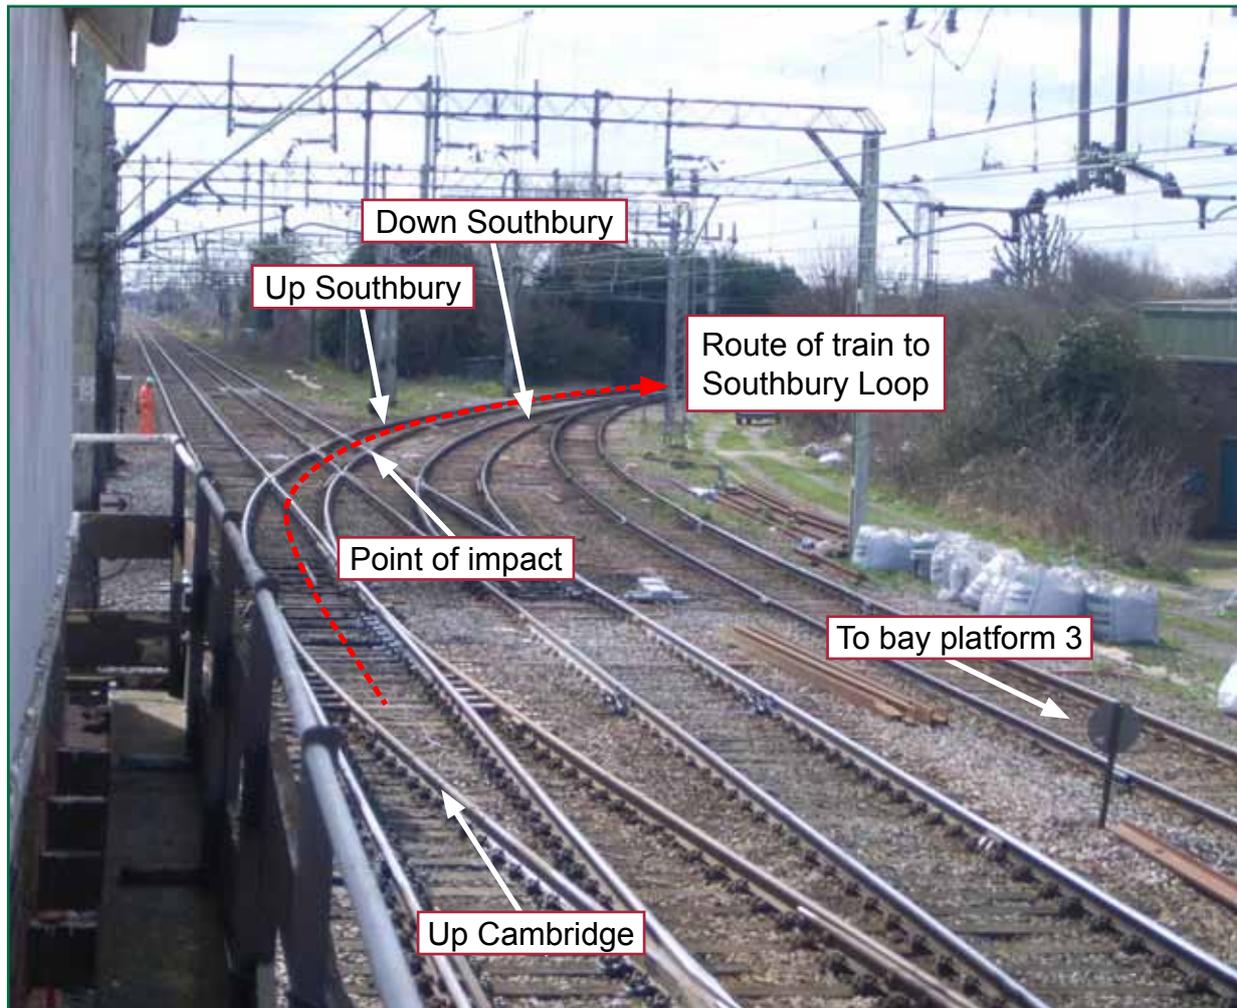
Figure 2: Cheshunt Junction seen from the north (looking south)

- 14 The junction itself is the divergence of two double track routes. An additional track leads from the loop line directly into the bay platform 3 at the station, enabling trains to use the bay without interfering with movements on the Cambridge line (figure 2).

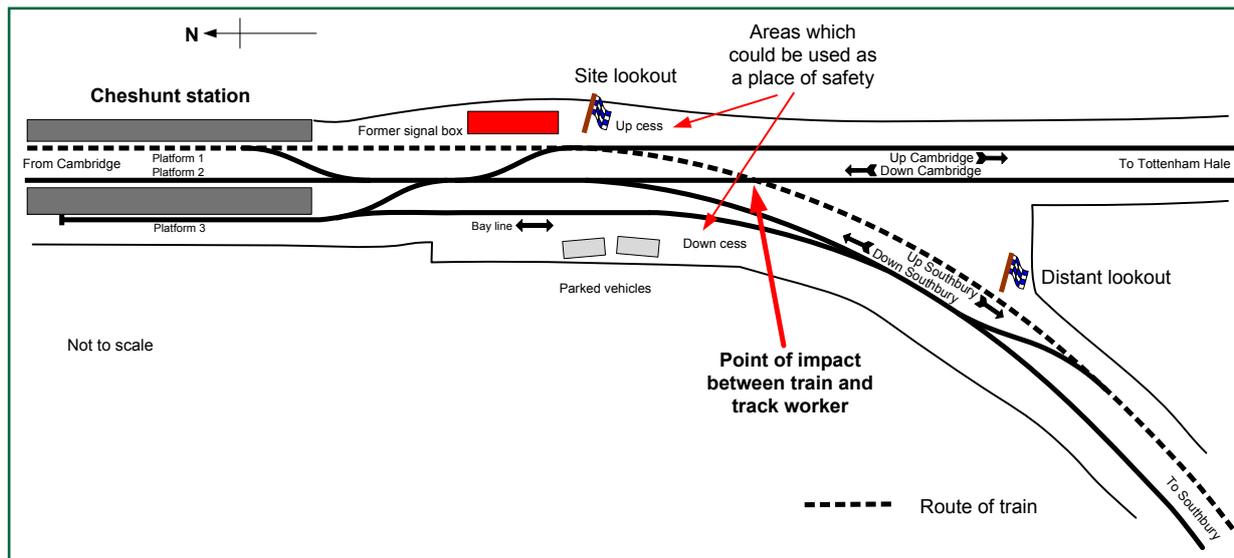
Figure 3: Track layout showing movement of train, positions of lookouts, position of safety and point of impact

- 43 At about 11:43 hrs, as the train passed over the diamond crossing, it struck the chargeman. The final image of the forward facing CCTV fitted to the train in which the track chargeman is visible shows that he was standing in the *six foot* between the Southbury lines, with his back to the train.

- 71 The RAIB observed the movement of trains for a period of one hour from 10:45 hrs on Friday 16 April to establish the conditions arising from the early visibility and frequency of trains passing Cheshunt, and therefore the conditions which the team working at Cheshunt would have experienced before the accident (figure 3).
