Rail Accident Investigation Branch

RAIB Bulletin 09/2010

Collision between a freight wagon door and signal in Kilsby Tunnel, 15 March 2010

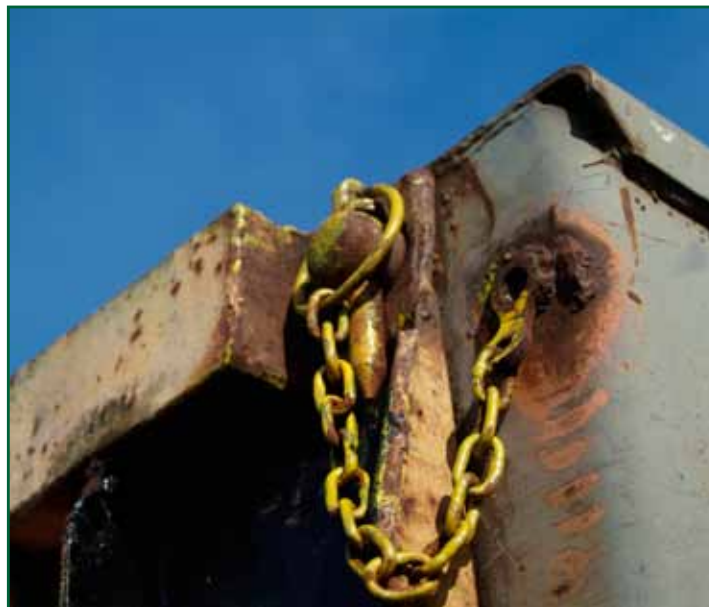
- 2 The wagon involved in the incident was an OCA type. It has six drop down doors; three on each side. The doors are hinged on their bottom edge and held closed in traffic by a spigot and securing pin arrangement located at the corner of each door (figure 1). When released, the door normally drops to the horizontal position. A design feature slows the opening speed of the door and reduces the effort required to close and secure it, effectively making it a one-person operation. The door has to be pushed down from the horizontal position to its 'vertical open' position against a spring, which otherwise holds the door in a horizontal position. When all six doors are vertically open, the four central pillars can be removed to give unrestricted access to the wagon.

Figure 1: the pin passing through the spigot, shown in the fully engaged position and securing the door

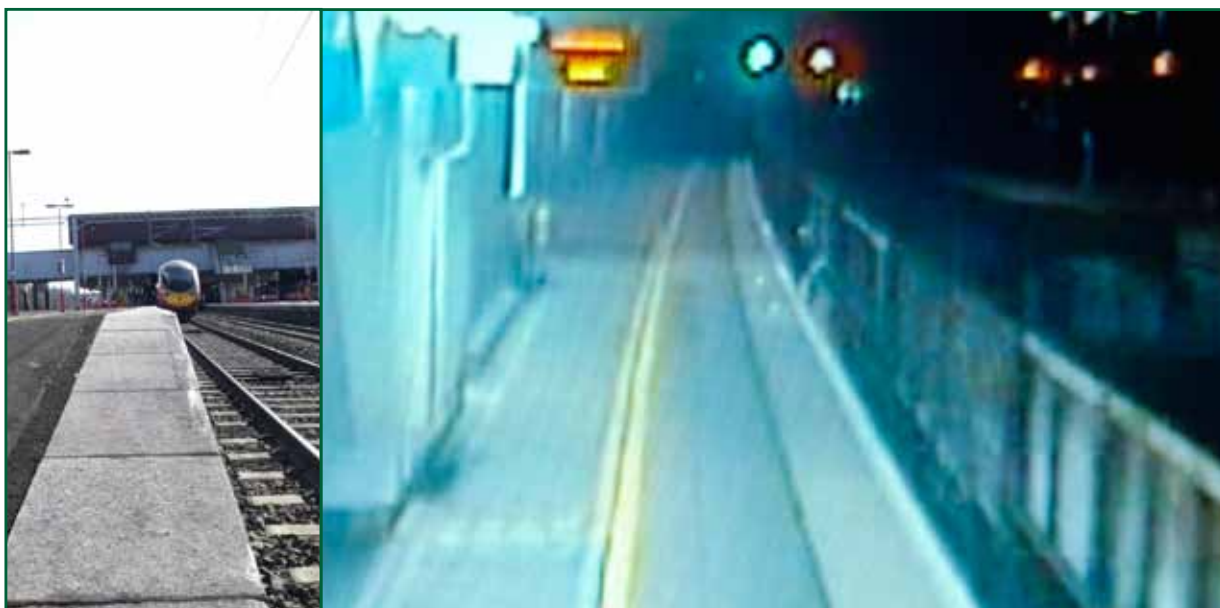
- 4 Train 6T22, comprising empty OCA, OBA and OAA type wagons, departed from Basford Hall and travelled south via Stafford and Birmingham International (figure 2). No incidents were reported, although unknown to the driver, a door on OCA wagon 112107 had dropped down between Crewe and Birmingham. The first known incidence of damage caused by the open door was on platform 4 at Birmingham International station, where it had collided with the north end of the platform ramp, although no-one observed or reported this at the time (figures 3 and 4).

Figure 3 (left): initial impact mark and scrape marks on platform 4 at Birmingham International station.
 Figure 4 (right): wagon 112107 colliding with the up platform 4 at the same station. The wagon door had already fallen from the 90° to the 180° position.

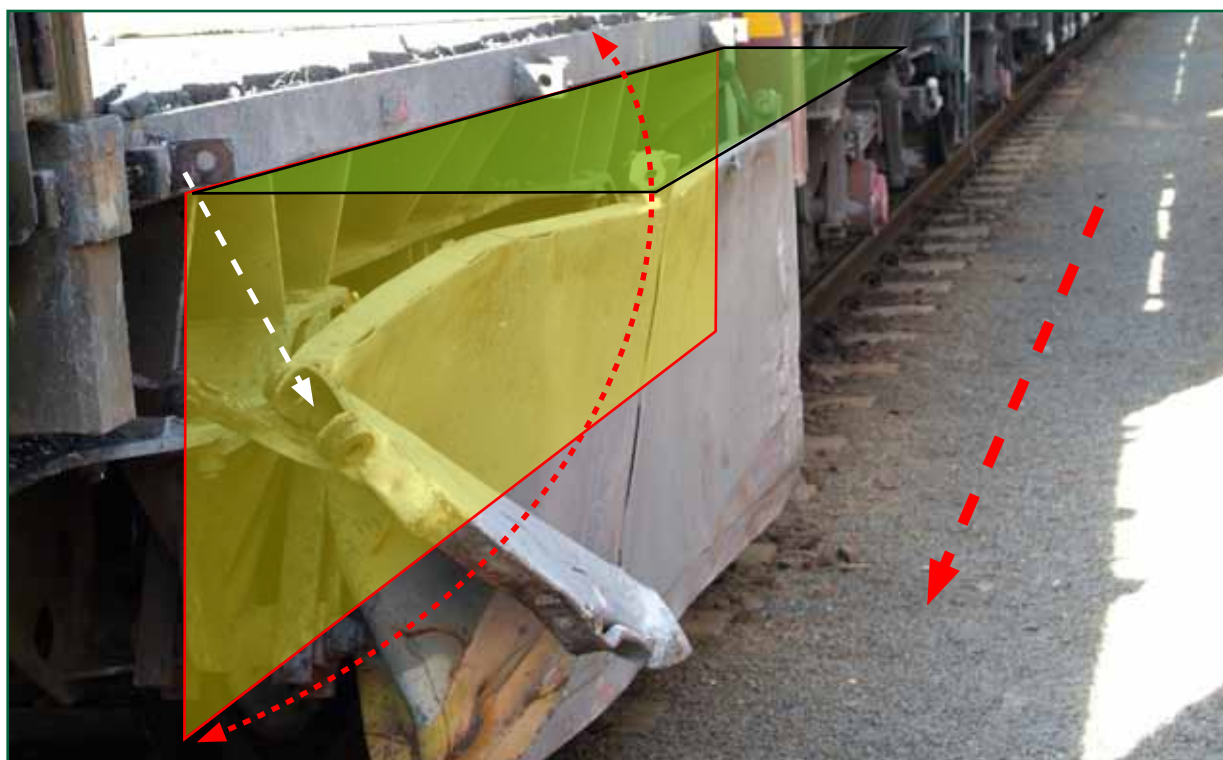
- 6 The signalling centre at Rugby became aware of the failure of signalling equipment in this area and, assuming that a cable theft might have occurred, notified the British Transport Police to request their attendance. Network Rail incident response staff also attended the site and having seen the damage to the signal, asked the signaller to investigate recent train movements through the area. Train 6T22 was stopped at Wembley and the driver was requested to examine the train. The driver later reported that the 11th wagon had sustained damage to an open door on the left-hand side in the direction of travel (figure 5).

Figure 5: The damaged left-hand door of wagon 112107

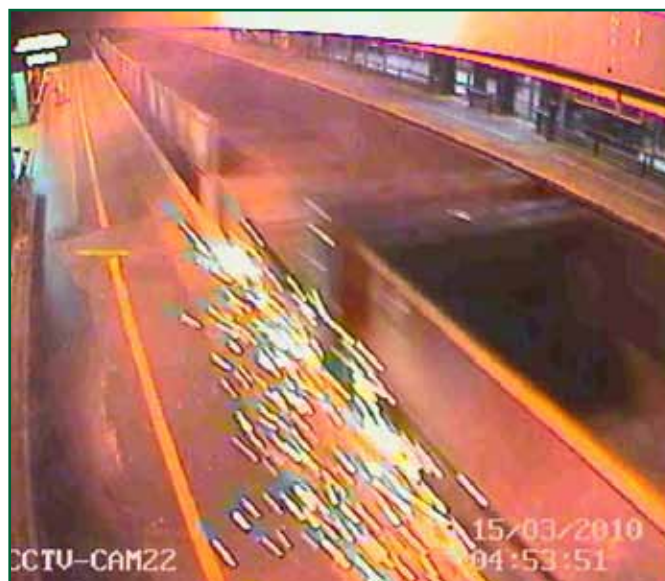
- 7 After leaving Kilsby Tunnel the train had passed through several stations. CCTV from Watford Junction station showed the wagon door colliding with the platform wall and surface area (figure 6).

Figure 6: Wagon 112107 colliding with a platform at Watford Junction station

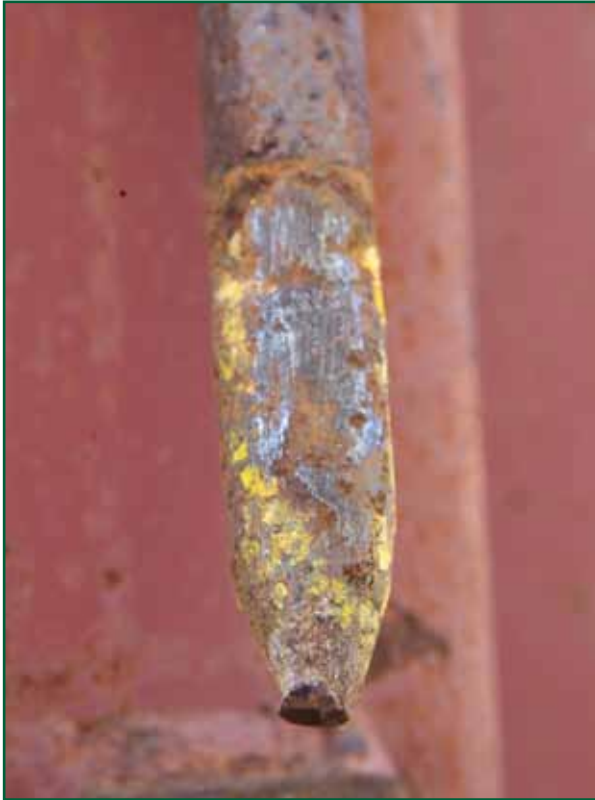
- 9 The RAIB's examination showed that the three pins on the incident wagon had not been recently engaged within the spigot and door mechanism. This could be deduced from the build-up of rust on the pin and the lack of recent contact mark with the spigot housing (figures 7 and 8).

Figure 7: reference sample used to show contact marks after pin had been forcibly removed

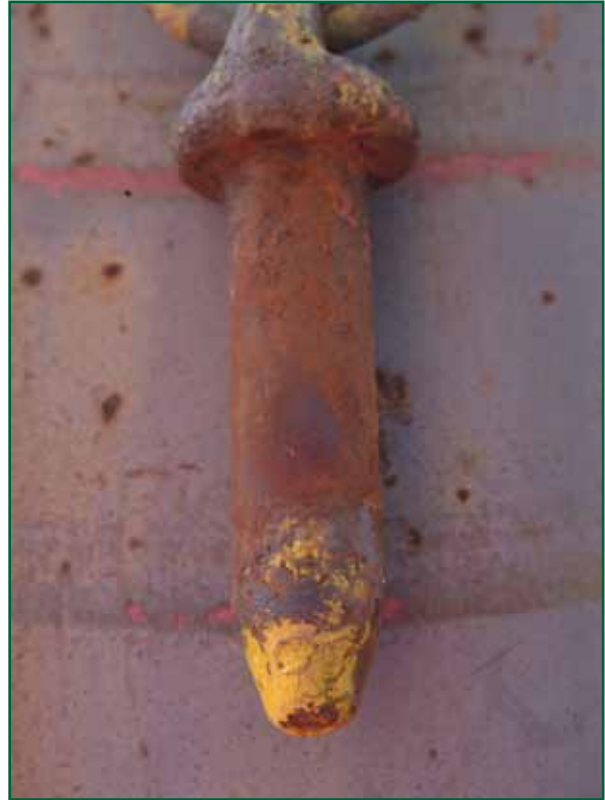
- 8 The train was later examined by the RAIB. Three of the six pins on the incident wagon (left-hand side in the direction of travel) were hanging down and not engaged.

Figure 8: one of the three disengaged incident wagon pins found hanging at the side of the open wagon door

- 19 This incident occurred because the wagon doors were not properly secured when train 6T22 left Basford Hall. The incident at Kilsby Tunnel and others referred to in the previous section have highlighted that the security of doors in this family of wagons depends on the actions of train preparation staff in physically checking that pins are not only in the appropriate spigot but also fully engaged and providing adequate restraint.
- 20 The wagon frame, door, spigot and pin may become damaged during routine operational activities, causing staff to use a tool or hammer to insert or extract the securing pin. This method may result in further damage to the pin and spigot occurring which prevents the pin from fully engaging through the spigot.

- a) The general rustiness or colour of the door attachment mechanism can make it difficult for a train preparer to see if pins are fully engaged and this difficulty may be exacerbated when lighting conditions are poor. Staff involved in train preparation must be aware that they need to physically check that the pin is fully engaged through the spigot as the deformation that may occur between the door and the wagon frame may allow the pin to disengage if it is not fully inserted through the spigot.

- b) There is a need within maintenance and inspection regimes on wagons of this type to examine the drop-down doors and the condition of the pins, spigots and door latching components. Vehicle maintenance checks on the door mechanism should include an examination for visible damage and ensure that there is sufficient tolerance to allow the pin to be put in and taken out without further damage being caused.

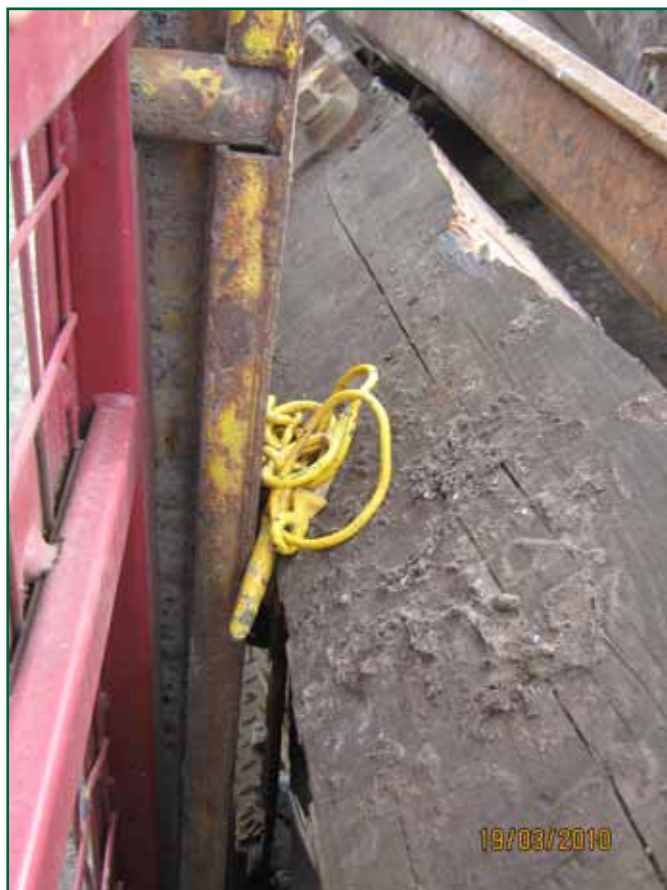
- 15 It was reported to the RAIB that train 6Y20 had arrived in the TMA yard at Crewe with an insecure door. The train was inspected and two pins on an OBA wagon were found to be missing. The pins were found on the load within the wagon (figure 9).

Figure 9: pin found on wagon of train 6Y20 on 19 March 2010
