# RAIB Bulletin 10/2010

## Train collision with level crossing gate, Stow Park, Lincolnshire, 20 February 2010

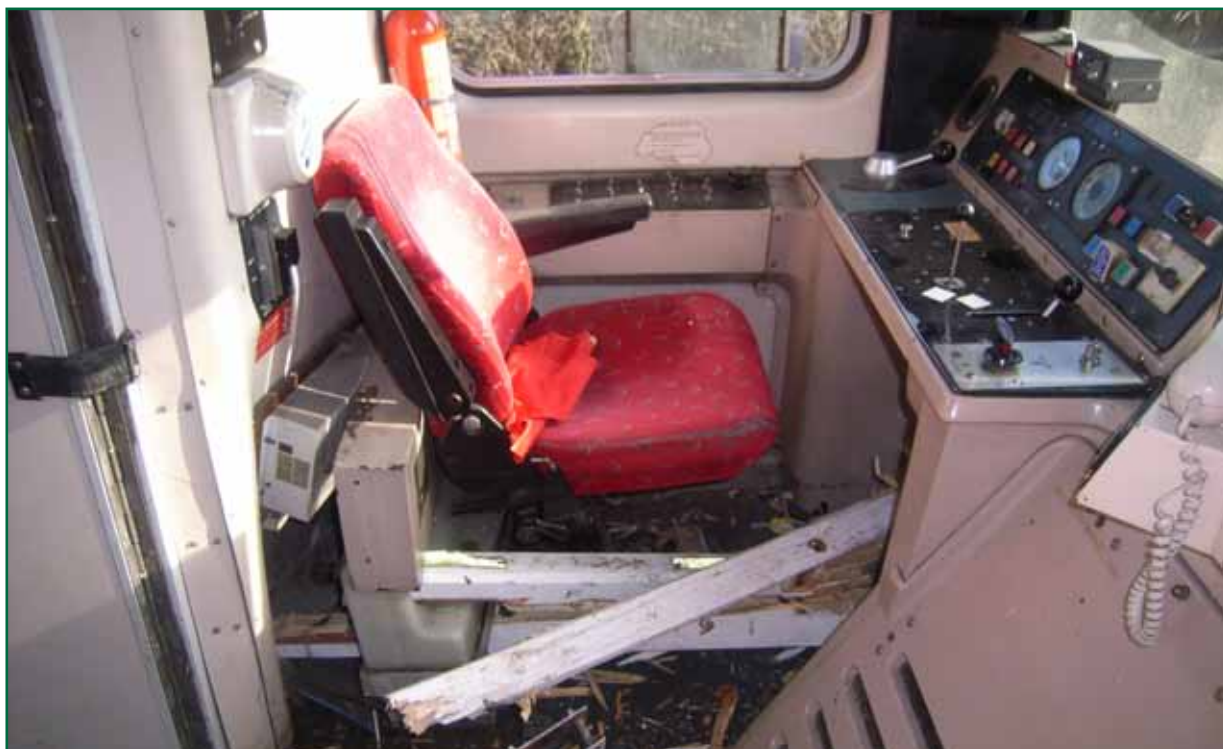
- 1 At 06:45 hrs on Saturday 20 February 2010, the 05:39 hrs train from Sheffield to Lincoln, formed of two-car diesel multiple unit number 144009, struck the up<sup>1</sup> side gate at Stow Park level crossing, which had become partly open, at a speed of about 49 mph (79 km/h).
- 2 The timber crossing gate was destroyed by the collision and the upper rail of the gate penetrated the cab of the train through the nearside marker light fitting. This caused minor injuries to the driver's legs and damage to the electrical cubicle mounted behind the driver's seat (figure 1). The driver narrowly avoided being seriously injured by the penetrating pieces of timber from the gate and none of the five passengers on the train were injured.
- 3 The driver applied the emergency brake and the train stopped about 60 metres past the crossing (figure 2).

Figure 1: Cab interior following collision with level crossing gate

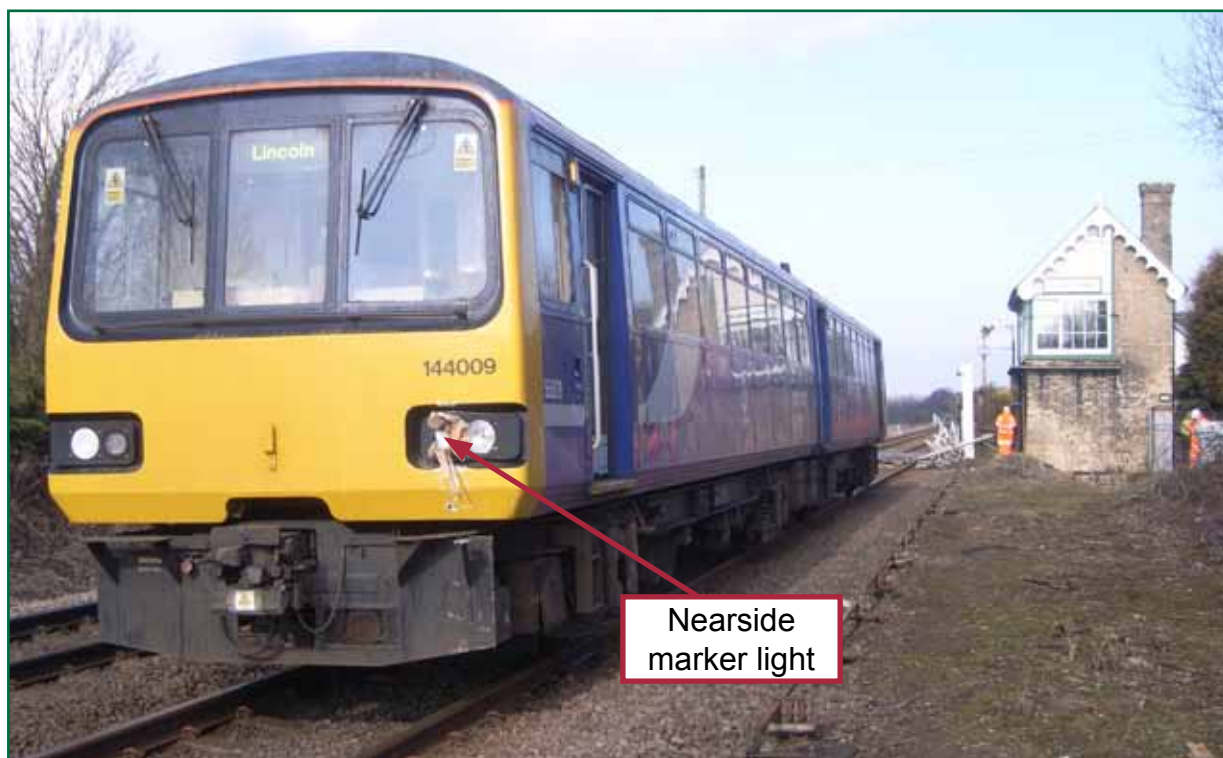
Figure 2: Train involved in the accident at Stow Park crossing

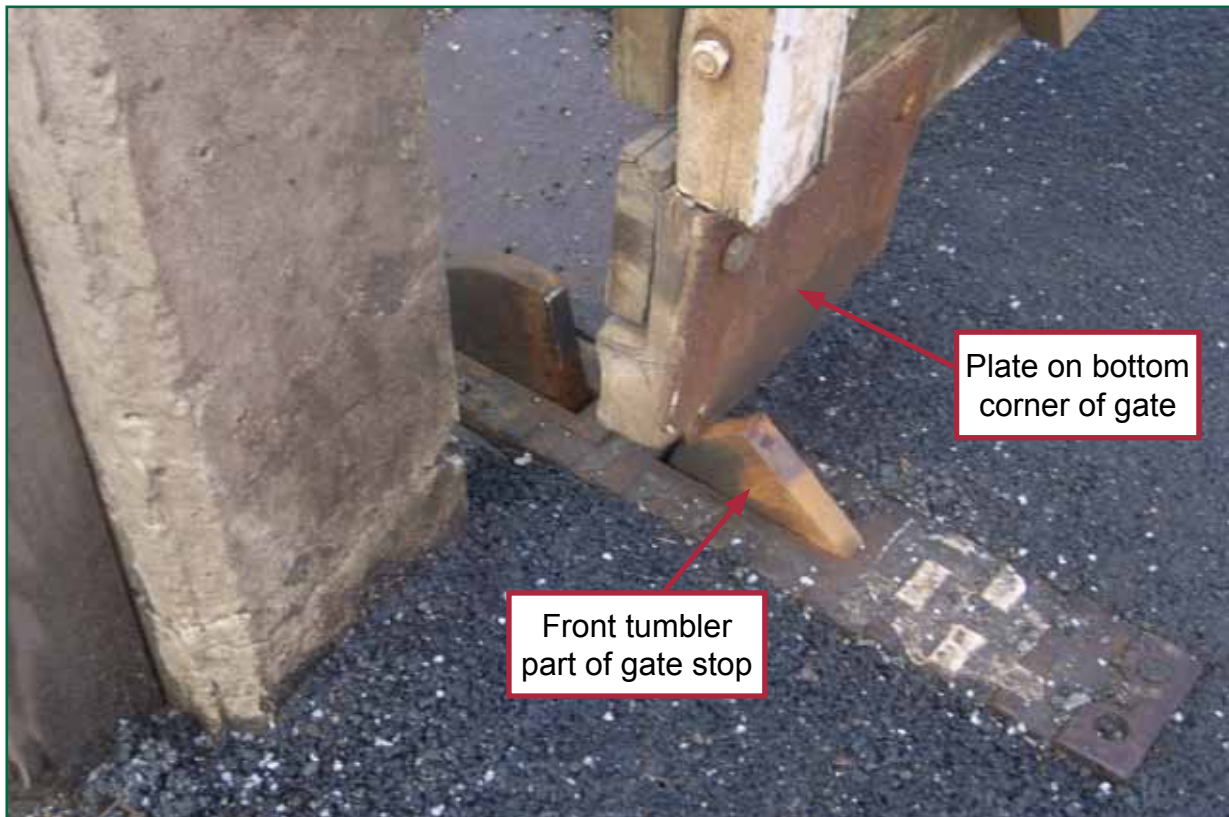
- 7 In order for the gates to be retained in position, and to prevent them swinging back, there has to be sufficient overlap between the front tumbler of the gate stop and the bottom corner of the gate (figure 3). This has to be maintained to take account of all normal changes in temperature occurring during the year which affects the height of the bottom corner of the gate.

Figure 3: Down side gate stop with gate in position across the road

- 9 The RAIB's investigation found that the up side gate was not securely held in position across the road because there was insufficient overlap between the front tumbler part of the gate stop and the bottom corner of the gate. The gate had therefore been able to swing back into the path of the train.

- 14 The probable cause of the accident was that the travel of the up side gate stop had been reduced when the crank was replaced and it no longer rose sufficiently far above the surface of the road to reliably prevent the gate from being able to ride over the gate stop and swing back across the railway. The low temperature of the previous night was also likely to have been a factor in causing the height of the bottom corner of the gate to increase (paragraph 7).

- 15 Since the accident occurred, Network Rail has renewed the up side gate and adjusted the gate drive. It has also removed the backboard to the mirror, and shortened the post on which the mirror was mounted, to improve the signaller's view of the up side gate stop.
