Rail Accident Investigation Branch

RAIB Bulletin 05/2010

Train door incident at Liverpool Street, London on 4 February 2010

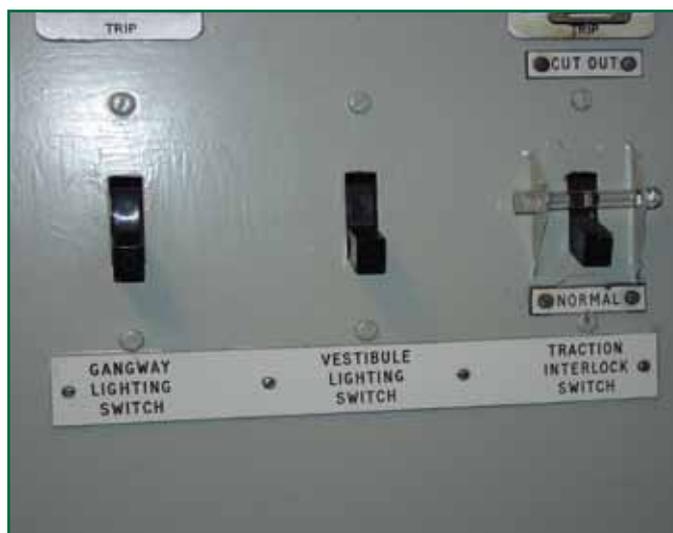
7. The RAIB examined the train at Liverpool Street station and subsequently collected documents and witness evidence related to the incident.
8. When the train was examined after the incident, the traction interlock switch (TIS) in the country (north) end cab of unit 317505 was found to be in the 'cut out' (isolated) position. The TIS is located on the cab bulkhead behind the driver's seat, and is one of a row of three switches. The other two switches in the row control lights in the gangway and vestibule adjacent to the cab (figure 1). This meant that it was possible for the driver to apply power to move the train although the doors were not closed and locked. The rule book (module TW5 section 33.1) prohibits a train from entering service from a maintenance depot (such as Ilford) if the TIS is unsealed or isolated. Section 33.2 of module TW5 prohibits a train from entering service from somewhere other than a maintenance depot (such as Chingford sidings) if the TIS is isolated.

Figure 1: Switches on cab bulkhead of class 317, showing TIS in normal position with glass seal intact

10. The On Train Data Recorder (OTDR) showed that the TIS had been cut out while the unit was in Ilford depot, and was still in this state up to the time of the incident on 4 February. There are several reasons why this may need to be done. In particular, on 29 January the unit went on a test run in connection with the investigation of a traction motor fault. On this run, monitoring equipment inside the train was connected to the traction motors by cables passing through one set of doors, which had to remain partly open for this purpose. With the doors partly open, it was necessary to cut out the TIS to enable the test run to be carried out. To cut out the TIS it is necessary to break a glass rod which obstructs movement of the switch. The remains of this rod were found on the cab floor after the incident.

11. The person who prepared the train at Ilford depot did not notice that this sealing rod had been broken and that the TIS was in the 'cut out' position. A check on this switch, and a test of the correct operation of the traction interlock by attempting to take power with the doors open, is part of the train preparation process which should have been followed before the unit was released from the depot for service on 3 February. There are two 'depot drivers' at Ilford depot. One of them was not aware of the requirement to test for power with the doors released. The other had been trained to do this, but had been advised not to do it at Ilford depot because it was not possible to carry out a power test without activating the depot protection system within the shed at Ilford.

24. Underlying factors were the design of the class 317 cab, with the door interlock lights located out of a seated driver's range of vision, the design of the TIS which made it easy for a driver to miss the fact that it was isolated, and the casual methods of working adopted by a few drivers in sometimes taking power before the traction interlock is obtained.

25. National Express East Anglia is modifying the TIS on the class 317 units which it operates, by fitting a cover over the switch which can only be closed when the switch is in the 'normal' position, and displays a patch of contrasting colour when the switch is in the 'cut out' position. A similar modification has already been applied to the class 315 units operated by the company, and is intended to make it easier for train preparers and drivers to see that the TIS is isolated. Once this modification has been completed, the company proposes to remove the requirement to test the operation of the traction interlock from the train preparation process. RAIB has written to the other operator of class 317 units to bring this matter to its attention.

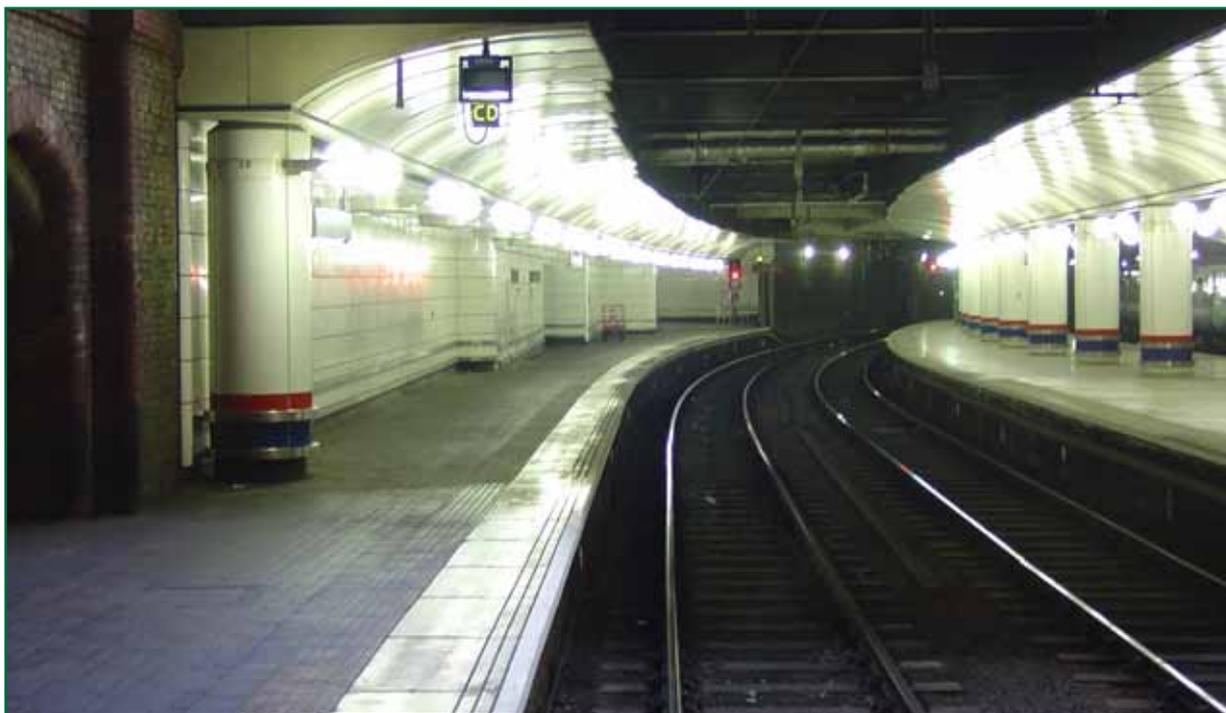
18. At Liverpool Street station, trains are dispatched from platform 1 by platform staff using a key switch to make 'CD' appear on an indicator suspended above the track ahead of the train (figure 2). This sign indicates to a driver that the train doors should be closed. When the doors are closed, and all the lights on the outside of each coach have gone out, the platform staff (the dispatcher) should then use another key switch to make 'R' appear on the indicator ahead of the driver. Only when 'R' appears should the driver understand that it is safe to take power and move the train. On this occasion the dispatcher was still waiting for the doors to close when the train moved off, although the driver thought that he saw the 'R' displayed. The data recorder in Liverpool Street signalling centre confirms that 'R' was not displayed before the train left.

Figure 2: View from cab of train in platform 1 at Liverpool Street, showing 'CD' display

22. The immediate cause of the incident was that the driver applied power without confirming that the train doors had closed, and without seeing the 'R' indication on the display ahead of the train.
