Rail Accident Investigation Branch

Rail Accident Report

Incident at Romford station, 4 February 2010

Report 20/2010
December 2010

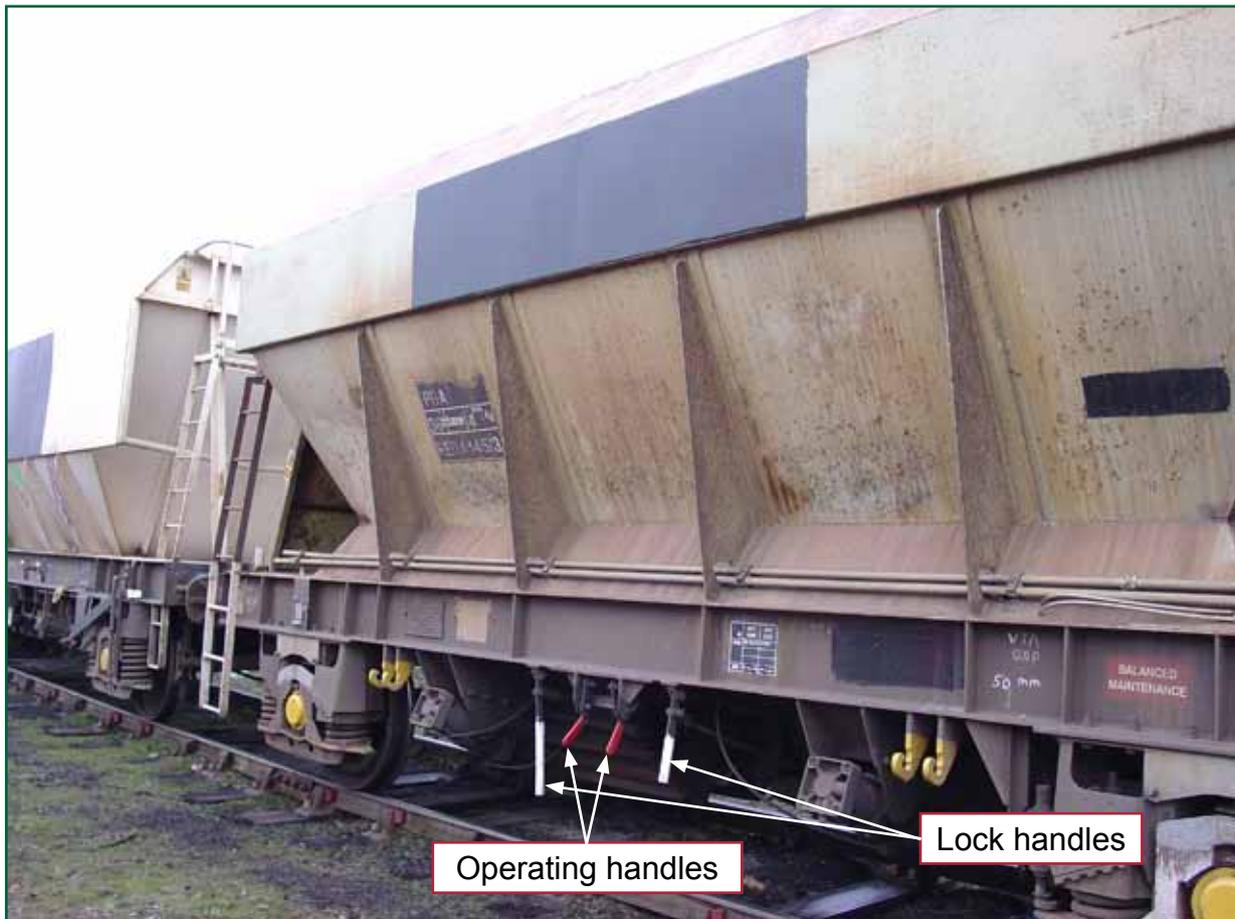
Figure 4: Wagon 14513, showing door control and locking handles

- 16 PGA wagons are air-braked four-wheeled vehicles, which carry mineral or aggregate material in two hoppers, each with a set of power-operated bottom doors which can be controlled by a person standing on the ground alongside the wagon (figure 4).

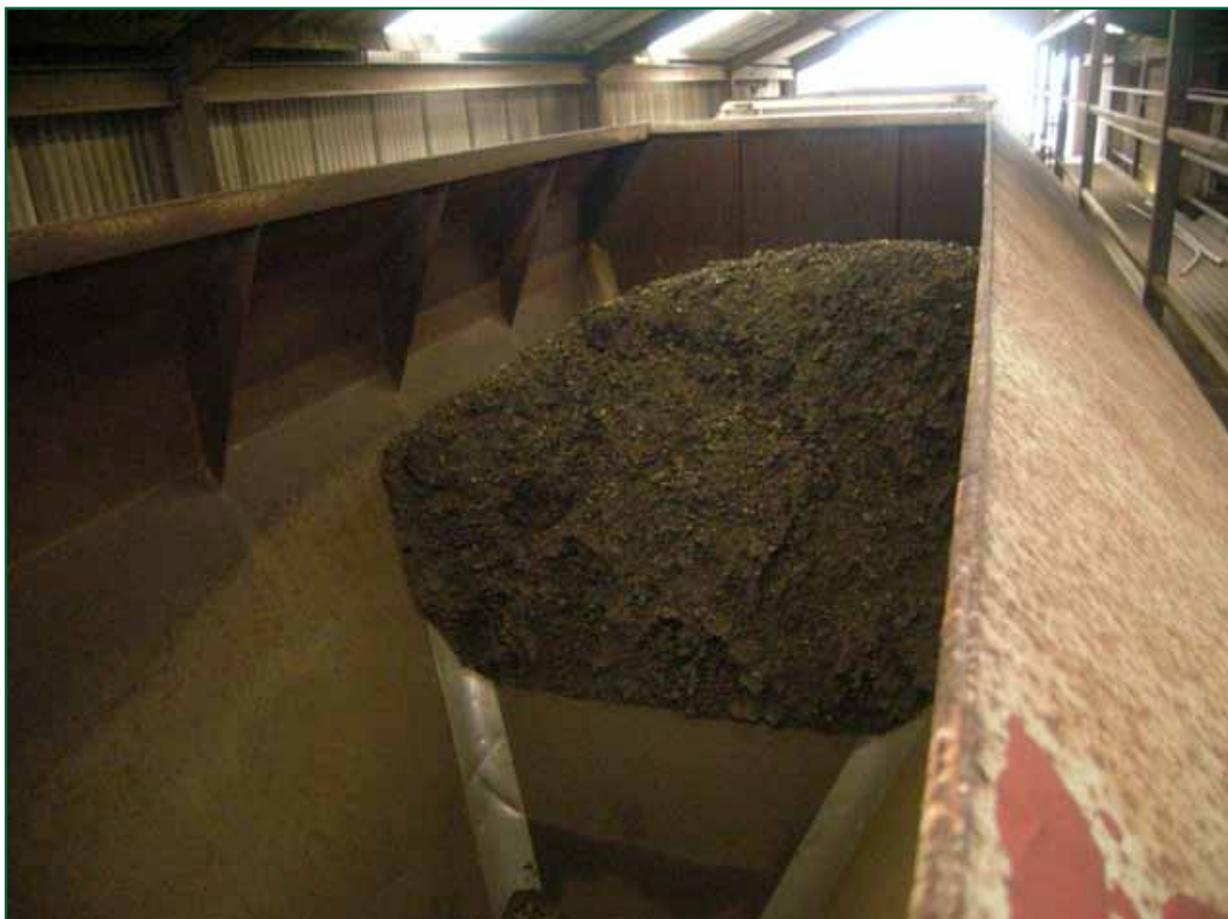
Figure 5: Remaining load in wagon 14513, after the incident

- 32 **The immediate cause of the incident was that ballast fell through an open door on wagon 14513, and ricocheted off the track onto the platform.**
- 33 When the RAIB examined the train at Ipswich, one of the two sets of doors on wagon 14513 was found to be almost fully open. The other doors were closed, but not fully locked.
- 34 The CCTV from Romford station shows that as the train passed through, it generated a cloud of dust. After they had dealt with the injured people, the station staff searched the area and found a quantity of ballast spread along platform two, and saw that there was some more that appeared to have been recently dropped on the track.

- 40 While the wagon was stationary in Acton yard, from 4 January to 3 February, most of the load is likely to have stuck in the wagon even though one set of doors was open: initially because the load was frozen, and latterly for the reasons discussed in paragraph 36. However, when the wagon was moved some of the load did come out, and several tonnes were found on the tracks in the yard where the wagon was shunted on 3 February. This suggests that a wagon door was open on or after 4 January when the wagon arrived at Acton.
- 41 After the incident, when the RAIB examined the train at Ipswich, the leading pair of doors on wagon 14513 was found to be open, and the other pair, although closed, was not fully locked. One of the two hoppers was empty, and the other was almost full (figure 5).

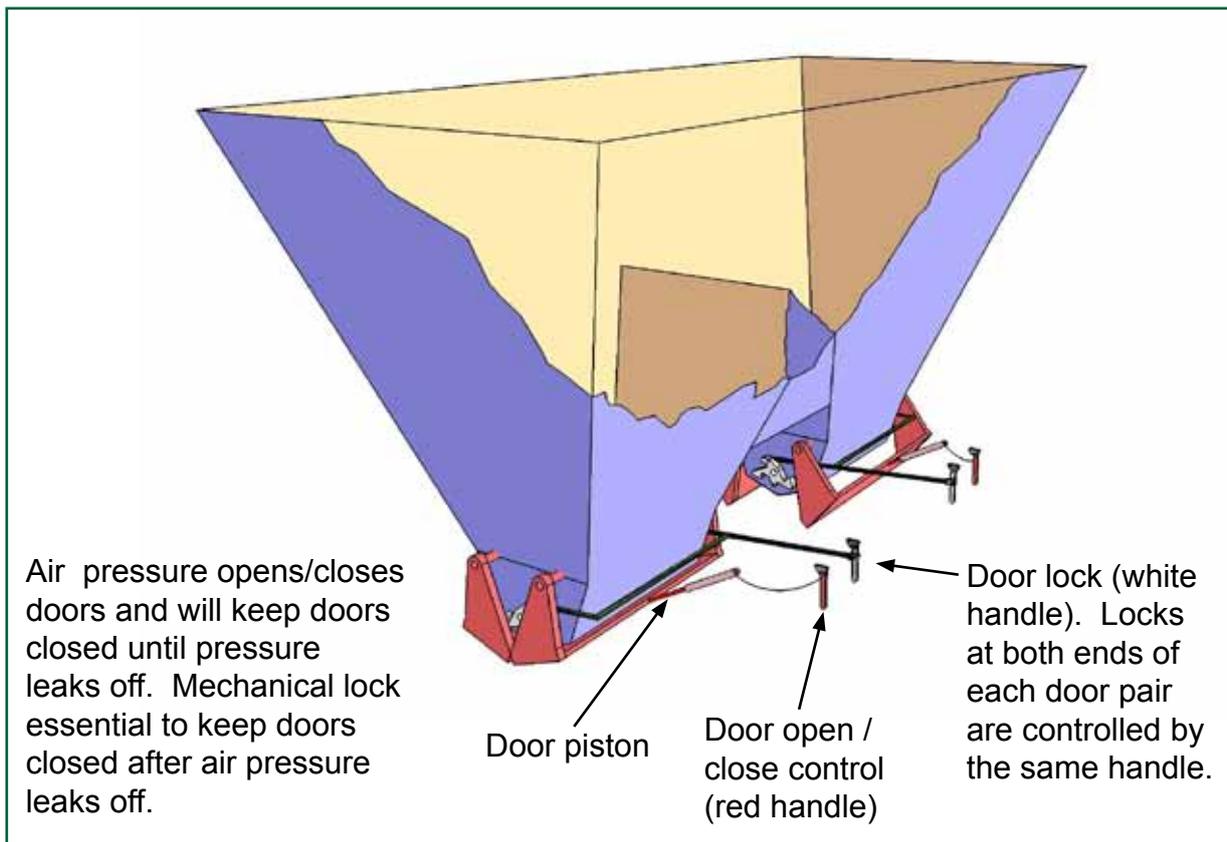
Figure 6: Door arrangements on PGA wagons

- 43 The hopper doors on PGA wagons are power-operated, and are opened and closed by air cylinders (figure 6). These are controlled by red-painted handles below the *solebar* of each wagon. There is a separate lock mechanism which acts on both ends of each pair of doors, and is operated mechanically by white-painted handles below the solebars⁴.

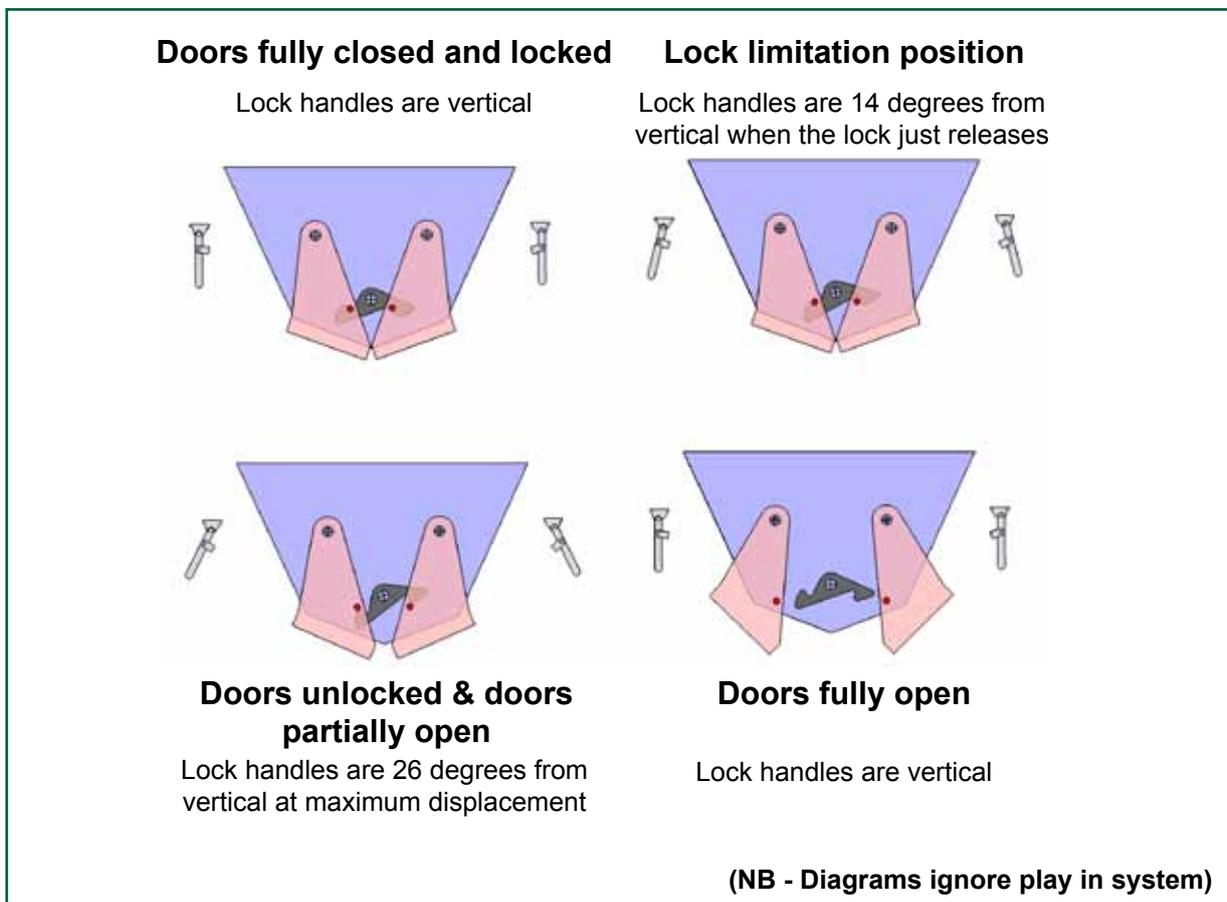
Figure 7: Door locking handles

- 44 The lock mechanism uses a hooked cam which engages with a pin on each door (figure 7). Closing the doors should cause the lock to engage, but friction in the linkages and obstruction by stones may mean that the lock is not fully secure until the white handles have been forcibly operated by the person unloading the wagon. Witness evidence suggests that staff were in the habit of kicking the white handles to secure the locks. Once the doors are locked, the design of the mechanism means that it is not possible for them to be unlocked without deliberate action by an operator.

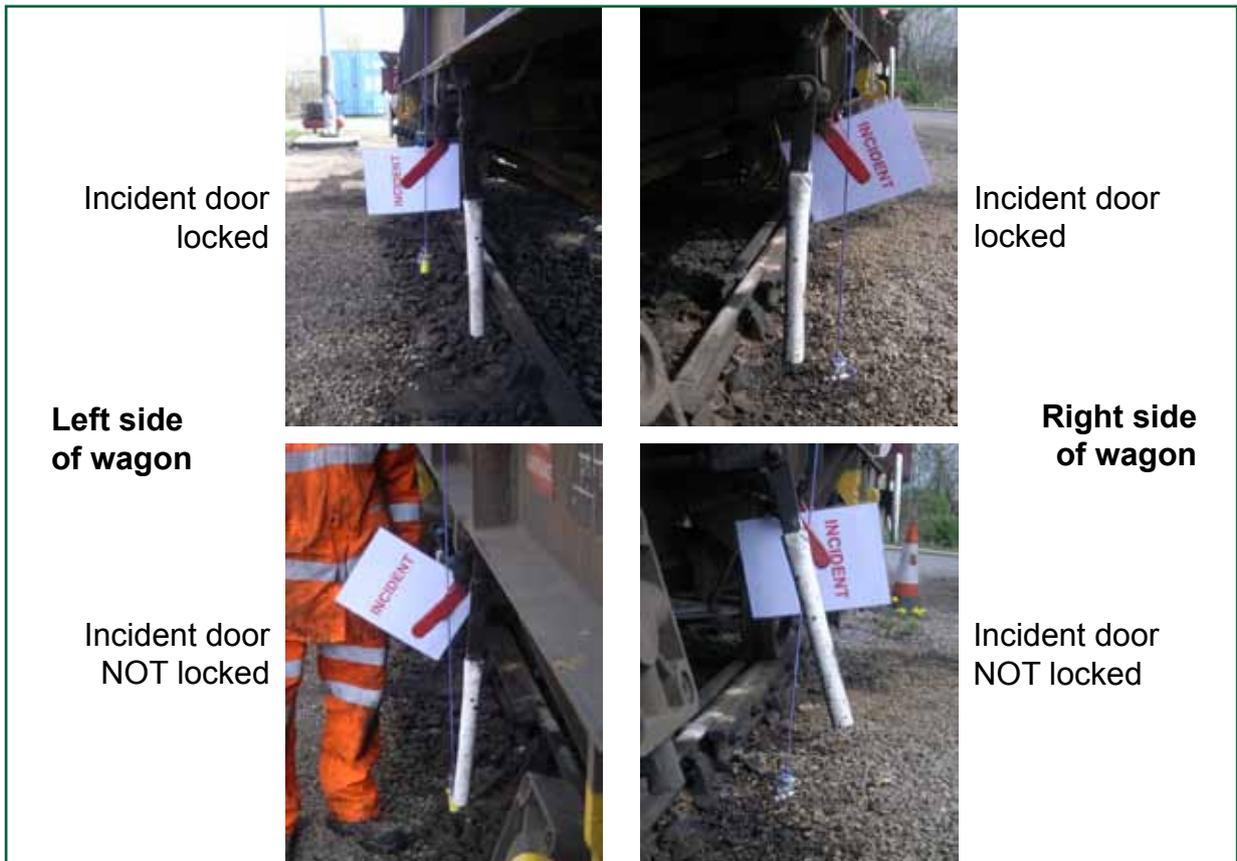
Figure 8: Variations in handle position between doors locked and unlocked

- 42 The position of the lock handles on the PGA wagon can lead staff to believe that the doors are closed and locked when the doors are actually partially or fully open. The design of the mechanism permits this condition to exist. This was a causal factor.**

- 45 The lock handles are designed to be nominally vertical when the lock is engaged and secure, and to stick out at an angle if it is not. However, the RAIB's tests found that, because of the design of the cam, and wear and distortion in the rodding linking the handles to the cam, the variation in the position of the handles was very small, and could not be relied on to indicate the state of the lock (figure 8). Handles could appear to be vertical with the doors both locked and unlocked. This is a probable causal factor, because witness evidence indicates that staff making visual checks relied on the position of the handles to indicate the condition of the doors.

- 1 *The intention of this recommendation is that the PGA wagon fleet should be modified to enable wagon discharge operators to have a clear indication of the state of the doors.*

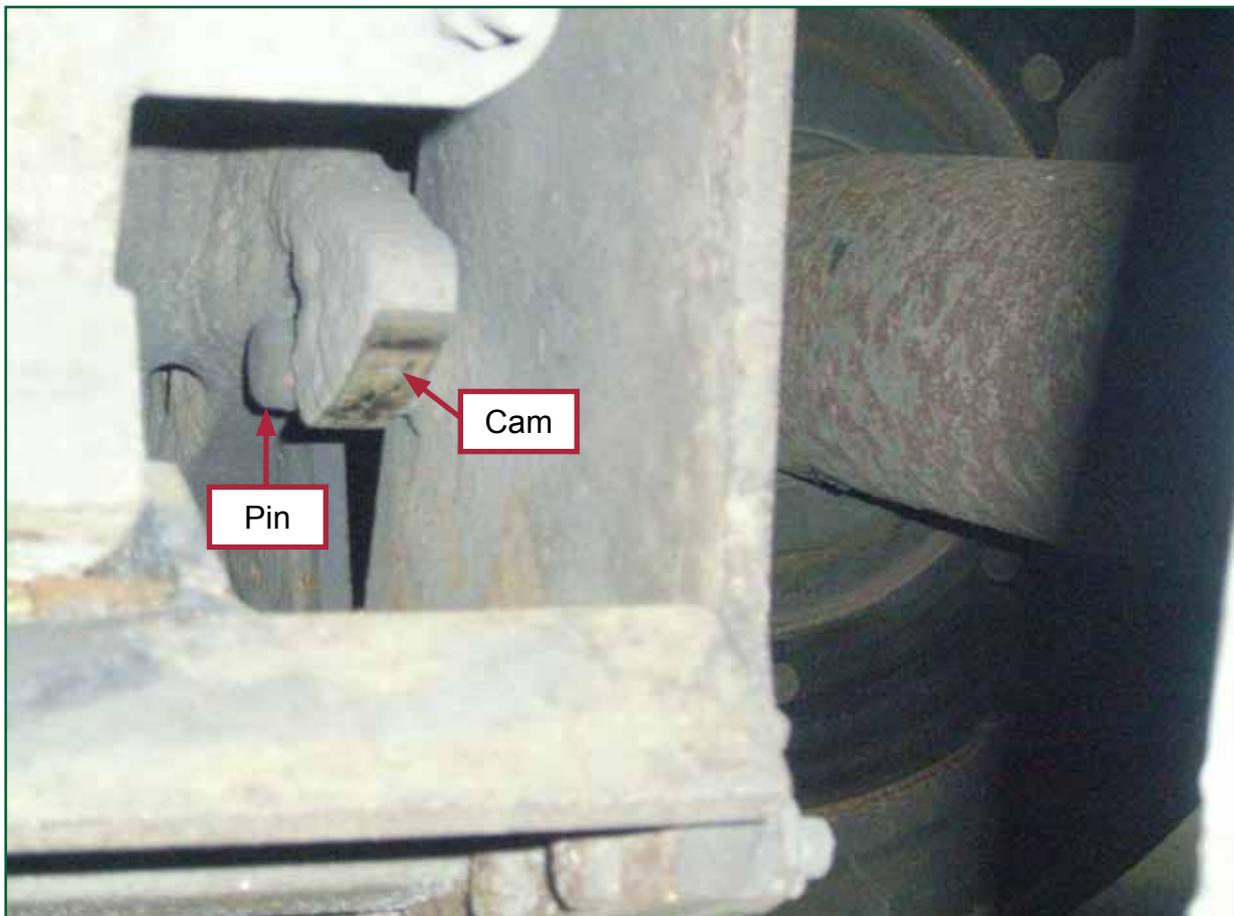
Figure 9: View of lock mechanism, between doors and hopper, showing cam not fully engaged with pin

- 47 The only way to be certain that the lock is secure is to confirm that the cam has engaged with the door pin by looking through the gap between the ends of the doors and the hopper (figure 9). This is not easy to do: it is awkward and time-consuming, and requires a torch, sometimes even in daylight.
