Rail Accident Report

Collision at Exeter St Davids station 4 January 2010

Report 10/2010
June 2010

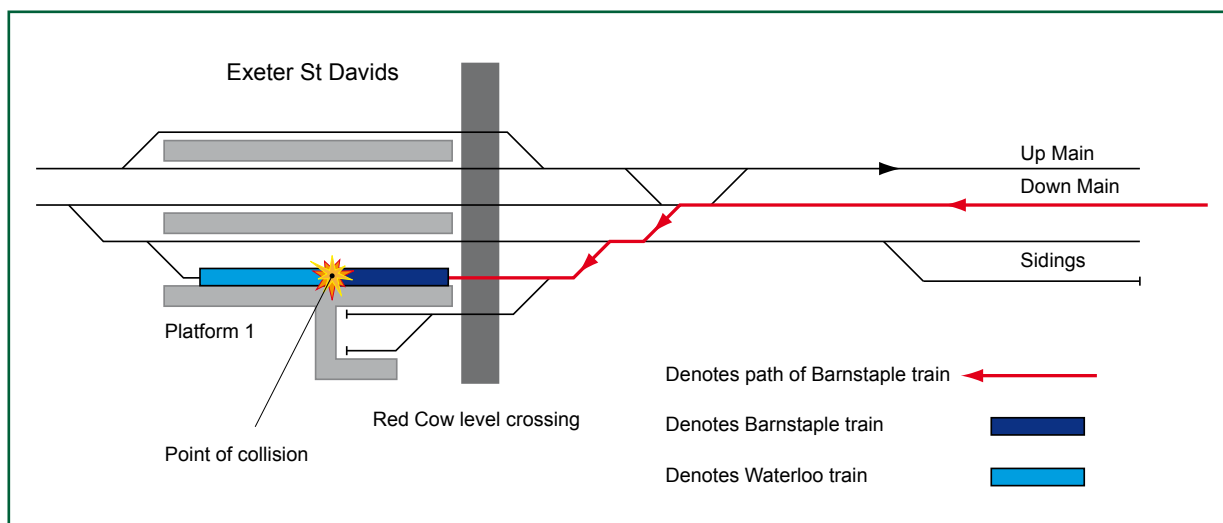
Figure 2: Layout of track and path of train involved

- 15 On the immediate approach to platform 1 from the east end of the station, trains pass over Red Cow closed circuit television (CCTV) level crossing (see figure 2). This level crossing is situated on a busy road linking the A377 with the Exwick area of Exeter.

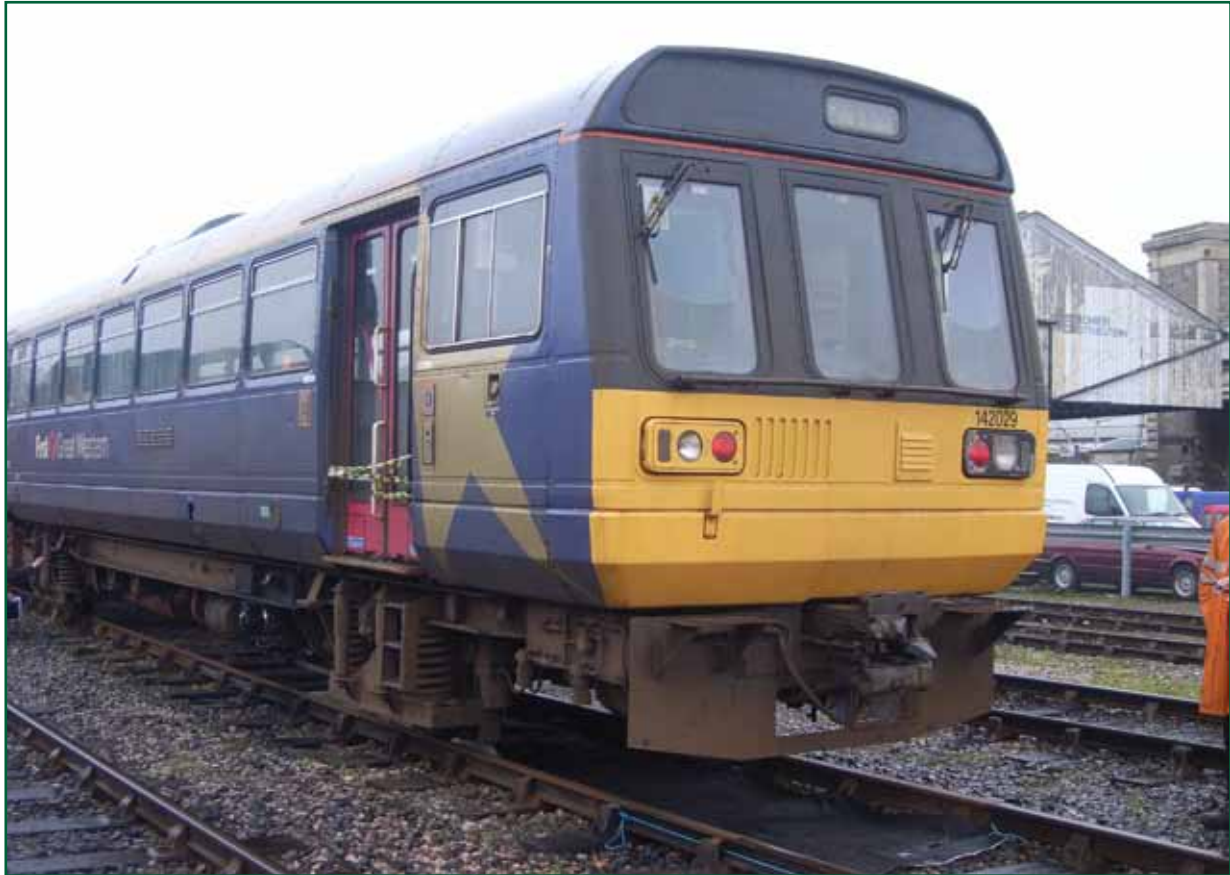
Figure 3: Class 142 'Pacer' unit involved in the accident at Exeter St Davids

- 41 The class 142 unit was not equipped with a sanding system. The use of sand as a means of improving adhesion between the wheel and rail is well-established and of proven value. The lack of sanding equipment on the class 142 unit was a contributory factor in this accident.

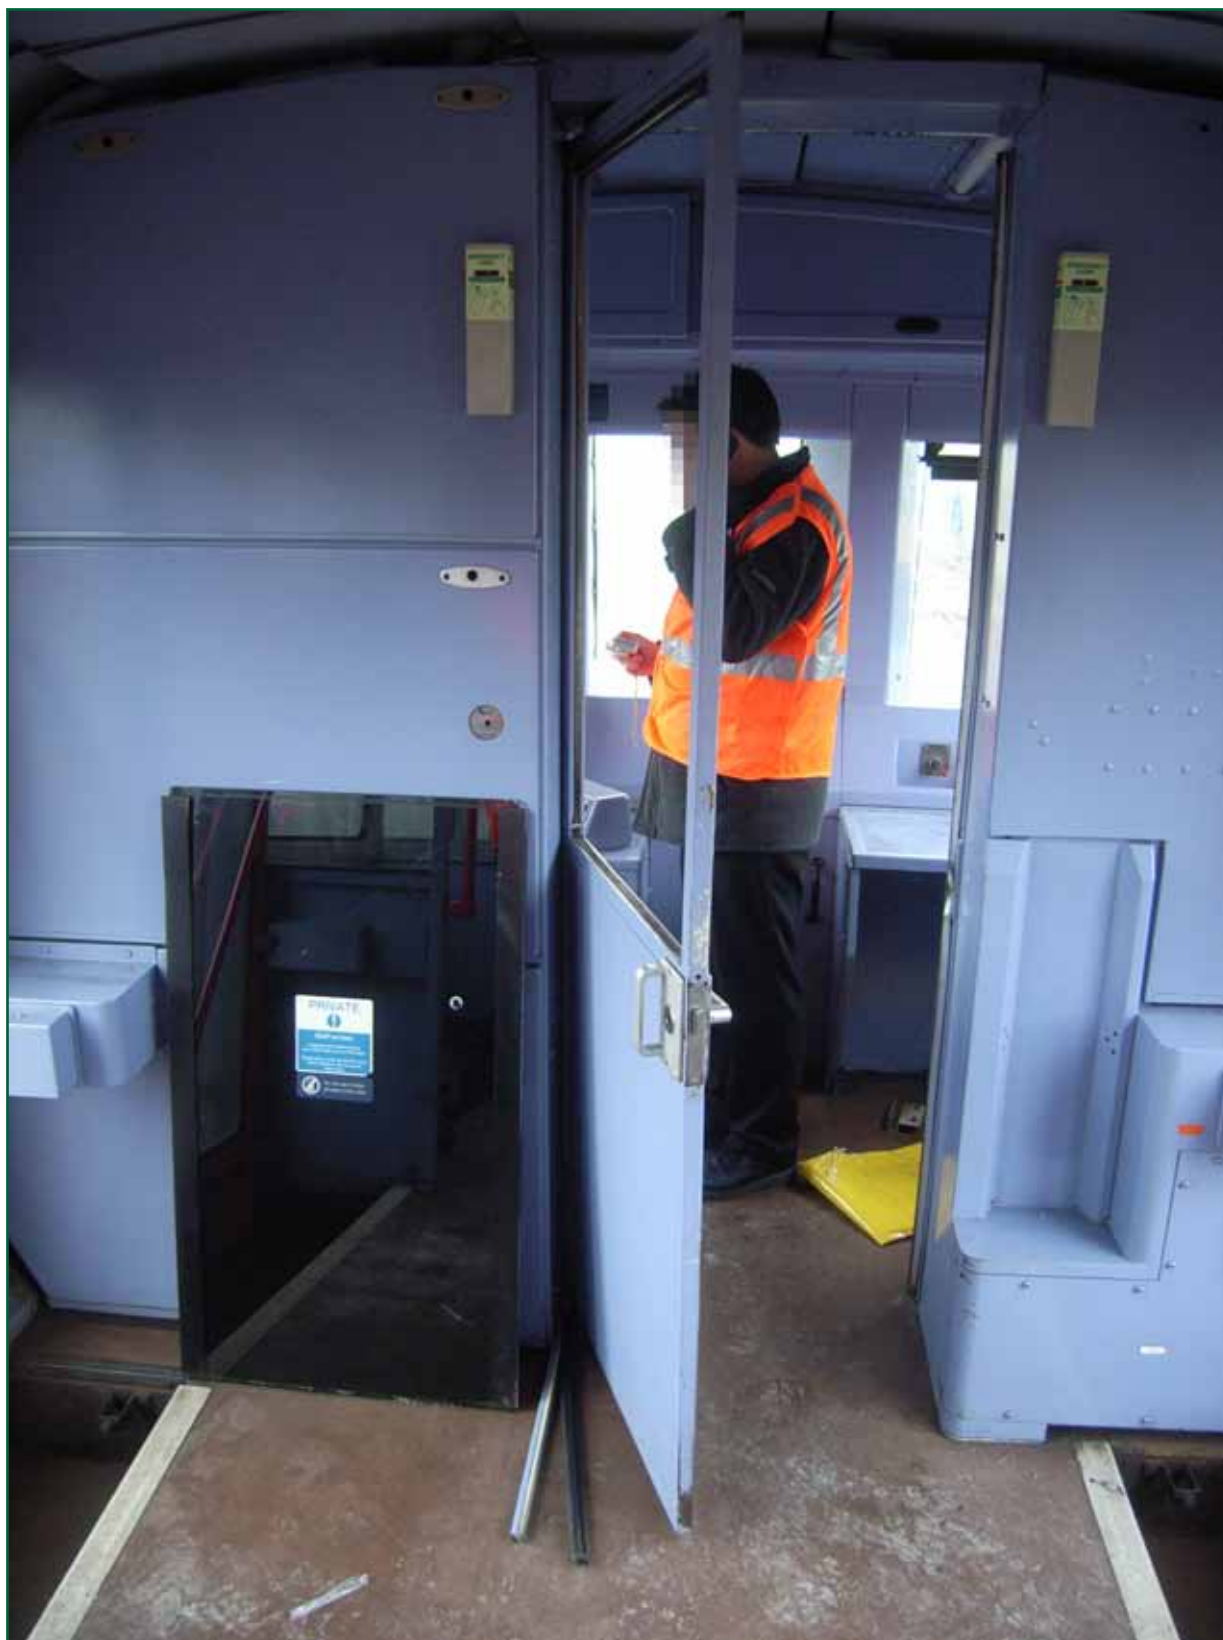
- 72 The damage to both trains was minor. However, on the class 142 unit, a large window located in the door giving access to the rear driving cab from the passenger saloon became detached from its frame and fell to the floor as a result of the impact (see figure 4). At the time of the collision there were no people in the vicinity of the window.
- 73 It was established that the glass unit sits in a bottom channel that is held in place by six welds which secure it into the door window frame. Of the six welds, two were in good condition, two were incomplete and exhibited signs of rust, and two had failed completely before the accident. The force of the collision overloaded the welds allowing the bottom channel to detach from the door frame and the glass unit to slide out (see figure 5). This created the potential for an injury for anyone who had been in the vicinity.

Figure 4: Glass window ejected from door following collision

- 80 Following the accident, FGW issued an urgent safety advice in accordance with Railway Group Standard GE/RT8250 'Reporting High Risk Defects' to inform other operators of class 142 units of the door glass detachment weld issue.
- 81 In the light of this action addressing the factor identified in paragraph 79a, the RAIB has decided not to issue a further recommendation.

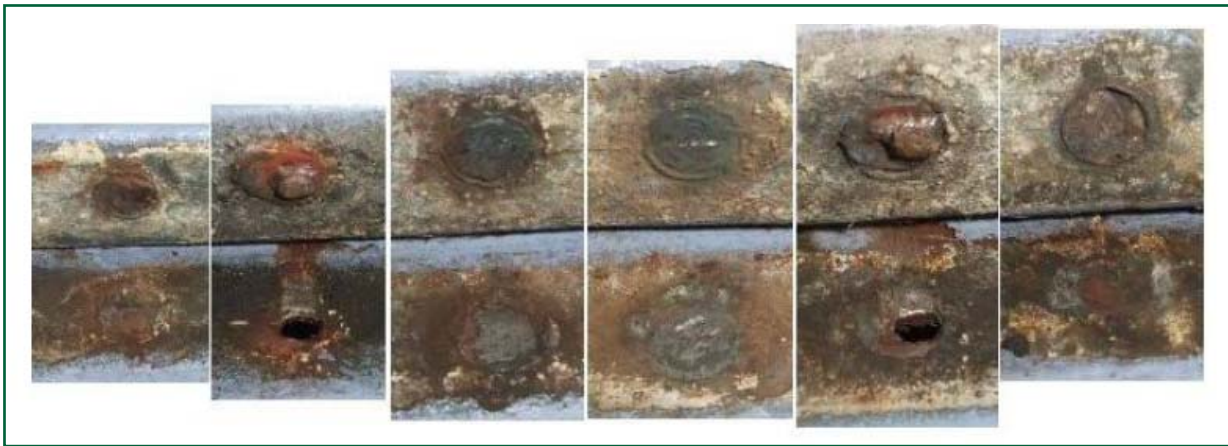
Figure 5: Failed welds (channel weld portion in top images and doorframe in bottom images) (Images courtesy of FGW)

- 79 Although not linked to the accident at Exeter St Davids on 4 January 2010, the RAIB observes that:
- a. the failure of the welds holding the window in the door giving access to the rear driving cab from the passenger saloon and subsequent detachment of the glass on the class 142 unit created the potential for an injury for anyone who had been in the vicinity (paragraph 73, see paragraph 80);
 - b. not all train operators systematically identify in their route risk assessments the potential hazards associated with low adhesion where there may be a need for trains to stop immediately beyond a level crossing (paragraph 75, **Recommendation 1**).
