Rail Accident Investigation Branch

Rail Accident Report

**Near-miss on Victory level crossing, near
Taunton, Somerset
19 December 2009**

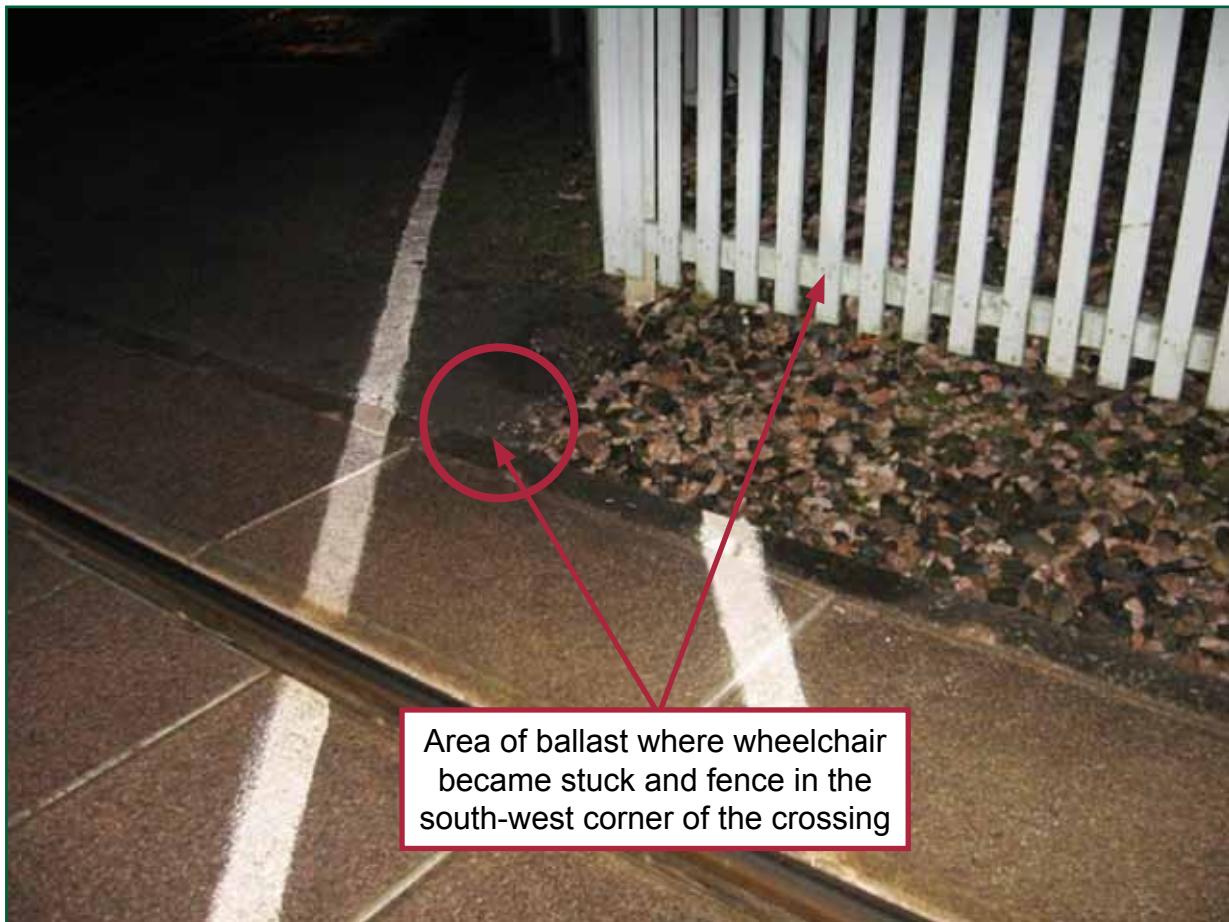
Figure 2: Area of ballast and fence in south-west corner of the crossing (photograph courtesy of Network Rail)

- 38 **One of the front wheels of the wheelchair became stuck in an area of ballast in the south-west corner of the crossing.**
- 39 Since March 2007, the crossing surface included an area of ballast approximately 1 metre wide and 2.4 metres long at the south-west corner (figures 2 and 3). The wheelchair user had used the crossing on most days since then. On this occasion, the course taken by the wheelchair user directed him towards it and he either misjudged his position or was distracted and his front wheels encountered the ballast.

- 40 **When the down line through Victory level crossing was re-laid in March 2007, the asphalt strip on the south side of the crossing was not replaced along the full length of the crossing. A section of ballast was left in the south-west corner. The non-application of asphalt to the full length of the south side of the crossing is a causal factor in this incident.**

- 47 The following week, on the night of 17/18 March 2007, the local Network Rail off-track gang fitted new crossing panels to recreate the down side section of the level crossing. The down line edge beams were also re-installed. A sub-contractor laid asphalt to the level of the crossing surface and adjoining road approach. Photographs taken by the HOCR department during the work (figure 10) indicate that the asphalt installed at this stage did not extend beyond the left-hand side of the carriageway (in the direction of travel) on the south side of the crossing and did not correspond with what had been present previously. A short section of ballast remained at the south-west corner of the crossing (figure 2).

Network Rail should enhance its level crossing inspection standards and checklist forms, and the data collection forms used in the level crossing risk assessment process, to highlight the potential hazards from inconsistent crossing surfaces to small wheels such as those on wheelchairs and children's pushchairs and arrange suitable training/briefing for staff using the forms (paragraphs 95b and 96b).

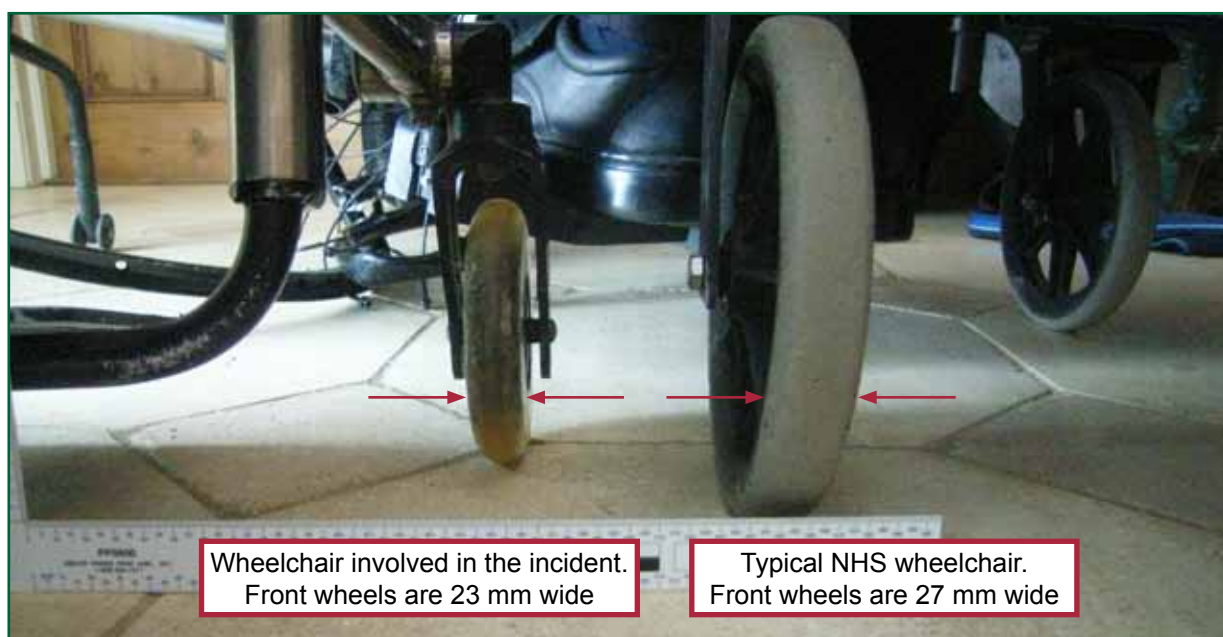
Figure 5: Wheels of wheelchair involved in incident (left) and standard NHS wheelchair (right)

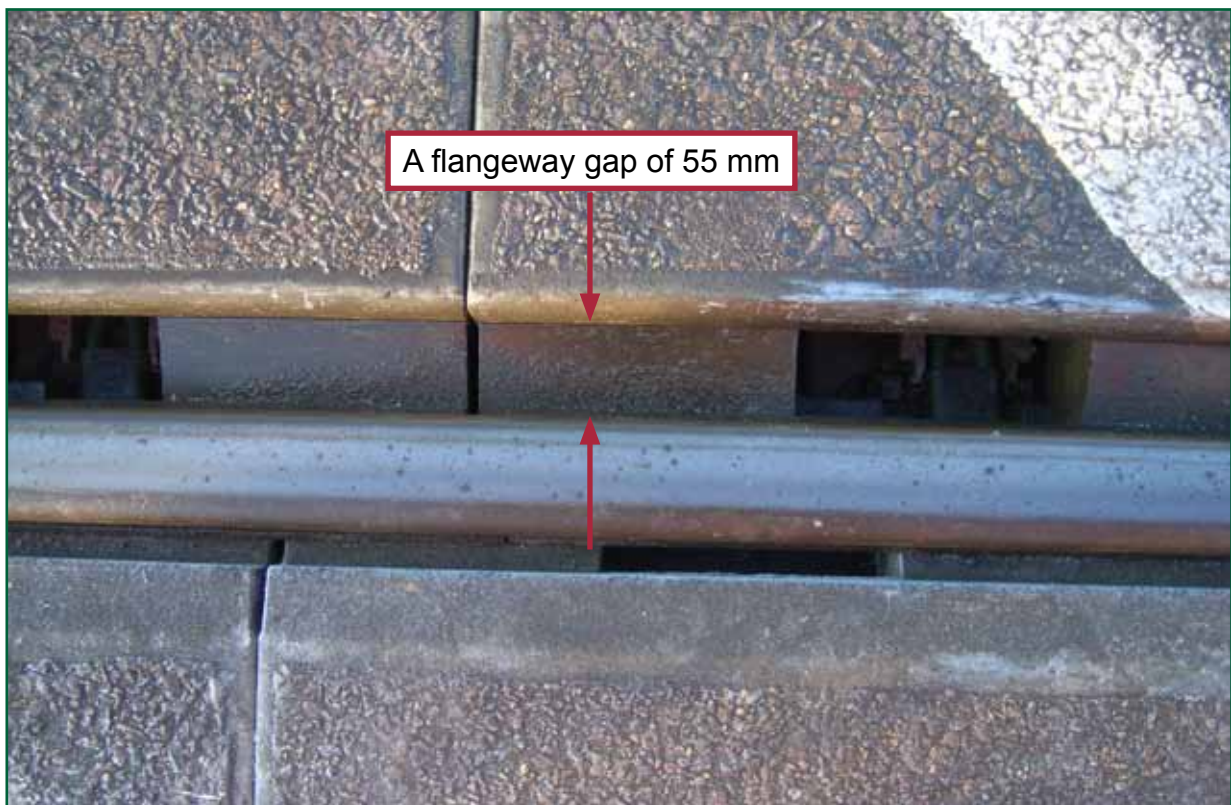
- 21 At Victory level crossing the flangeway gaps were measured to vary between 55 and 62 mm.
- 22 Edge beams (figure 4) are installed on the north and south sides of the crossing to secure the outer crossing panels and to provide an edge for the asphalt section that is used to fill the gap between the crossing panels and the road approaches.

Figure 6: Example of the flangeway gap at Victory level crossing

Network Rail should, taking account of research in this country and developments overseas (paragraph 83), review methods for minimising the hazards from the flangeway gap at level crossings, particularly those that are skewed relative to the roadway or path, to users with small-wheeled equipment, such as wheelchairs and pushchairs, with a view to evaluating the costs and benefits of options for improving the safety of users of level crossings (paragraph 95d).

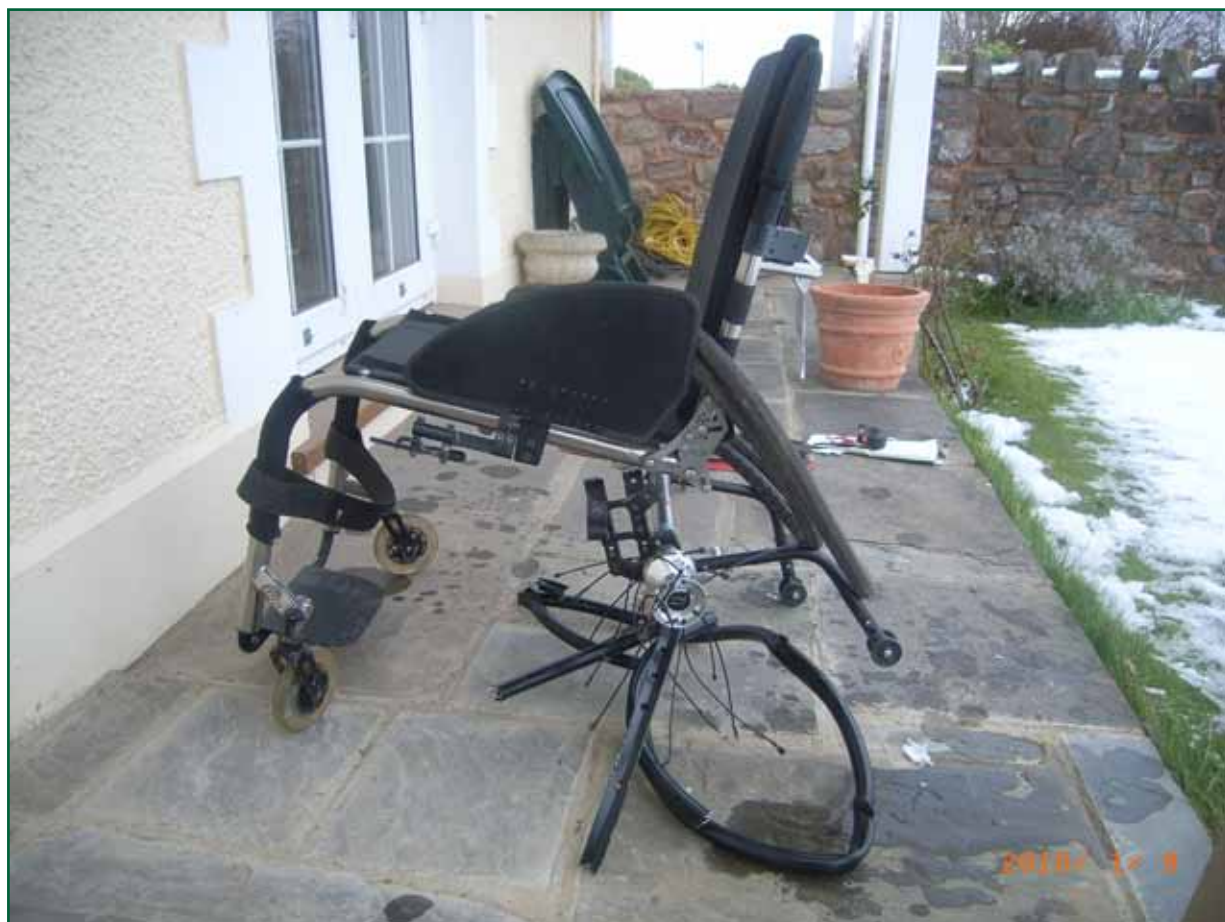
- 31 The wheelchair suffered significant damage (figure 7). The wheelchair user suffered some bruising to his right leg when he pulled himself from the wheelchair and was left shocked by the incident.

Figure 7: The damaged wheelchair

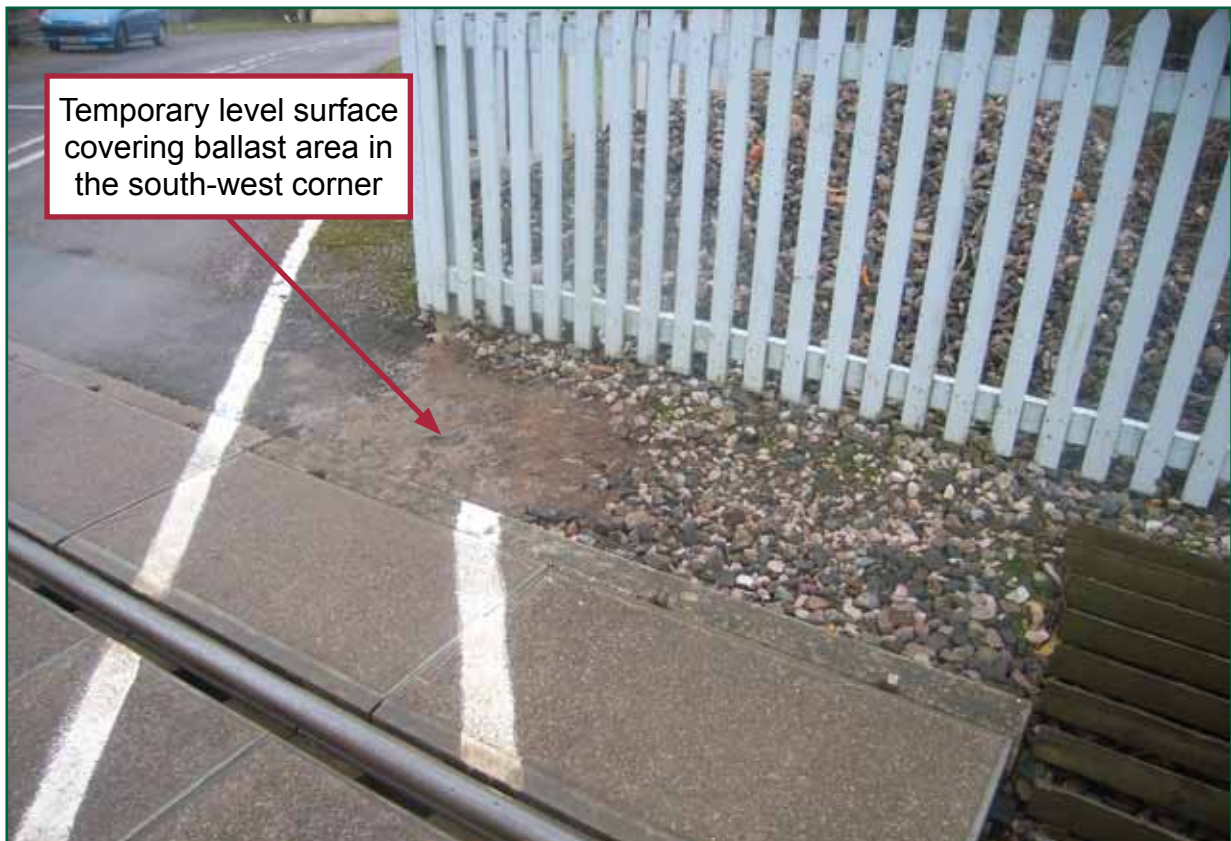
Figure 8: Interim work carried by Network Rail following the incident to provide a level surface

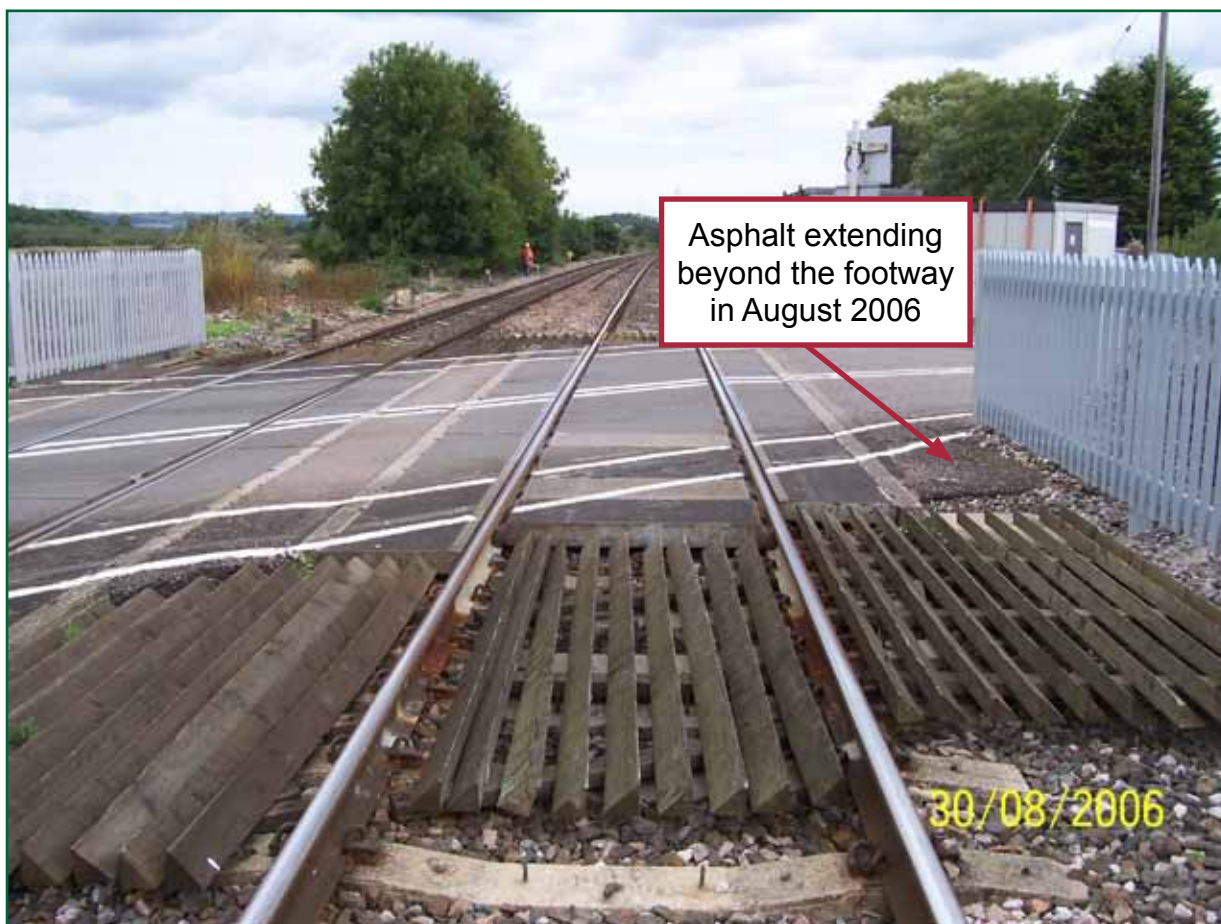
- 43 Photographic evidence from August 2006 shows the condition of the crossing before this work took place. It indicates that the asphalt that filled the gap between the level crossing surface and the road highway originally extended beyond the corner fence post towards the end of the edge beam on the south side (figure 9).

Figure 9: The asphalt section in August 2006 (photograph courtesy of Network Rail)

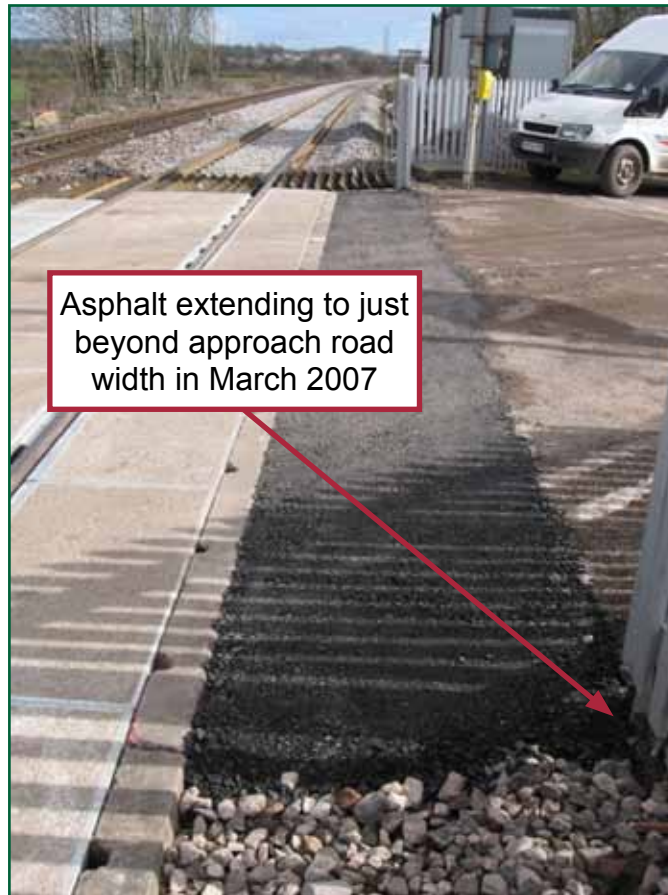
Figure 10: The asphalt section following the work in March 2007 (photograph courtesy of Network Rail)

- 48 The Network Rail off-track gang had completed two long shifts on 17 and 18 March 2007 and had left site before Dean and Dyball and the sub-contractor finished the asphaltting. Network Rail's representative on site from the HOCR department was not fully conversant with the requirements for level crossings: the off-track gang had been contracted for this purpose. Therefore, when the level crossing was handed back on the morning of 18 March 2007, nobody on site was competent to judge whether the asphalt at the interface with the crossing surface had been restored to its original length and no site plan was available as a reference source.
