Rail Accident Investigation Branch

Rail Accident Report

**Near miss involving a freight train and two
passenger trains, Carstairs
22 December 2009**

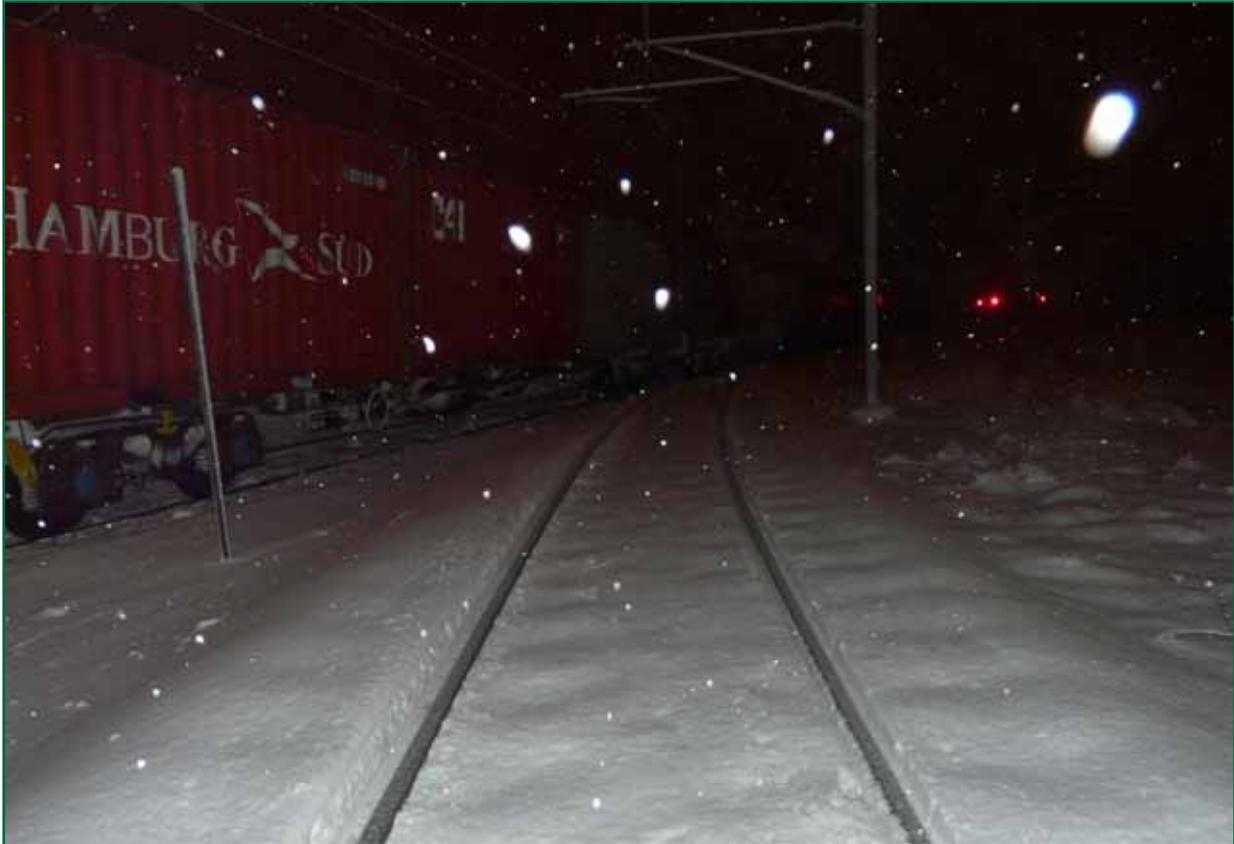
- 15 The weather conditions throughout the day were poor with temperatures at or below freezing. There were light snow showers during the afternoon. At the time of the incident, it was dark and the temperature at Carstairs had fallen to -2°C . There was also a light snow shower in the area at around this time. Snow was lying to about the level of the *rail head*. On those lines on which trains were still running, the rail heads were clear of lying snow but were wet. Figure 4 shows the weather conditions about one hour after the incident.

Figure 4: Weather conditions about one hour after the incident - train 4L81 can be seen on the left (courtesy of Network Rail)

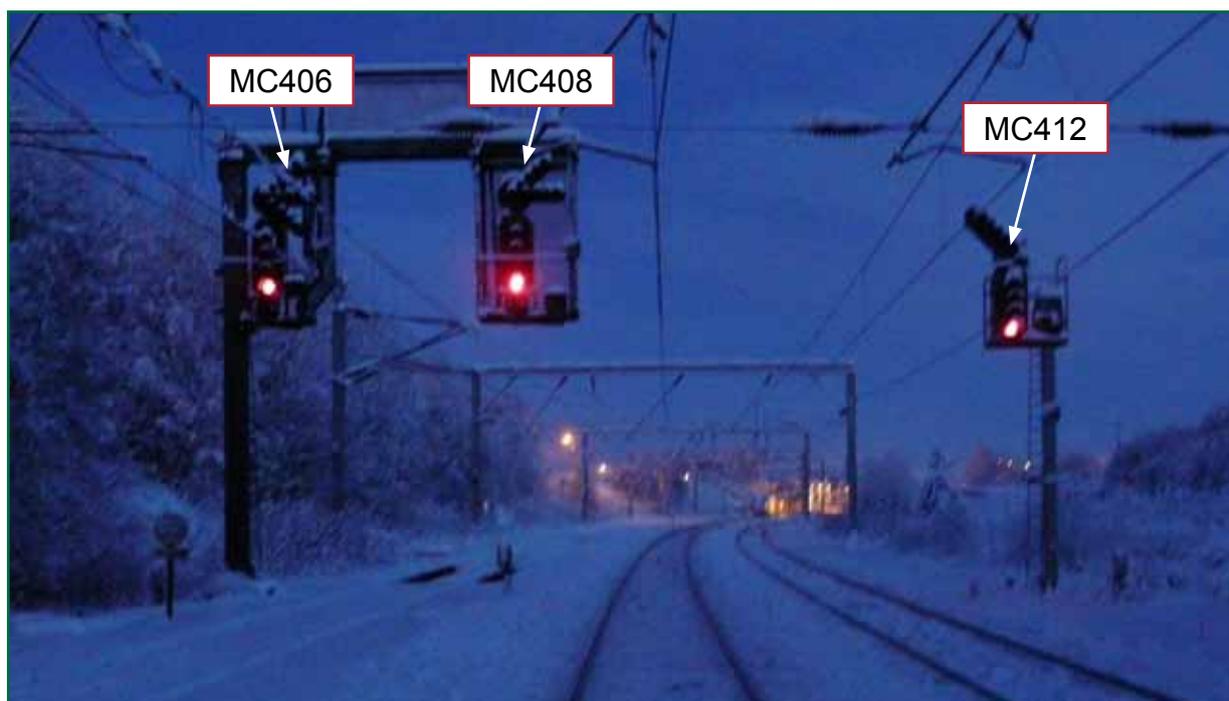
- 30 Figure 7 shows the conditions on the approach to signal MC408 on the night.

Figure 7: Approach to signal MC408 on night of the incident (courtesy of Network Rail)

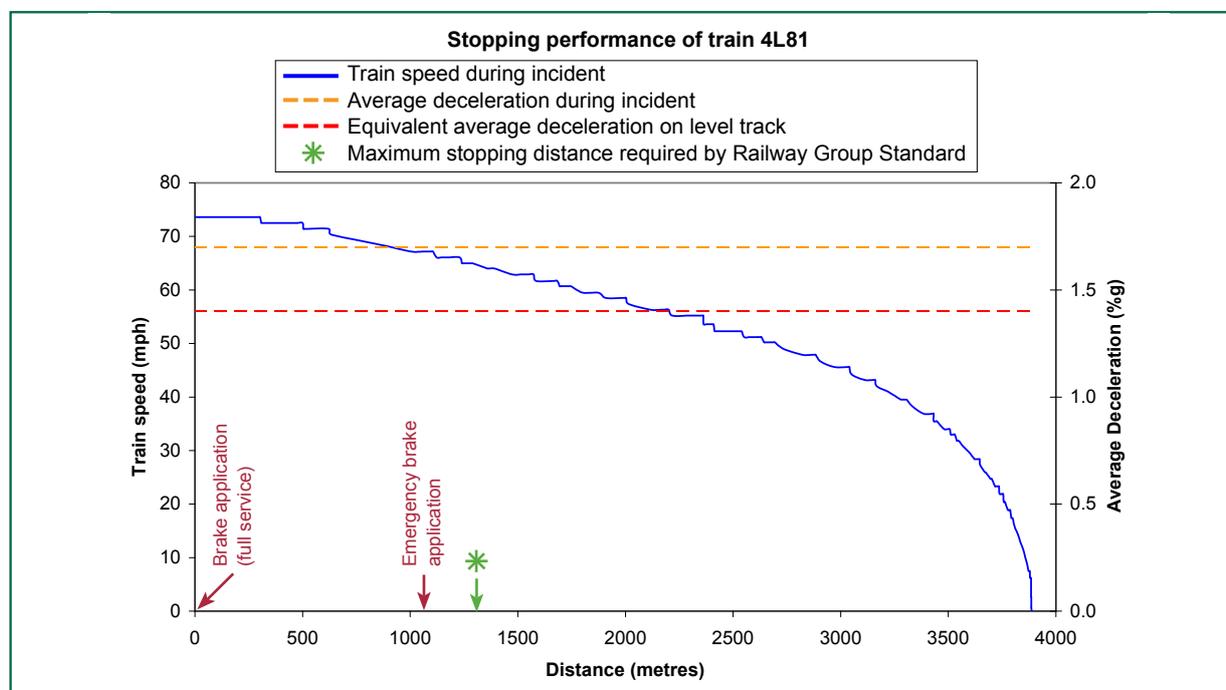
- 42 The braking performance of train 4L81 was calculated using the data from the leading locomotive's data recorder, and can be seen in figure 9. The train took just under 3900 metres to stop from a speed of 74 mph (119 km/h), giving an average deceleration of 1.4%g. When the effect of the falling gradient is taken into account, the equivalent deceleration on level track would be 1.7%g. This is much less than the deceleration required by Railway Group Standard GM/RT2043 which sets out the braking requirements for freight trains. This requires a minimum average deceleration on level track of 4.6%g from a speed of 75 mph (121 km/h). However brake test reports³ show that the brakes on the locomotives and wagons that formed this train would have been expected to give an average deceleration of about 6%g on level track.

Figure 9: Graph showing stopping performance of train 4L81 (speed taken directly from the train's data recorder)

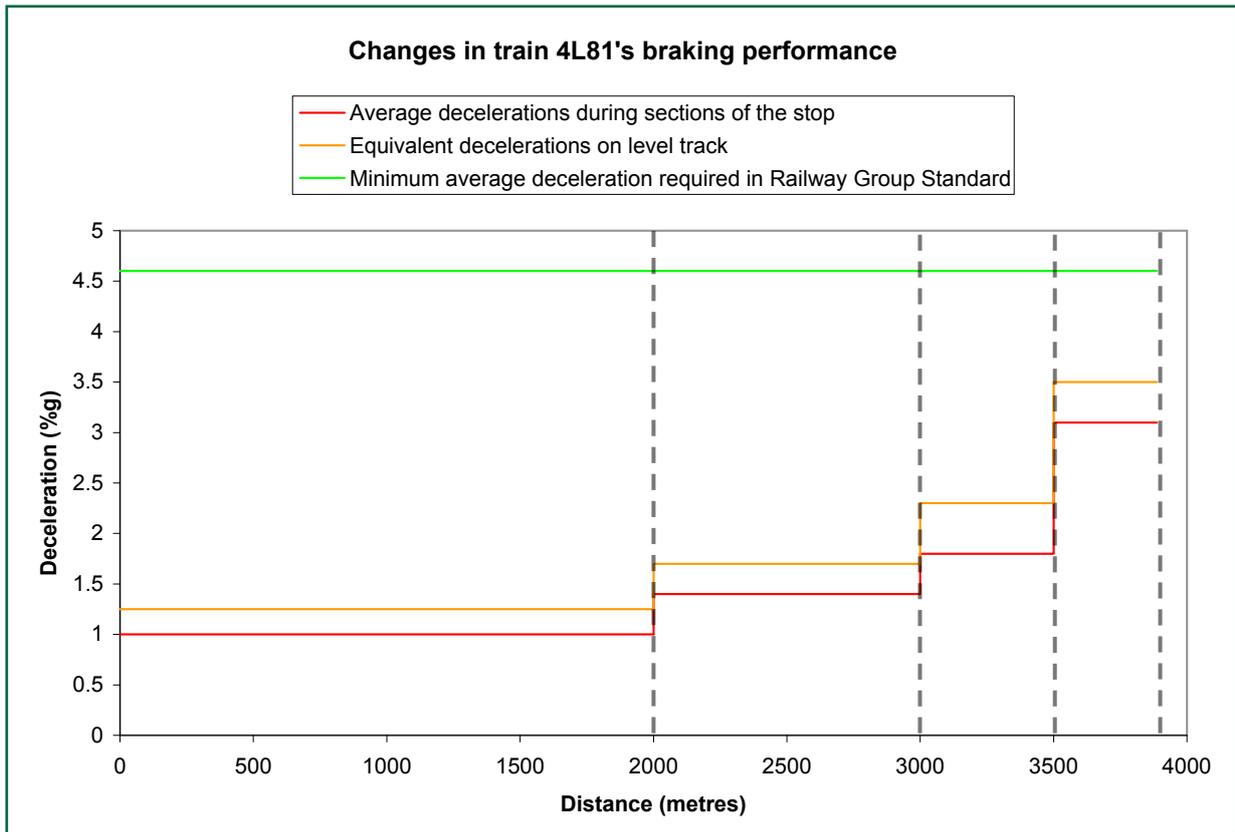
Figure 10: Graph showing changes in train 4L81's braking performance

- 43 Figure 10 shows that train 4L81's braking performance progressively got better during the stop. It was very low during the first 2000 metres but was starting to approach the minimum requirement over the final 350 metres. The CCTV footage from Carstairs station confirms that the train decelerated quite quickly in the final stage of its stop.

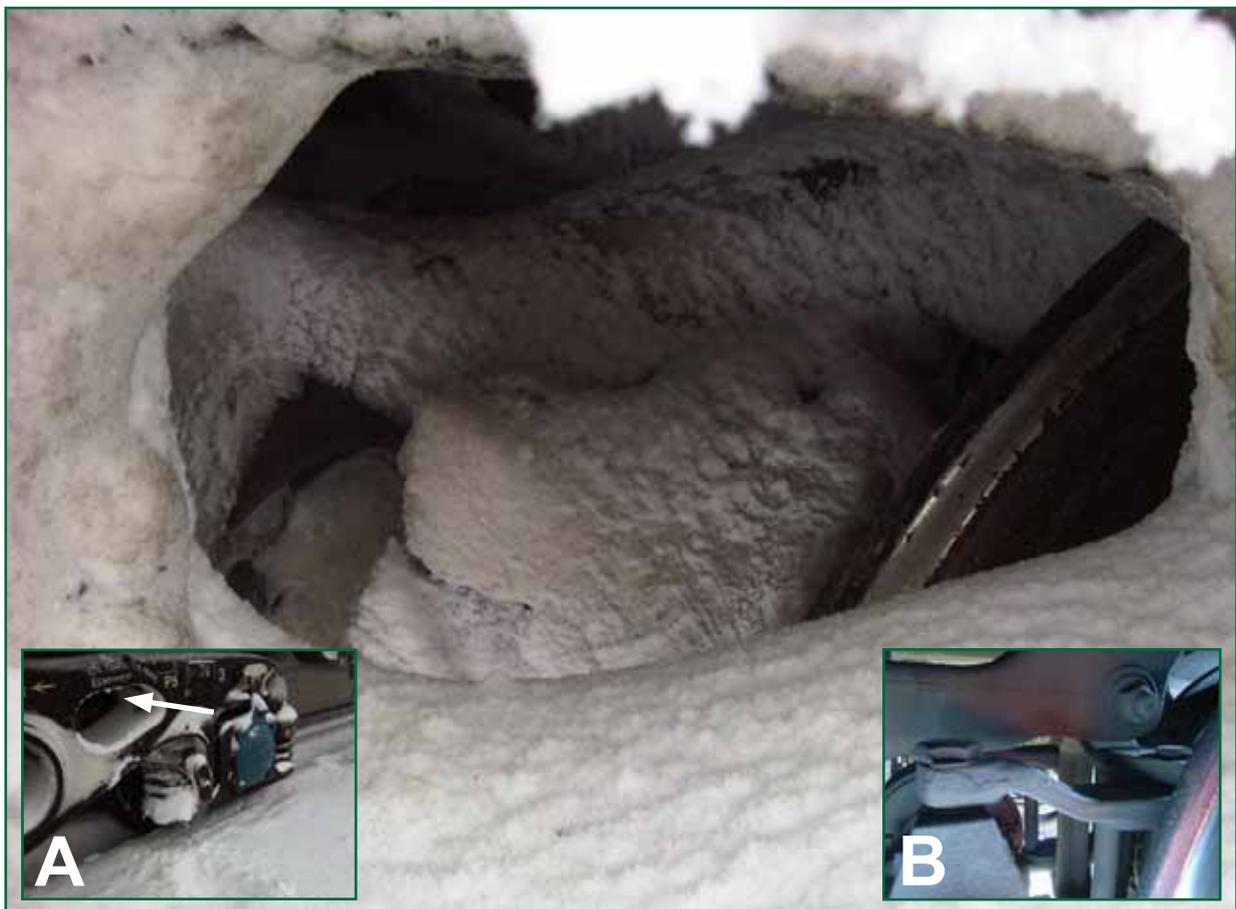
Figure 14: Snow and ice built up around the brake calliper assembly of a FSA/FTA wagon on train 4L81: inset image A shows an inspection opening in the side the bogie frame; the main image shows the view through this opening; and inset image B is the same view without snow and ice present (main image and inset image A courtesy of Davis Wagon Services)

- 56 The RAIB obtained accounts from the staff who examined the wagons 15 hours after the incident. These accounts and photographs indicate that there was a significant build up of ice and snow covering all brake callipers, pads and discs under each wagon. On about half of the brake sets there was compacted snow and ice within the frame of the brake calliper assembly. The remaining sets were not covered as much, so parts of the brake callipers and actuator were still visible. An example of this build up of ice and snow is shown in figure 14.

- 57 As these staff arrived some time later, what they saw may not have necessarily reflected the state of the brake equipment at the time of the incident. While the train had been standing at Carstairs, there had been occasional snow showers with light winds. However, the brake rigging is sheltered underneath the wagon frame, the bogie frame and behind the wheels, so it is unlikely that very much new snow would have blown under the wagons and collected on it after the incident. Therefore the condition of the brake rigging as seen afterwards was probably representative of its condition during the incident.

- 58 The staff that arrived about 36 hours after the incident to de-ice the wagons found that all of the brake pad and brake calliper assemblies were covered in varying amounts of ice and snow. Staff visually checked the application and release of the brakes on each wagon before and after de-icing them. Before de-icing, the movement of each set of brake rigging was reported as restricted and slow. Once the rigging had been freed from ice and snow, the brakes released and applied quickly and there was an audible 'clunk' when the brake pads made contact with the brake disc. This indicates that the iced up brake rigging was preventing the wagons' brakes from working correctly.

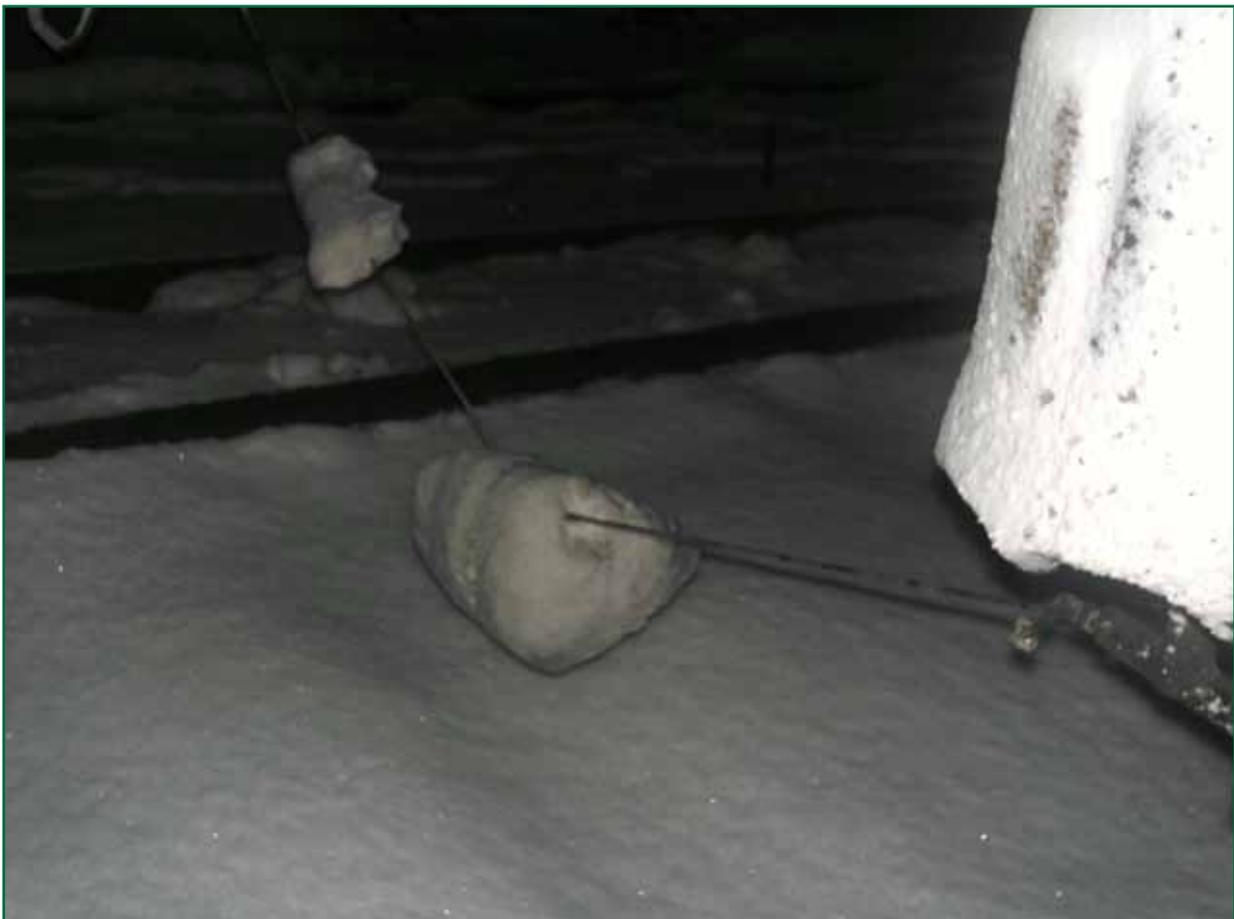
- 24 The RAIB found that an instance of this type of failure happened during the winter of 2009/2010. The driver of a DB Schenker freight train from Tees Yard to Margam reported that his train was not slowing down as quickly as he expected it to and he suspected that the brakes were not applying on some of the wagons. The train was recessed and its wagons (types BCA, BLA and BZA) were examined by DB Schenker staff. Underneath a number of wagons they found snow and ice had built up around the brake distributor pull cord as shown in figure 16. Its weight was sufficient to pull the cord which stopped the brakes applying.

Figure 16: Snow and ice built up around distributor pull cord (Courtesy of DB Schenker)

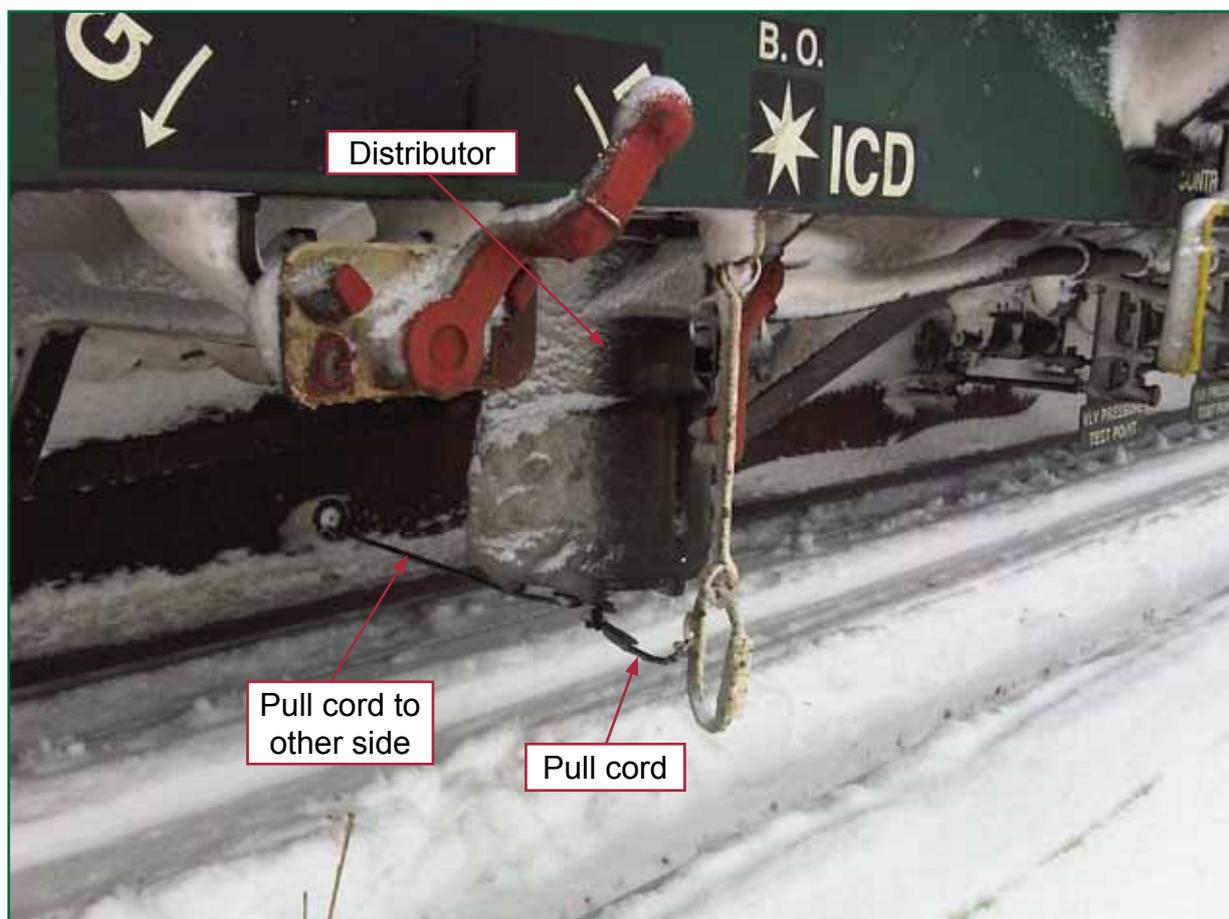
- 25 The RAIB determined that this was unlikely to happen on the FSA and FTA wagons. The pull cord located on the same side of the wagon as the brake distributor is very short and the pull cord from the far side is located very high up on the underframe. It does not hang down in the same way as cords on other stock and is routed across the wagon through holes in the underframe. Figure 17 shows the pull cords on one of train 4L81's wagons on the day after the incident, which are free of snow and ice.

Figure 17: Photograph of distributor pull cord on train 4L81 (Courtesy of Davis Wagon Services)
