Rail Accident Investigation Branch

Rail Accident Report

Derailment near Gillingham tunnel, Dorset 28 November 2009

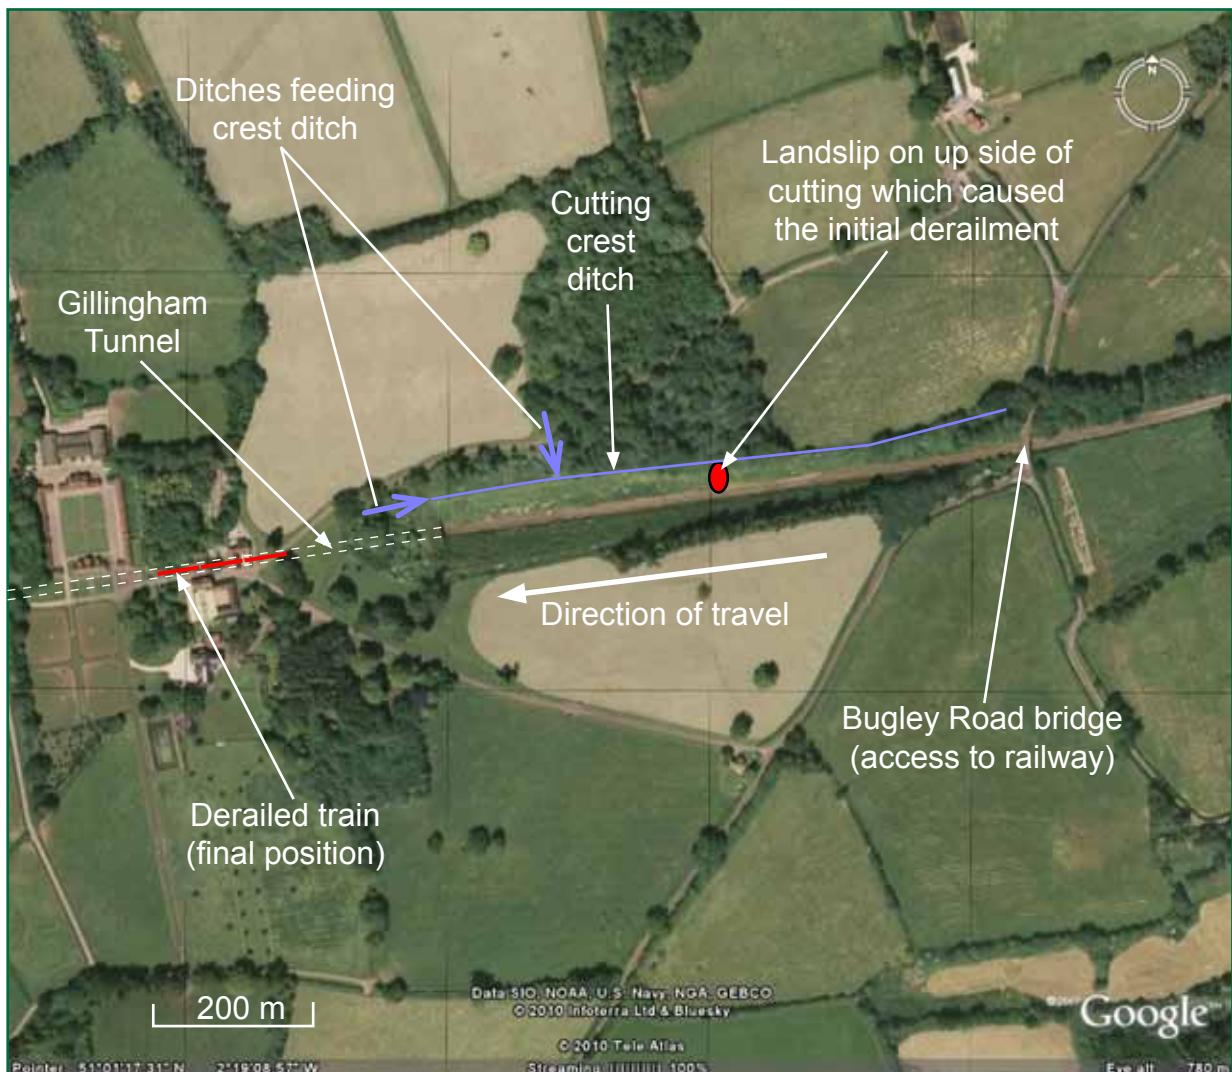
Figure 2: Accident overview (image courtesy of Google Earth)

- 18 The derailment took place in a cutting which is 8 metres deep at the site of the landslip which caused the derailment. A ditch along the northern cutting crest is intended to intercept water from adjacent farmland and woodland to prevent it running down the cutting slope (figure 2). This ditch crosses the Network Rail boundary at several places and is outside the boundary at the location of the landslip (figure 4).
- 19 The railway runs through the incident area in a straight line with a maximum permitted speed of 85 mph (137 km/h). It was constructed as a double track railway in the mid nineteenth century. In 1967, it was reduced to a single track running along the middle of the area formerly occupied by the two tracks. This resulted in a wide cess along the both sides of the single track (figure 3).

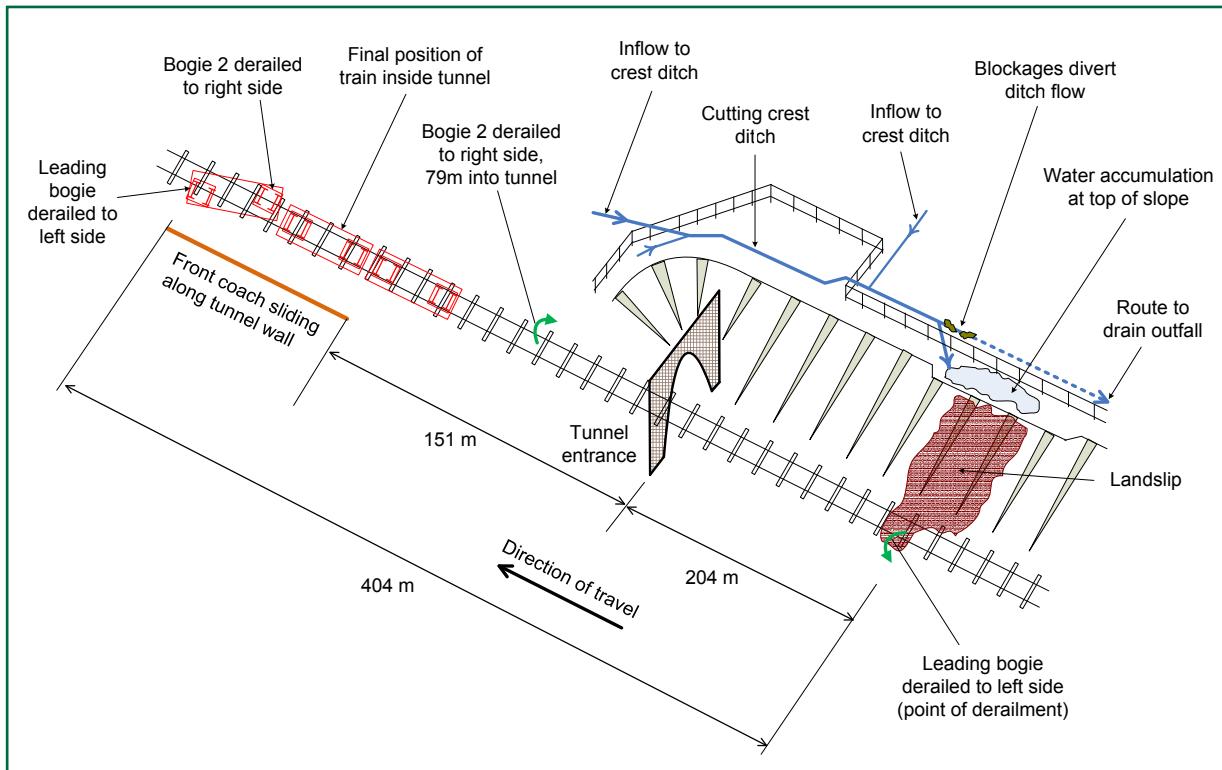
Figure 4: Plan of accident site (not to scale)

- 25 Network Rail had taken over maintenance of the crest ditch in the months leading up to the accident even though parts of this ditch were just outside the Network Rail boundary (figure 4). Land owners are normally responsible for maintaining ditches on their own land but it can be difficult to establish the extent of these obligations and, even if they are known, it can be difficult to force a neighbour to undertake the work. Rather than addressing these complex issues, Network Rail sometimes decide to maintain ditches on neighbouring land if the neighbour permits access. This approach had been adopted at Gillingham.

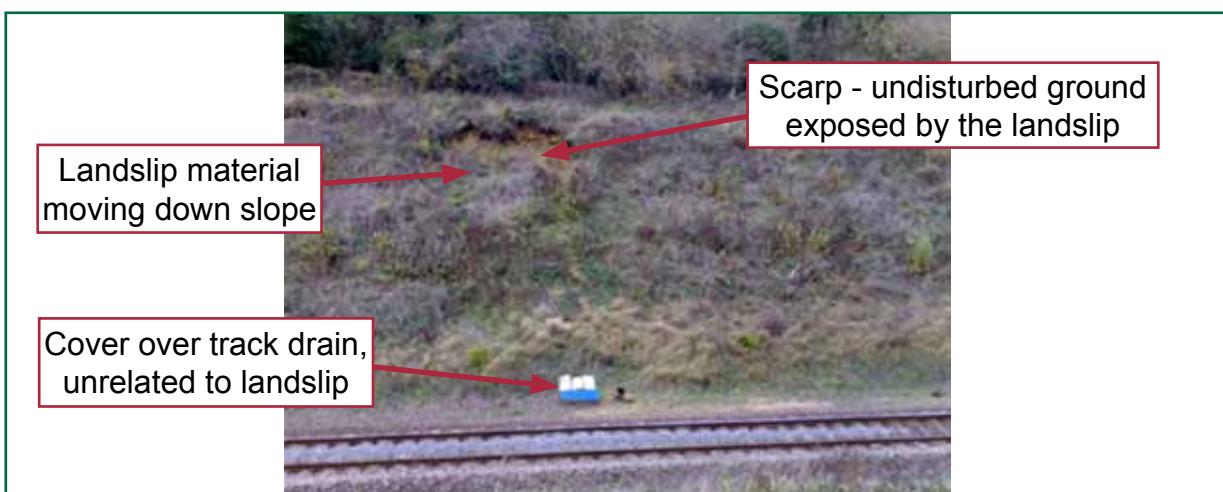
Figure 5: Landslip which occurred shortly before 17 December 2008 (image courtesy of Network Rail)

- 46 An Aecom employee undertook the first annual re-examination at the incident site on 8 January 2008 as part of the 2007/08 examination season. The next inspection, part of the 2008/09 season, was made on 17 December 2008 when the examiner observed a recent landslip at 107 miles 34 chains and immediately reported this to Network Rail (figure 5). As a result, the E&DT visited the site on 8 January 2009 and located a blockage in the crest drain which had led to water overflowing and triggering the landslip. The E&DT asked the Wessex drainage team to clear this blockage .

¹¹ Landslips not affecting the track can take several forms; an example is shown in figure 5.

- 47 The Wessex drainage team had been unaware of the crest drain until they were asked to remove the blockage by the E&DT. The drainage team removed the blockage on 28 January 2009 and spent 18 person-days on more extensive maintenance of the ditch in July 2009.
- 48 The next annual examination of the slope was undertaken by an Aecom employee on 25 November 2009. He found no significant deterioration of the slope since his previous visit in December 2008.
- 49 Members of the Wessex drainage team inspected the drain on 26 November 2009 and reported verbally to the drainage team manager that it was in a satisfactory condition.

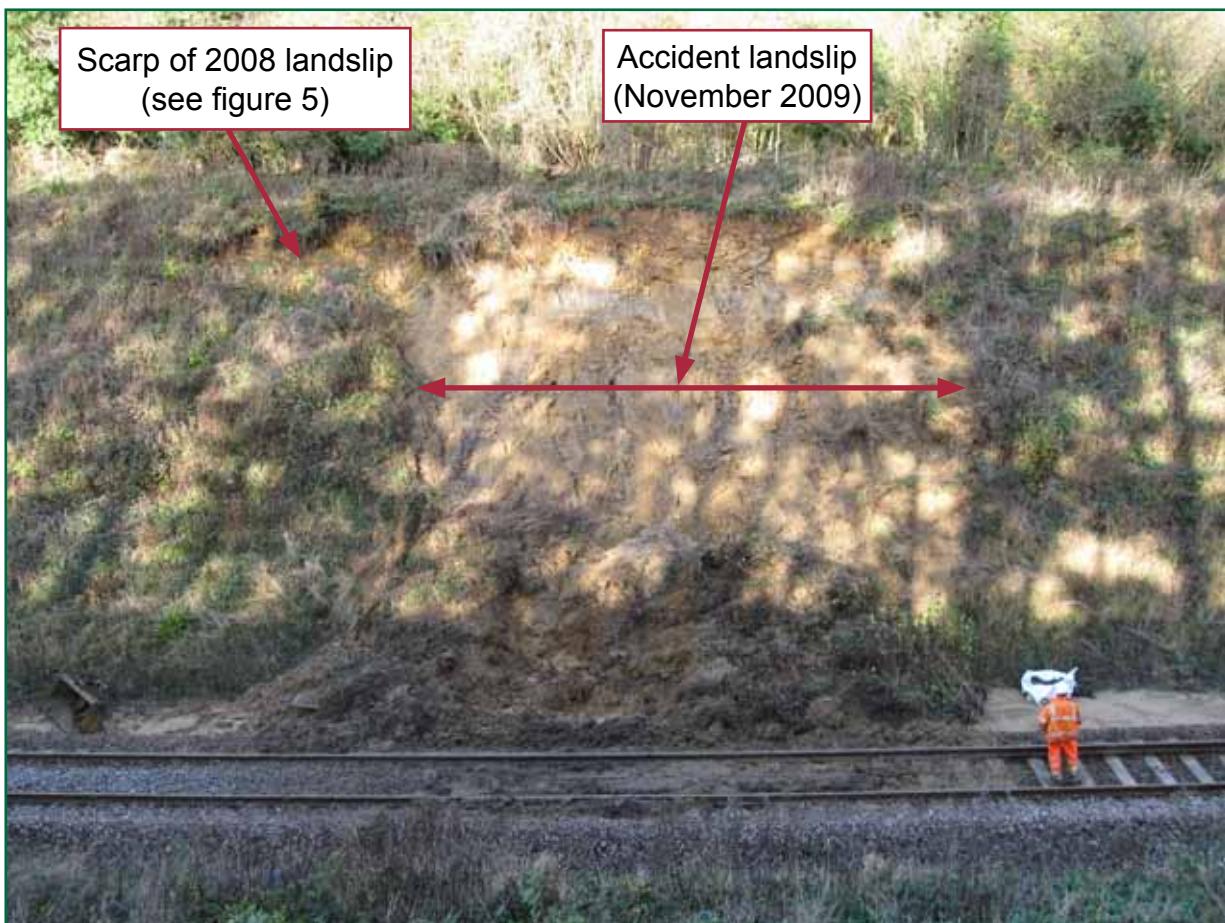
Figure 6: Accident and December 2008 landslips (Image courtesy of Network Rail)

- 50 On 28 November 2009 a train travelling towards London passed the accident site in darkness and without incident at about 18:40 hrs; approximately 40 minutes before the accident. After this train passed, debris from a landslip caused by an overflowing drainage ditch blocked the line at 107 miles 34 chains. There were no witnesses to this event, which took place adjacent to the landslip reported in December 2008 (figure 6).

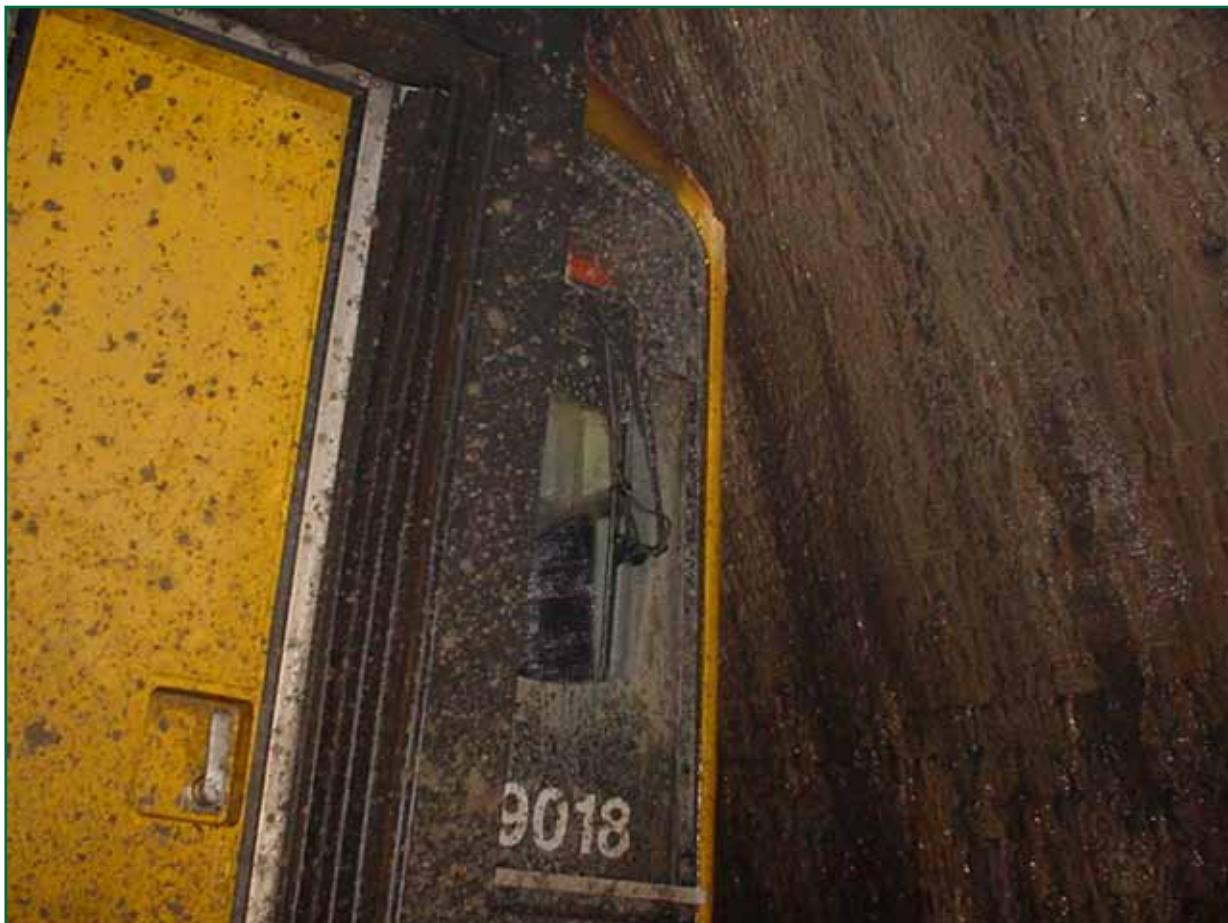
Figure 7: Train leaning against tunnel wall after the accident

- 53 The rear bogie of the front coach derailed when it was 79 metres inside the tunnel. The front coach leant towards the left until the front left corner of this coach struck the tunnel wall 151 metres from the tunnel entrance. This coach slid along the tunnel wall until, 27 seconds after the initial derailment, the train stopped with its leading end 200 metres inside the tunnel (figure 7).

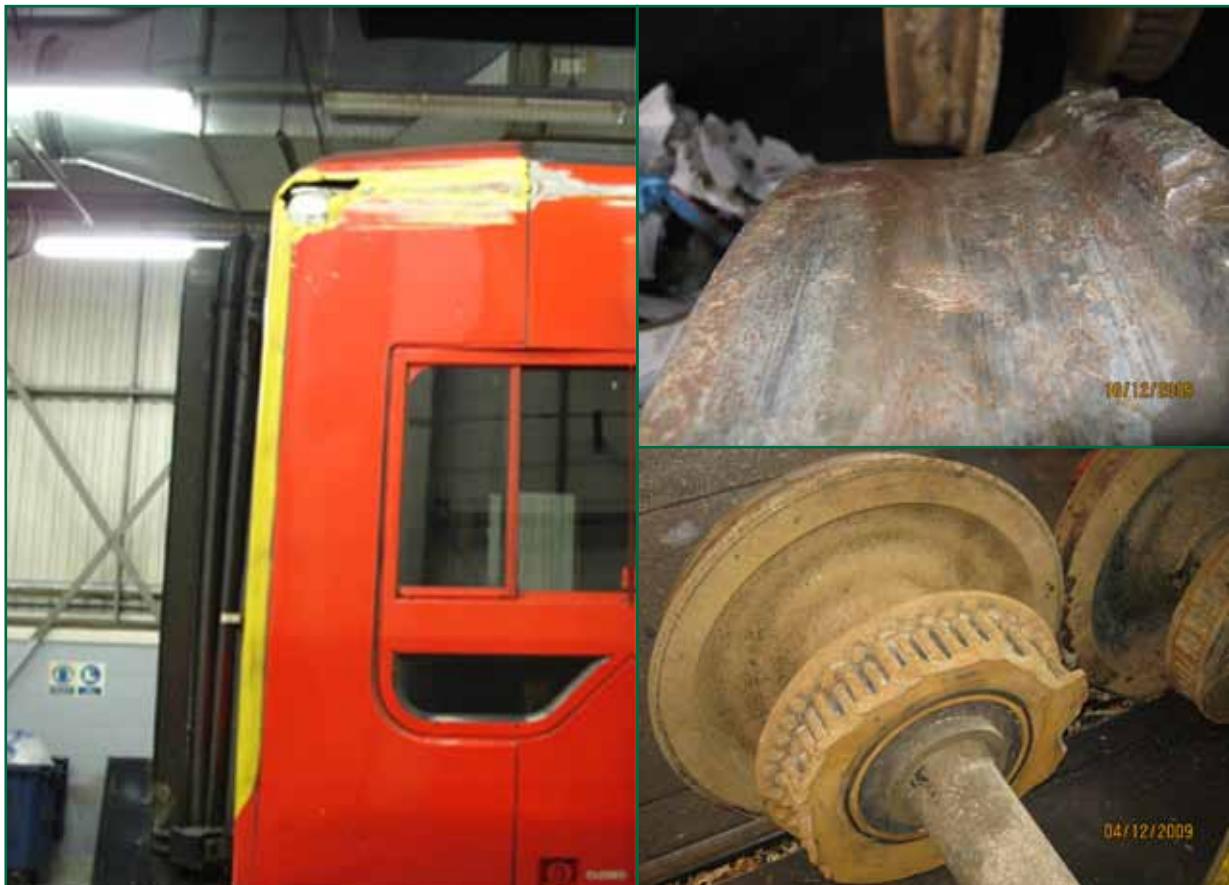
Figure 8: Body and wheelset damage (Images courtesy of South West Trains and Railcare)

- 54 Two passengers reported minor injuries. The leading coach sustained damage to the bodywork and components including wheels, brakes and the engine (figure 8).
- 55 Approximately 450 metres of track required repair. The line remained closed for five days until 04:52 hrs on 3 December 2009.

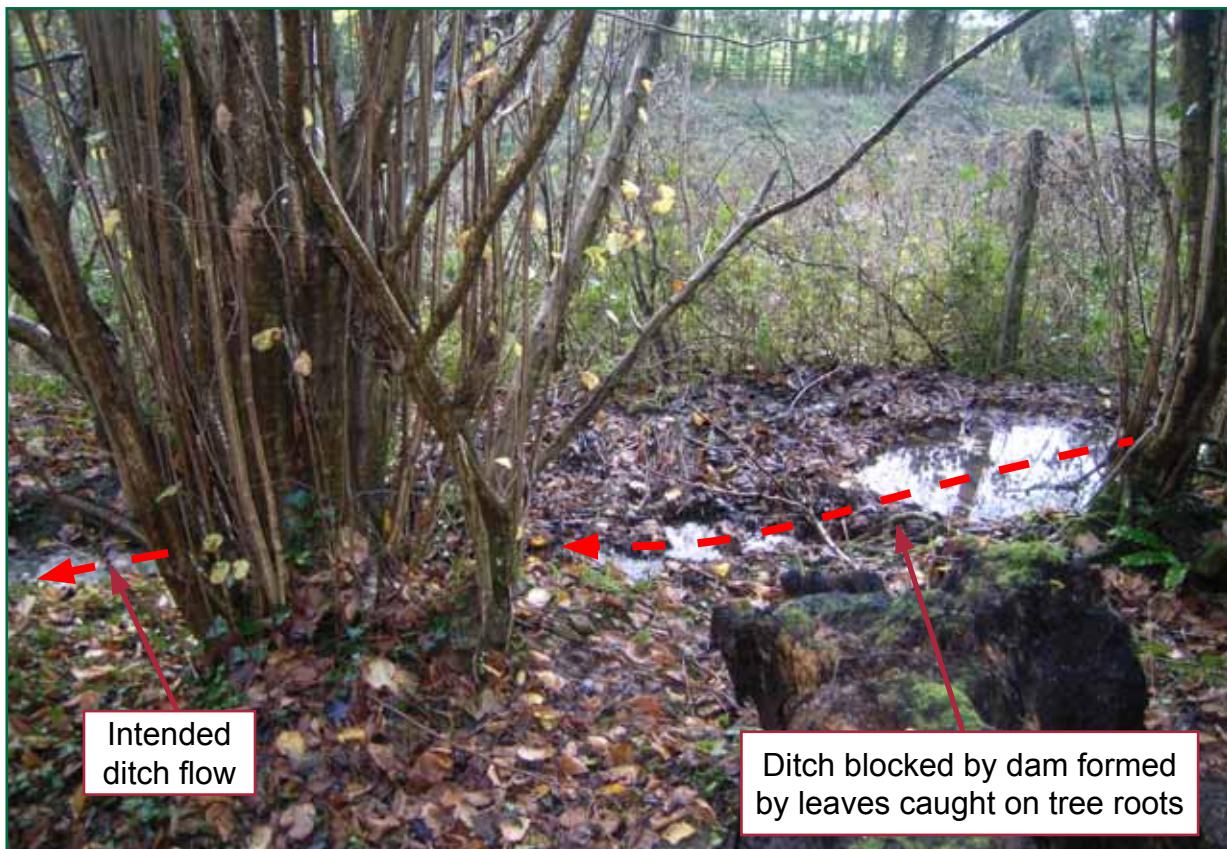
Figure 9: Blocked cutting crest ditch (railway boundary fence and cutting in background)

- 60 The immediate cause of the accident was a landslip triggered by water overflowing from a blocked ditch.
- 61 Inspection of the site after the accident showed that leaves had blocked the crest ditch causing water to overflow and accumulate at the top of the cutting slope (figure 9). This would have made a landslip more likely because:

- 66 The ditch, at least in the area where tree roots caused the blockage, was not dug out to an adequate size during maintenance work. There is no evidence that, in the absence of obstructions, the ditch capacity would have been inadequate. It is uncertain whether the ditch size was sufficient to deal with the leaves, branches and twigs expected to fall from the surrounding vegetation. It is certain that the roots caused leaves and twigs to accumulate and block the ditch. The presence of roots is a causal factor and the ditch size is a possible causal factor.

- 67 The ditch overflowed due to a blockage caused by leaves and twigs being trapped in tree roots which partially obstructed the ditch (figure 9). These roots would have been present when the ditch was maintained in July 2009, and had not been removed. Neither the volume of water nor the leaf fall were exceptional so it can be concluded that the roots were, at least in part, the reason why the ditch overflowed.

- 68 The Wessex drainage team had not removed the roots as it was impractical to do this with the hand tools they normally carried. There is no record of how they dealt with the roots but it is likely that they followed their normal practice and widened the ditch by an amount they judged to be sufficient to compensate for the blocking effect of the roots.

- 75 Network Rail had no process for establishing ditch conditions to be achieved during maintenance work, including how to deal with roots whose removal was impractical with hand tools, and the size of ditch required. The absence of this process is a causal factor.
- 76 The RAIB found no evidence that Network Rail had established the dimensions required for satisfactory operation of the incident ditch. Witness evidence indicates that this also applies to most ditches on the rail network. Network Rail documents did not require ditch size criteria to be used for maintenance and inspection purposes.
