# Rail Accident Report

## Fatal accident at Halkirk level crossing, Caithness 29 September 2009

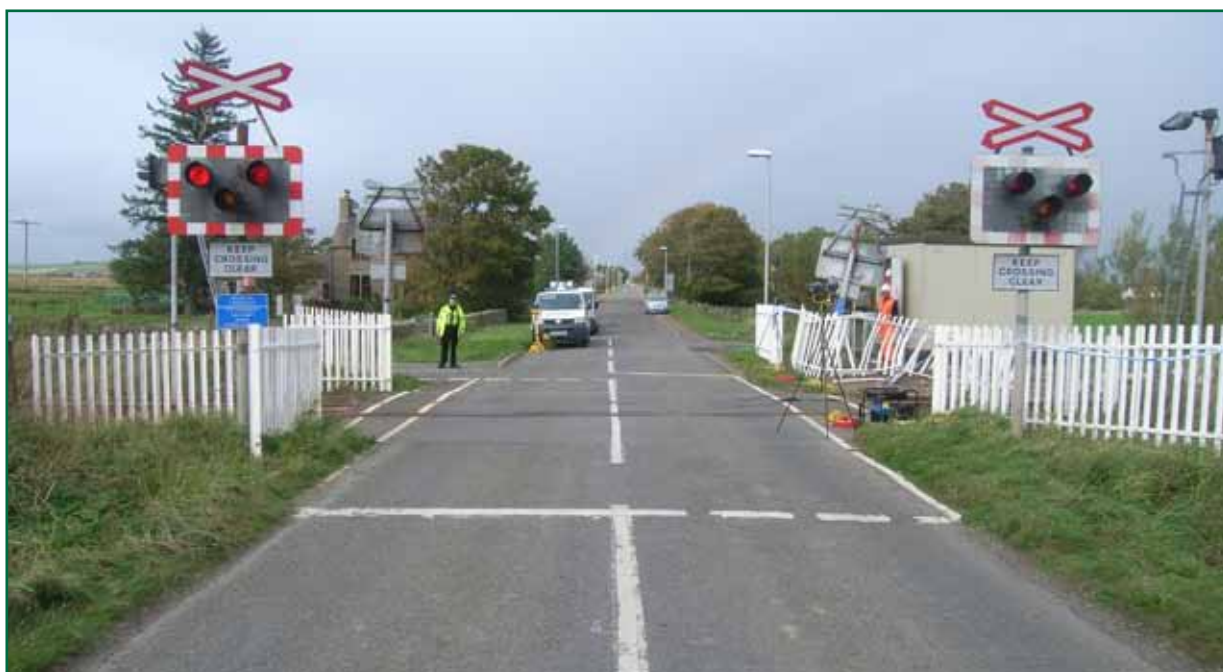
Figure 3: Halkirk level crossing from the south

- 33 The train hit the rear of the car leaving vertical indentations caused by the train's gangway on the nearside rear passenger door and roof. The impact caused the car to rotate in an anti-clockwise direction when viewed from above and be pushed into steel picket fencing and the post supporting the road traffic light signals at the north-east corner of the crossing (figure 3).

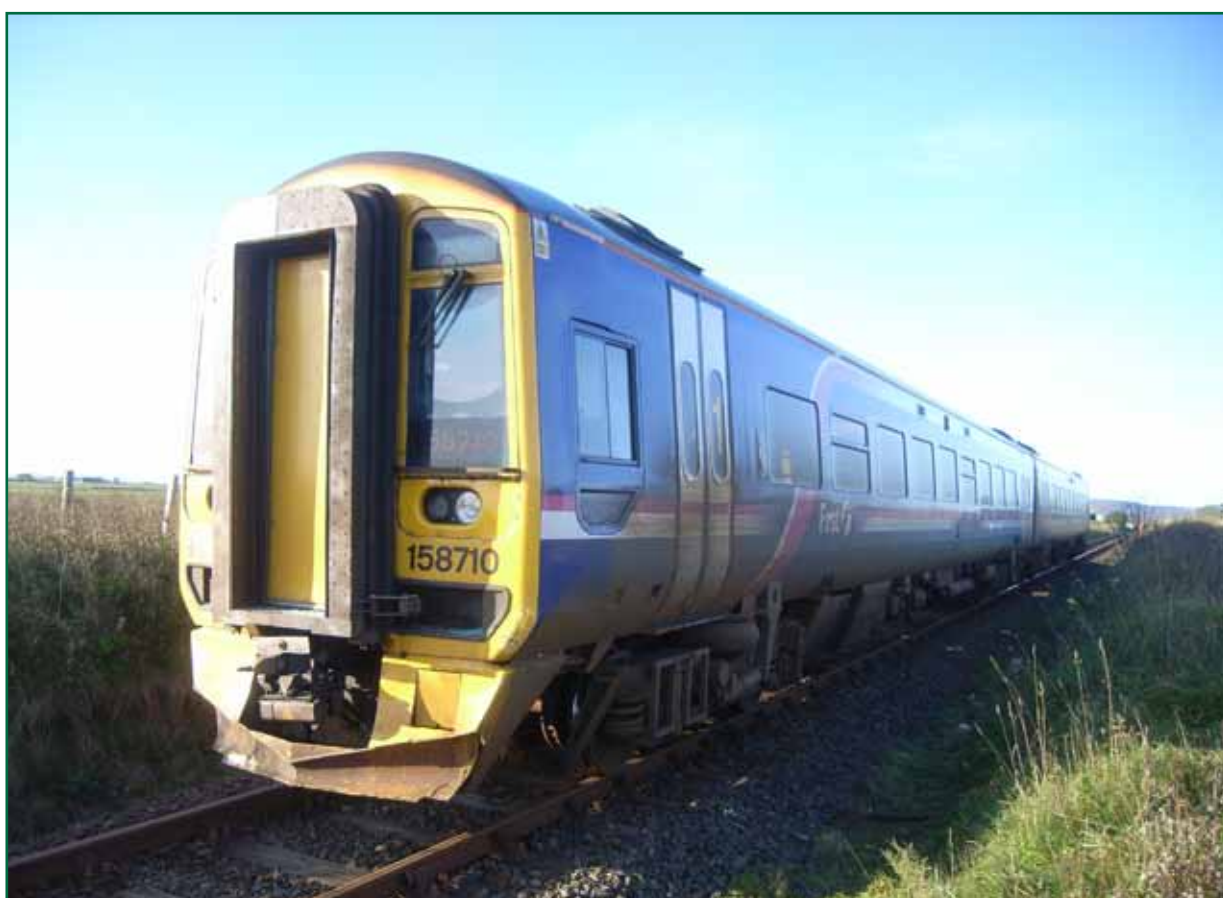
- 37 The three occupants of the car were fatally injured and the car was severely damaged on its nearside.
- 38 The train sustained minor damage to its front end, particularly the coupling. There was also some bodywork damage, the most serious of which was the hole in the left-hand side of the leading coach caused by the second impact with the car (figure 6).
- 39 Level crossing equipment on the north side of the crossing was damaged by the impact of the car.

Figure 6: The train involved in the collision at Halkirk level crossing

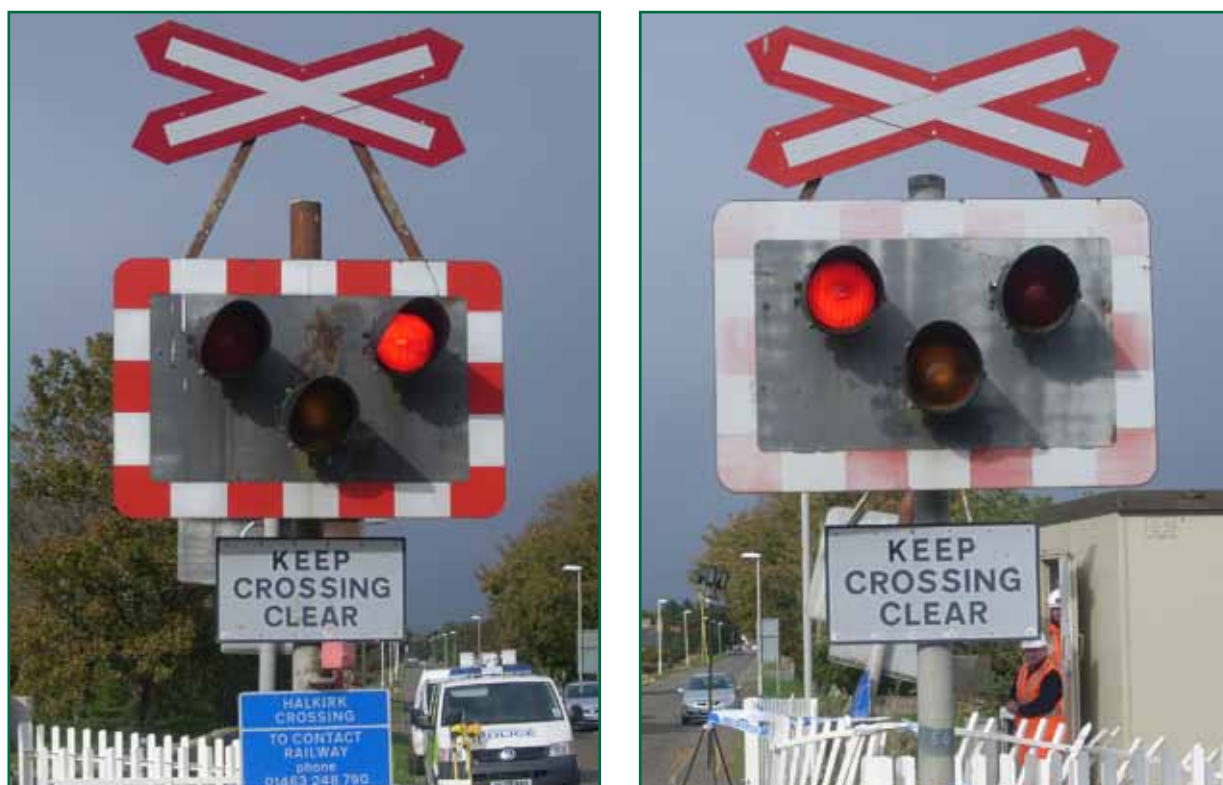
- 76 The matt black backboards and chequered surrounds (particularly the offside backboard) were faded and unable to prevent the reflection of sunlight (figure 7). The expert's view was that this would have been tolerable for a vehicle driver with normal eyesight.
- 77 The poor condition of the backboards, in combination with falling sunlight, reduced the conspicuity of the lights to any approaching road vehicle. Although unlikely to have significantly affected someone with standard eyesight, this was of particular significance to a road vehicle driver with sub-standard eyesight and a greater susceptibility to the effect of glare.

Figure 7: Condition of road traffic light signals, Halkirk crossing, south side

- 80 However, the optical tests found that the condition of the backboards was such as to reduce the amount of contrast between the lit red light units and the areas of the backboards, an effect that was more significant in the case of the right-hand backboard. This reduced the conspicuity of the lights.

- 81 Network Rail's routine inspection of 22 April 2009 (Appendix D, paragraph 27) noted that both the south side road traffic light signal chequered red and white borders were unsatisfactory: the nearside backboard was starting to rust and the off side backboard was faded. The defect was allocated a priority in accordance with Network Rail's procedures for the work to be completed within six months. A work arising form was completed on 24 April 2009 for action by the signal maintenance function. Remedial action was not taken before the next inspection, and the same defects were noted at the following inspections on 2 June and 21 July 2009. New work arising forms were completed duplicating the one that had been completed on 24 April 2009 and allocating the same priority for the work to be completed within six months.

- 82 The signal maintenance function did not take action in response to the work arising forms because they were waiting for the start of a project sponsored by Network Rail headquarters to upgrade the road traffic light signals at crossings identified as highest risk to LEDs. This project included converting most AOCLs.
- 83 The inspection checklists used by staff carrying out inspections of level crossings only required that a check was made 'that the road signals, and their associated hoods, are in acceptable condition'. The maintenance specification applicable to the crossing required a check of the backboard but emphasised that the check related to damage and the proper security of the road lights. There was no direct requirement to check that the colour of the backboard was providing the best contrast with each lit red light unit.

- 1 *The intention of this recommendation is that Network Rail should maintain the backboards fitted to road traffic light signals at level crossings so as to maximise the contrast between the lit red light unit and the backboard.*

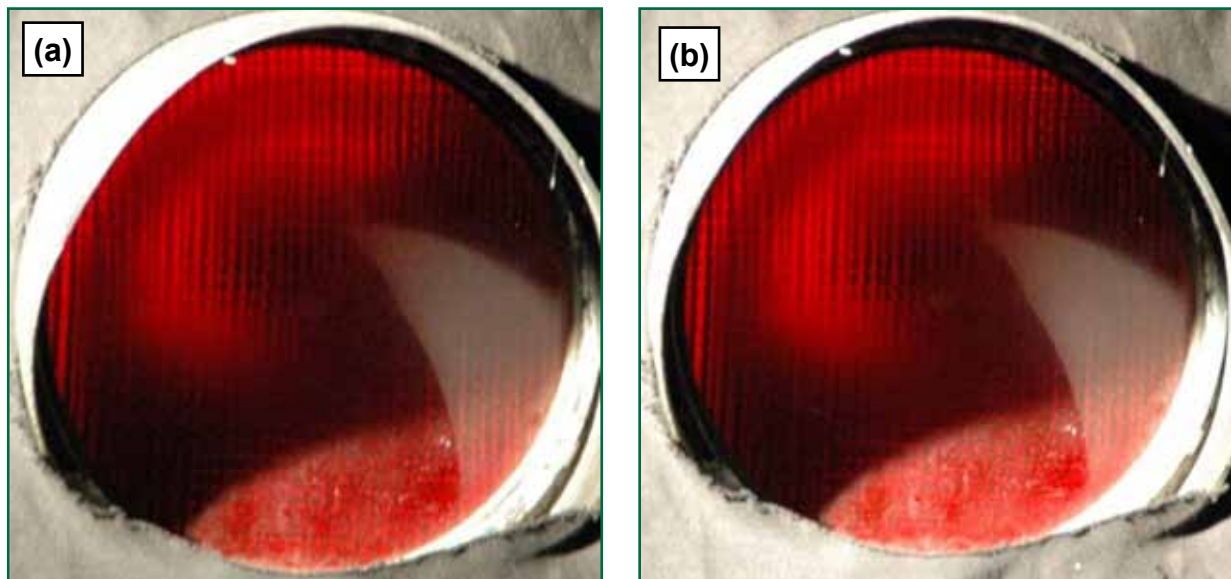
- 78 Figure 8 shows the effect of sunlight on the road traffic light signals, with the sun in the same position as it was at the time of the accident. This effect was investigated further with respect to the condition of the backboards and the amount of *contrast* between them and the lit red light units of the road traffic light signals. The difference long hoods would have made, had they been fitted, was also investigated.
- 79 The optical tests (paragraph 41) carried out found that only a small area of each lit red light unit would have been affected by sunlight at the angles associated with viewing the lights at the time of the accident (figure 8). These show a small crescent at the base of the lens and an arc shaped reflection from inside the hood. Therefore, the effect of sunlight swamping the red light units was not likely to have been a significant factor.

Figure 8: The effect of sunlight on the near side road traffic light signal red light units during tests from (a) 100 metres and (b) 50 metres

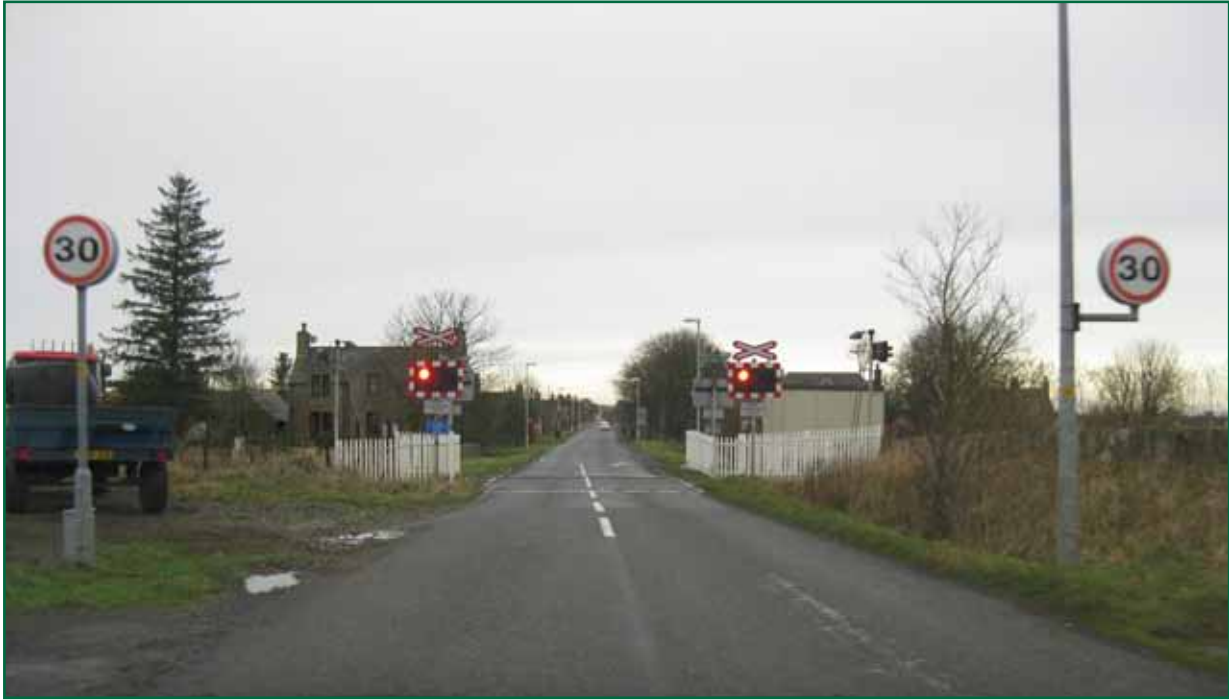
- 88 The specialist human factors consultant commissioned by the RAIB advised that the commencement of the 30 mph (48 km/h) speed limit close to the crossing on the south side (figure 9) could be a distraction to motorists approaching the crossing. This proximity of the speed limit signs to the crossing might reduce the attention given to the crossing, or remove attention away from it completely. The signs might also draw a car driver's attention to the vehicle speedometer to check vehicle speed and away from maintaining vision out of the vehicle's windscreen. Other signs in the vicinity of a level crossing that are not related to that crossing could also be a potential distraction.

Figure 9: the 30 mph signs at Halkirk crossing (taken after the accident and the renewal of the road lights to the LED type)

- 2 *The intention of this recommendation is that Network Rail should take into account the human factors issue of highway speed limit and other signs positioned close to level crossings while assessing the risk.*

Network Rail should consider amending the level crossing risk management toolkit to include the human factors issue and associated risk reduction measure relating to the potential distraction caused by highway speed limit signs and other signs positioned close to level crossings (paragraph 135c).
