RAIB Bulletin 01/2010

Passenger train collision at Darlington 3 October 2009

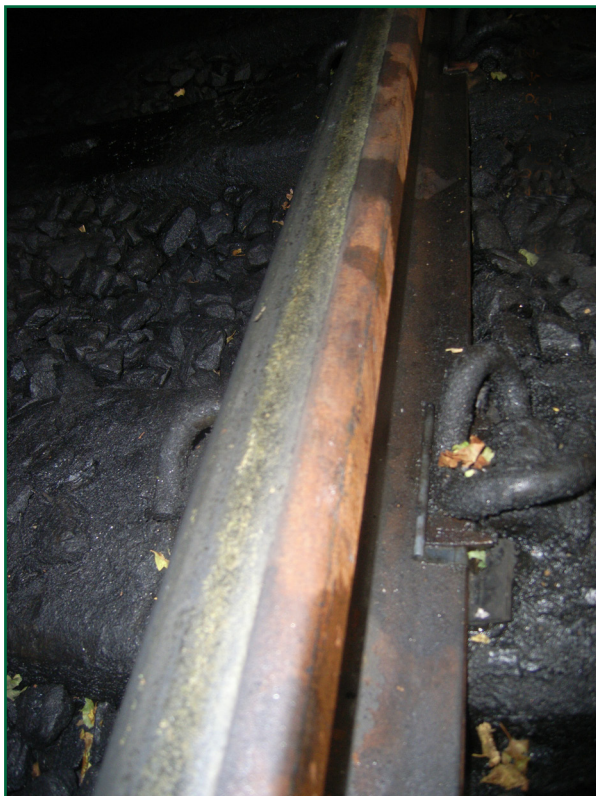
10. The primary cause of the accident was contamination of the rail head at the south end of the station. Samples were taken from the rail head (see figure 2) and the wheels of the main-line train, which was equipped with disc brakes (see figure 3). The swabs from both sources showed high levels of leaf/vegetation material.

Figure 2: Contamination on the rail-head at the south end of the station

12. There were high wind speeds in the area at the time. A speed restriction was in force in order to protect against damage to the overhead line equipment. It is likely that the high winds resulted in leaves and other vegetation being blown onto the line, from where it could be picked up by the wheels of passing trains and transported short distances. This material, having been deposited from trees during the early part of autumn, is likely to have had a high moisture content, which would have made a significant contribution to the low level of adhesion available. The colour of the contaminant (see figures 2 and 3) also suggests that the material was moist.

15. The analysis of the rail head samples also showed the presence of hydrocarbons. A rail greaser is located approximately 160 metres south of the mid-platform signal, shortly after the location where the driver of the branch-line train started to brake. It is likely that the rail greaser was the source of the hydrocarbons. A subsequent examination of the equipment by the infrastructure owner showed that the rate at which grease was being dispensed was within permissible parameters. It may, however, have provided a rail-based medium to which the contaminant could adhere.

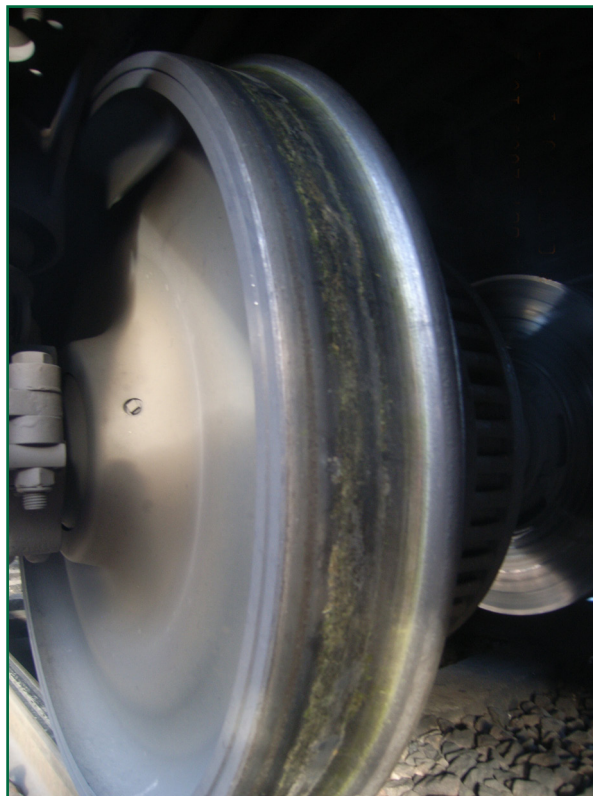
Figure 3: Contamination on one of the wheels of the main-line train

11. It is likely that the contaminant had been carried into the area from a location approximately two miles south of the station, on the main line, by earlier trains. The driver of an earlier northbound main-line train had reported problems in braking at this location and the driver of the main-line train involved in the accident recalls passing through leaves being thrown up by a southbound passing train in roughly the same area. Platform 4 at Darlington is covered and would not have been vulnerable to contamination by any vegetation in the vicinity of the station.

13. Both main-line trains were equipped with disc brakes, which meant that when they braked on the approach to Darlington station, the wheels were not rapidly cleaned by the action of tread brakes on the wheel rims. Instead, the train(s) continued to deposit vegetation on the rail head.
