Rail Accident Investigation Branch

# Rail Accident Report

## Overhead line failure, St Pancras International 23 September 2009

Report 12/2010  
August 2010

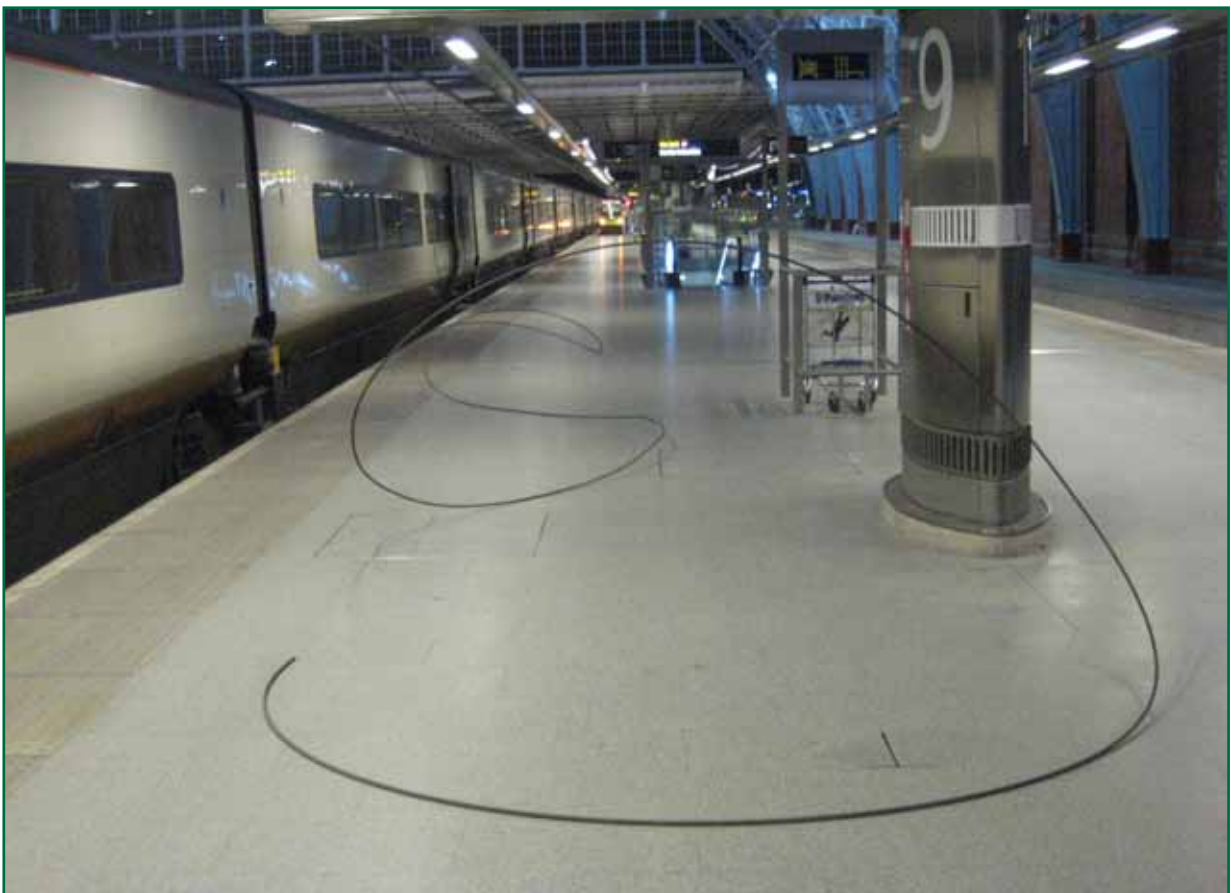
- 4 At approximately 18:35 hrs on 23 September 2009, the overhead wire supplying electric power to trains parted and fell onto the platform where passengers were leaving a Eurostar train which had just arrived at platform 9 of London St Pancras International station.
- 5 The supply system circuit breaker opened automatically to de-energise the wire, but the electrical controller made two attempts to re-energise the wire manually, in addition to the automatic reclosure of the supply system circuit breaker shortly after each automatic opening.

Figure 1: Photograph of displaced wire on platform (courtesy of Network Rail)

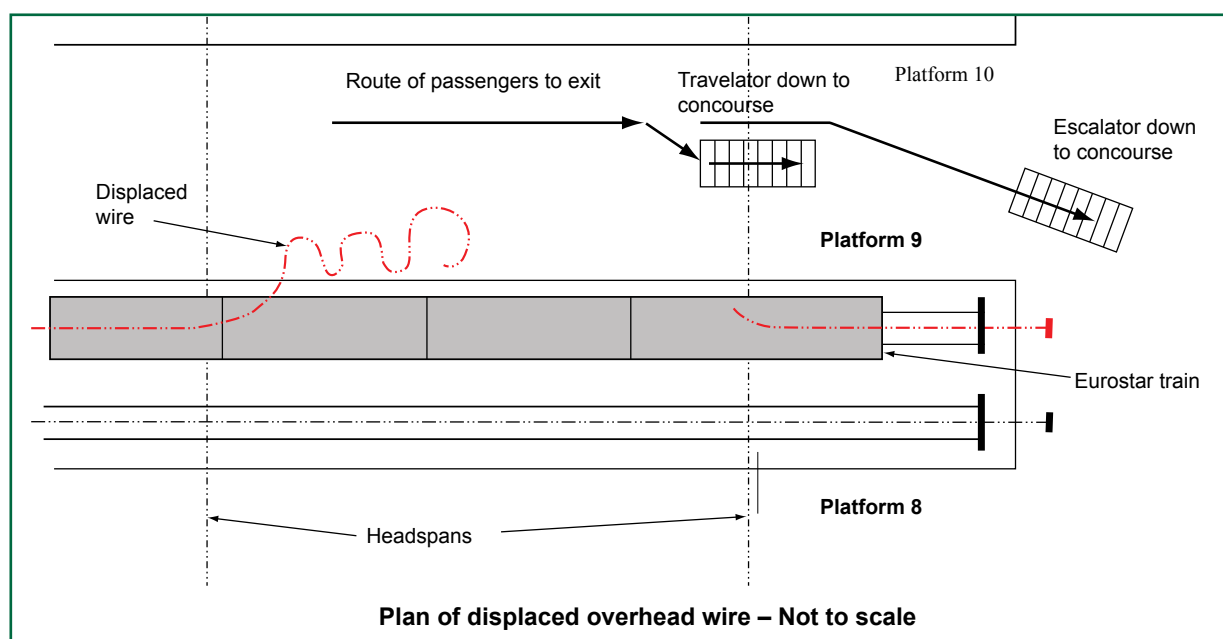
Figure 3: The route taken by passengers to leave the platform past the displaced overhead wire

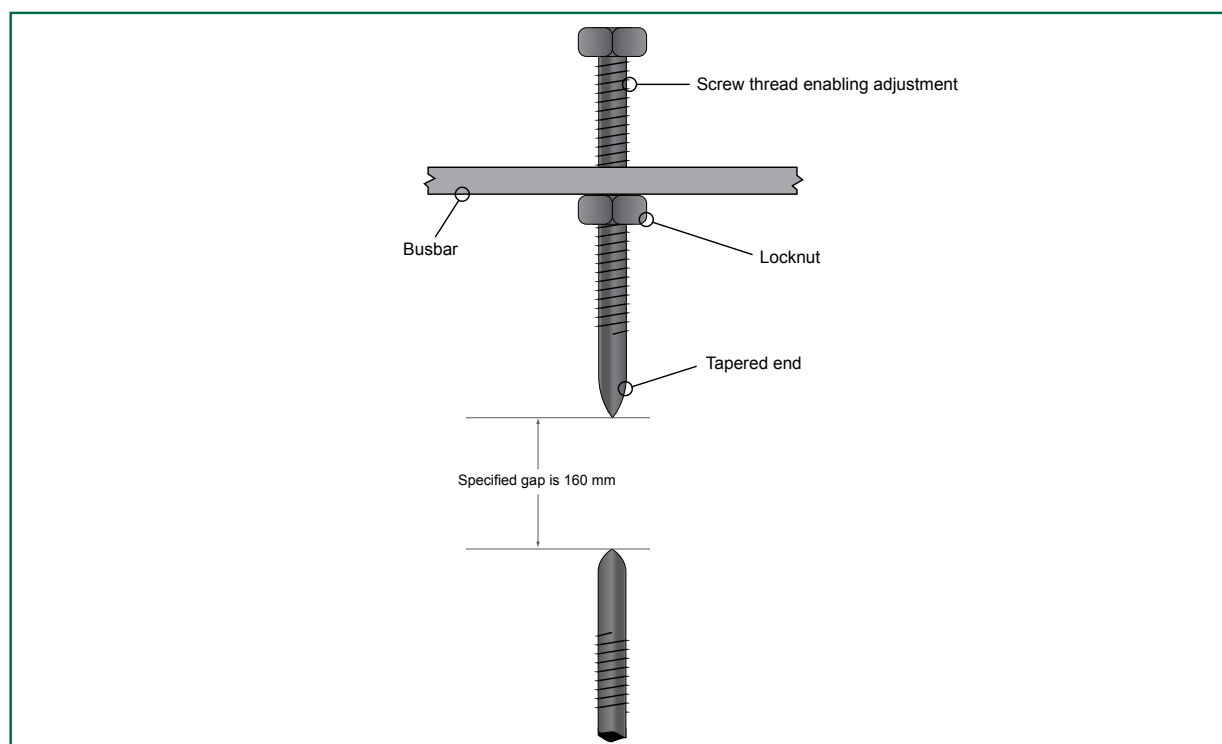
Figure 6: Arrangement for locating the upper electrode in the busbar

77 When the lightning arrester was examined after the incident there was erosion present, the lock-nut had fully wound down and the upper electrode was loose. If the electrodes had been in as-new condition, this position of the upper electrode would have produced a spark gap of 122 mm. The gap is specified to be 160 mm.

- 78 The electrode and busbar were subjected to vibration tests by mounting them firmly on equipment used to calibrate accelerometers. Vibrations were induced at varying frequencies to establish any conditions under which the electrode would move. Movement occurred when vibration between 180 and 250 Hz was applied and both the lock nut and the electrode would rotate and move downwards when a maximum acceleration of 0.2g was applied. This showed that, when the lock-nut was not correctly tightened, the electrode could rotate and move freely downwards.

- 79 The maintenance instructions specifically state that the spark gap is to be checked as being 160mm +/- 2mm, and adjusted as necessary, every six months. Its last scheduled examination before the incident was in April 2009, but the records of that examination have not been found. If the electrode had been adjusted and the lock-nut had not been tightened adequately, sufficient time would have elapsed to permit the nut to loosen and the electrode to move downwards.

- 80 One pantograph on power car 373016 had been changed on 12 March 2009. The pantographs are close to the section of the busbar where the lightning arrester is mounted. It is possible that that section of the busbar was disturbed during the pantograph change, the lock-nut was loosened very slightly and that at the examination in April the looseness was not found.

- 81 Eurostar initiated a special examination of the lightning arresters on all power cars, whether based in the UK, France or Belgium, to ensure that they are locked tightly at the correct separation. No other loose lock-nuts were found during this examination.

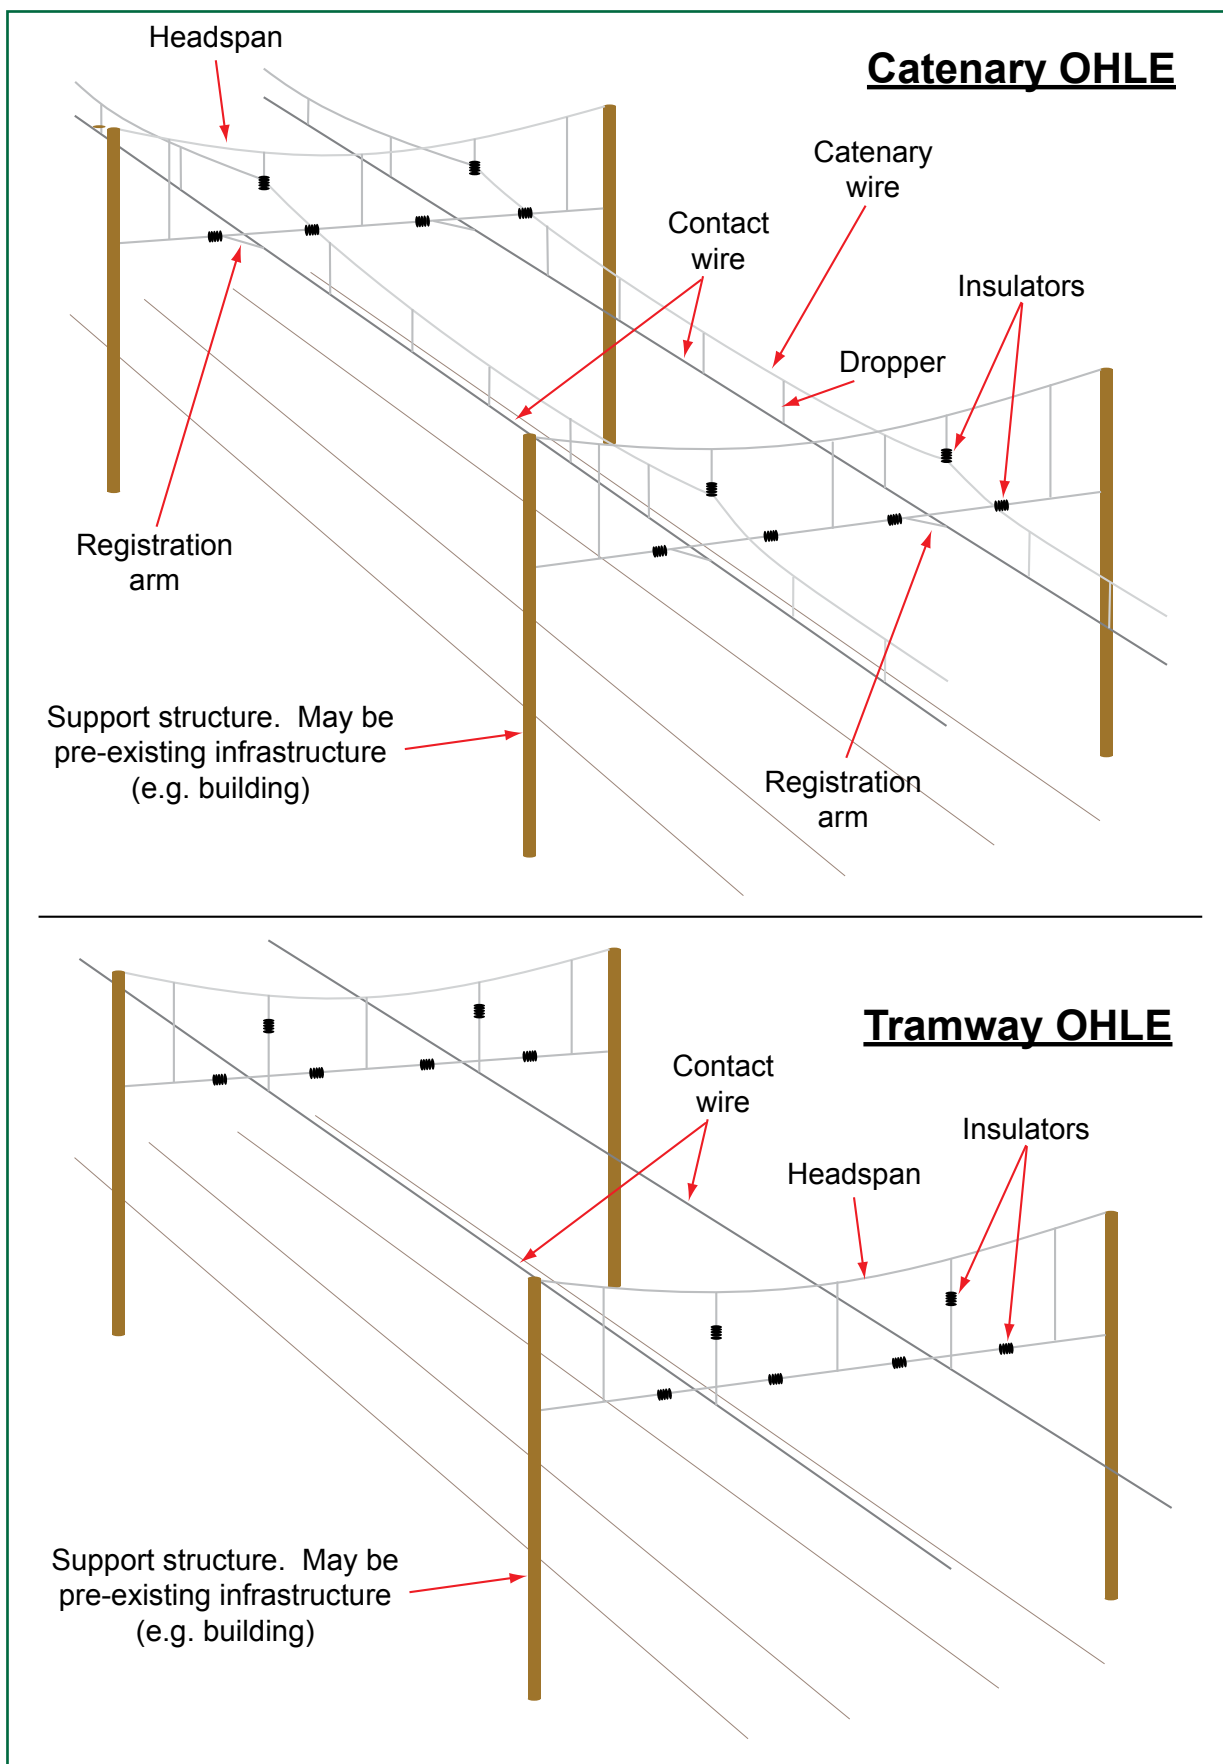
**115 The 'tramway' OHLE provided no restraint to prevent the contact wire falling onto the platform once it had parted. This exacerbated the consequences of the failure and is therefore contributory.**

- 124 If twin contact wires, connected to each other and each of the same cross section as the contact wire actually used, had been installed, the current density at the points of contact with the pantograph would have been halved. The heat input to each wire would also have been halved and it is possible that it would not have been sufficient to cause the wire to weaken and part.

- 125 As the wire fell onto the platform it would have remained electrically energised until it came into contact with a sufficiently earthed item. The wire would also tend to return to the coiled state it would have been in when stored on the cable drum prior to installation. This would cause it to whip quickly away from the point where it parted. Both these phenomena, the wire being electrically live and moving rapidly, presented a hazard to anyone present on the platform.

- 126 The area of the platform affected by the fallen wire, and therefore the hazard it presented, is related to the length of wire actually displaced. Reducing the length of wire displaced (by restraining it) would have limited the consequences caused by this contributory factor described in paragraph 125.

Figure 7: Diagram showing the different types of OHLE
