Rail Accident Report

Overhead line failure, St Pancras International 23 September 2009

Report 12/2010
August 2010

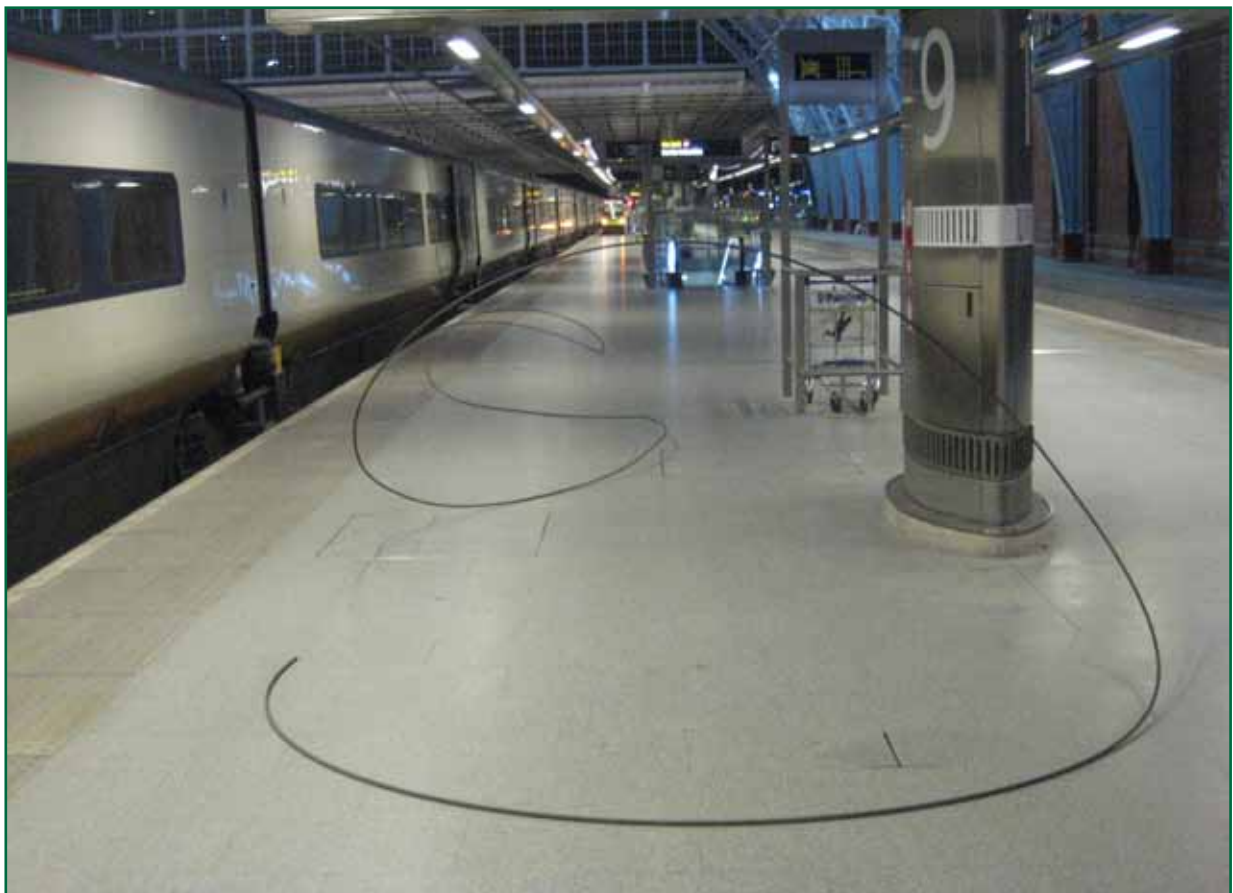
- 4 At approximately 18:35 hrs on 23 September 2009, the overhead wire supplying electric power to trains parted and fell onto the platform where passengers were leaving a Eurostar train which had just arrived at platform 9 of London St Pancras International station.
- 5 The supply system circuit breaker opened automatically to de-energise the wire, but the electrical controller made two attempts to re-energise the wire manually, in addition to the automatic reclosure of the supply system circuit breaker shortly after each automatic opening.

Figure 1: Photograph of displaced wire on platform (courtesy of Network Rail)
