# Rail Accident Report

## Collision on the Great Orme Tramway 15 September 2009

# Collision on the Great Orme Tramway

## 15 September 2009

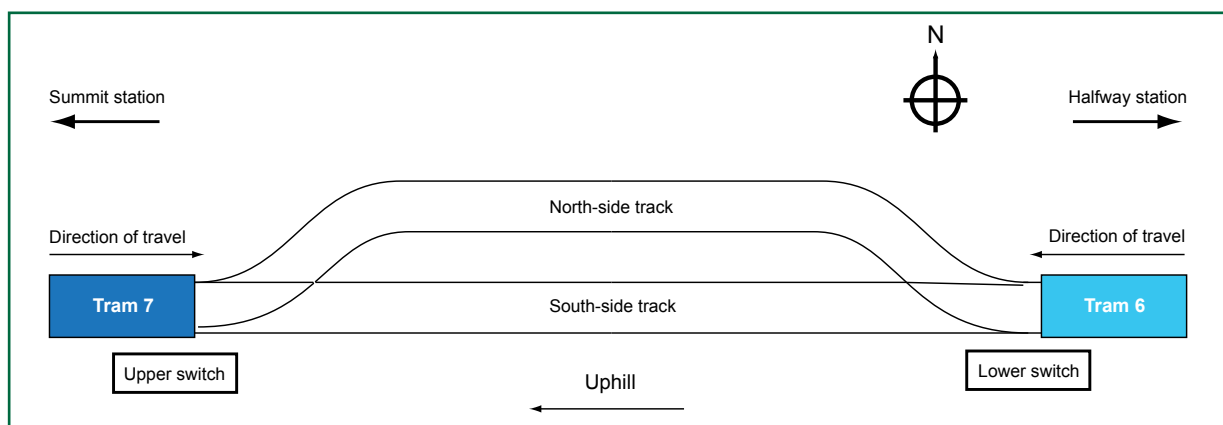
Figure 2: Plan of accident site

- 5 Tram 6 was travelling uphill and tram 7 downhill (figure 2). As tram 6 travelled over the lower *points* of the loop, its front *bogie* was correctly directed to the right-hand, north-side track, but its rear bogie was incorrectly directed to the left-hand, south-side track. Tram 7 was descending on the left-hand track and, although the braking systems of the winch and both trams were activated, the trams collided. The bodies of both trams were damaged in the collision (figure 3), but there was no damage to the infrastructure. The upper section of the tramway was closed for the remaining six weeks of the 2009 season.

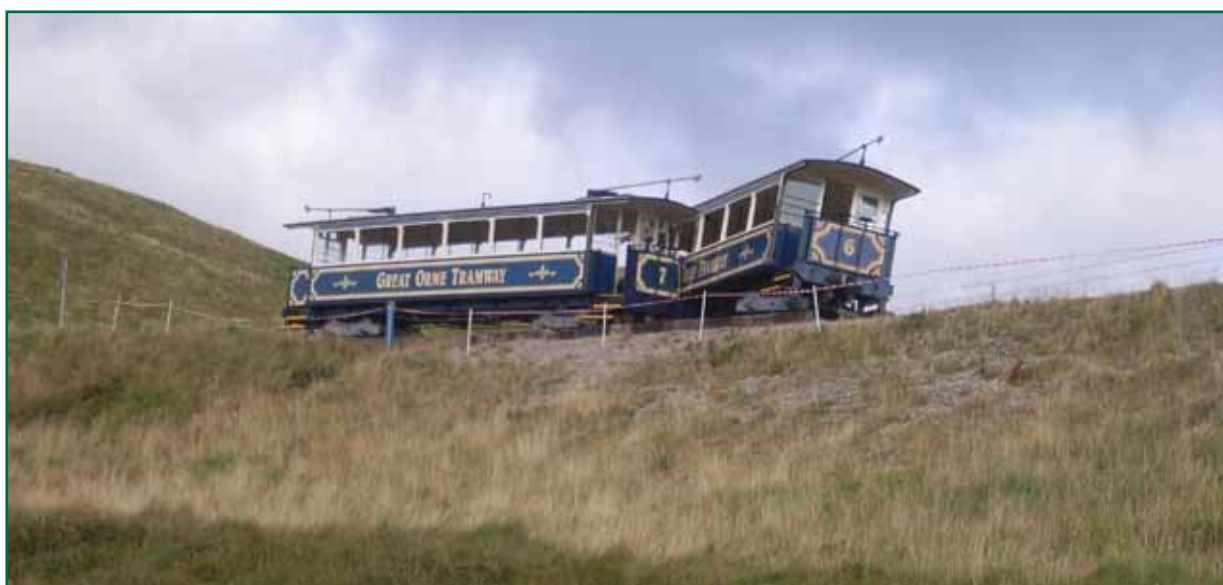
Figure 3: The trams after the accident

- 26 There was a minor injury to one person caused by debris.
- 27 All wheels of both trams remained on the rails until the collision when the wheels of the front bogie of tram 6 were derailed by the impact. The bodies of both trams were damaged, but there was no damage to the infrastructure.

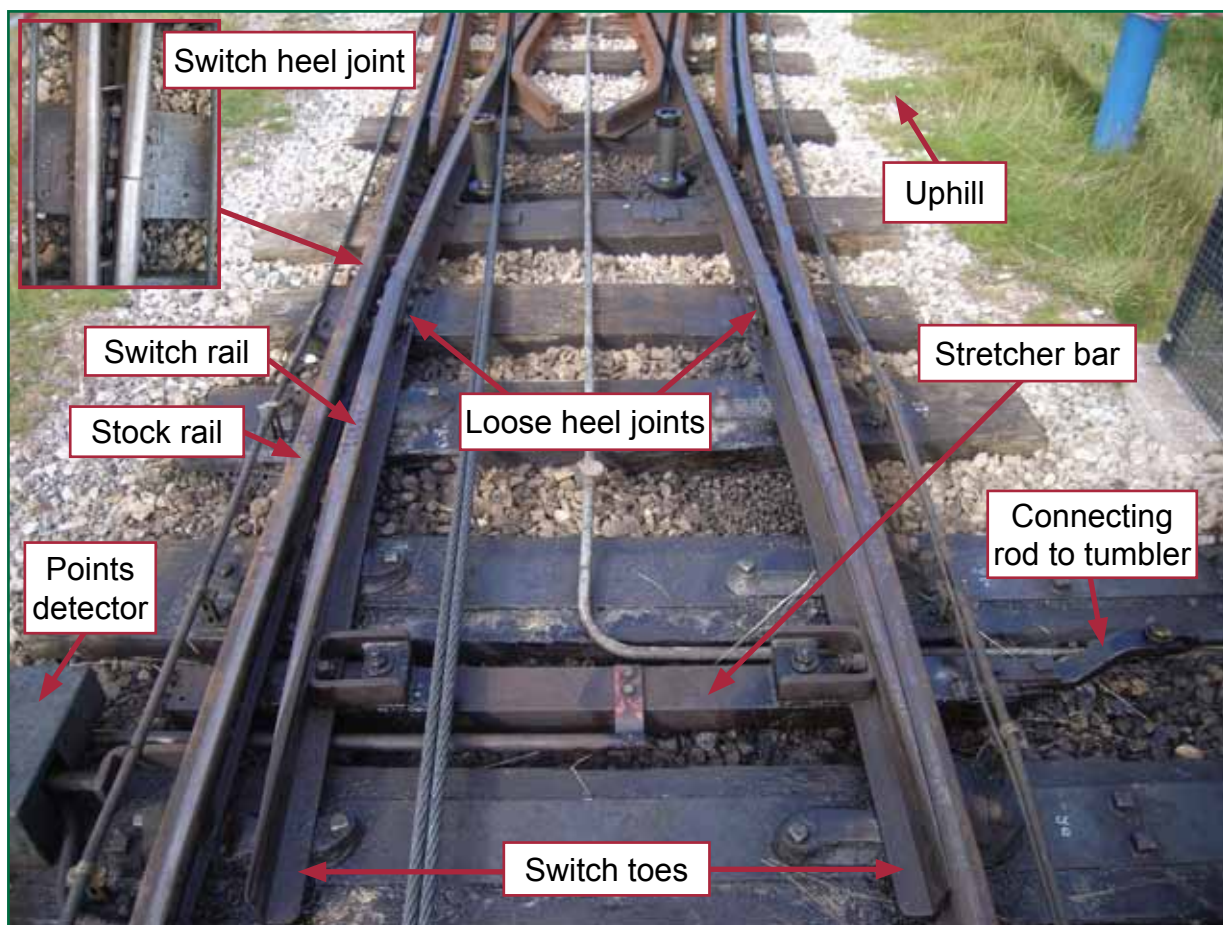
- 13 The points consisted of *loose heel switch* rails on timber *bearers*. A loose heel switch consists of switch rails that are hinged at the *heel*. This allows the rails' free ends (the *toes*) to be positioned for directing a tram to its intended route (figure 6).

Figure 6: The lower points looking in an uphill direction

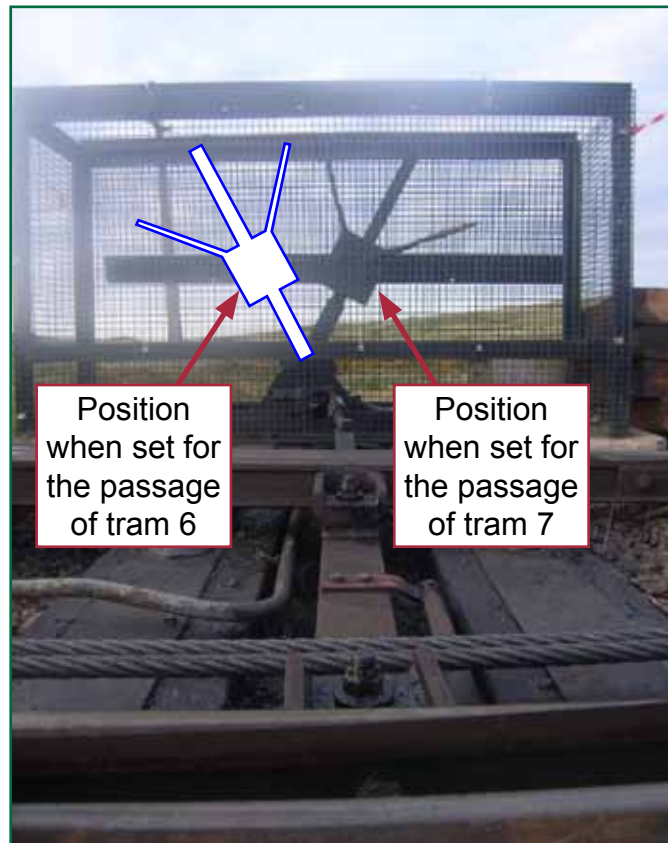
Figure 7: Tumbler weighted lever positions

- 14 The two switch rails of each point were connected together by a stretcher bar. The stretcher bar was connected to a track-side device, known as a tumbler, via a connecting rod. The tumbler was a mechanism that had a weighted lever. The lever was moved either side of its vertical position by the action of a tram leaving the loop (figure 7).

- 24 The trams did not stop immediately due to the delay in the monitoring system (paragraph 17) and in the control of the cable slack by the compensators (paragraph 9). The speed of each tram was less than 5 mph (8 km/h) at the point of collision.
- 25 After the accident the points and the tumbler were found to be in a position set for an uphill journey of tram 7 (figure 7).

- providing additional support to the heel areas of the points; and
  - measuring and overhauling the tumblers, including adding a variable length arm to allow the output force from the tumblers to be adjusted.

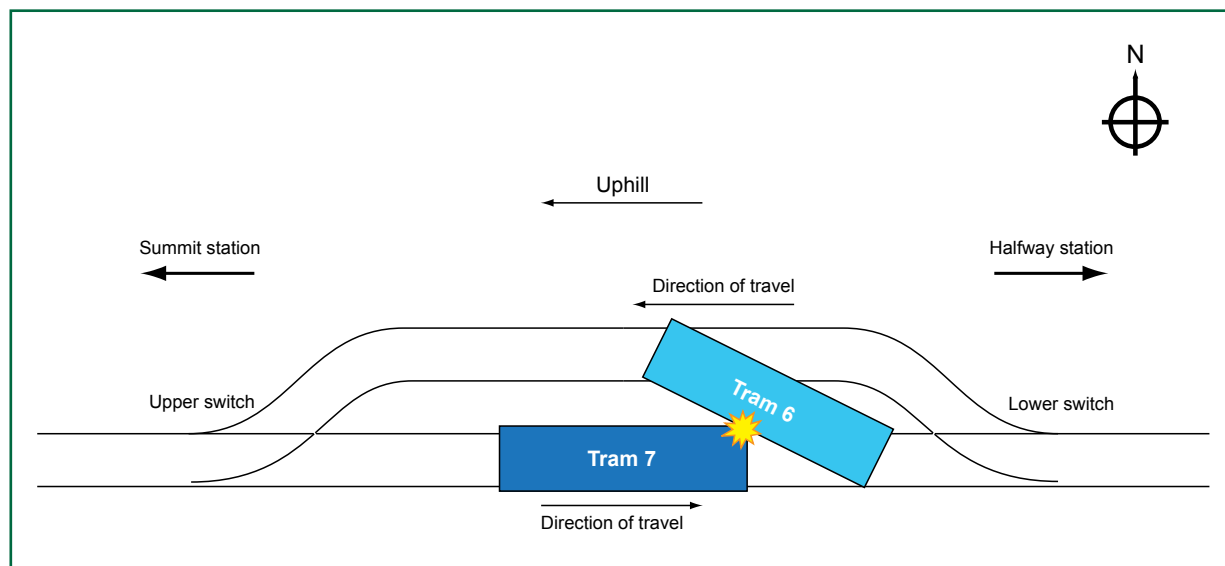
- 4 At 12:15 hrs on 15 September 2009 two trams travelling in opposite directions collided at the passing loop on the upper section of the Great Orme Tramway, Llandudno (figure 1). One person suffered minor injuries in the collision.

Figure 8: Positions of trams following the accident

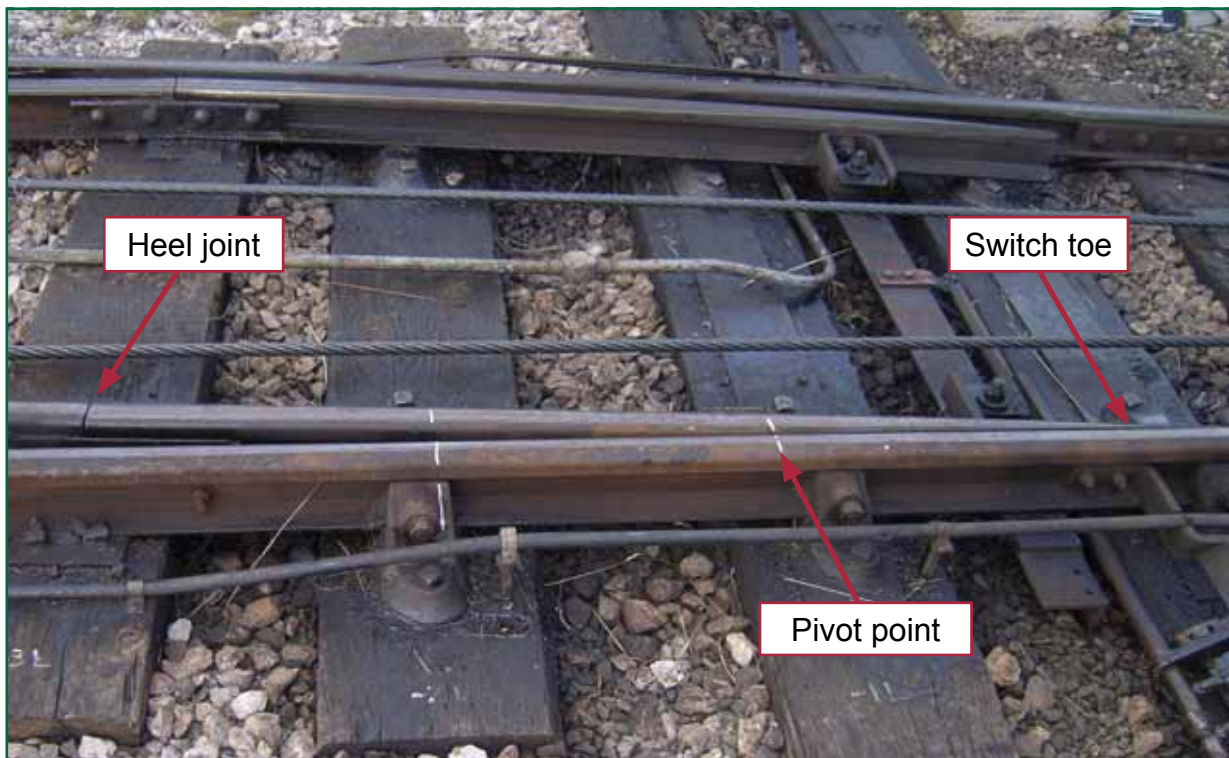
- 42 The force from the weighted lever tends towards its maximum when the lever is at one or other of its resting positions and reduces to zero when in a vertical position. The movement of the tumbler lever during these tests showed that there was sufficient energy from the wheels via the switch rails to accelerate the weighted lever towards a more vertical position and overcome its at-rest holding force.
- 43 RAIB observations showed that as the left-hand wheels of the leading bogie passed over the heel joint of the left-hand switch rail, the switch rail moved about a pivot formed by contact between the switch rail head and the adjacent stock rail head. This was at a point approximately half way along the switch rail (figure 9). The resulting switch rail deflection to the left at the heel led to the toes of the points moving to the right.

Figure 9: Left-hand switch and stock rails of the lower points

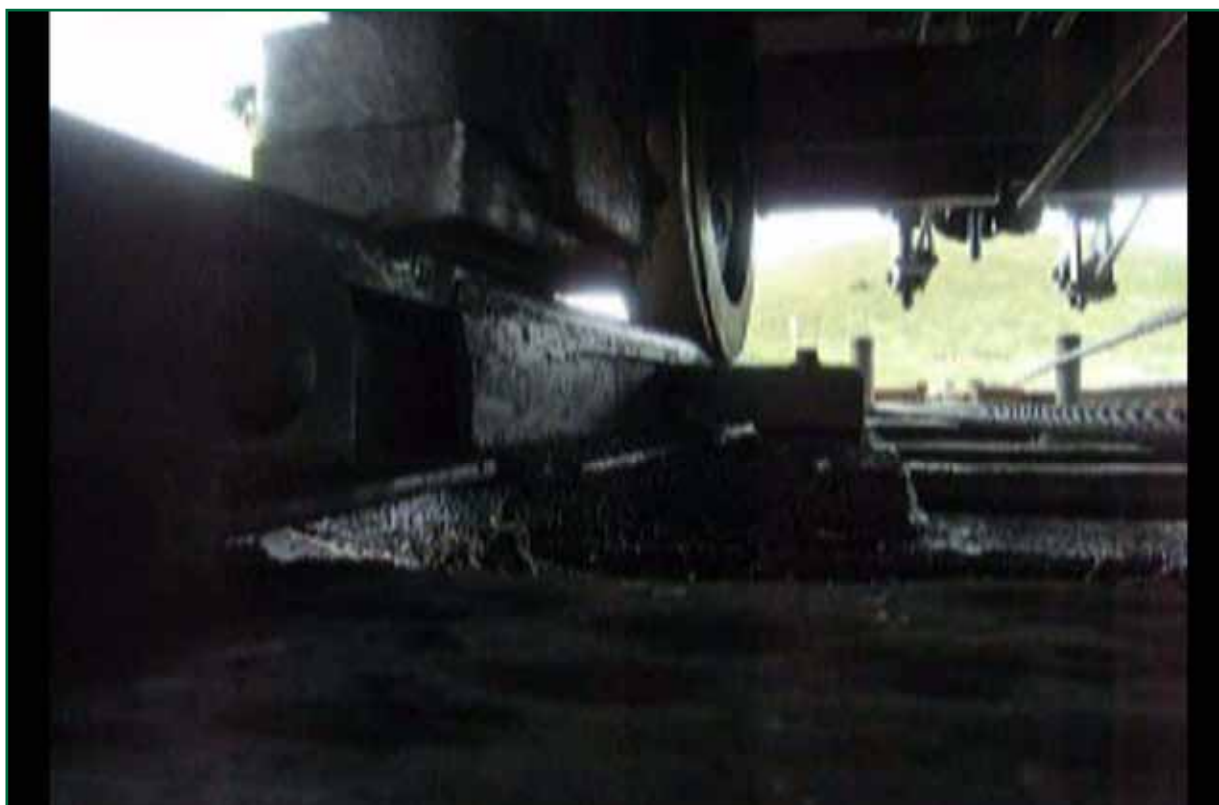
- 47 The track geometry affected both the levels of rail forces and the way in which they overcame the holding force of the tumbler.
- 48 The alignment of the track changed significantly at the heel of the lower points in directing tram 6 to the right when travelling uphill, whereas the track for tram 7 followed a gentler left-hand curve. The RAIB video images of the tests showed that the left-hand leading wheel of the leading bogie was in flange contact with the left-hand switch rail before it reached the heel joint (figure 10). While flange contact is not an uncommon feature in tramway operations, it can result in high lateral rail forces. The change in geometry to the right at the heel area would have further increased this lateral force.

Figure 10: Flange contact between leading left-hand wheel and left-hand switch rail
