Rail Accident Report

Collision on the Great Orme Tramway 15 September 2009

15 September 2009

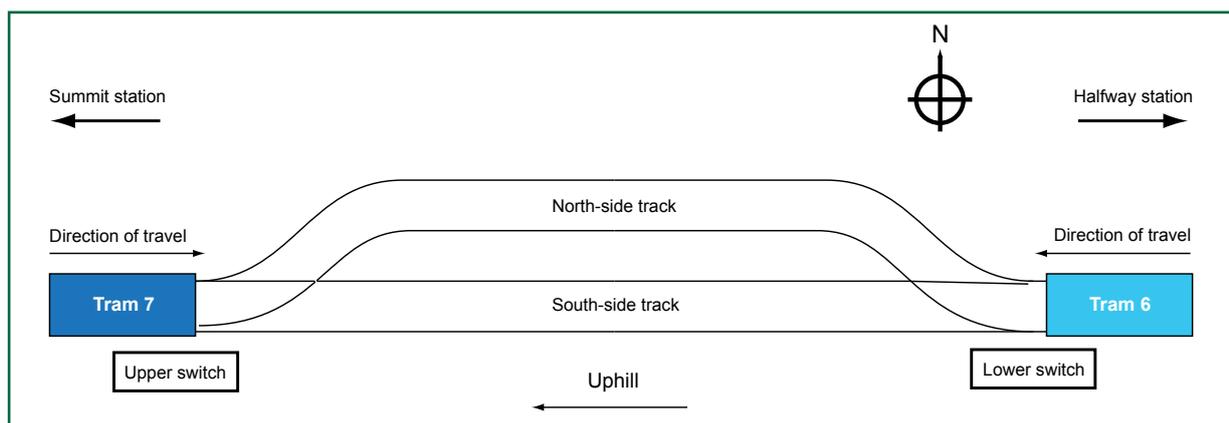
Figure 2: Plan of accident site

- 5 Tram 6 was travelling uphill and tram 7 downhill (figure 2). As tram 6 travelled over the lower *points* of the loop, its front *bogie* was correctly directed to the right-hand, north-side track, but its rear bogie was incorrectly directed to the left-hand, south-side track. Tram 7 was descending on the left-hand track and, although the braking systems of the winch and both trams were activated, the trams collided. The bodies of both trams were damaged in the collision (figure 3), but there was no damage to the infrastructure. The upper section of the tramway was closed for the remaining six weeks of the 2009 season.

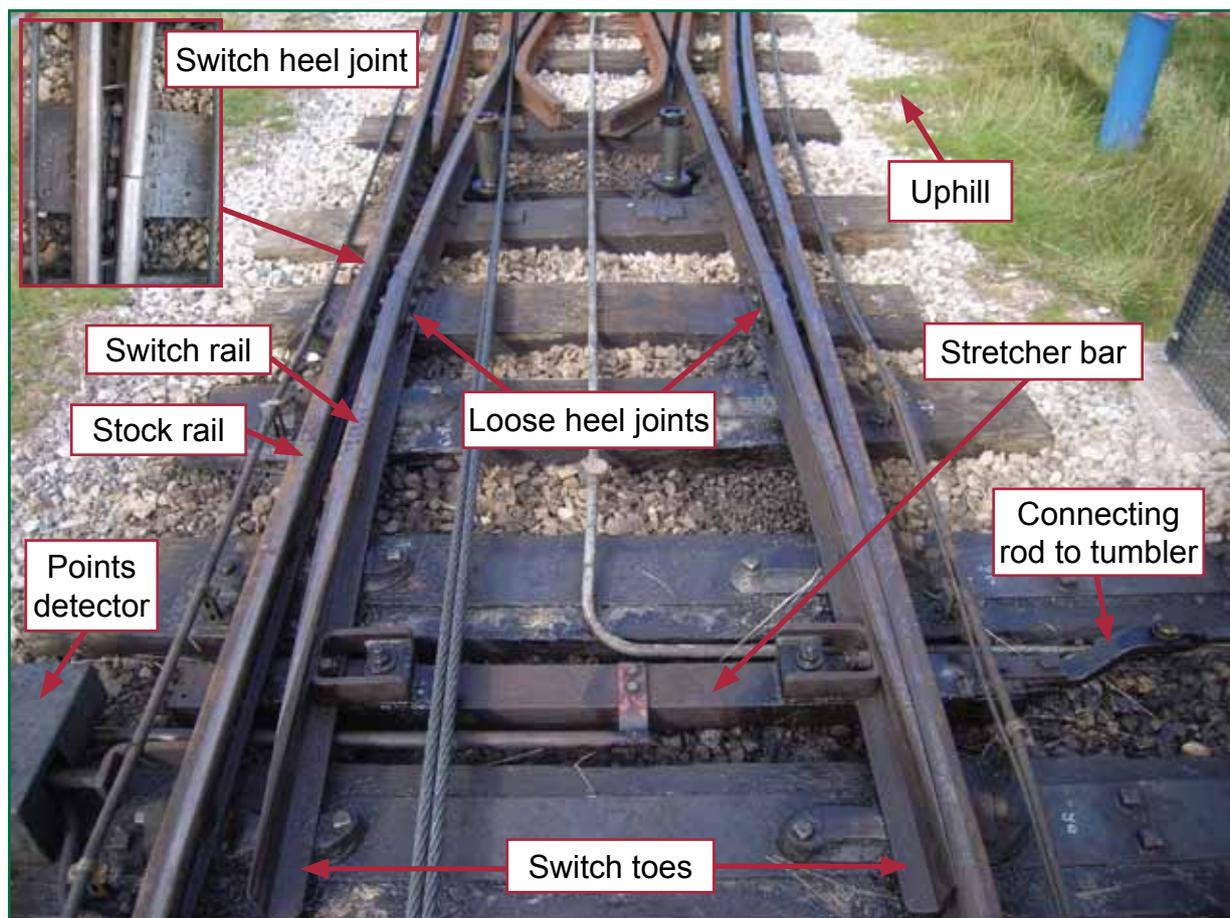
Figure 6: The lower points looking in an uphill direction

- 13 The points consisted of *loose heel switch* rails on timber *bearers*. A loose heel switch consists of switch rails that are hinged at the *heel*. This allows the rails' free ends (the *toes*) to be positioned for directing a tram to its intended route (figure 6).

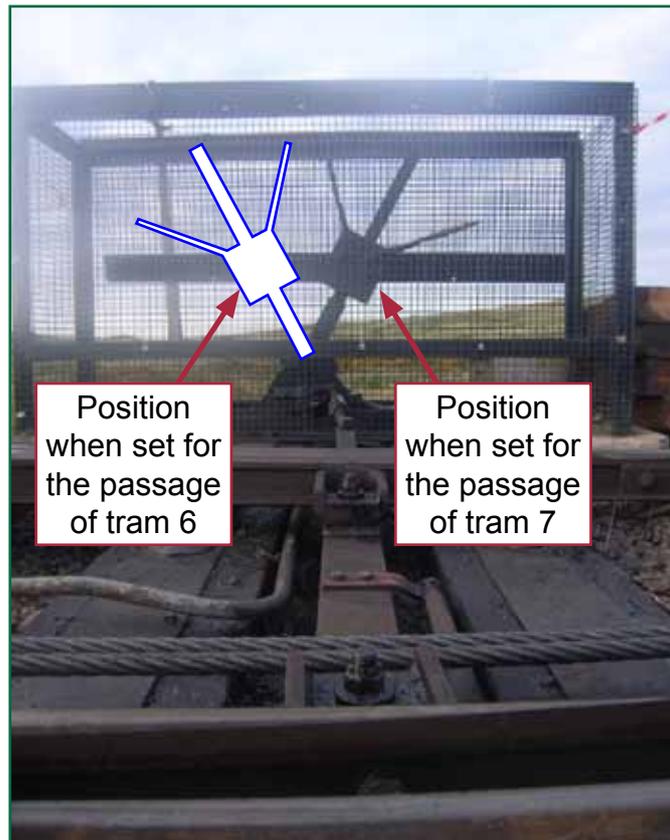
Figure 7: Tumbler weighted lever positions

- 14 The two switch rails of each point were connected together by a stretcher bar. The stretcher bar was connected to a track-side device, known as a tumbler, via a connecting rod. The tumbler was a mechanism that had a weighted lever. The lever was moved either side of its vertical position by the action of a tram leaving the loop (figure 7).

- 24 The trams did not stop immediately due to the delay in the monitoring system (paragraph 17) and in the control of the cable slack by the compensators (paragraph 9). The speed of each tram was less than 5 mph (8 km/h) at the point of collision.
- 25 After the accident the points and the tumbler were found to be in a position set for an uphill journey of tram 7 (figure 7).

- 52 Measurements by the tramway's consultant after the accident found an imbalance between the holding forces from the tumbler in each of its resting positions, albeit this was measured at the tumbler and not at the switch rails. The holding force was less for the position set for tram 6 than for tram 7.

- 53 In both positions a lever was applied to manually open the closed-side switch rails. Although no force values were measured, the tramway's consultant found that the tumbler provided less resistance to moving the points away from the position set for tram 6 than that set for tram 7 ie they were unbalanced. This is probably due to one or a combination of the following:

- providing additional support to the heel areas of the points; and
 - measuring and overhauling the tumblers, including adding a variable length arm to allow the output force from the tumblers to be adjusted.

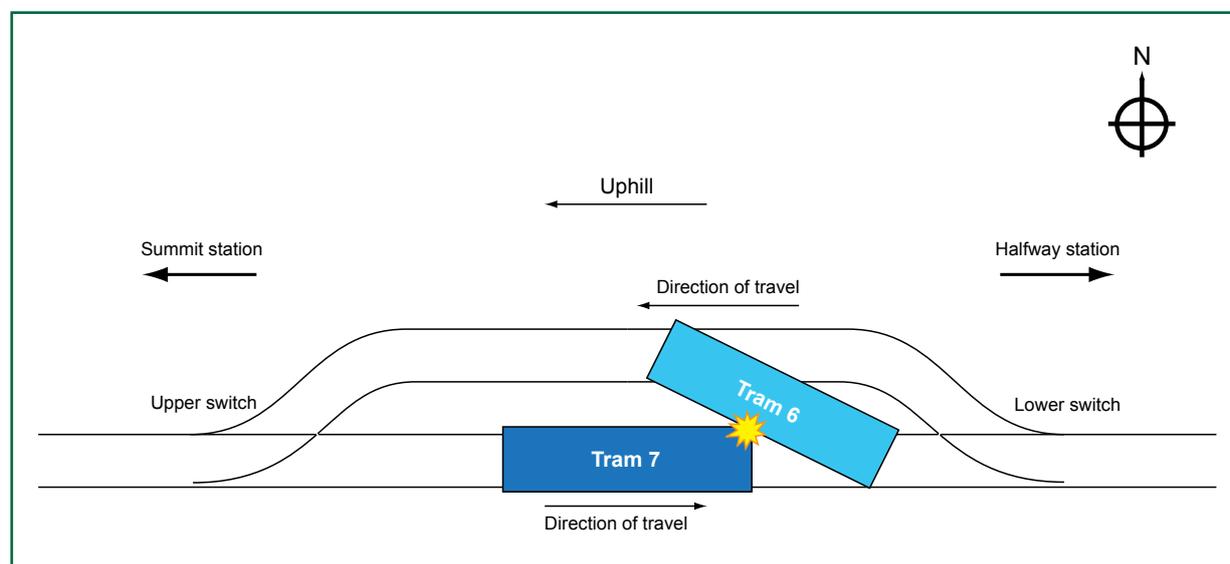
Figure 8: Positions of trams following the accident

- 22 The trams were travelling at around 5 mph (8 km/h) as each approached the loop. Tram 7 entered the loop via the upper points and was correctly directed to the south-side track. The front bogie of tram 6 was correctly directed to the north-side track by the lower points, but its rear bogie was directed to the south-side track and into the path of tram 7 (figure 8).

- 34 The immediate cause of the collision was the lower points moving under tram 6 directing the rear of the tram into the path of tram 7.**
- 35 The observations of the tram attendant (paragraph 21), together with post-accident tests of the detection and monitoring system, indicated that the points were set for the correct route prior to the arrival of tram 6.
- 36 Site examinations found no evidence that any of the wheels of tram 6 had derailed prior to the collision. For the front bogie of tram 6 to have been directed to the correct route, and its rear bogie to the incorrect route, the lower points must have changed position as tram 6 passed over them. This is supported by the points and the tumbler being found set for tram 7 after the accident (paragraph 25).

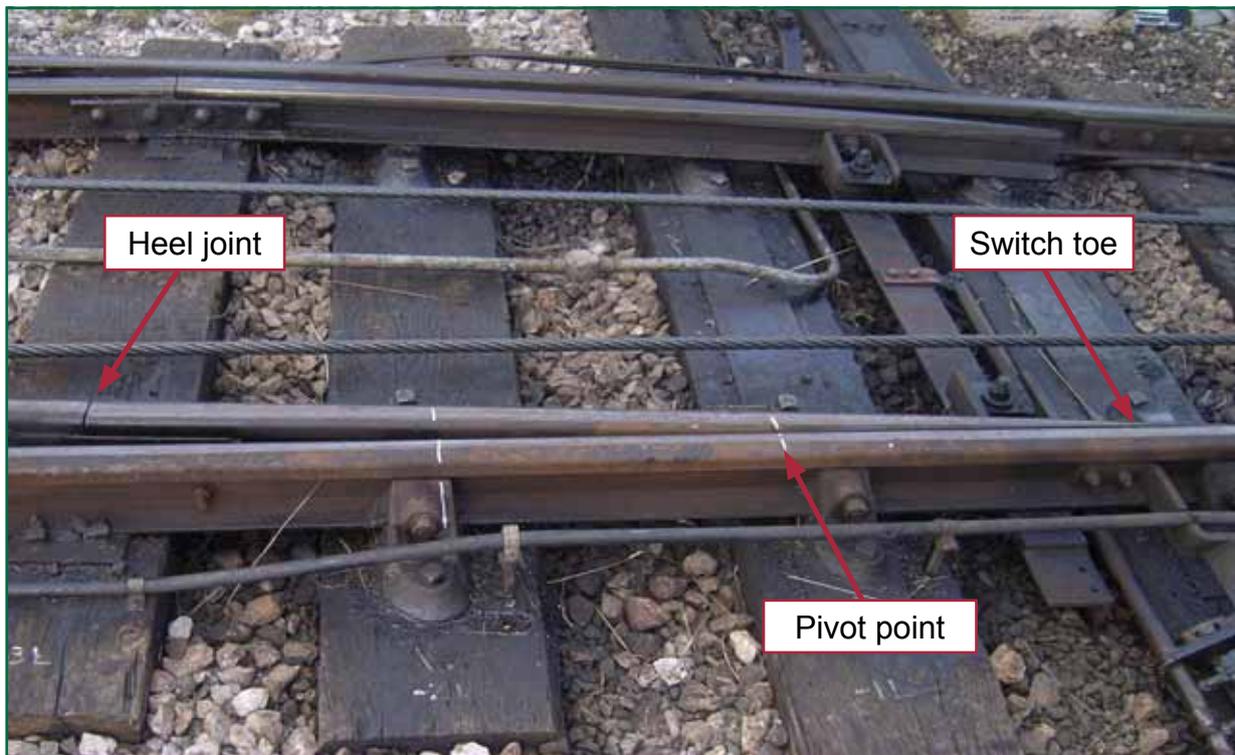
Figure 9: Left-hand switch and stock rails of the lower points

- 42 The force from the weighted lever tends towards its maximum when the lever is at one or other of its resting positions and reduces to zero when in a vertical position. The movement of the tumbler lever during these tests showed that there was sufficient energy from the wheels via the switch rails to accelerate the weighted lever towards a more vertical position and overcome its at-rest holding force.
- 43 RAIB observations showed that as the left-hand wheels of the leading bogie passed over the heel joint of the left-hand switch rail, the switch rail moved about a pivot formed by contact between the switch rail head and the adjacent stock rail head. This was at a point approximately half way along the switch rail (figure 9). The resulting switch rail deflection to the left at the heel led to the toes of the points moving to the right.

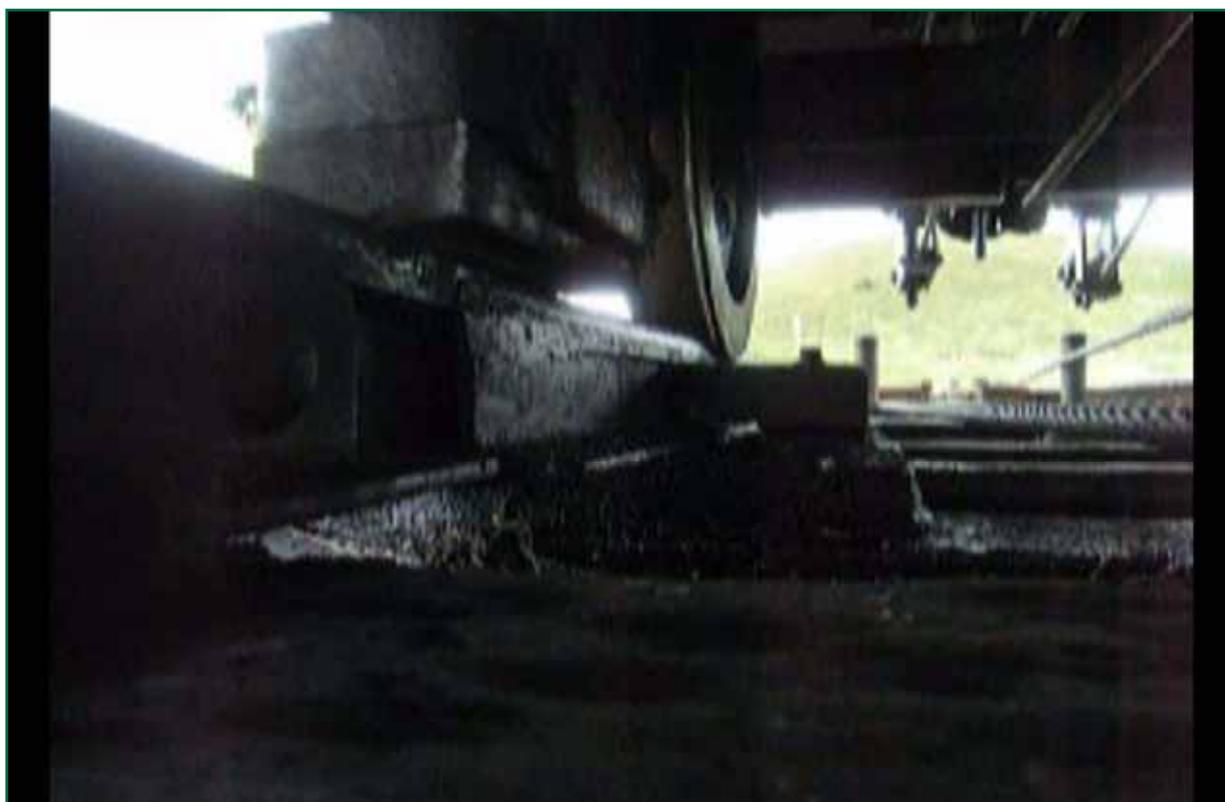
Figure 10: Flange contact between leading left-hand wheel and left-hand switch rail

- 47 The track geometry affected both the levels of rail forces and the way in which they overcame the holding force of the tumbler.
- 48 The alignment of the track changed significantly at the heel of the lower points in directing tram 6 to the right when travelling uphill, whereas the track for tram 7 followed a gentler left-hand curve. The RAIB video images of the tests showed that the left-hand leading wheel of the leading bogie was in flange contact with the left-hand switch rail before it reached the heel joint (figure 10). While flange contact is not an uncommon feature in tramway operations, it can result in high lateral rail forces. The change in geometry to the right at the heel area would have further increased this lateral force.

- 49 The *track gauge* through the points was up to 13 mm wide with signs of lateral movement of some of the slide chairs. There was evidence of up to 5 mm of lateral movement of the left-hand *closure rail* at the bearer beyond the heel of the points. The track gauge at the heel changed from an excess of 8 mm to 0 mm over a distance of 670 mm in an uphill direction. This change in gauge over such a short distance would also have assisted in increasing the lateral wheel forces beyond those normally expected and hence those imparted to the switch rail. The widening of the track gauge was likely to be due to deterioration of the bearers within the points.

50 The rail heads of the points should be level across the track gauge by design. The RAIB measured up to 12 mm of *static cross-level* through the points between the switch toes and the heel. Cross-level is principally controlled by the support conditions of the bearers and the ballast. Gaps were observed under some of the chairs. This affected the support of the tram wheels, with the cross-level differences probably increasing under the weight of trams. This would have changed the vertical forces seen by the switch rails, altering the frictional forces between rails and the slide chairs and affecting the lateral forces on the tumbler (paragraph 44).

- 74 Over the closed period between October 2009 and March 2010, the tramway has undertaken remedial work on the upper loop, including:
- correcting the vertical alignment (cross-level and gradient) by lifting the track and adding approximately 70 tonnes of ballast;

- adding ballast retention boards to reduce the movement of ballast on the embankment;
 - correcting the lateral alignment of the track;
 - renewing deteriorated sleepers and bearers (paragraph 49);
