# RAIB Bulletin 03/2010

## Passenger train collision with road vehicle at Broken Cross bridge between Salisbury and Grateley, 22 September 2009

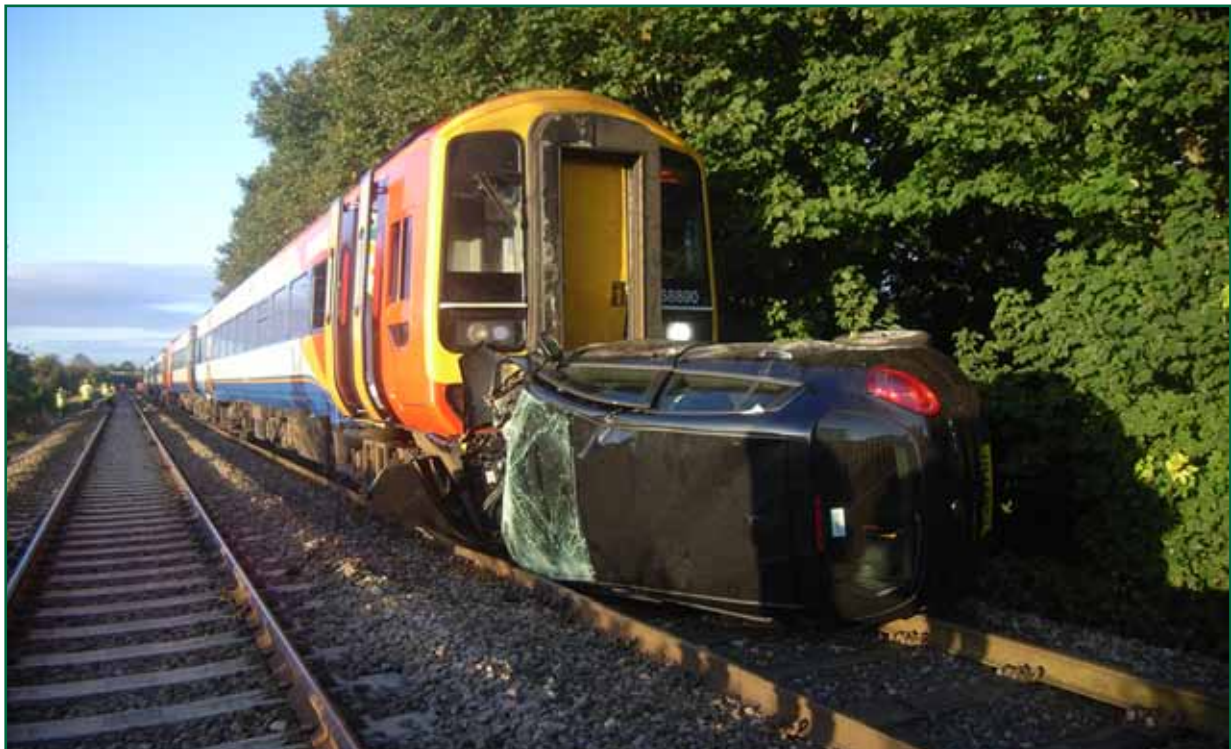
1. Before dawn on 22 September 2009, a passenger train collided with a car which had left the highway at Broken Cross bridge near Salisbury, and rolled onto the railway line a few seconds before. The car, which had been travelling south on the A338, landed on its passenger door side and facing towards an oncoming train.
2. The car driver, the only occupant of the vehicle, was able to see the lights of the approaching train and climbed out of the vehicle before the collision occurred. He attempted to make an emergency call using his mobile phone, but was unable to prevent the collision. The train driver applied the emergency brake, and the train came to a halt after propelling the car along the track for a distance of 460 metres (see figure 1).

Figure 1: Train and car following collision. The road bridge from which the car fell can be seen in the distance

3. The train, comprising a two car class 158 diesel multiple unit (leading) and a three car class 159 diesel multiple unit, was damaged by the collision and the effects of flying ballast which struck four of the five under-floor diesel engines. There were no injuries to the three crew and nine passengers on the train. Evidence from the train's data recorder showed that the train was travelling at 65 mph (105 km/h) at the time of the collision, on a section of track with a line speed of 80 mph (129 km/h). The train's forward facing CCTV indicates that the driver had approximately two seconds warning of the collision when the train's headlights reflected off the car's number plate.

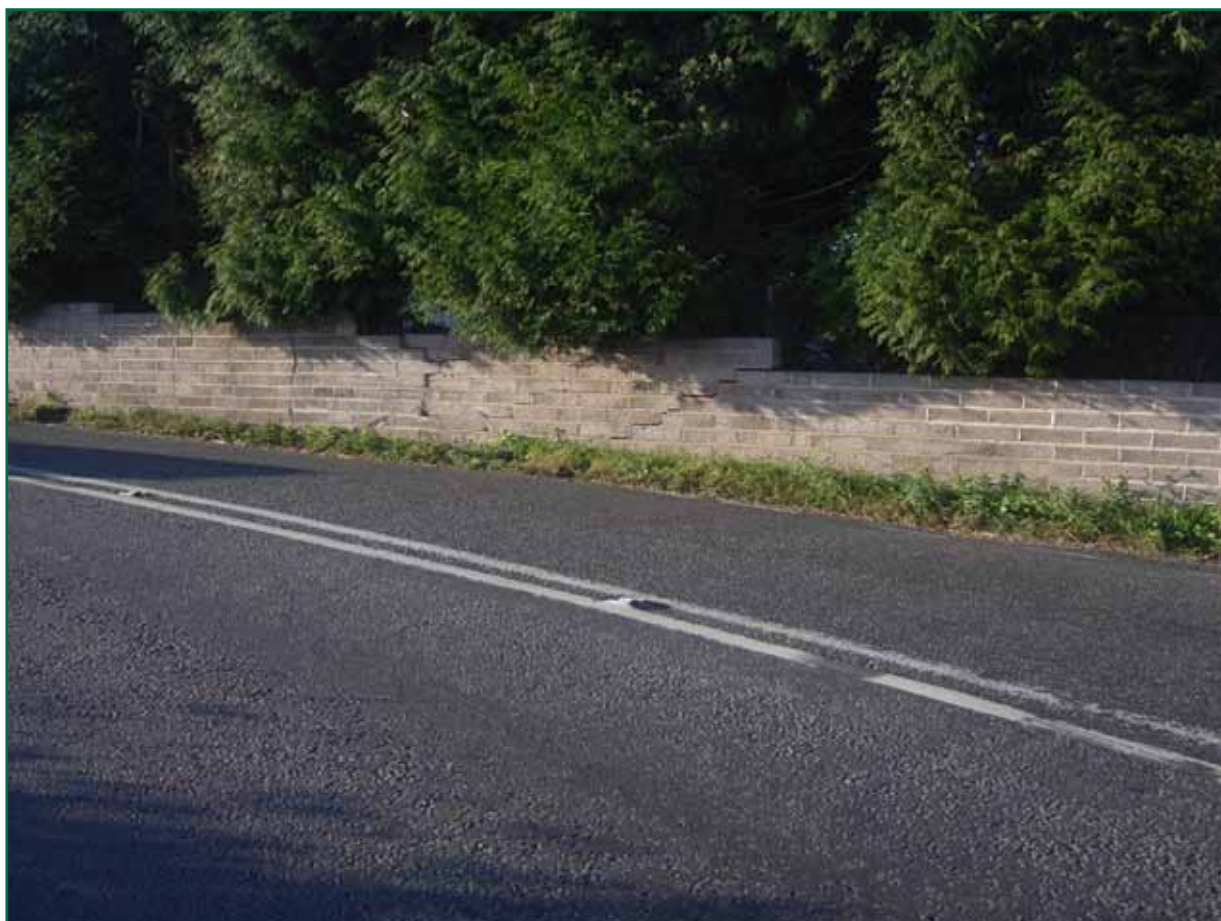
4. The bridge is situated on a double bend, which requires drivers to slow down as they approach. The car involved in the accident was travelling south and did not negotiate the left-hand bend approaching the bridge. It crossed the carriageway before colliding with a substantial garden wall constructed of concrete blocks (figure 2) on the opposite side of the road. The force of this impact did not topple the wall, but instead caused the car to rebound diagonally back across the road. This trajectory projected the car to the left of the bridge parapet and onto the railway (figure 3). There were no other vehicles involved.

*Figure 2: Concrete block wall showing impact damage*

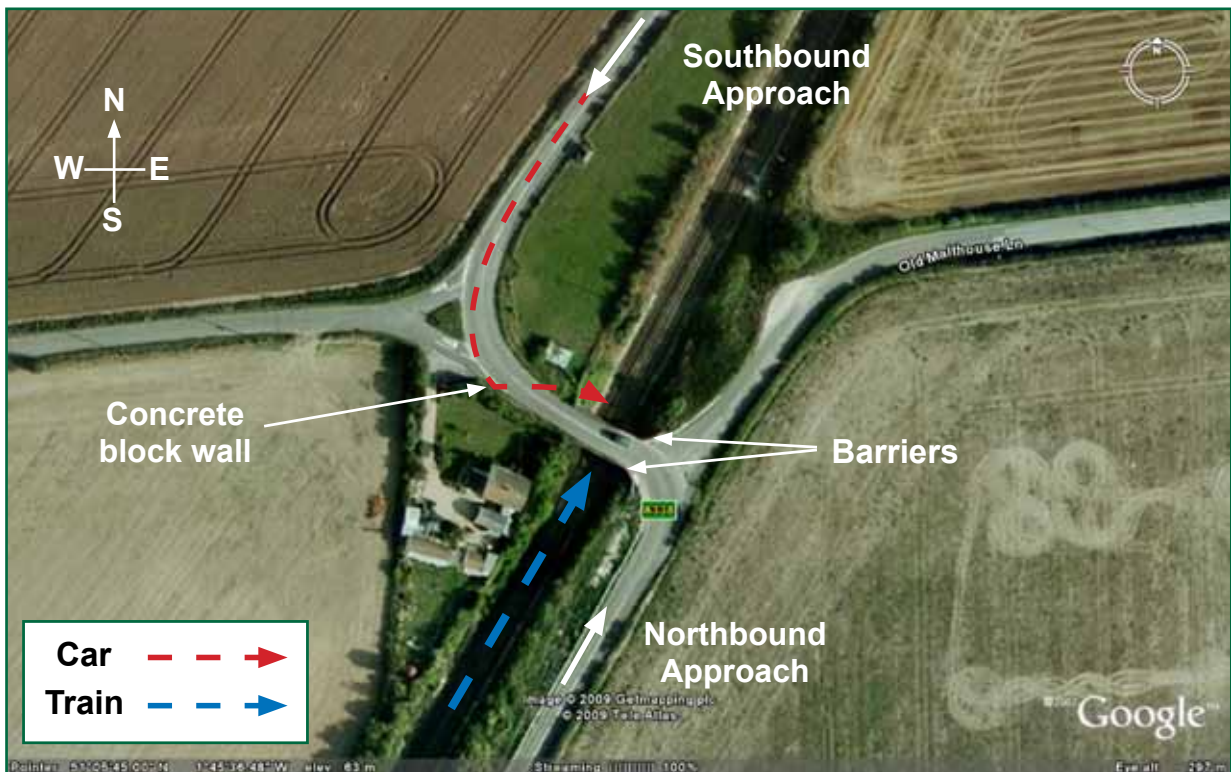
Figure 3: Path of car before the collision with train

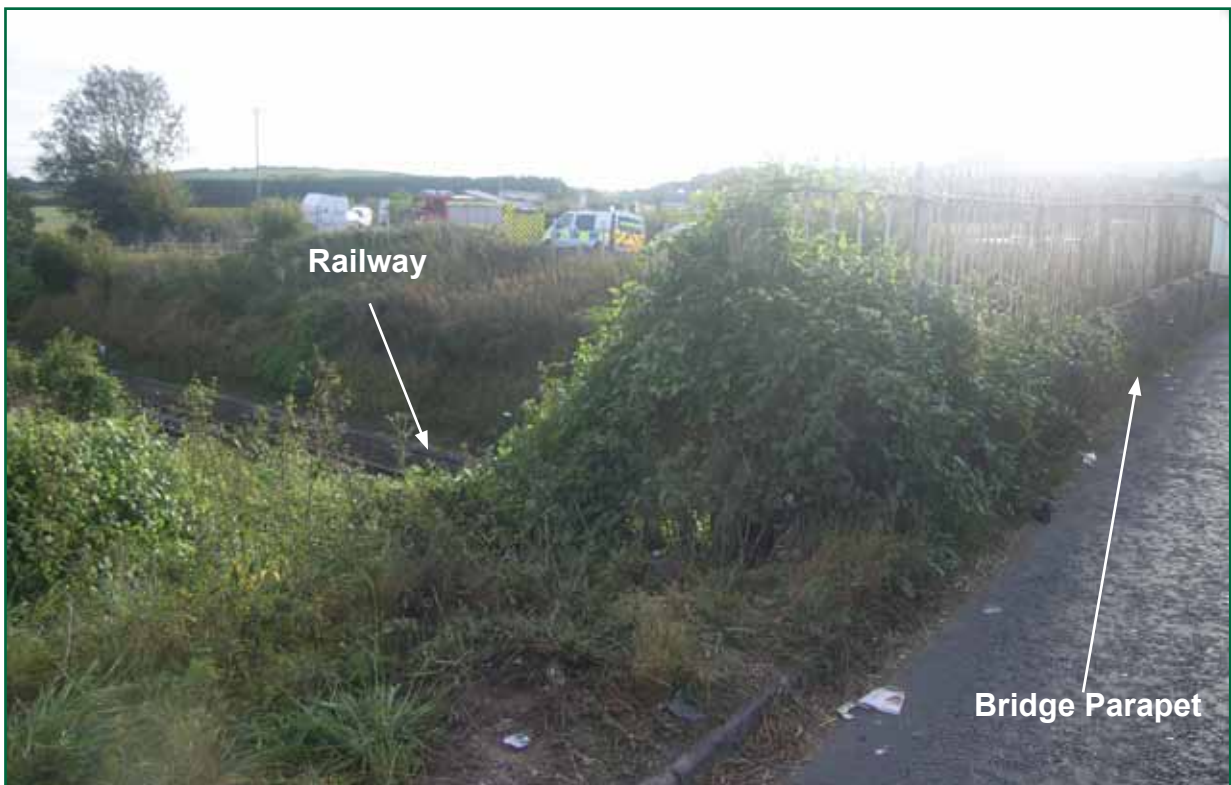
5. The west approach to the bridge is not provided with highway crash barriers extending from the end of the bridge parapets (figure 4), and the adjacent railway boundary fence was incapable of preventing the car from passing through. The east approach is immediately adjacent to a bend, and is provided with crash barriers on both sides of the carriageway as a consequence (figures 3 and 5).

Figure 4: Gap at north-west corner of the bridge through which the car travelled

13. Barriers were not installed at the west end of the bridge as the risk of vehicle incursion from southbound vehicles was not considered significant, and historically, most accidents had occurred at the opposite end of the bridge (paragraph 6). However, guidance within the DfT report emphasises that 'curved approaches increase the chance of an accident due to reduced sighting distance and reaction time', and 'sites need to be protected at their most vulnerable points (eg at bends) and from all possible points of approach (nearside, offside, all directions and access points)'. This, and the fact that the RVI score remained above 90, suggests that further mitigation measures were required to address the known risk factors (paragraph 7). However, the RAIB do not consider that the particular risk of a vehicle rebounding off the garden wall on the opposite side of the road and onto the railway was of itself reasonably foreseeable.

19. As a result of this accident, Wiltshire Council has taken the decision to install safety barriers at the north-west corner of the bridge to prevent a recurrence. This work commenced at the end of 2009, and it is anticipated that this will cause the overall RVI score to drop below 90 when the structure is subsequently rescored.

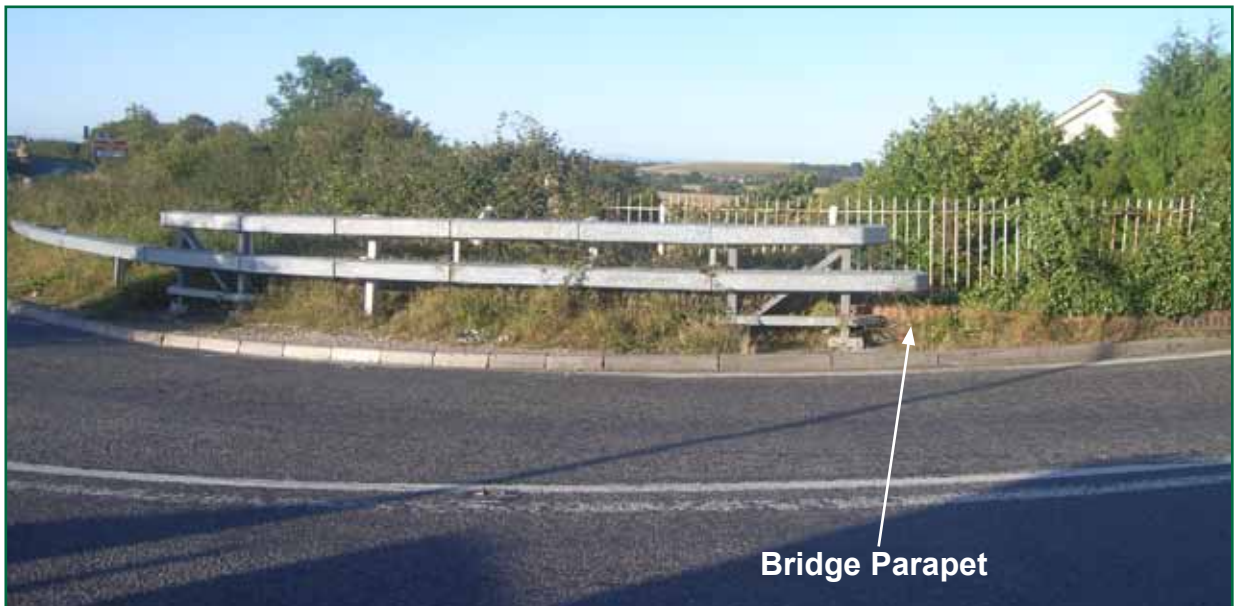
*Figure 5: Steel crash barrier installed at the south-east corner of the bridge*

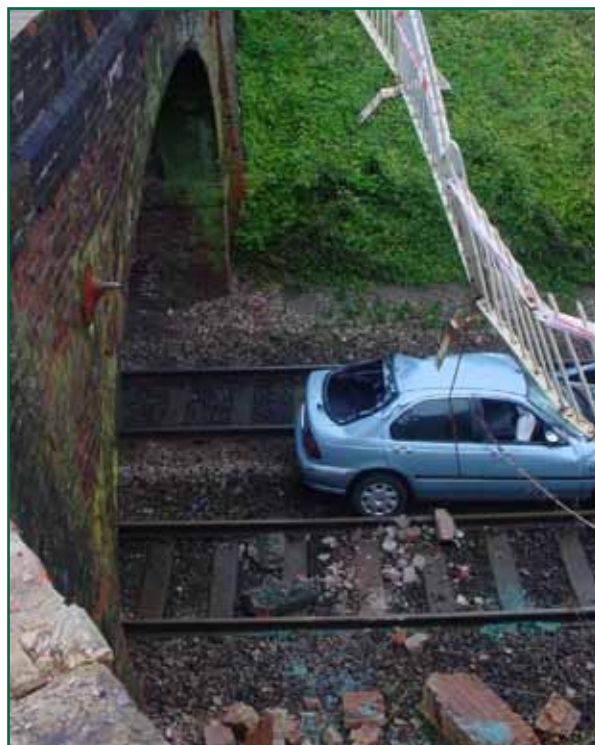
- Collision records for this site for the ten year period to September 2009 show that there have been 15 incidents involving northbound vehicles during this period that resulted in personal injury<sup>1</sup>. The most serious of these occurred in November 2003 when a car crashed through the north-east parapet and landed between the tracks (figure 6). On that occasion, trains were stopped before a collision occurred. During the same ten year period, only one accident is recorded involving a southbound vehicle, which collided with the garden wall in a similar manner to the most recent accident, but without rebounding onto the railway.

*Figure 6: 2003 incursion involving a northbound vehicle*

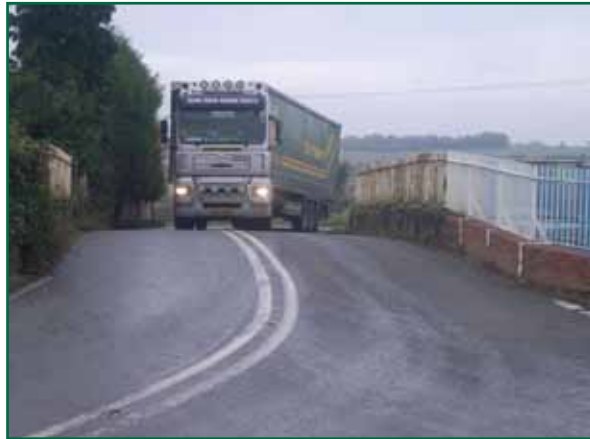
7. The relatively high frequency of accidents at this site indicates that other risk factors are present. The reverse curve and narrow carriageway combine to limit visibility for oncoming traffic, while requiring large vehicles to straddle the double white line in the centre of the road. This creates a collision risk with vehicles approaching in the opposite direction (figure 7), the risk to the railway being compounded by the substandard level of containment offered by the low brick parapets. Furthermore, there are road junctions on both approach bends (figure 3).

*Figure 7: Southbound vehicle straddling centre white lines due to sharply curved road alignment*
