RAIB Bulletin 03/2010

Passenger train collision with road vehicle at Broken Cross bridge between Salisbury and Grateley, 22 September 2009

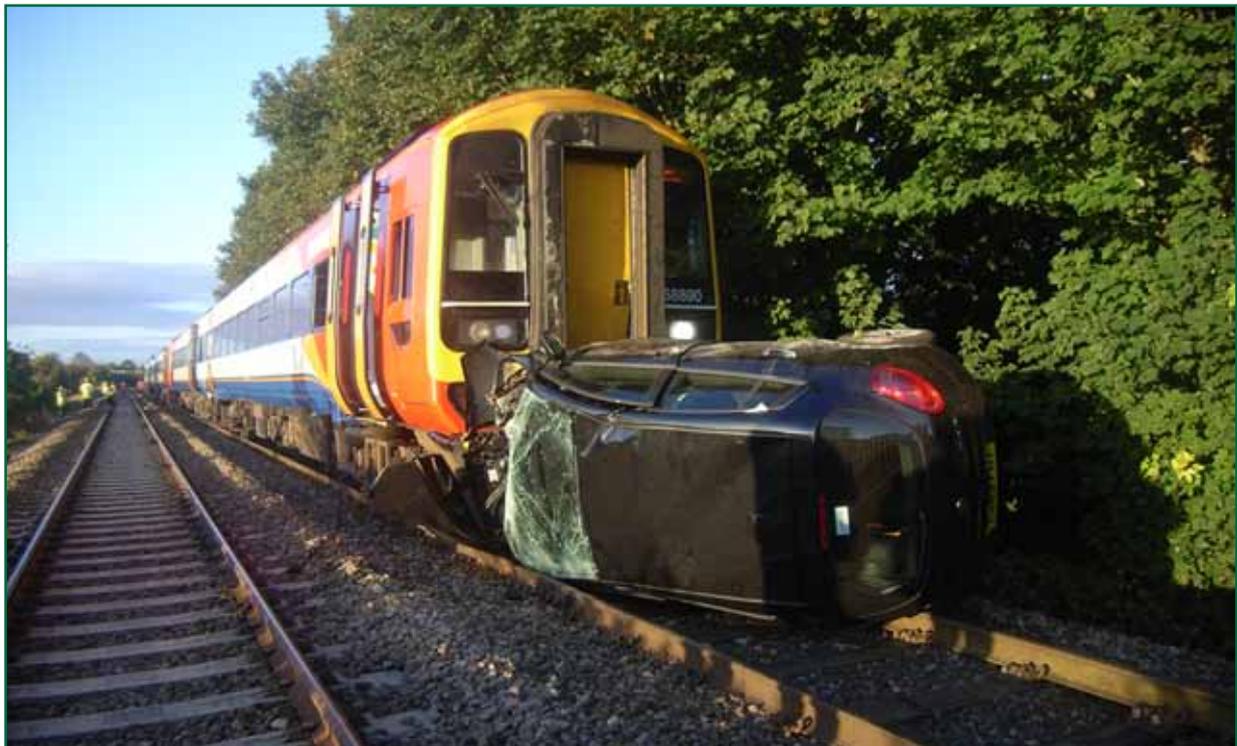
1. Before dawn on 22 September 2009, a passenger train collided with a car which had left the highway at Broken Cross bridge near Salisbury, and rolled onto the railway line a few seconds before. The car, which had been travelling south on the A338, landed on its passenger door side and facing towards an oncoming train.
2. The car driver, the only occupant of the vehicle, was able to see the lights of the approaching train and climbed out of the vehicle before the collision occurred. He attempted to make an emergency call using his mobile phone, but was unable to prevent the collision. The train driver applied the emergency brake, and the train came to a halt after propelling the car along the track for a distance of 460 metres (see figure 1).

Figure 1: Train and car following collision. The road bridge from which the car fell can be seen in the distance

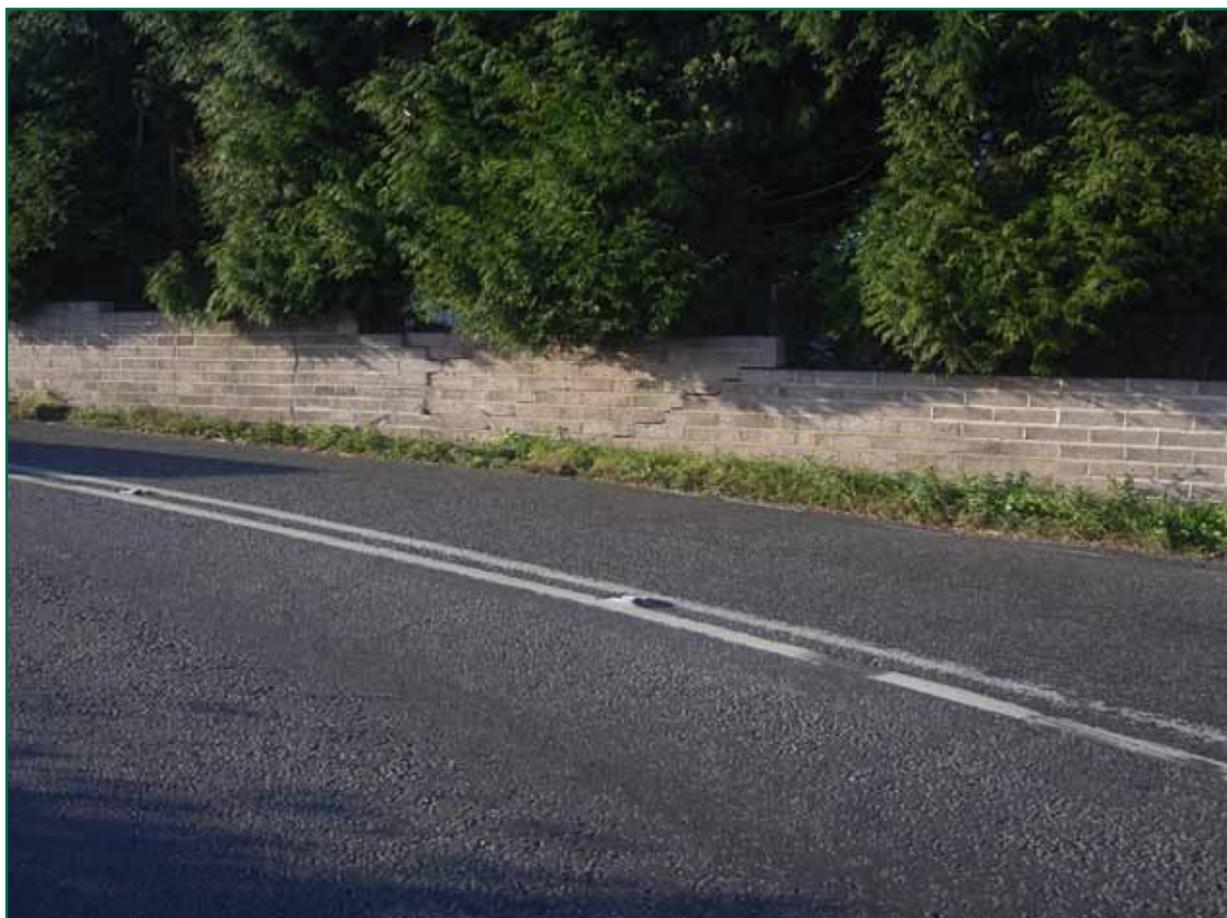
4. The bridge is situated on a double bend, which requires drivers to slow down as they approach. The car involved in the accident was travelling south and did not negotiate the left-hand bend approaching the bridge. It crossed the carriageway before colliding with a substantial garden wall constructed of concrete blocks (figure 2) on the opposite side of the road. The force of this impact did not topple the wall, but instead caused the car to rebound diagonally back across the road. This trajectory projected the car to the left of the bridge parapet and onto the railway (figure 3). There were no other vehicles involved.

Figure 2: Concrete block wall showing impact damage

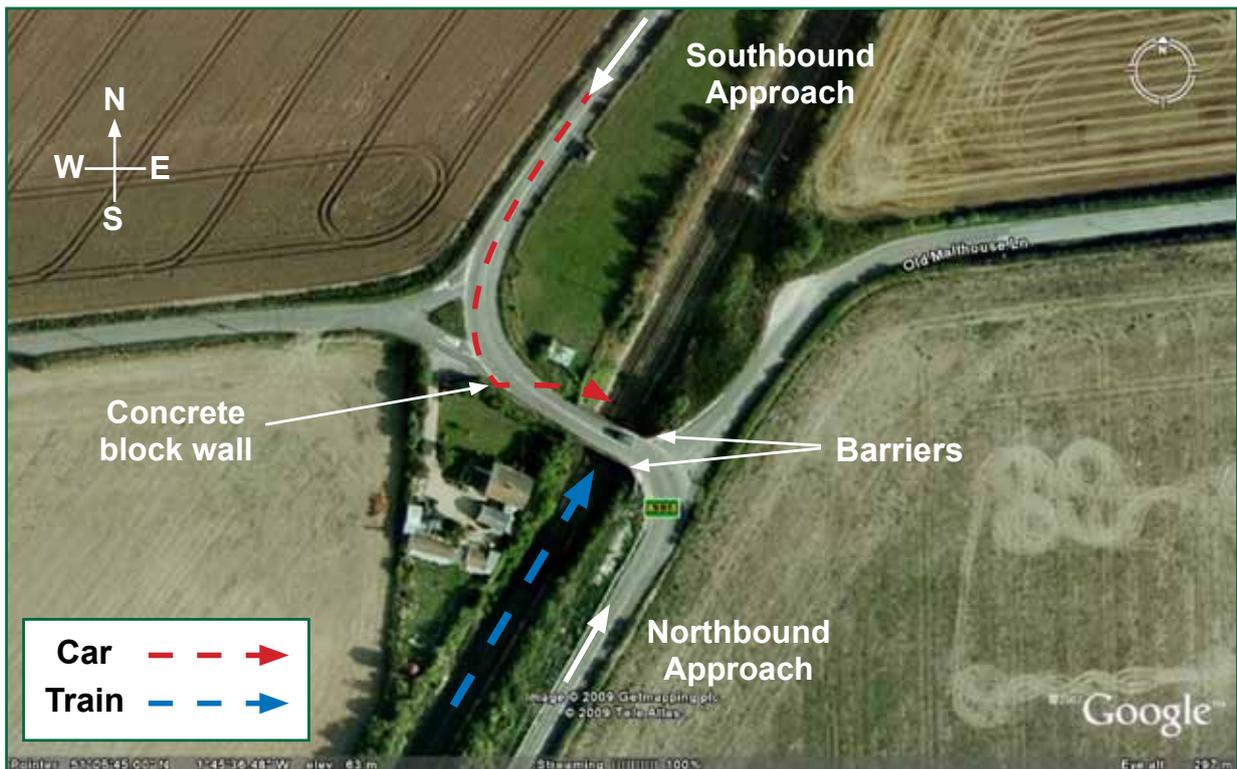
Figure 3: Path of car before the collision with train

7. The relatively high frequency of accidents at this site indicates that other risk factors are present. The reverse curve and narrow carriageway combine to limit visibility for oncoming traffic, while requiring large vehicles to straddle the double white line in the centre of the road. This creates a collision risk with vehicles approaching in the opposite direction (figure 7), the risk to the railway being compounded by the substandard level of containment offered by the low brick parapets. Furthermore, there are road junctions on both approach bends (figure 3).

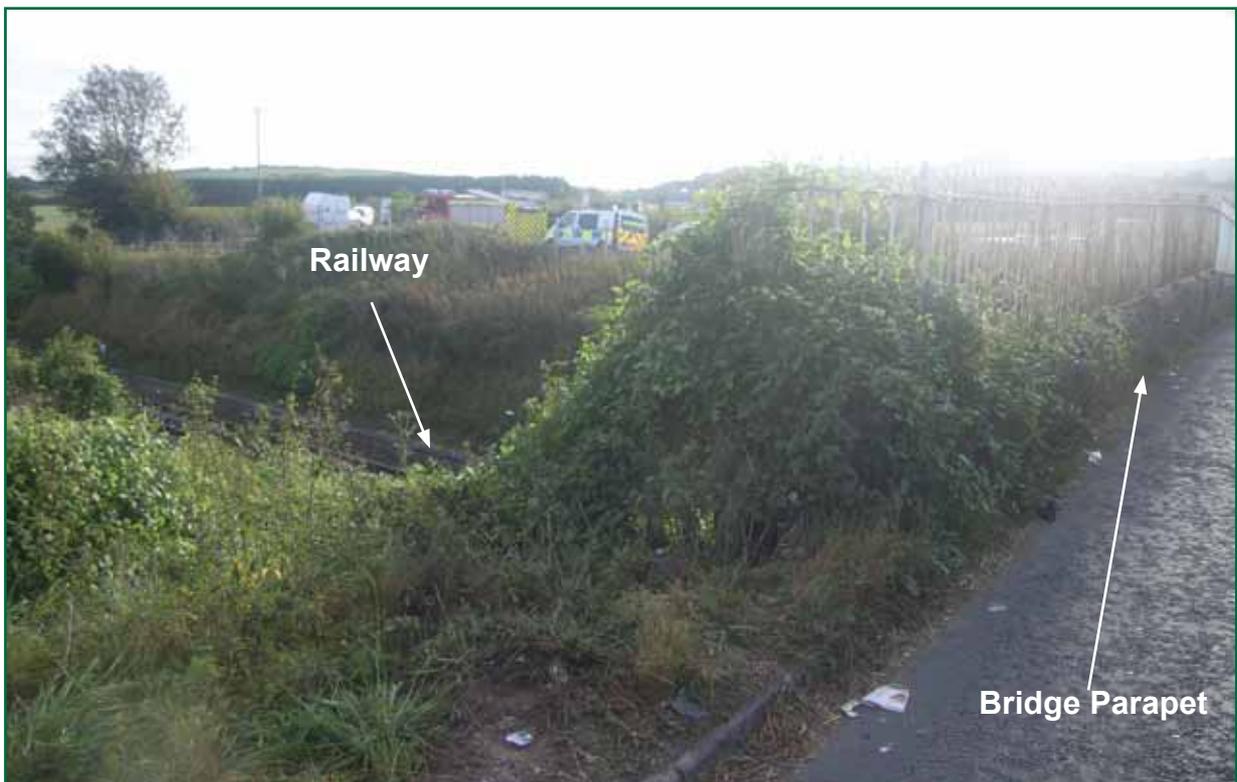
5. The west approach to the bridge is not provided with highway crash barriers extending from the end of the bridge parapets (figure 4), and the adjacent railway boundary fence was incapable of preventing the car from passing through. The east approach is immediately adjacent to a bend, and is provided with crash barriers on both sides of the carriageway as a consequence (figures 3 and 5).

Figure 4: Gap at north-west corner of the bridge through which the car travelled

13. Barriers were not installed at the west end of the bridge as the risk of vehicle incursion from southbound vehicles was not considered significant, and historically, most accidents had occurred at the opposite end of the bridge (paragraph 6). However, guidance within the DfT report emphasises that 'curved approaches increase the chance of an accident due to reduced sighting distance and reaction time', and 'sites need to be protected at their most vulnerable points (eg at bends) and from all possible points of approach (nearside, offside, all directions and access points)'. This, and the fact that the RVI score remained above 90, suggests that further mitigation measures were required to address the known risk factors (paragraph 7). However, the RAIB do not consider that the particular risk of a vehicle rebounding off the garden wall on the opposite side of the road and onto the railway was of itself reasonably foreseeable.

19. As a result of this accident, Wiltshire Council has taken the decision to install safety barriers at the north-west corner of the bridge to prevent a recurrence. This work commenced at the end of 2009, and it is anticipated that this will cause the overall RVI score to drop below 90 when the structure is subsequently rescored.

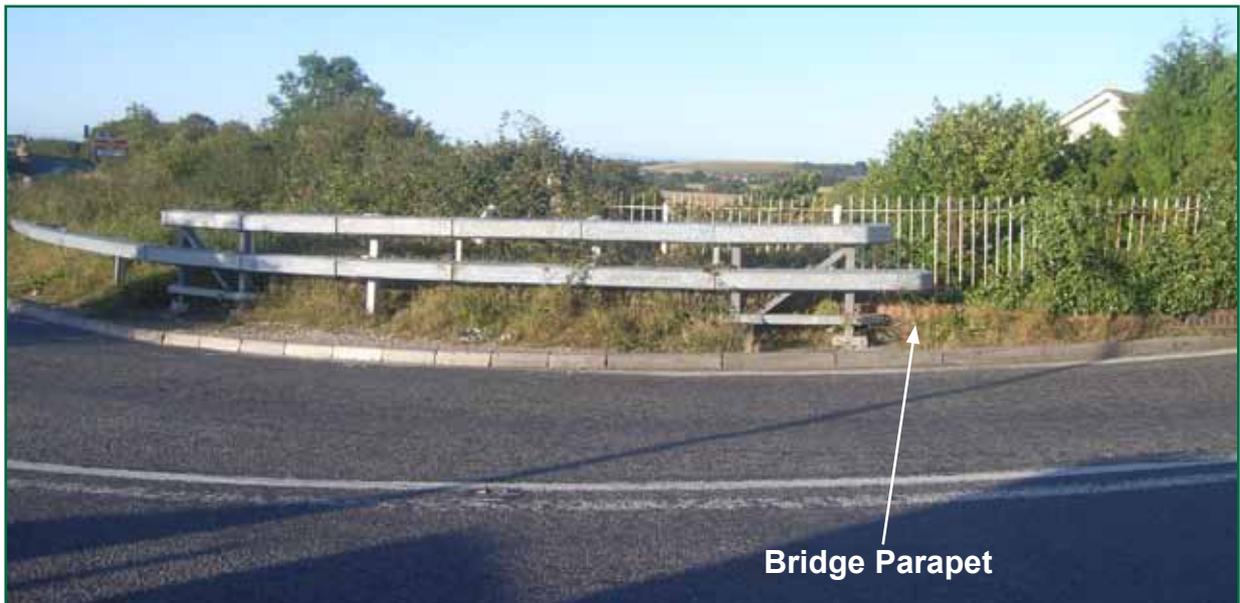
Figure 5: Steel crash barrier installed at the south-east corner of the bridge

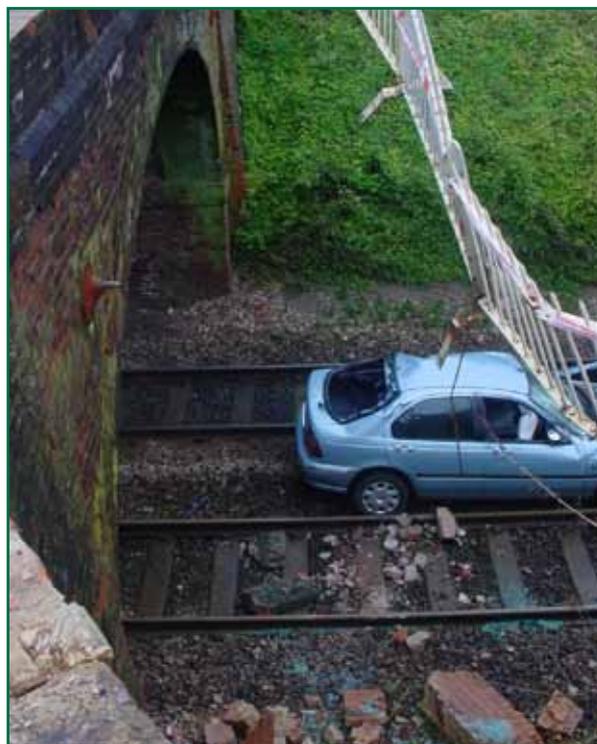
- Collision records for this site for the ten year period to September 2009 show that there have been 15 incidents involving northbound vehicles during this period that resulted in personal injury¹. The most serious of these occurred in November 2003 when a car crashed through the north-east parapet and landed between the tracks (figure 6). On that occasion, trains were stopped before a collision occurred. During the same ten year period, only one accident is recorded involving a southbound vehicle, which collided with the garden wall in a similar manner to the most recent accident, but without rebounding onto the railway.

Figure 6: 2003 incursion involving a northbound vehicle

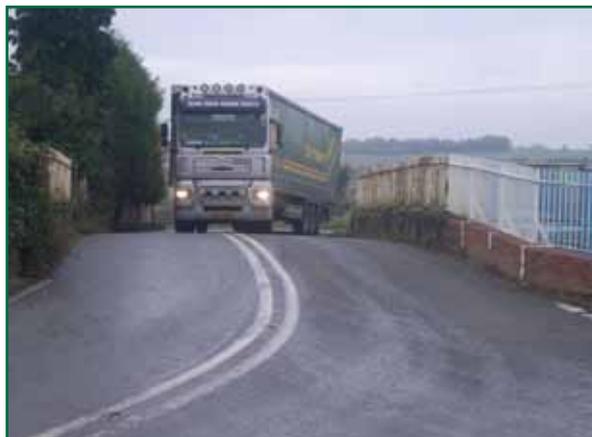
Figure 7: Southbound vehicle straddling centre white lines due to sharply curved road alignment
