RAIB Bulletin 07/2010

Fatal accident at a user worked crossing on 2 September 2009

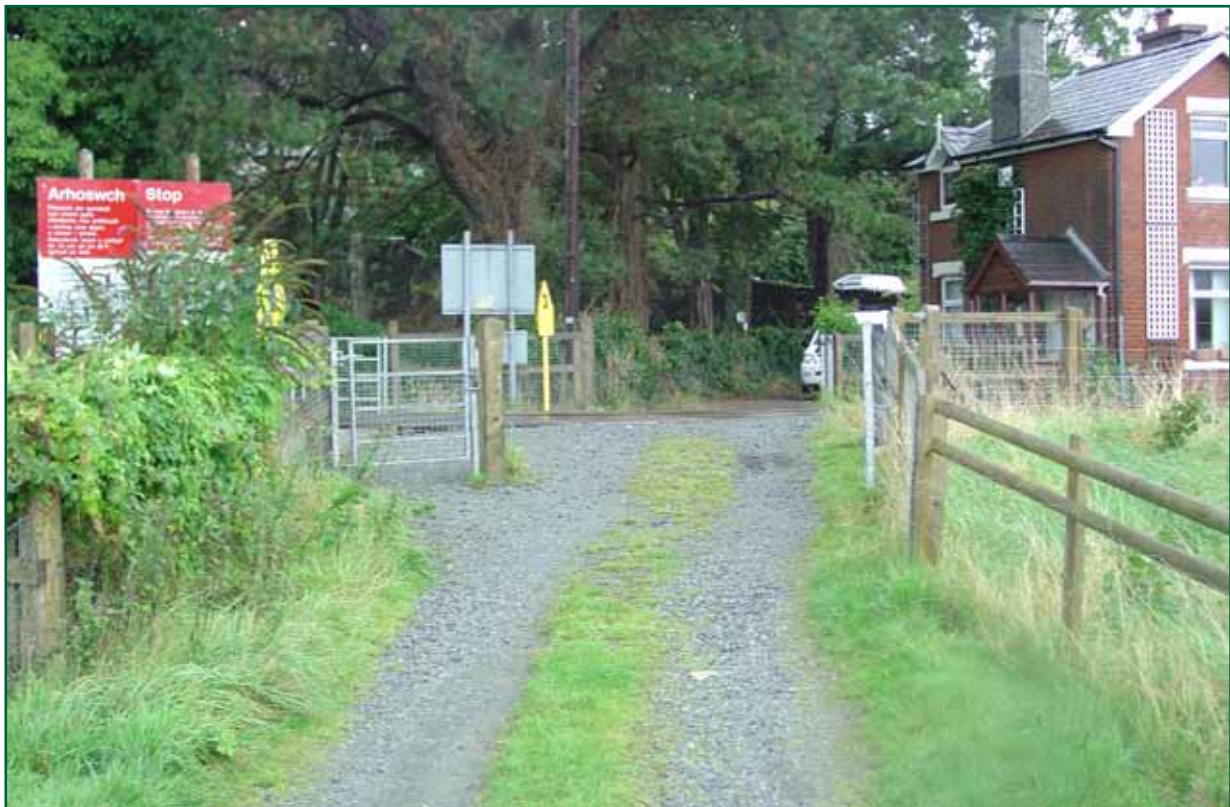
- 5 Between the station and the crossing the track curves to the left such that a train approaching the station cannot see the crossing. There are no whistle boards² either side of the crossing requiring trains to sound their horns. The road approach to the crossing from the south side is shown in figure 2. Telephones and signs with instructions in both Welsh and English on how to use the crossing are provided on each side of the crossing. At the time of the accident, the sign on the south side was partially obscured by vegetation.

Figure 2: View of the crossing approaching from the south

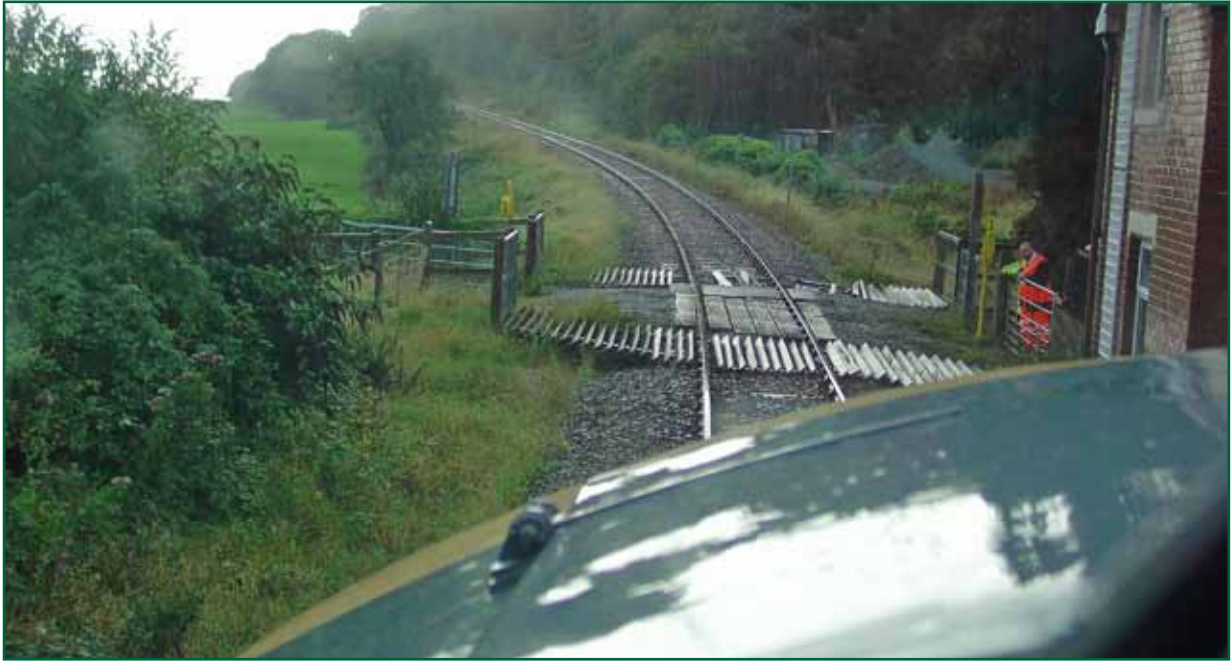
Figure 3: View of the crossing from the driving cab of the locomotive at a distance of approximately 10 m from the crossing

- 12 The train driver's view of the car approaching from the south side of the crossing was restricted by a large bush (figure 3). The train driver reported that he first noticed the car when the locomotive was about 10 m from the crossing. The proximity of the locomotive to the crossing when the car first appeared was also confirmed by one of the other drivers. Travelling at 27 mph (43 km/h), the locomotive would have covered this distance in about one second. Had the speed of the train over the crossing been 20 mph (32 km/h), i.e. the sign had been placed in accordance with the sectional appendix, it is considered unlikely that the impact would have resulted in a significantly different outcome.
- 13 Post-accident testing showed that the locomotive's speedometer, brakes, lights, windscreen wipers and horns were in correct working order and within the relevant specifications.

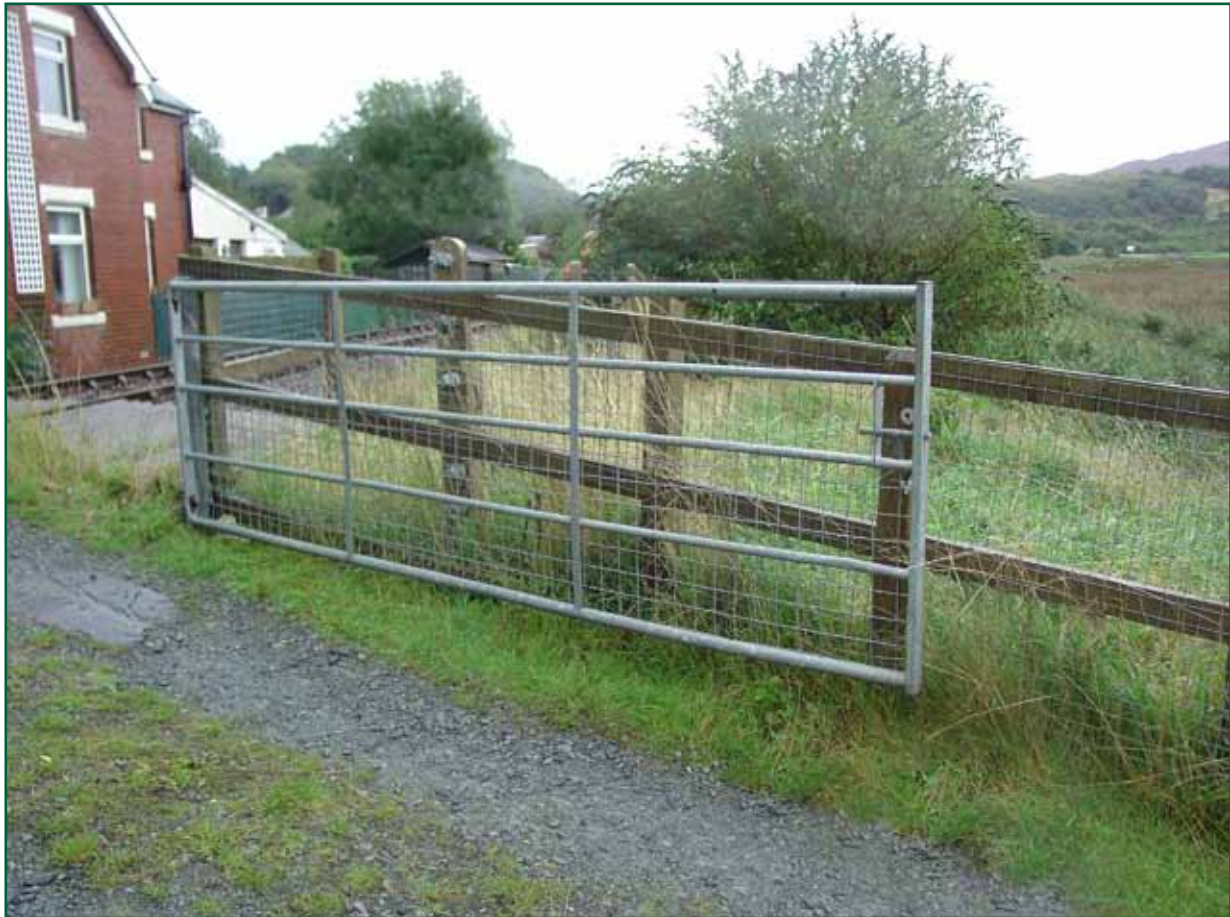
Figure 4: Restricted view from road on the south side of crossing in the direction of Penrhyndeudraeth station

- 16 From the position a car driver would normally have parked their car to open the gates, and from which they would then have driven onto the crossing, the visibility of the approaching locomotive would have been severely restricted by the same bush which restricted the train driver's view (paragraph 11). The restricted view is shown in figure 4.

- 17 From the gate at the south side of the crossing, the sighting distance for a train approaching from Penrhyndeudraeth station was approximately 64 m and less from a position 1 to 2 m back from the gate due to the large bush (figure 4). Although not relevant to this accident, sighting from the north side of the crossing was about 150 m from the gate, reducing rapidly further back from the gate to about 5 m from a position 2 m back from the gate due to a house at the railway boundary. Sighting distances for trains approaching in the 'up' direction (ie towards Penrhyndeudraeth station), were 260 m from the south side of the crossing and 440 m from the north side.
