# RAIB Bulletin 07/2010

## Fatal accident at a user worked crossing on 2 September 2009

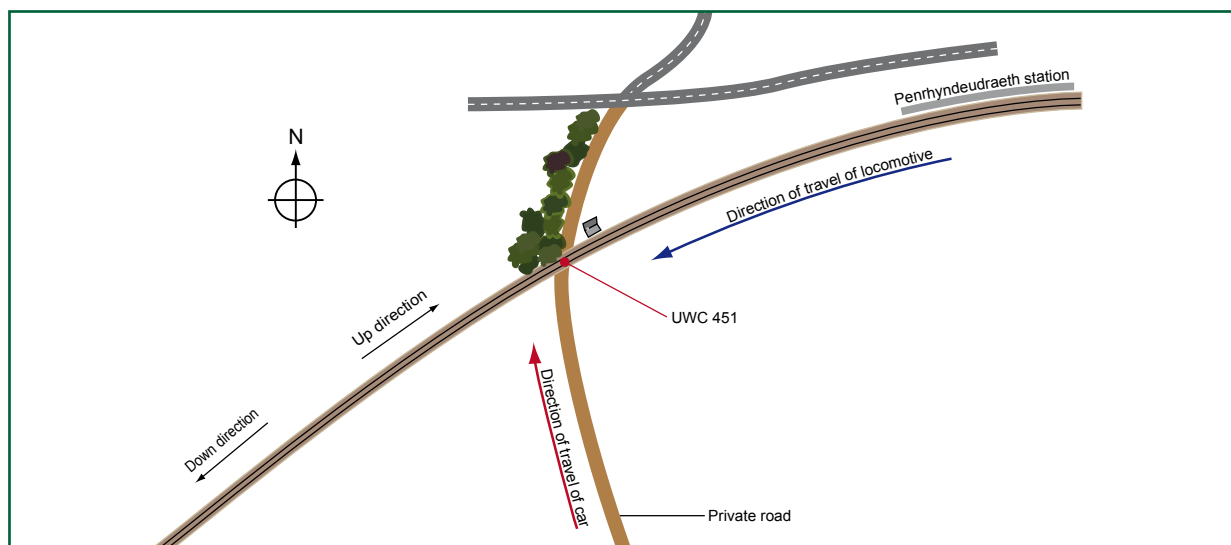
- 1 On 2 September 2009, at approximately 11:35 hrs, train 0Z97, a single locomotive running along the Cambrian Coast line, collided with a car at a user worked crossing (UWC)<sup>1</sup>, No. 451, at Penrhyndeudraeth in North Wales. The car was crossing the line in a northerly direction just as the locomotive was reaching the crossing, travelling in a south westerly (down) direction. Figure 1 shows the accident location and the directions of movement of the car and train.

Figure 1: Location of the collision and movements of the car and train

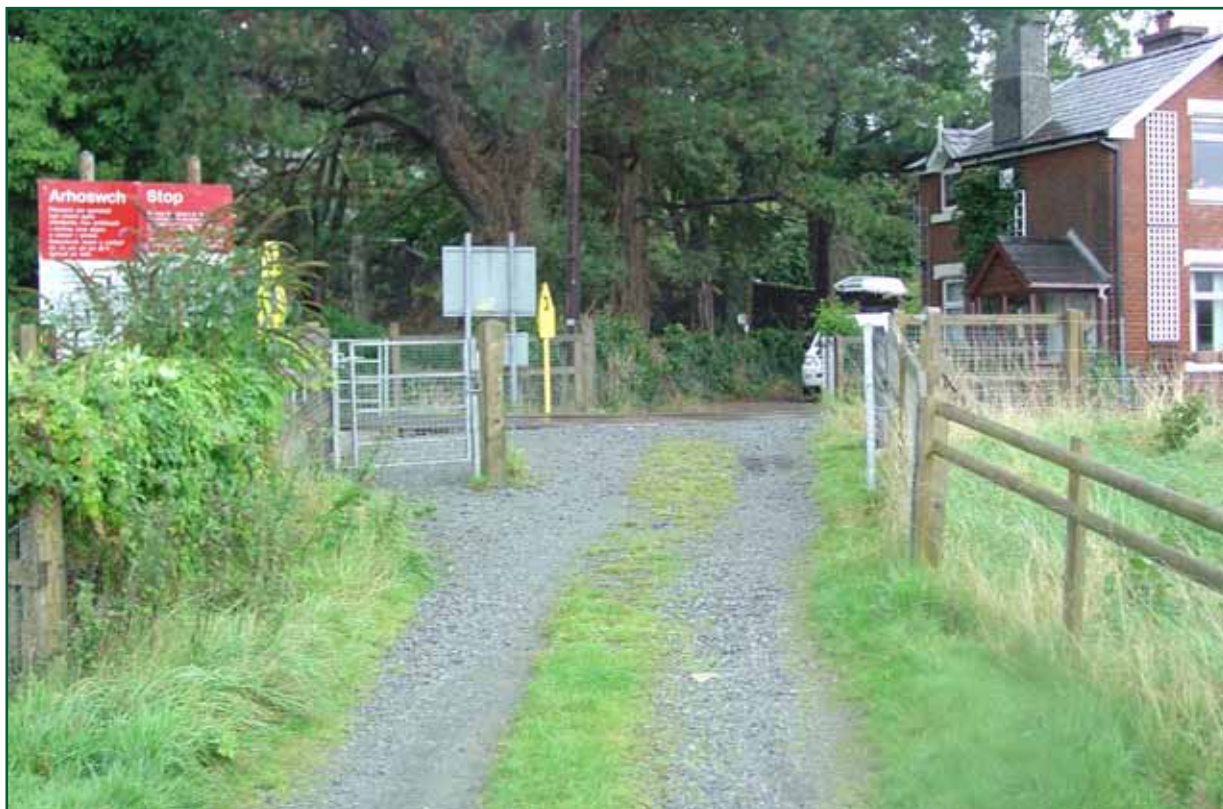
- 5 Between the station and the crossing the track curves to the left such that a train approaching the station cannot see the crossing. There are no whistle boards<sup>2</sup> either side of the crossing requiring trains to sound their horns. The road approach to the crossing from the south side is shown in figure 2. Telephones and signs with instructions in both Welsh and English on how to use the crossing are provided on each side of the crossing. At the time of the accident, the sign on the south side was partially obscured by vegetation.

Figure 2: View of the crossing approaching from the south

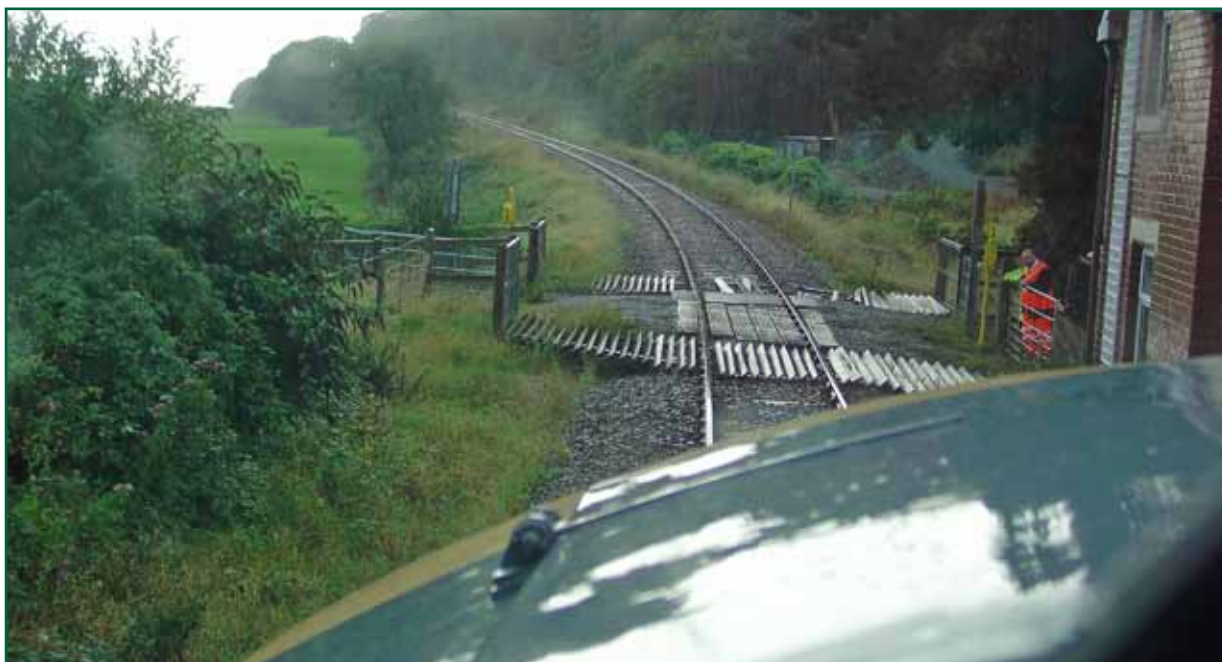
Figure 3: View of the crossing from the driving cab of the locomotive at a distance of approximately 10 m from the crossing

- 12 The train driver's view of the car approaching from the south side of the crossing was restricted by a large bush (figure 3). The train driver reported that he first noticed the car when the locomotive was about 10 m from the crossing. The proximity of the locomotive to the crossing when the car first appeared was also confirmed by one of the other drivers. Travelling at 27 mph (43 km/h), the locomotive would have covered this distance in about one second. Had the speed of the train over the crossing been 20 mph (32 km/h), i.e. the sign had been placed in accordance with the sectional appendix, it is considered unlikely that the impact would have resulted in a significantly different outcome.
- 13 Post-accident testing showed that the locomotive's speedometer, brakes, lights, windscreen wipers and horns were in correct working order and within the relevant specifications.

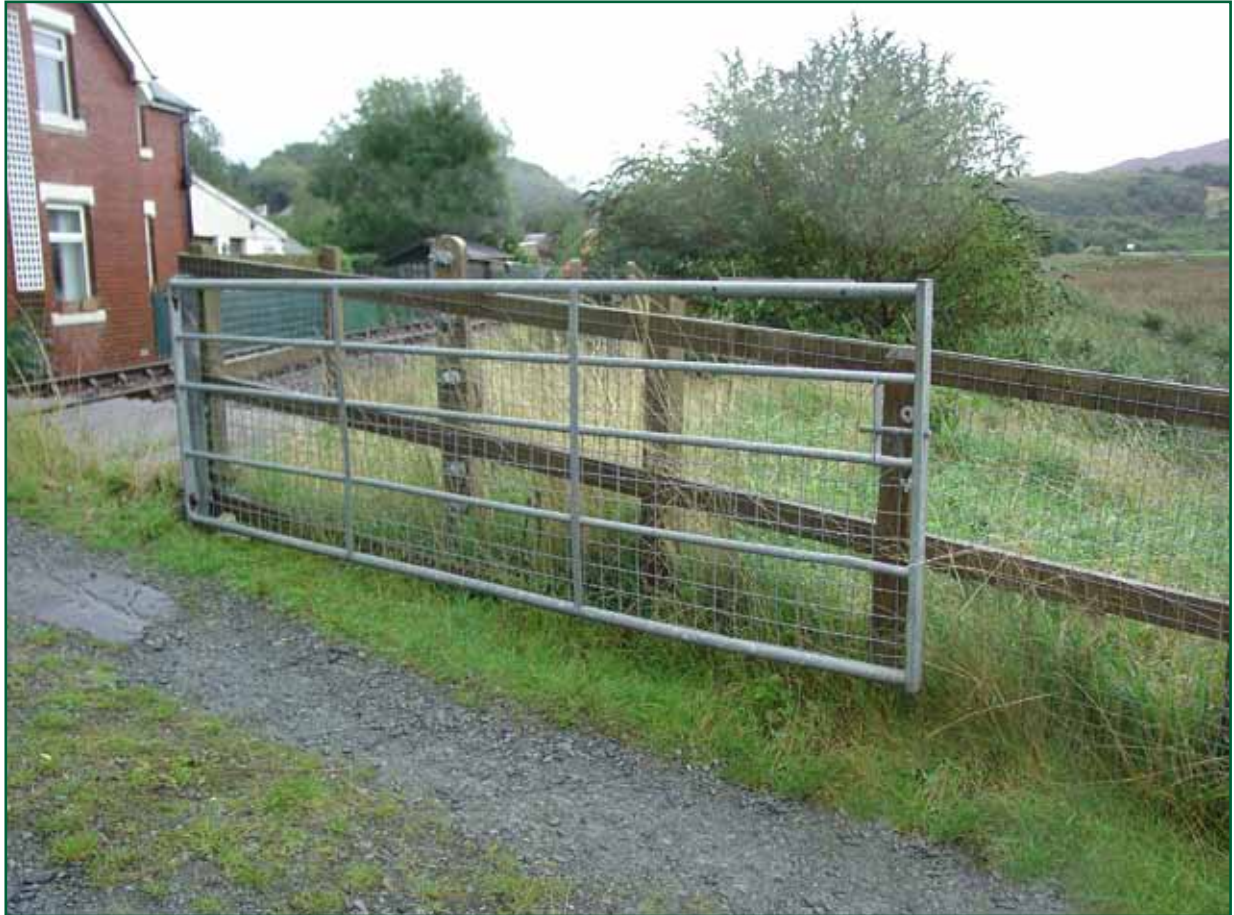
Figure 4: Restricted view from road on the south side of crossing in the direction of Penrhyndeudraeth station

- 16 From the position a car driver would normally have parked their car to open the gates, and from which they would then have driven onto the crossing, the visibility of the approaching locomotive would have been severely restricted by the same bush which restricted the train driver's view (paragraph 11). The restricted view is shown in figure 4.

- 17 From the gate at the south side of the crossing, the sighting distance for a train approaching from Penrhyndeudraeth station was approximately 64 m and less from a position 1 to 2 m back from the gate due to the large bush (figure 4). Although not relevant to this accident, sighting from the north side of the crossing was about 150 m from the gate, reducing rapidly further back from the gate to about 5 m from a position 2 m back from the gate due to a house at the railway boundary. Sighting distances for trains approaching in the 'up' direction (ie towards Penrhyndeudraeth station), were 260 m from the south side of the crossing and 440 m from the north side.
