Rail Accident Investigation Branch

Rail Accident Report

Derailment at Wigan North Western station 25 August 2009

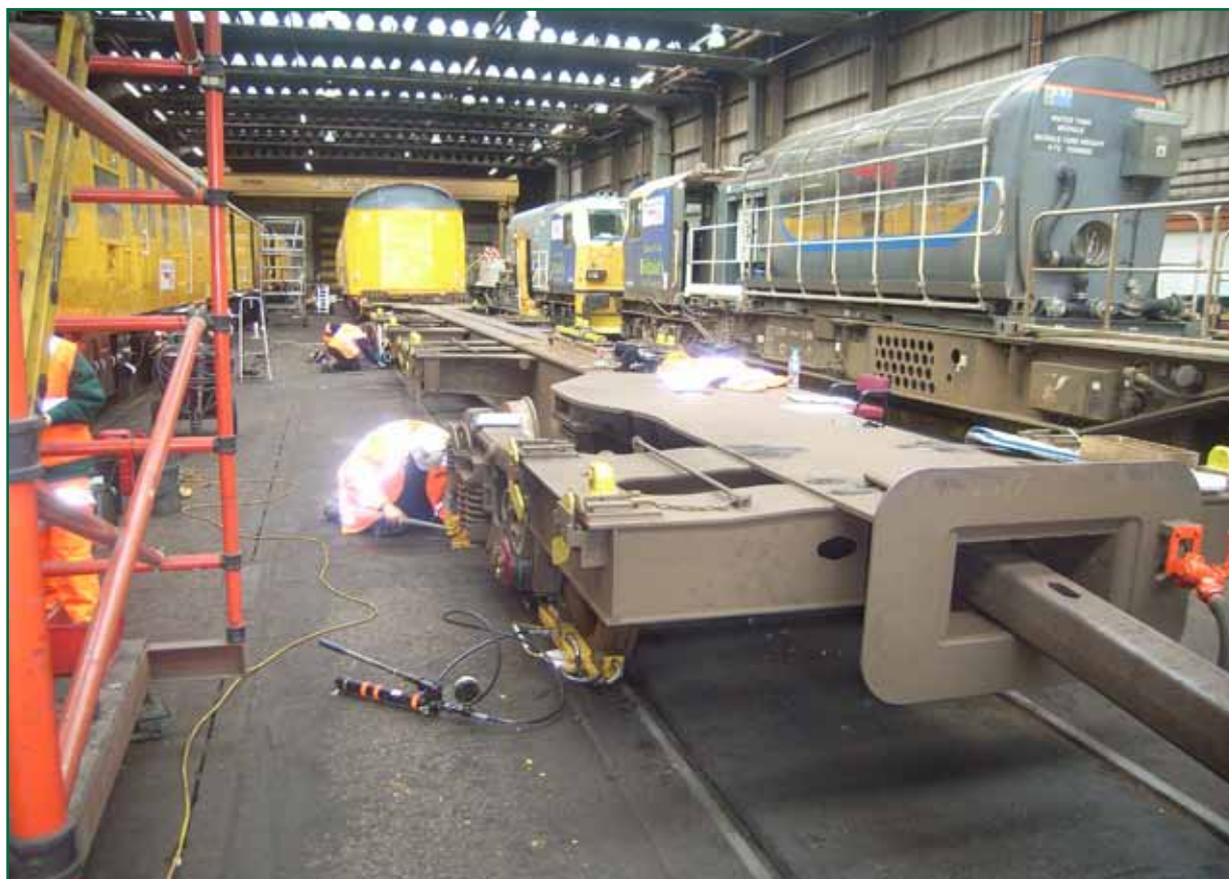
Figure 2: Wagon which derailed showing bar coupling to adjacent wagon

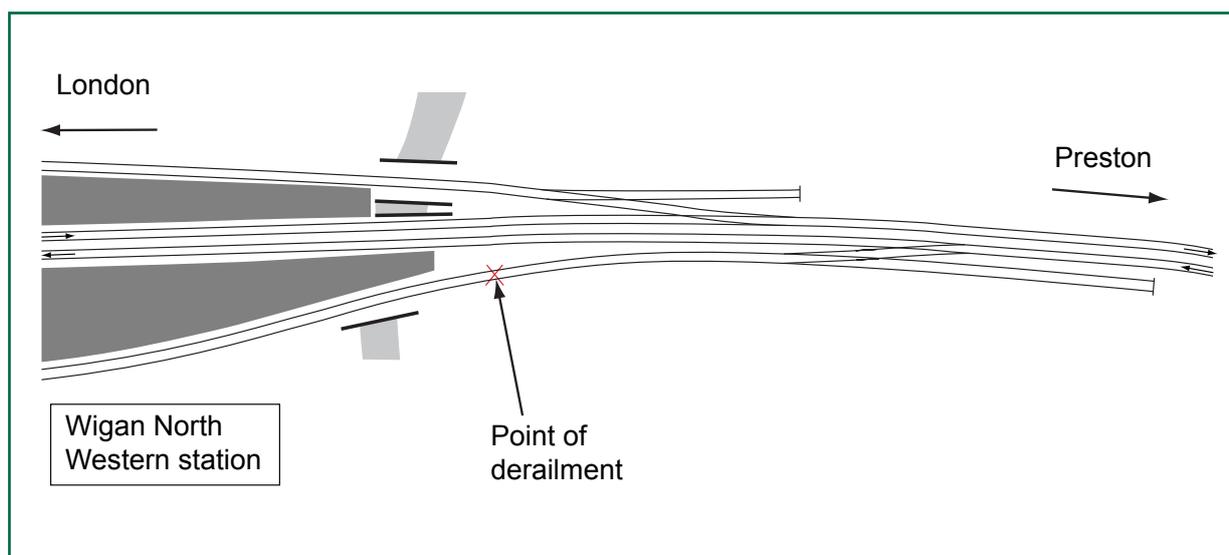
- 6 The train was slowing down to stop and was travelling at 12 km/h (7.5 mph) at the time the derailment occurred on a left-hand curve on *plain line* to the north of the platform (figure 3). Slight damage was caused to the track and the derailed wagon. Some signalling cables were damaged in the derailment and the track through platform one was closed for 24 hours while repairs were undertaken.

Figure 3: Plan of the site

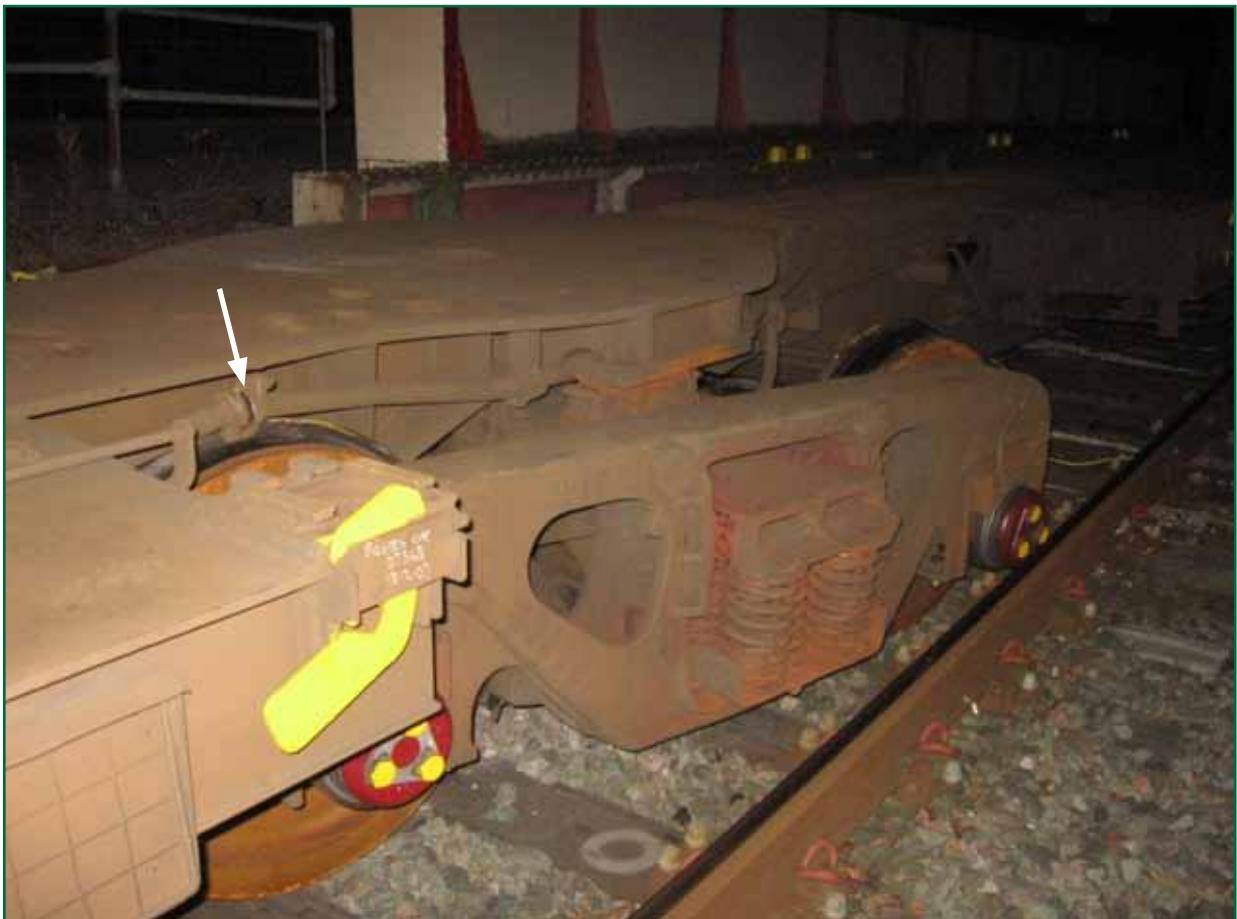
Figure 5: The derailed bogie with (arrowed) the fractured brake pipe (photograph courtesy of Network Rail)

- 19 Nobody was injured in the derailment. All wheels of the leading bogie of wagon 610117 were derailed and slight impact damage was caused to some of the sleepers and the cross girders of the bridge. Several signalling cables were cut, affecting signalling circuits of the up loop line.
- 20 The up loop line and platform one at Wigan North Western station were out of use for 24 hours while track and cable repairs were undertaken. The potential consequences of this derailment were limited by the low permitted speed of the line.

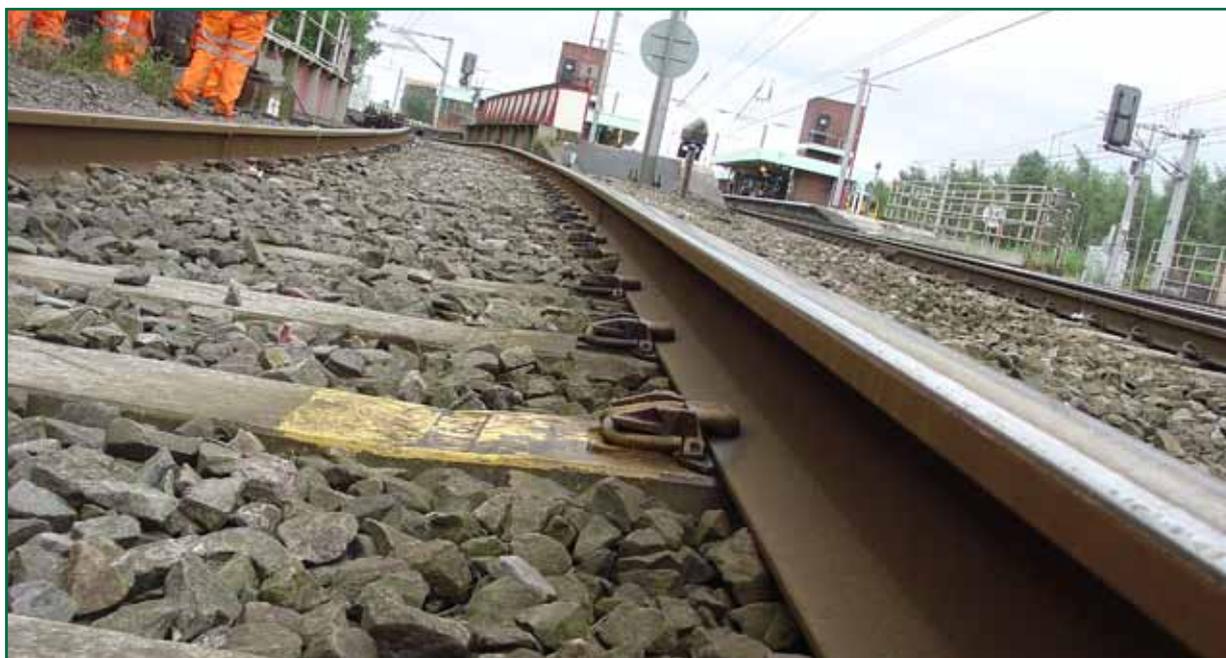
- 28 The track had been installed with a radius that was sharper than designed and was not fitted with a *check rail*. The lack of a check rail was causal to the derailment.
- 29 The track survey undertaken following the derailment showed that the track at the point of derailment had a minimum radius of 140 metres. The design drawing for the track showed that the design radius was 175 metres. Figure 6 shows the track at the site of the derailment following recovery of the train.

Figure 6: Site of the derailment, looking in the direction of travel of the train

Network Rail should check, on a risk basis, other sites where WCRM S&C Alliance has installed track to verify that it has been designed and installed correctly and should implement corrective action where necessary.

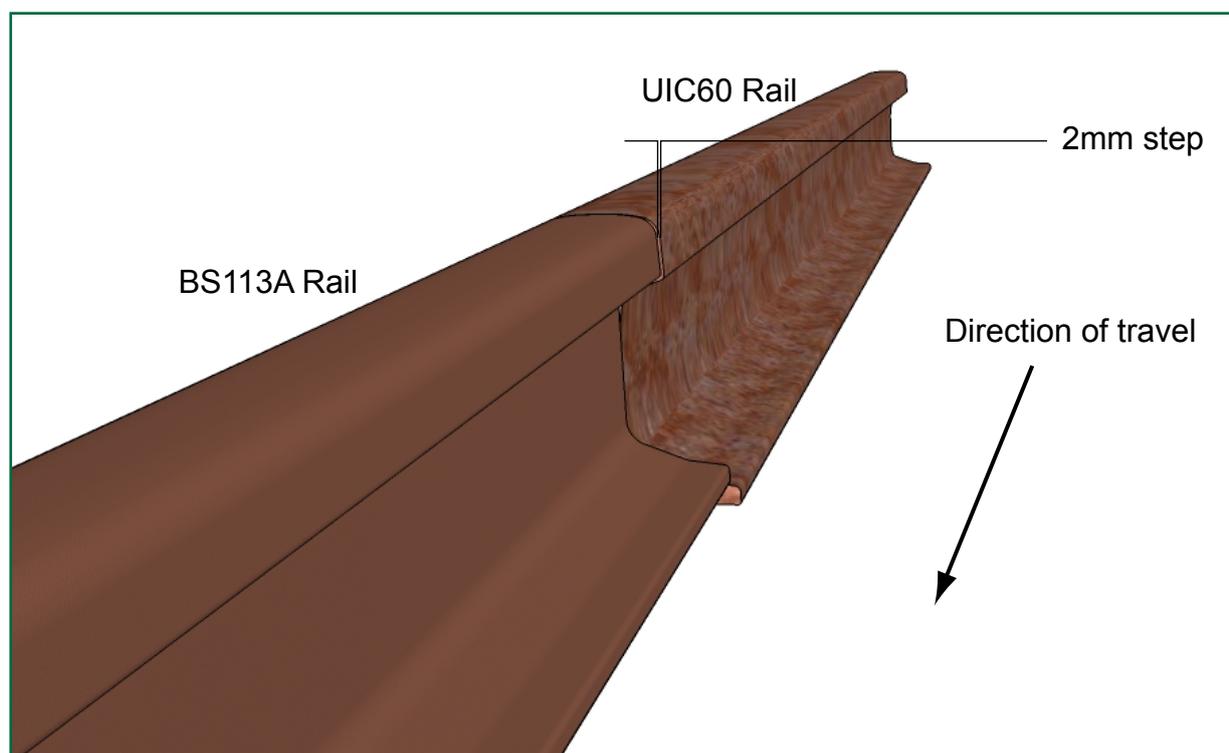
- 37 Transition rails were specified for the up loop line where the new UIC60 rail was to join the existing BS113A rail leading into the platform. The transition rails had to allow for the 2 mm difference in head width between UIC60 and BS113A rail. In the case of the rails fitted at Wigan north the transition rails were manufactured with the *running edges* aligned and a 2 mm step on the *field side* of the rail head. This meant that there were left and right-hand versions of the transition rail. When examined after the derailment, the transition rail fitted to the left side of the track (in the direction of travel) was found to be a left-hand one, but the rail fitted to the right side was also a left-hand rail. The effect of this was to produce a 2 mm step outwards (i.e. away from the *four-foot*) in the running edge of the rail where the UIC60 rail ended and the BS113A began (figure 7). The flanges of the wheels on the right-hand side of the train were in contact with the right-hand rail due to the curvature, as shown by the polished running edge of the right-hand rail. The derailment started at the transition between the rail sections.

Figure 7: Transition between UIC60 and BS113A rail

- 38 The drawing produced by the S&C manufacturer showing the details of the track construction showed the transition rails in the wrong orientation, i.e. with the UIC60 rail at the south end adjacent to the existing BS113A rail. It is not known whether the rails were delivered to site this way round and had to be turned on site (they were 10.8 metres long) or whether the error was spotted before dispatch and rectified. There were a pair of transition rails in the up loop and another pair in the up main, a total of four rails; two left-hand and two right-hand. It is possible that the rails became wrongly placed during installation due to them becoming misidentified during an operation to turn them lengthways.

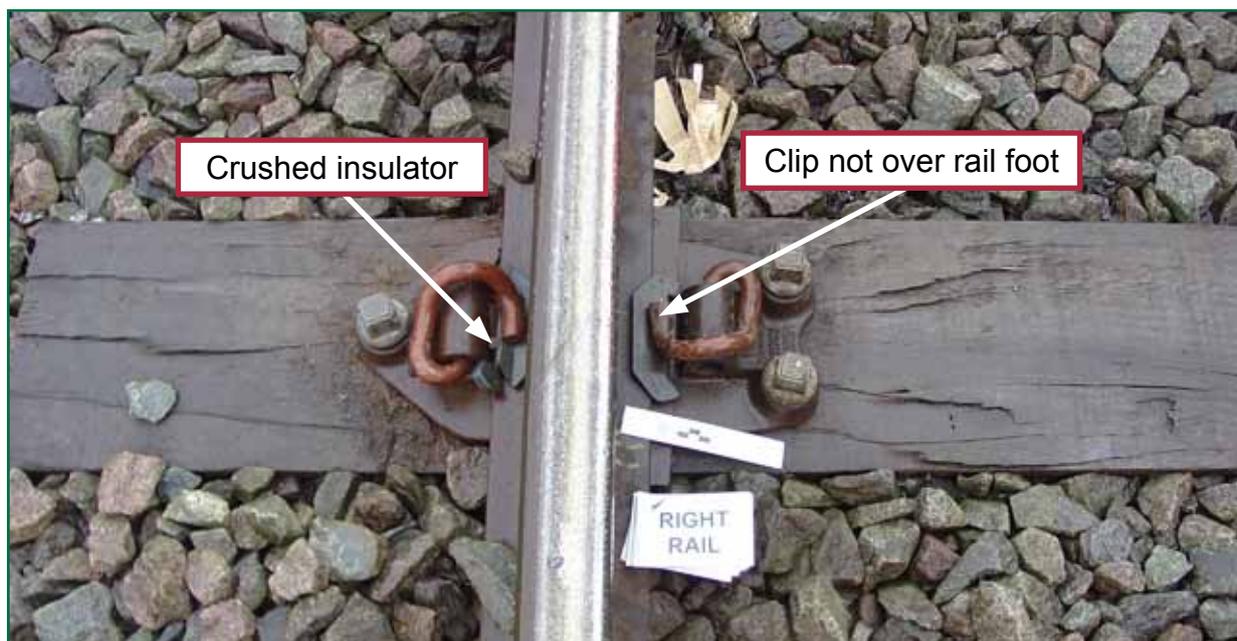
- 39 **The rail fastenings used to hold the rail to the baseplates and sleepers were not all of the correct type. This allowed the rail to move laterally, widening the track gauge. However, the dynamic analysis did not find that wide gauge increased the likelihood of derailment. The use of incorrect track fastenings is noted here as an observation.**

- 41 When examined following the derailment, the insulators used on the BS113A rail at the site of the derailment were found to be the wrong type for the sleepers and baseplates. This allowed the rail to move laterally, increasing the track gauge. Figure 8 shows the right rail seven sleepers after the transition from UIC60 to BS113A rail.

Figure 8: Right hand rail showing (arrowed) incorrect insulators and lateral displacement of rail

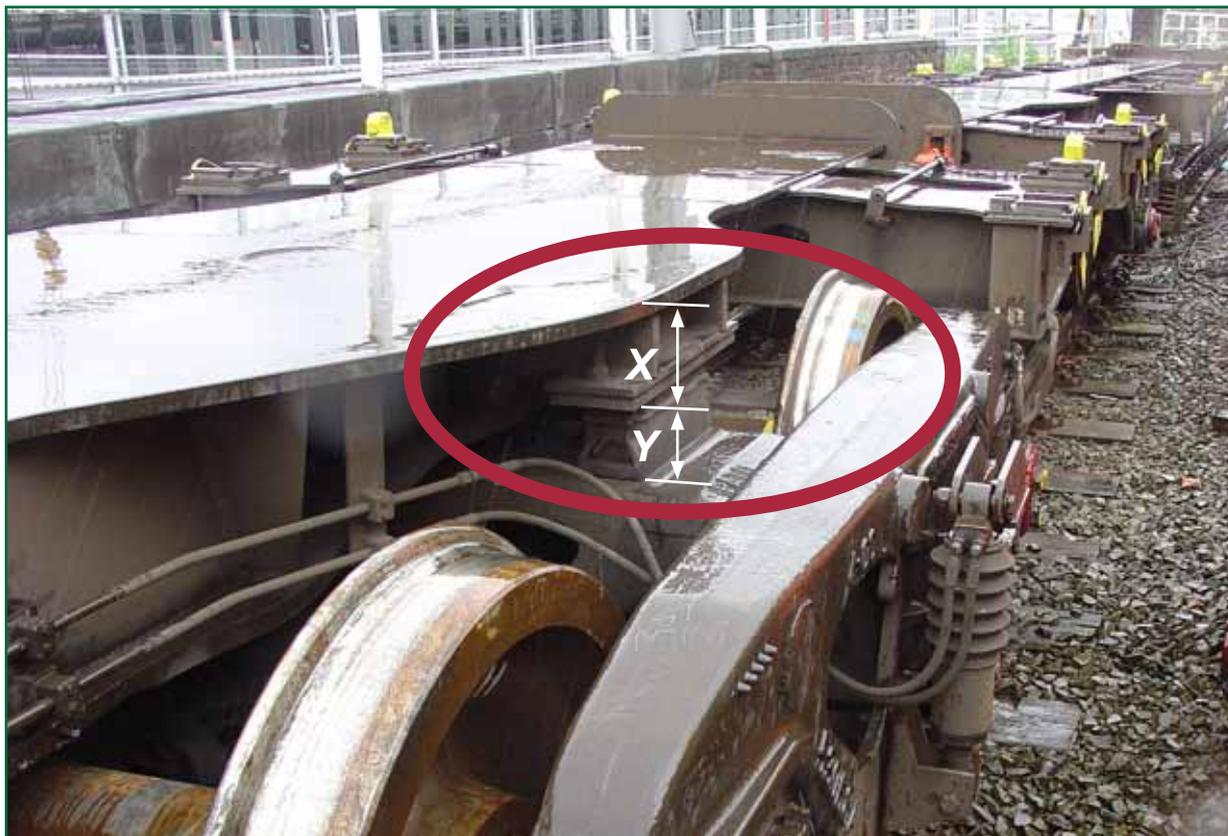
Figure 9: Right side of leading bogie of wagon 610117 showing (circled) sidebearer unit

- 57 The maintenance standard states that packing shims should be inserted to correct the sidebearer clearance. When measured by the RAIB the total distance from the top surface of the deck to the underside of the sidebearer shims (dimension **X** in figure 9) was as given in table 1.

- 58 The packings at the leading end were 12 mm thicker on the left side than the right. This is in the opposite sense to the wagon twist and sidebearer clearance and would have acted to further unload the leading right wheel. The packing shims were retained by bolts and, when examined after the derailment, the appearance of the bolts did not suggest that they had been removed during the recent VIBT. Figure 10 shows the sidebearer and its packings at the leading left side of wagon 610117.

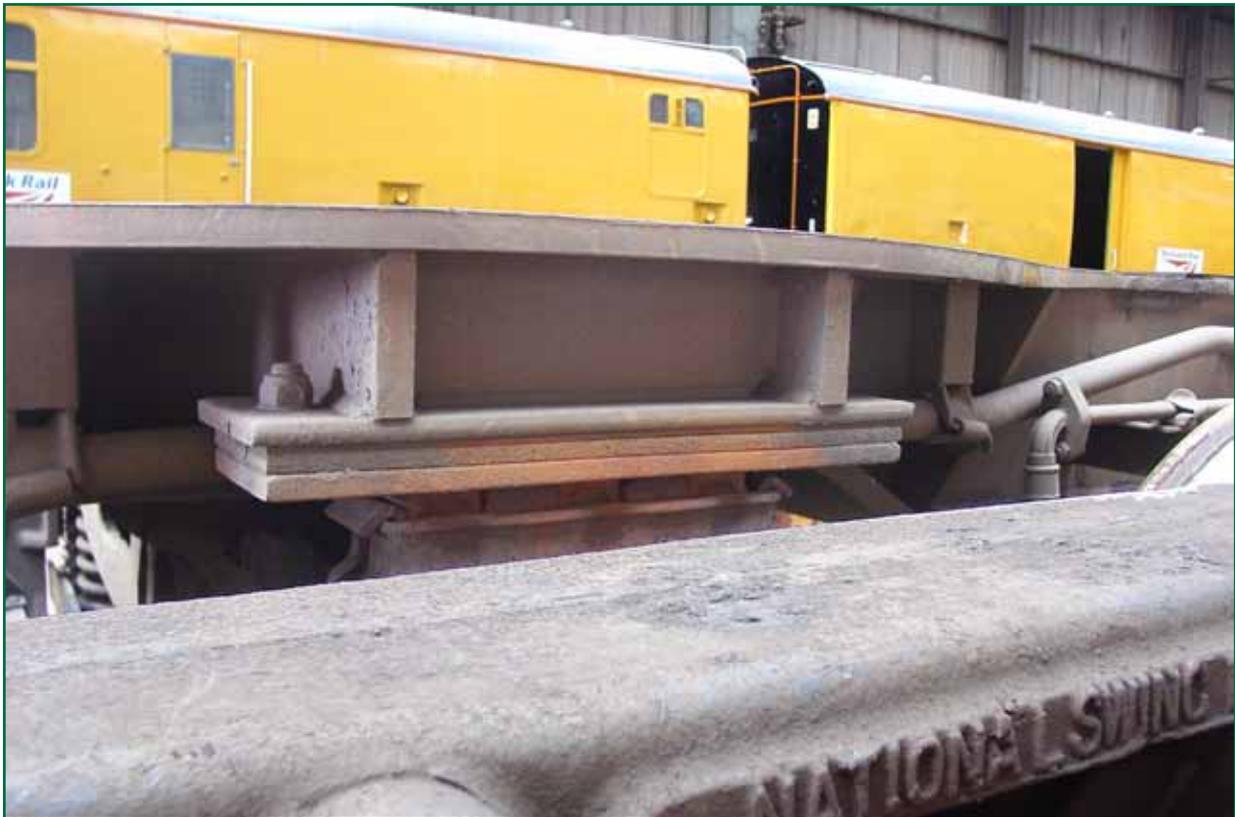
- 59 As described in paragraph 48, uncorrected twist in the frame of a vehicle will result in uneven wheel loadings. Packings of the wrong thickness inserted above the sidebearers will also produce the same effect. The wheel loads of the wagon were measured following the derailment using equipment that can only give an approximation of the true load. The values used in the computer simulation were adjusted to remove an erroneous reading and are given in figure 11. A sensitivity analysis indicated that when the values for the wheel loads were changed to those recorded, the derailment became more likely.

Figure 10: Sidebearer and packings fitted to leading left side of wagon 610117

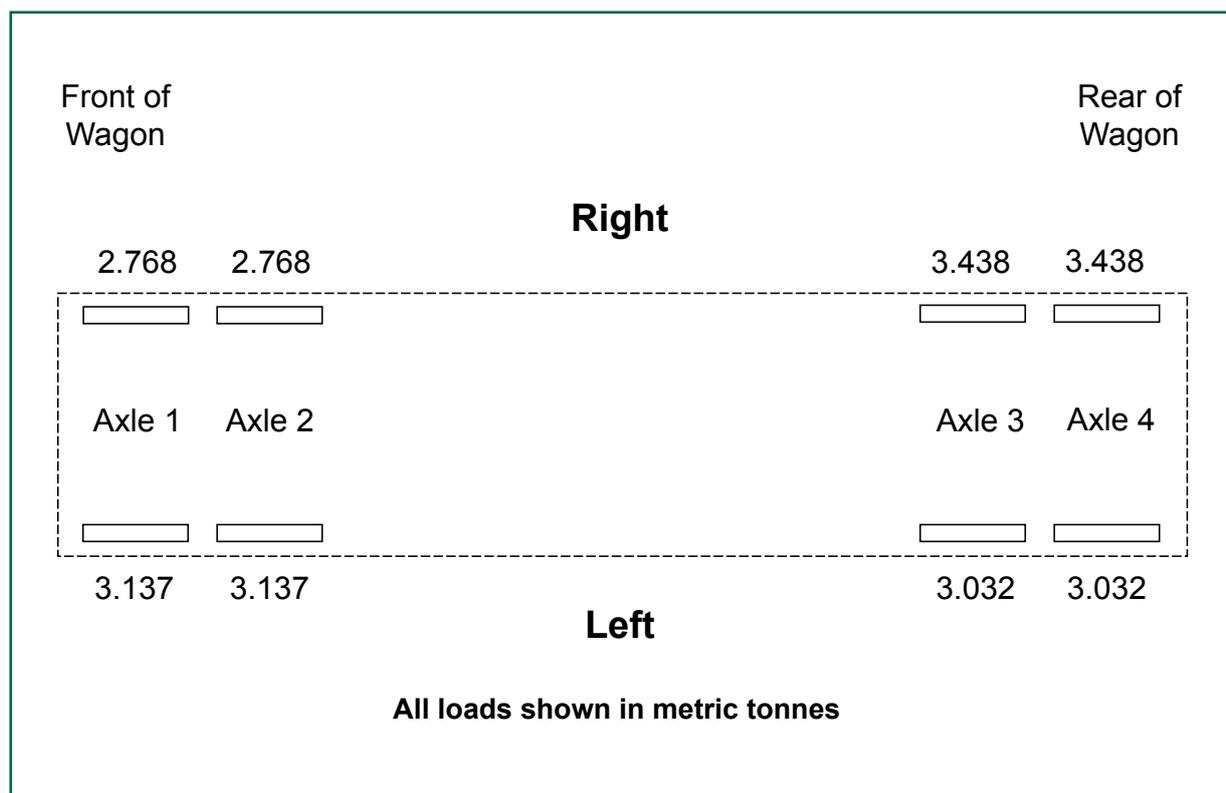
- 60 The computer simulation compared two vehicle models, one with the sidebearers set up to provide an even load on both sides of the vehicle, and one where the sidebearers were set up so as to produce wheel loads which matched those measured on wagon 610117 after the derailment. The wheel loads used are given in figure 11. The wagon with evenly loaded sidebearers was found to not derail when run over the track geometry measured at the site, even with the step in the running edge. The model with uneven loadings was predicted to derail shortly after passing the UIC60 to BS113A rail profile transition.

Figure 11: Wheel loads used in the dynamic analysis
