Rail Accident Investigation Branch

# RAIB Bulletin 04/2010

## **Collision between part of a freight train and a passenger train at Carluke, Scotland 18 August 2009**

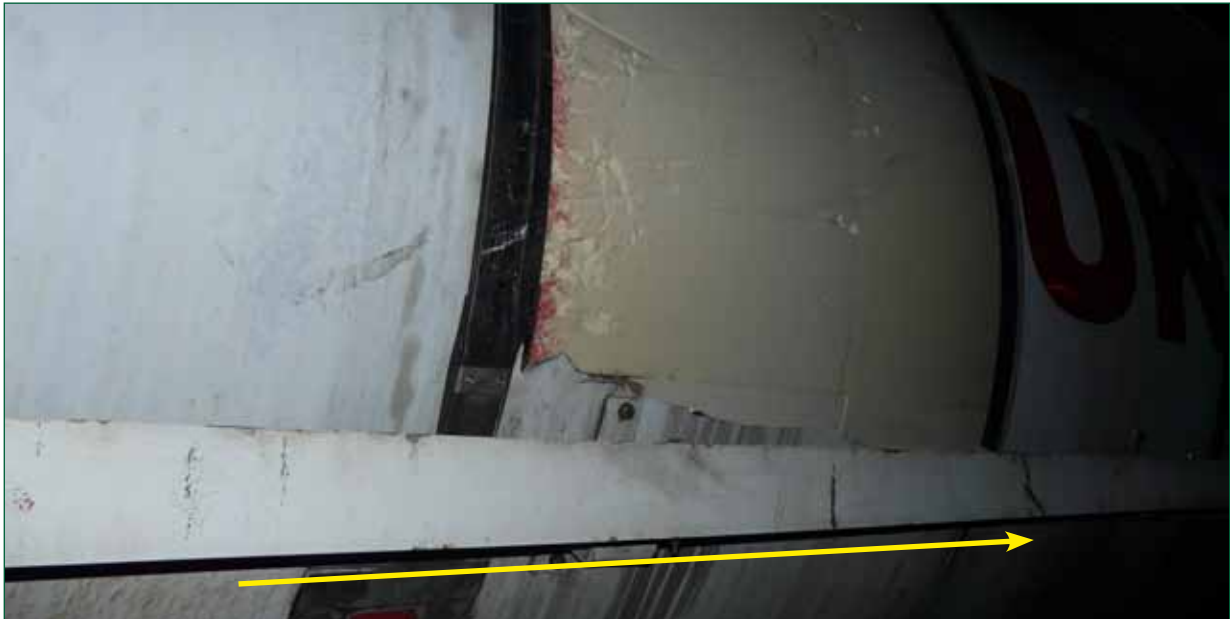
3. The driver reported that he had discovered a large piece of aluminium cladding hanging off the side of a tank<sup>1</sup> on the right-hand side<sup>2</sup> of the train. The driver did not examine the left-hand side of the train because the adjacent line on that side remained open to traffic. DBS made arrangements for a Rolling Stock Technician (RST) to be deployed to site to assess the damage and determine if the tank was fit to continue its journey. When the RST arrived on site, a Mobile Operations Manager (MOM) showed him the area of damage (by this time, a section of loose aluminium cladding had already been removed from the right-hand side of the tank (figure 1).

Figure 1: Image of the right-hand side of the tank after the 'H' panel cladding section had been cut off at Carstairs (direction of travel indicated with yellow line)

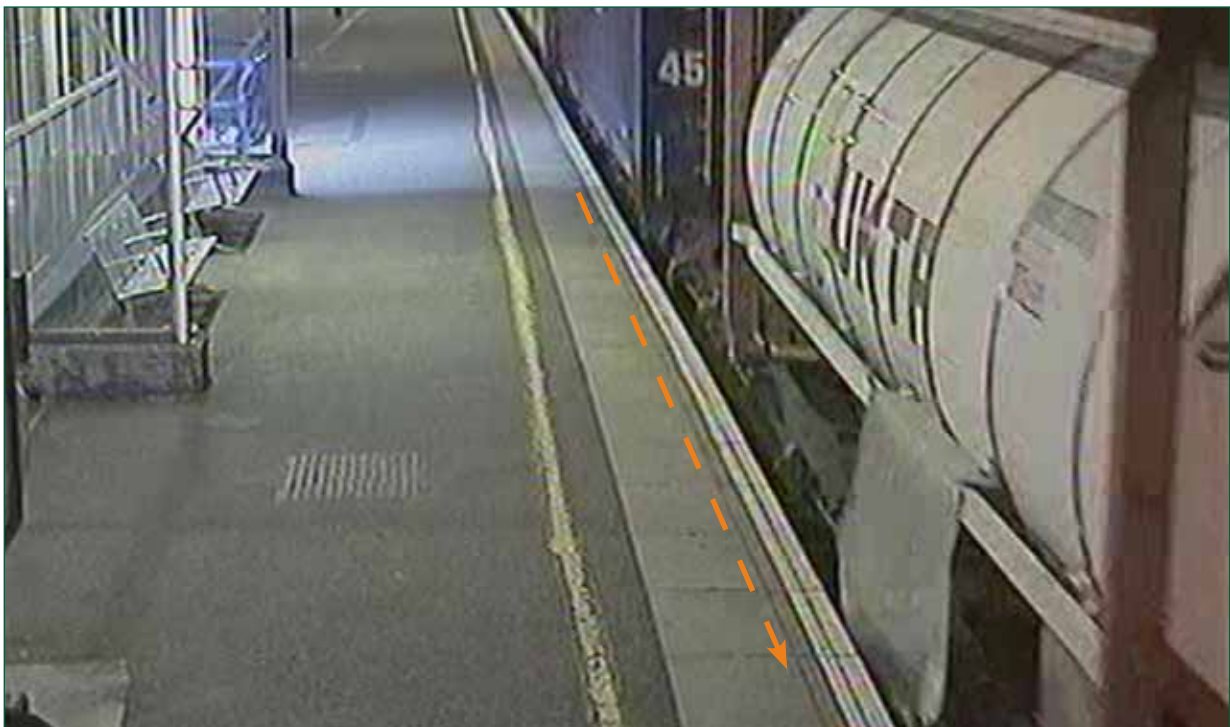
5. The train driver reported there were no leakages or spills from the tank and authority was given by the RST for the train to continue forward at normal speed. The train departed from Carstairs. It is likely that the cladding panel on the left-hand side of the tank was already either insecure or hanging from the tank (figure 2).

Figure 2: Image of the 'A' panel of the tank (located on the side opposite to that from which the panel was removed at Carstairs) passing through Manchester Piccadilly station platform after the train had been authorised to proceed without restriction. Direction of travel indicated by the orange arrow. By this time, the train had reversed direction at Crewe

29. The cladding panel worked loose on the right-hand side of the tank by the time the train reached Carluke, and possibly on the left-hand side as well. It is possible that the airflow generated between the cladding and the main body of the tank after the train left Mossend caused the cladding to become loose and out of gauge.

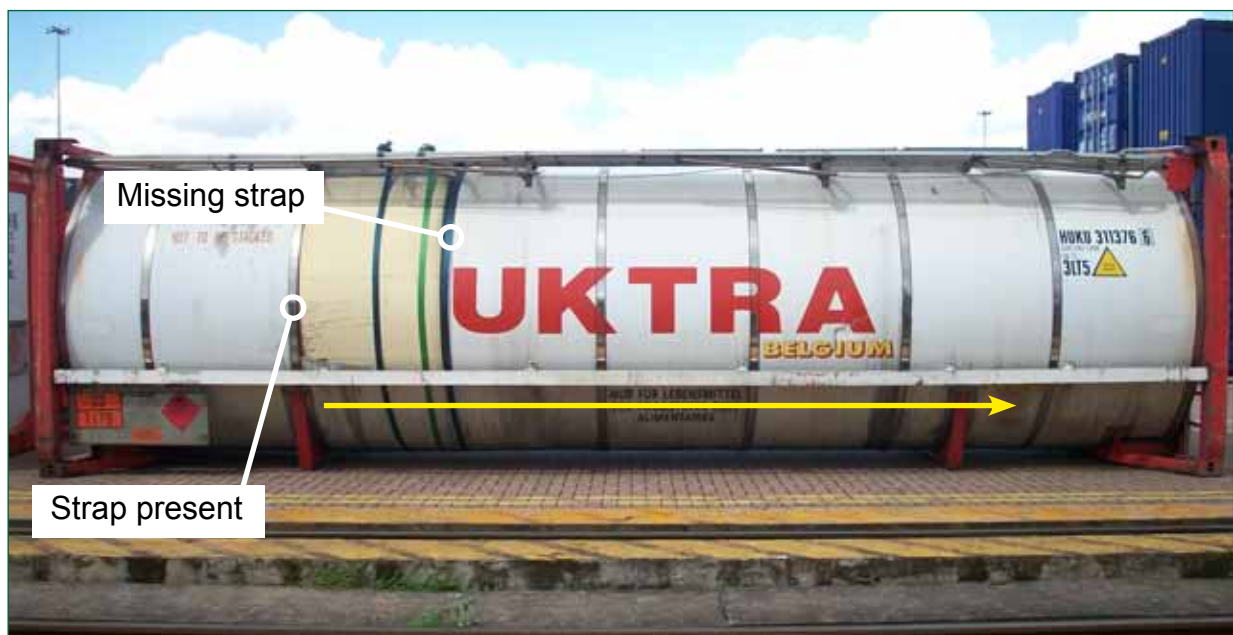
7. Cladding panels should be retained by a strap at each end, but the front strap (in the direction of travel at Carluke), which should have retained the loose panel, was missing (figure 3). The route followed by the train on departure from Mossend was later searched, but the strap was not found.
8. DBS took photographs of the damage at Trafford Park, with a representative of the owner of the container, Huktra, also present. One of the two retaining screws (Figure 4b) which secure the strap to the top of the tank was missing, but this part of the tank was not photographed. The other retaining screw was present, but not examined to establish how securely it was fastened.
9. The tank was secured in a safe state using fabric banding and ratchets to hold the adjoining panels and later transferred by road to Purfleet and on to Huktra in Belgium.

Figure 3: Image of the tank taken at Trafford Park, Manchester (direction of travel at the time of the incident at Carluke indicated with yellow line).

28. The cladding panel came loose as a result of the absence of the retaining strap. The strap was the key securing mechanism for the cladding panel. CCTV evidence shows that it is likely that the strap was missing when the tank arrived at Mossend. Its absence was not identified by staff responsible for checking the condition of the tank to ensure that it was fit to travel. As a minimum, it was overlooked by the driver who brought the tank by road from the distillery to Mossend and by the ground staff at Mossend.

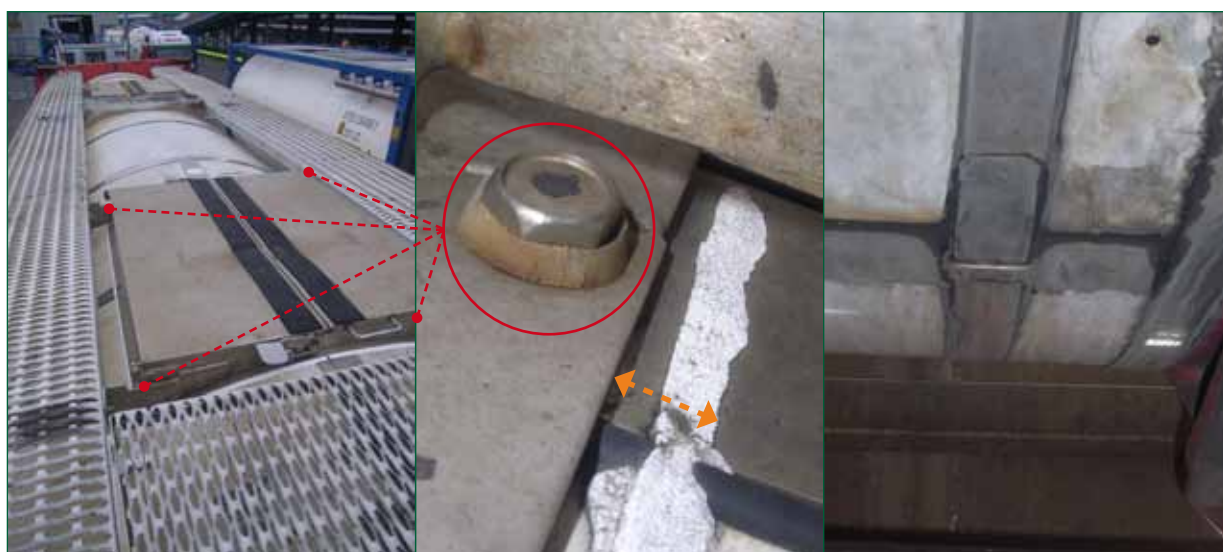
*Figures left to right: 4a: top door of tank; 4b: securing screw for one side of the retaining straps; 4c: strap on underside of the tank secured by two rivets*

- Owners to review whether the method of securing the straps to the tank is robust enough to prevent the strap from moving or the retaining screw from becoming loose. Consideration to be given to marking the retaining screws to indicate if movement has taken place.

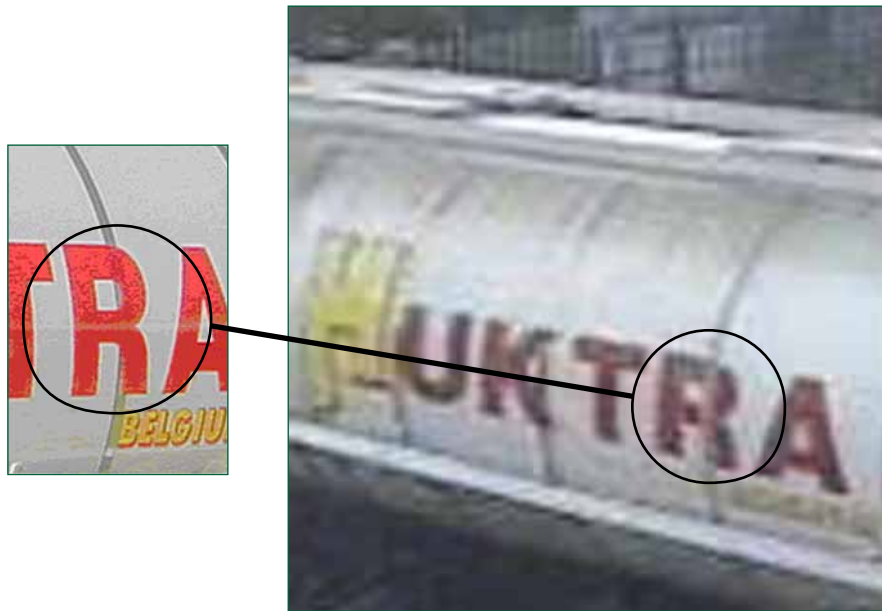
21. CCTV images at Mossend rail depot were available. They show the tank arriving at the depot and during some of the shunting movements that took place as the train was prepared for departure. The images appear to show one of the two straps which secured one of the cladding panels to the body of the tank as missing (figures 5 and 6). There are two features which suggest that this may have been the case:

- The lettering on the side of the panels is normally applied over the straps. There is a distinct line through the letter 'R', which would not be there if the strap with associated paintwork was in place.

- The line running through the letter 'R' appears not to reflect the light in the same way that would be expected of a metal strap. This suggests that the line is actually the discoloured surface that had originally been hidden by the strap

*Figure 5: Image of tank arriving by road at Mossend Rail depot on 18 August 2009. Image shows red painted surface on livery of letter 'R' (inset image) missing. The image also shows a distinct difference in the reflective properties of the area compared to an area where straps are present*

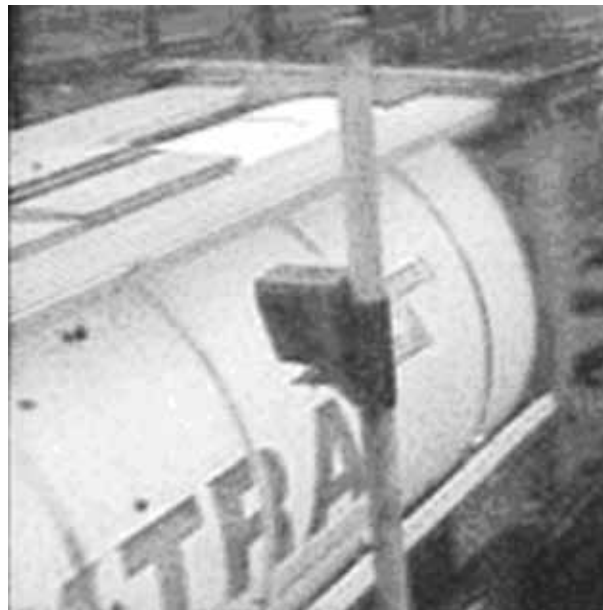
*Figure 6: CCTV image taken showing the tank being shunted within Mossend Yard on 18 August 2009*
