Rail Accident Investigation Branch

RAIB Bulletin 04/2010

Collision between part of a freight train and a passenger train at Carluke, Scotland 18 August 2009

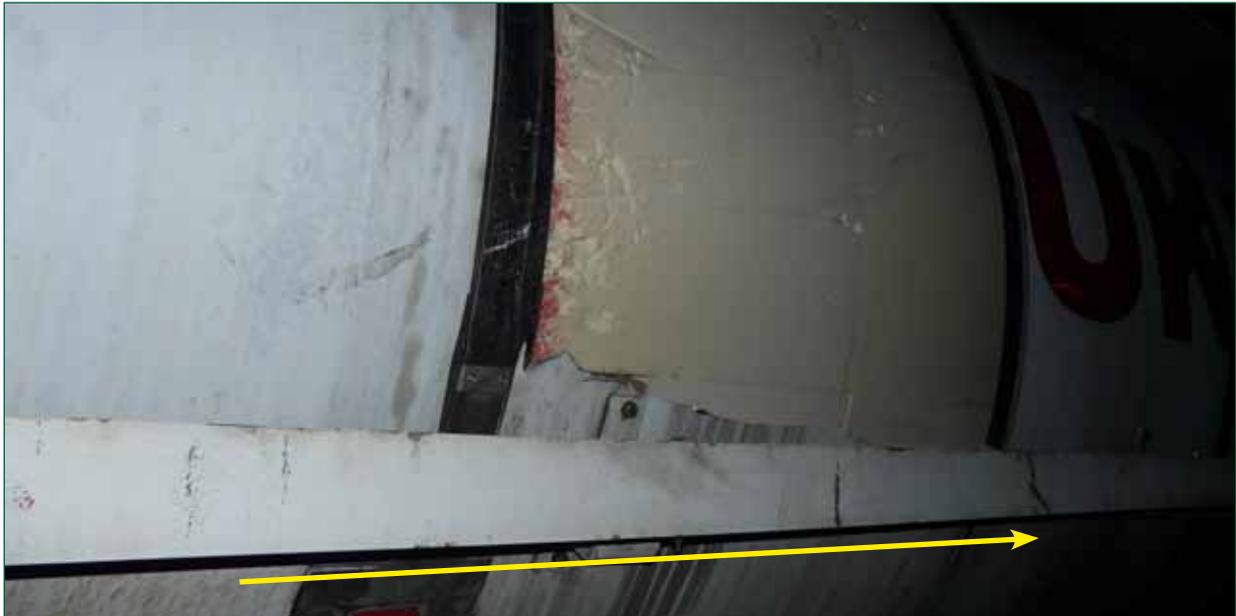
3. The driver reported that he had discovered a large piece of aluminium cladding hanging off the side of a tank¹ on the right-hand side² of the train. The driver did not examine the left-hand side of the train because the adjacent line on that side remained open to traffic. DBS made arrangements for a Rolling Stock Technician (RST) to be deployed to site to assess the damage and determine if the tank was fit to continue its journey. When the RST arrived on site, a Mobile Operations Manager (MOM) showed him the area of damage (by this time, a section of loose aluminium cladding had already been removed from the right-hand side of the tank (figure 1).

Figure 1: Image of the right-hand side of the tank after the 'H' panel cladding section had been cut off at Carstairs (direction of travel indicated with yellow line)

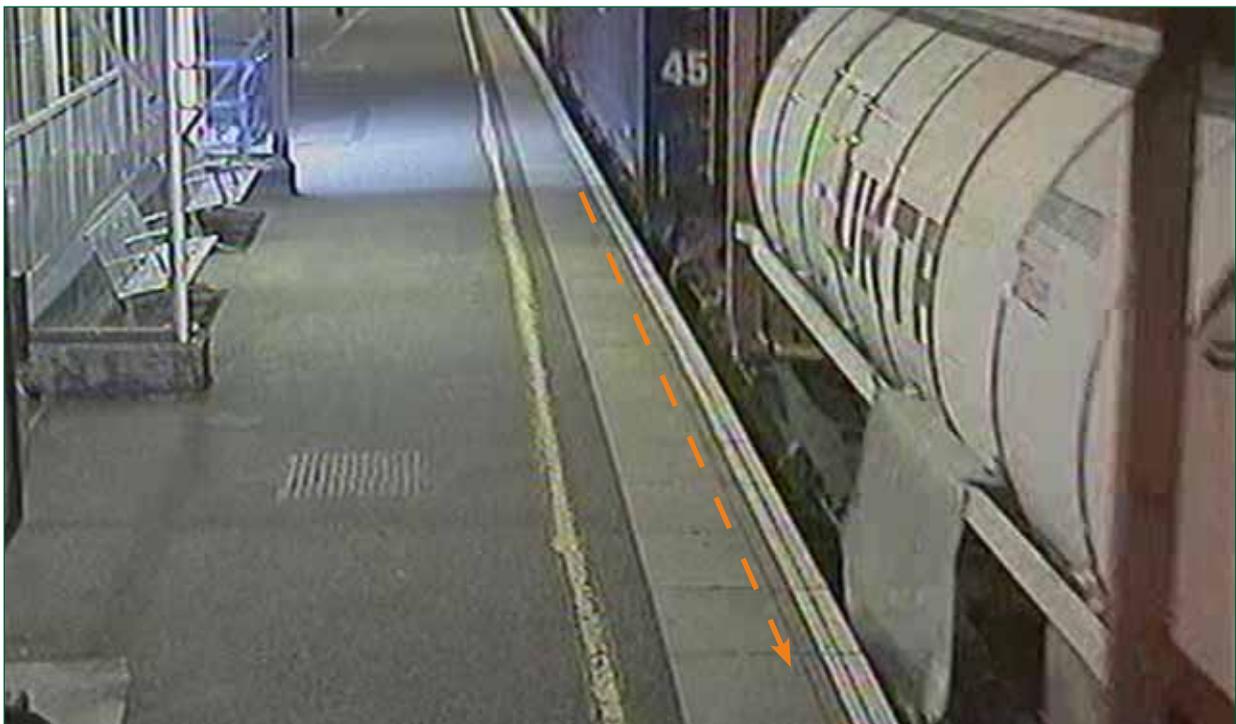
5. The train driver reported there were no leakages or spills from the tank and authority was given by the RST for the train to continue forward at normal speed. The train departed from Carstairs. It is likely that the cladding panel on the left-hand side of the tank was already either insecure or hanging from the tank (figure 2).

6. DBS had intended to examine the train again at Carlisle station but this did not take place because no member of staff qualified to undertake examination of freight vehicles was available. The train continued its journey and arrived at Trafford Park without any reported incident. The tank was examined again on its arrival at Trafford Park and the insecure cladding panel that had not been identified at Carstairs was found hanging over the side frame and out of gauge. This piece was also cut off from the tank.

Figure 2: Image of the 'A' panel of the tank (located on the side opposite to that from which the panel was removed at Carstairs) passing through Manchester Piccadilly station platform after the train had been authorised to proceed without restriction. Direction of travel indicated by the orange arrow. By this time, the train had reversed direction at Crewe

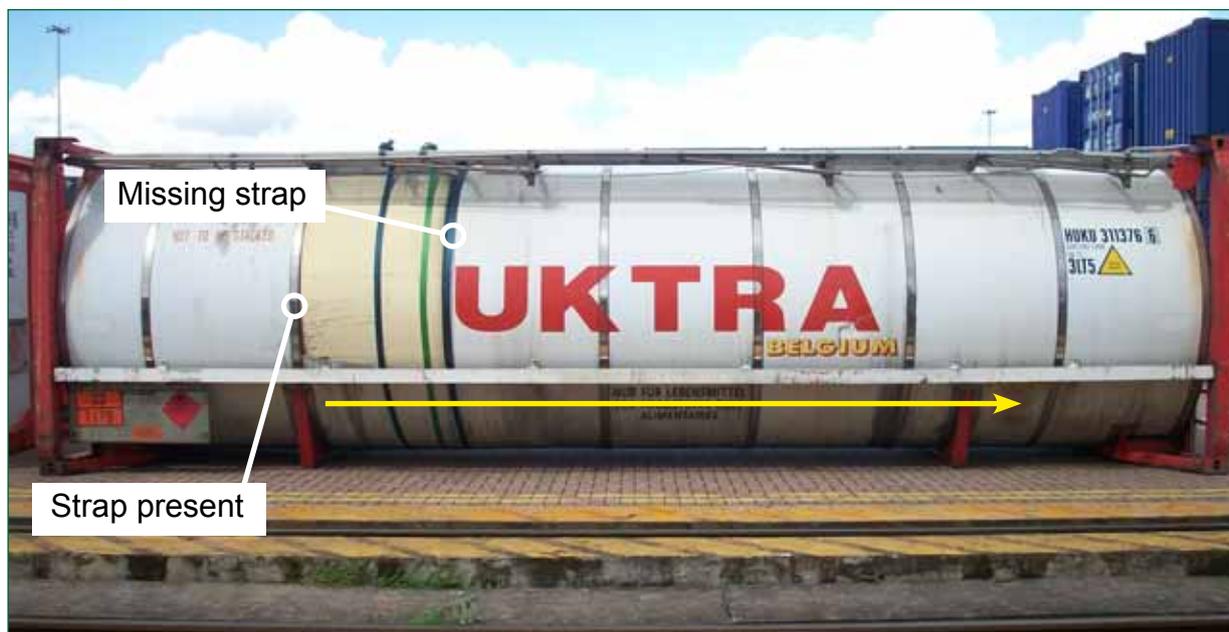
7. Cladding panels should be retained by a strap at each end, but the front strap (in the direction of travel at Carluke), which should have retained the loose panel, was missing (figure 3). The route followed by the train on departure from Mossend was later searched, but the strap was not found.
8. DBS took photographs of the damage at Trafford Park, with a representative of the owner of the container, Huktra, also present. One of the two retaining screws (Figure 4b) which secure the strap to the top of the tank was missing, but this part of the tank was not photographed. The other retaining screw was present, but not examined to establish how securely it was fastened.
9. The tank was secured in a safe state using fabric banding and ratchets to hold the adjoining panels and later transferred by road to Purfleet and on to Huktra in Belgium.

Figure 3: Image of the tank taken at Trafford Park, Manchester (direction of travel at the time of the incident at Carluke indicated with yellow line).

28. The cladding panel came loose as a result of the absence of the retaining strap. The strap was the key securing mechanism for the cladding panel. CCTV evidence shows that it is likely that the strap was missing when the tank arrived at Mossend. Its absence was not identified by staff responsible for checking the condition of the tank to ensure that it was fit to travel. As a minimum, it was overlooked by the driver who brought the tank by road from the distillery to Mossend and by the ground staff at Mossend.

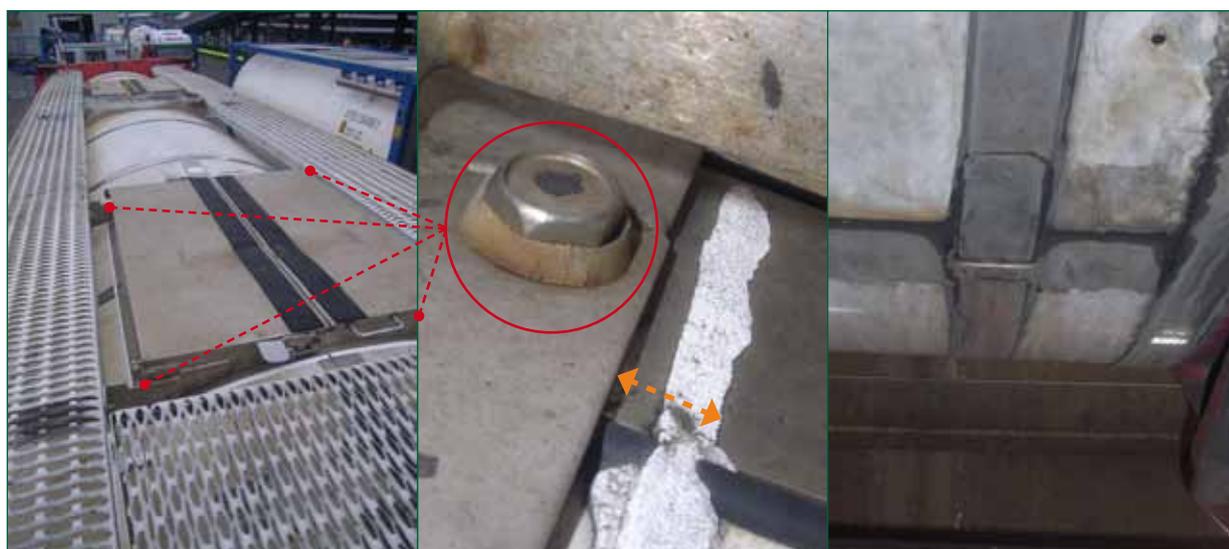
10. The design of tanks must comply with standards mandated by the International Union of Railways (normally abbreviated to 'UIC'). The carriage of dangerous goods by rail is covered by international regulations, normally referred to as the 'RID' regulations. The security of the cladding and strapping is not specifically referred to in the UIC standards, their main focus being on the integrity of the tank in preventing leakage or explosion.
11. Each cladding panel covers the circumference of the tank unless it is interrupted by a manifold door on the top of the tank (figure 4a). The strap is secured by two retaining screws (paragraph 8) on either side of the tank (figure 4b) and on the underside by two rivets (figure 4c).

Figures left to right: 4a: top door of tank; 4b: securing screw for one side of the retaining straps; 4c: strap on underside of the tank secured by two rivets

- Owners to review whether the method of securing the straps to the tank is robust enough to prevent the strap from moving or the retaining screw from becoming loose. Consideration to be given to marking the retaining screws to indicate if movement has taken place.

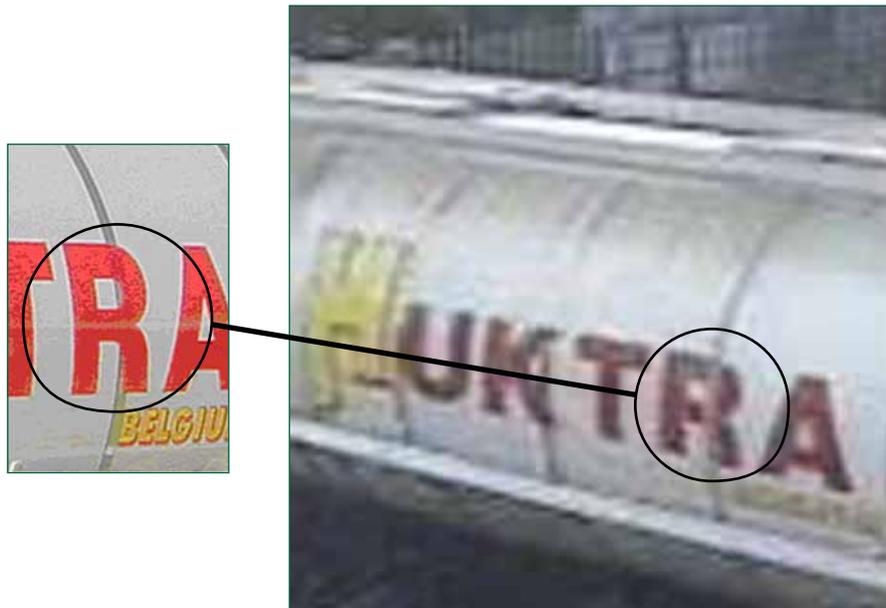
21. CCTV images at Mossend rail depot were available. They show the tank arriving at the depot and during some of the shunting movements that took place as the train was prepared for departure. The images appear to show one of the two straps which secured one of the cladding panels to the body of the tank as missing (figures 5 and 6). There are two features which suggest that this may have been the case:

- The lettering on the side of the panels is normally applied over the straps. There is a distinct line through the letter 'R', which would not be there if the strap with associated paintwork was in place.

- The line running through the letter 'R' appears not to reflect the light in the same way that would be expected of a metal strap. This suggests that the line is actually the discoloured surface that had originally been hidden by the strap

Figure 5: Image of tank arriving by road at Mossend Rail depot on 18 August 2009. Image shows red painted surface on livery of letter 'R' (inset image) missing. The image also shows a distinct difference in the reflective properties of the area compared to an area where straps are present

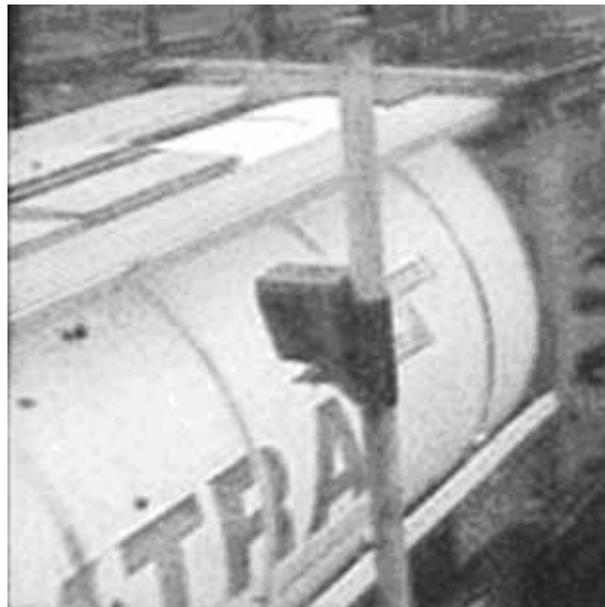
Figure 6: CCTV image taken showing the tank being shunted within Mossend Yard on 18 August 2009
