Rail Accident Investigation Branch

Rail Accident Report

Container doors hit passenger trains, Penrith Station and Eden Valley Loop, Cumbria 4 July 2009

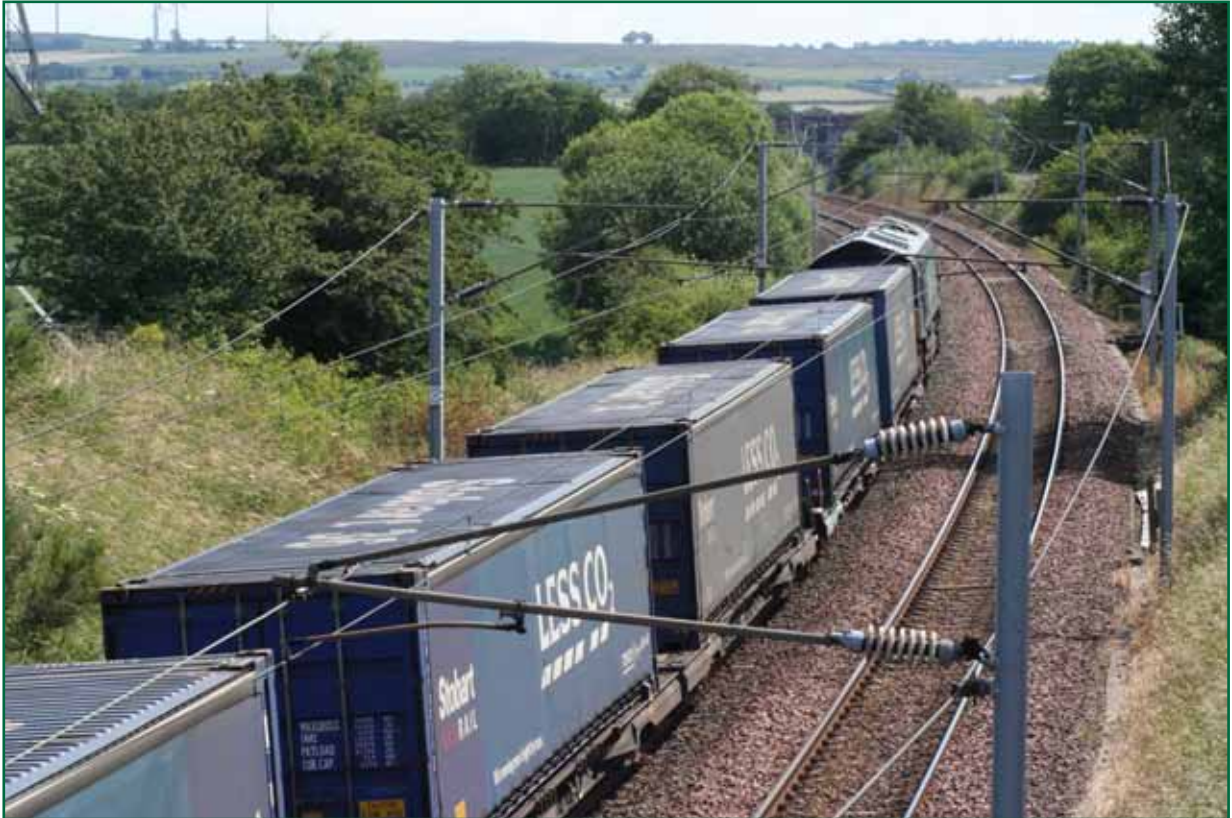
Figure 7: IKA wagons and 45 foot containers (image courtesy of Direct Rail Services)

- 4 Direct Rail Services (DRS) operated train 4M16, a Saturday only container freight train from Scotland to Daventry International Rail Freight Terminal. It consisted of a class 66 loco (66416) and 14 IKA wagons (Figure 7), semi-permanently coupled pairs of bogie mounted units. The train was carrying 28 empty 45 foot curtain sided containers. All the containers were returning after making deliveries to a Tesco depot. Eddie Stobart Ltd was the logistics company moving the containers on behalf of Tesco. W H Malcolm was the logistics provider who operated the two rail termini.

- 27 **The collisions with the passenger trains occurred because there was no feature on the container or wagon to prevent container doors, once they had come open, from going out of gauge.**

- 28 Freight operating companies generally attempt to load containers onto wagons such that the doors are against headstocks or other container doors. This approach limits access to the doors during transit and prevents any open doors going outside the loading gauge. However, when loading a 45 foot container onto an IKA wagon it is not possible to locate the doors adjacent to a headstock, as it is only possible to load one container per half wagon, and the container has to be loaded centrally to distribute the weight satisfactorily (Figure 7). There are no other features on an IKA wagon that would prevent a door that has come open from going outside the loading gauge. The lack of possible loading arrangements and physical features preventing doors that have come open from going out of gauge are contributory factors to the incident.

Freight Operating Companies should investigate, and, where reasonably practicable, implement, measures so that open container doors cannot swing outside the loading gauge (paragraph 34).

Freight Operating Companies should amend their specifications for future builds of container wagons to include measures that prevent open container doors swinging outside the loading gauge (paragraph 34).
