Rail Accident Investigation Branch

Rail Accident Report

Container doors hit passenger trains, Penrith Station and Eden Valley Loop, Cumbria 4 July 2009

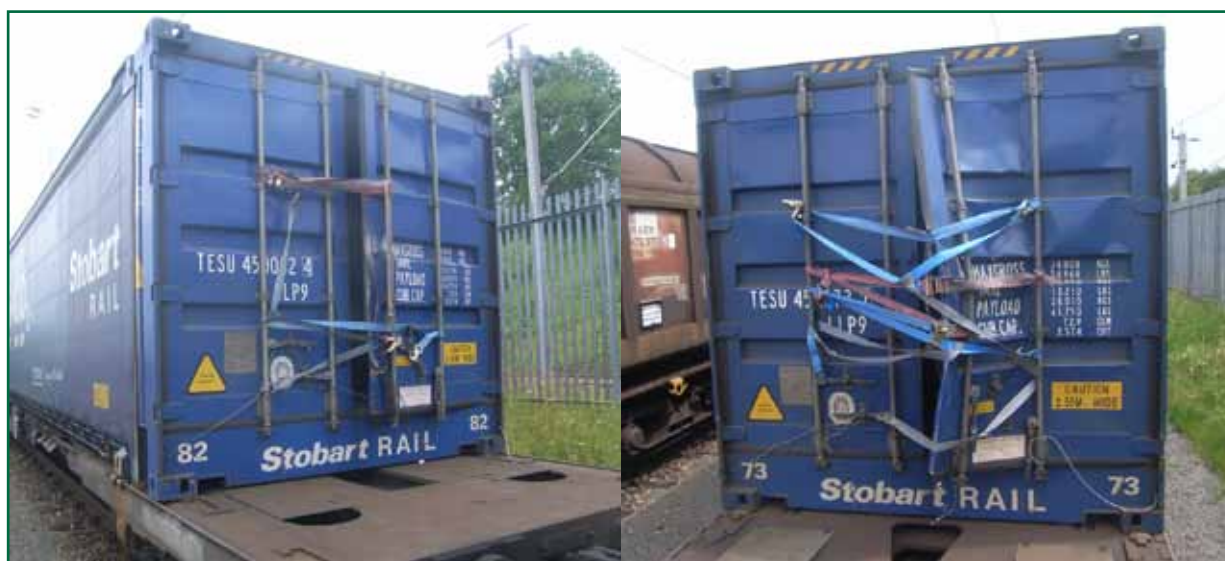
- 5 The doors that were open were those on the right-hand side of the leading container on the twelfth wagon (container number 450073) and the leading container on the thirteenth wagon (container number 450082). The doors were at the trailing end of both containers.

Figure 2: Damaged container doors

- 25 Station CCTV records at two stations north of Junction 'A' do not show any open container doors on train 4M16. However, station CCTV records from the three stations south of the Junction show the doors to be open. Container door handles are designed to remain locked shut without any external locking, and are not prone to opening under vibration (Figure 6). The distance between the station north of Junction 'A', where CCTV showed the containers closed, and the station to the south, where the CCTV showed them open, is approximately eight miles. Two doors on adjacent wagons coming open within eight miles indicates a common cause rather than two independent random events. Therefore their opening is likely to have been the result of some external interference while the train was stationary. Junction 'A' is the only location where train 4M16 was stationary between leaving the junction adjacent to the terminal and passing the first station south of Junction 'A', where the doors were open. The RAIB concludes that criminal action at Junction 'A', involving trespass onto the railway, breaking the seals and opening the two doors is the most likely cause of the open doors.

Direct Rail Services and DB Schenker should review their existing control measures to secure container doors, and consider whether stronger seals, such as heavy-duty security seals, would reduce the risk of doors being vandalised and coming open outside of the loading gauge (paragraph 35).

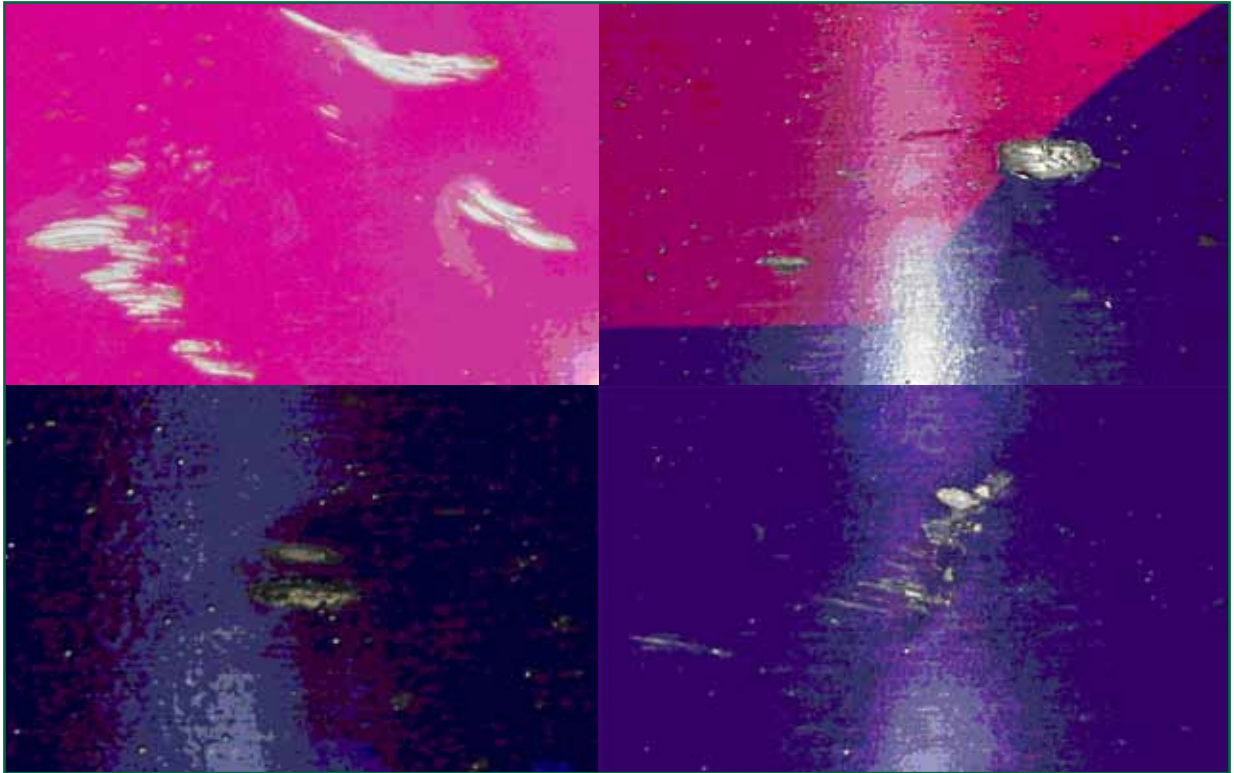
- 19 There was superficial bodywork damage to one car of the class 185 (Figure 3), although the crew and the passengers were unaware that any collision had occurred. The class 390 Pendolino suffered severe impact damage to the bodywork (30 mm deep) of five vehicles, requiring cut and weld repairs (Figure 4). The class 221 suffered damage to all cars consisting of scratching to bodywork, in particular doors, severe damage to one foot step (Figure 5) and structural damage in the area of a cab door. However, all three passenger trains were fit to continue and conclude their journeys.

Figure 3: Damage to class 185 (images courtesy of TransPennine Express)

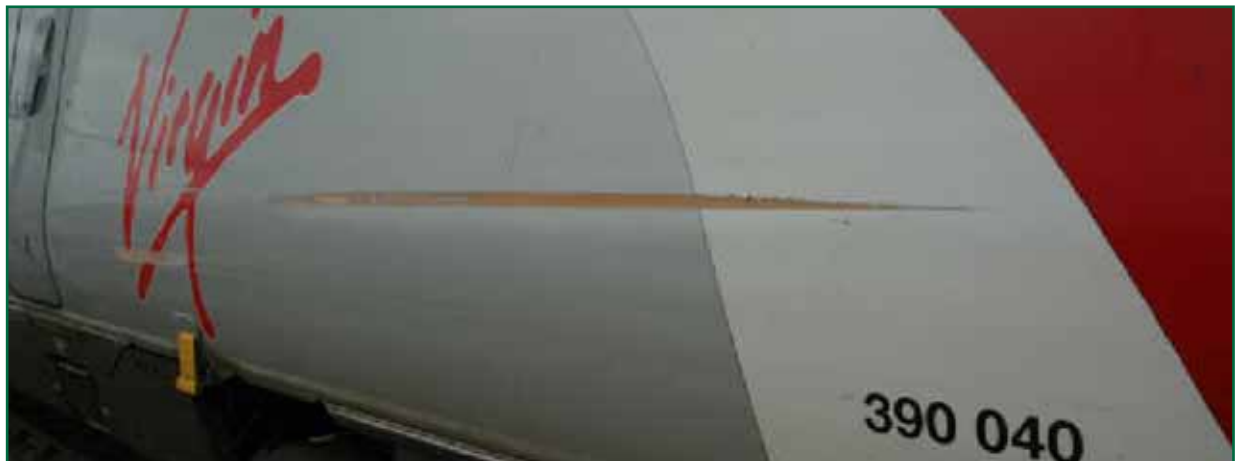
Figure 4: Damage to Pendolino 390040 (image courtesy of Direct Rail Services)

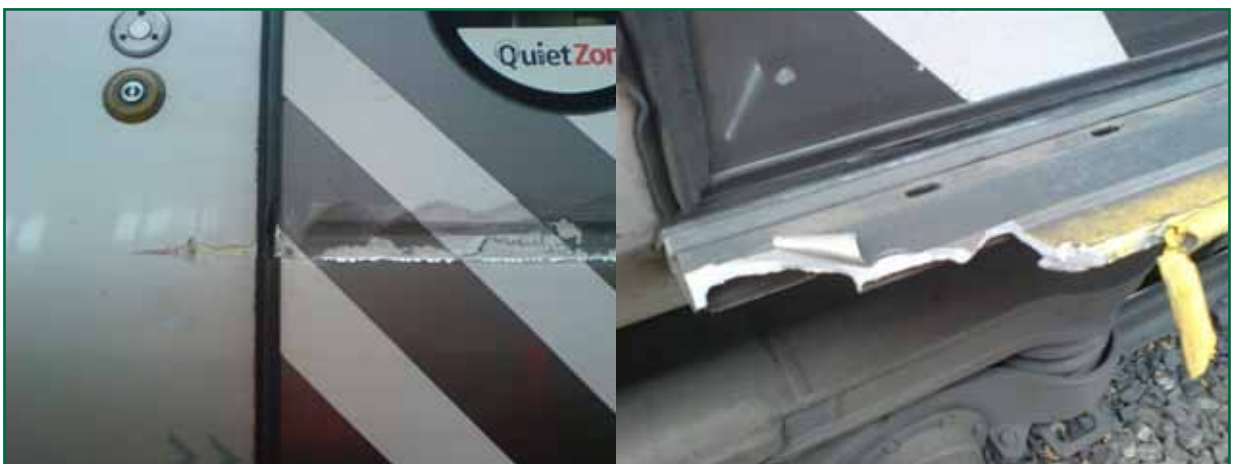
Figure 5: Damage to Super Voyager 221112 (image courtesy of Virgin Trains)

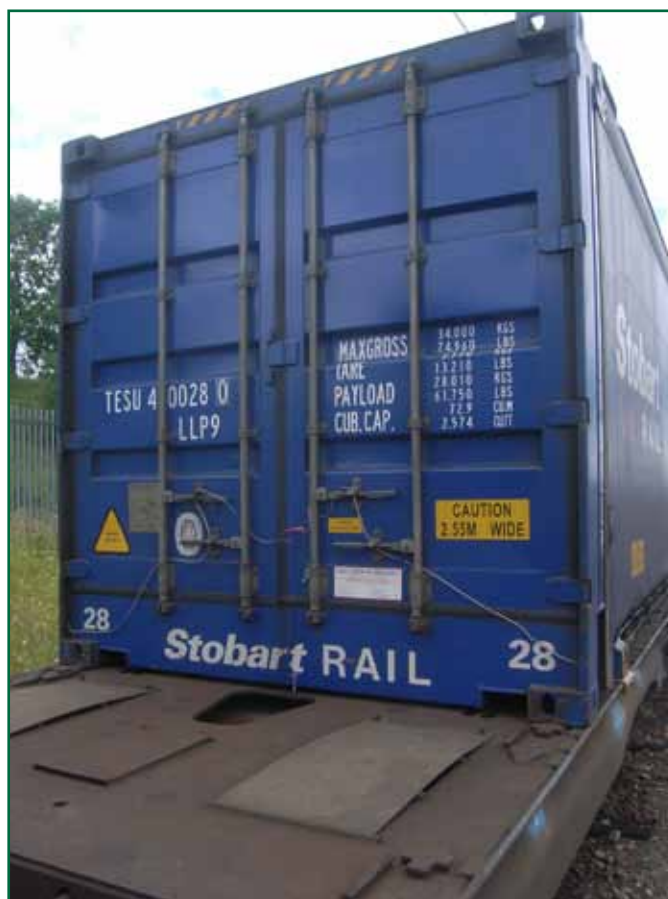
Figure 6: Door handle arrangements on a container

- 26 The seals used on these containers were sacrificial plastic seals which are easily removed by hand; other more robust security seals exist, although these can still be removed by bolt cutters. Witness evidence indicated that there is a concern over using heavy duty security seals on curtain-sided containers because it may cause criminals to cut the curtains of the containers to access the contents, which in turn introduces a risk onto the railway. However, it is considered that the use of heavy-duty security seals may deter opportunistic criminals. The use of the light-weight sacrificial seals is a probable contributory factor to the incident.

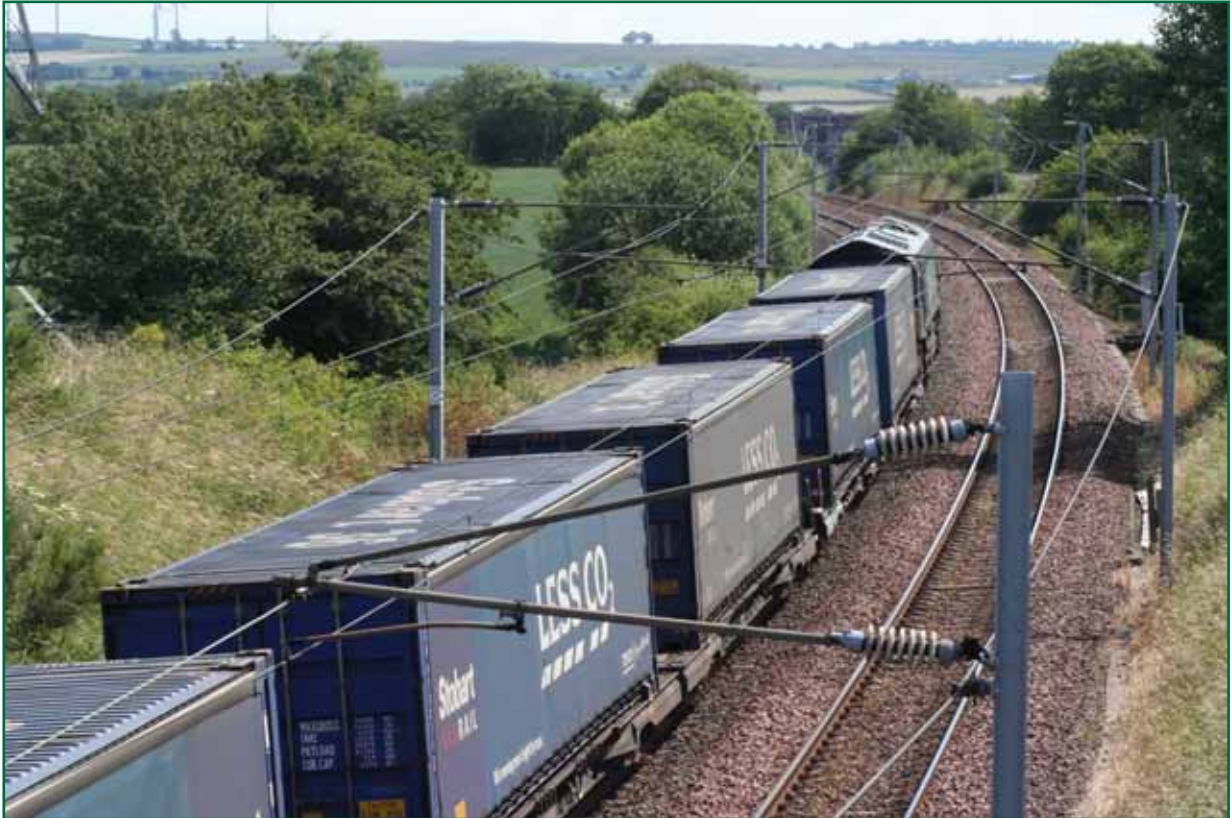
Figure 7: IKA wagons and 45 foot containers (image courtesy of Direct Rail Services)

- 28 Freight operating companies generally attempt to load containers onto wagons such that the doors are against headstocks or other container doors. This approach limits access to the doors during transit and prevents any open doors going outside the loading gauge. However, when loading a 45 foot container onto an IKA wagon it is not possible to locate the doors adjacent to a headstock, as it is only possible to load one container per half wagon, and the container has to be loaded centrally to distribute the weight satisfactorily (Figure 7). There are no other features on an IKA wagon that would prevent a door that has come open from going outside the loading gauge. The lack of possible loading arrangements and physical features preventing doors that have come open from going out of gauge are contributory factors to the incident.

Freight Operating Companies should investigate, and, where reasonably practicable, implement, measures so that open container doors cannot swing outside the loading gauge (paragraph 34).

Freight Operating Companies should amend their specifications for future builds of container wagons to include measures that prevent open container doors swinging outside the loading gauge (paragraph 34).
