RAIB Bulletin 08/2009

Collision between a moving tram and stationary tram

The event took place at Blackpool Starr Gate on 24 June 2009

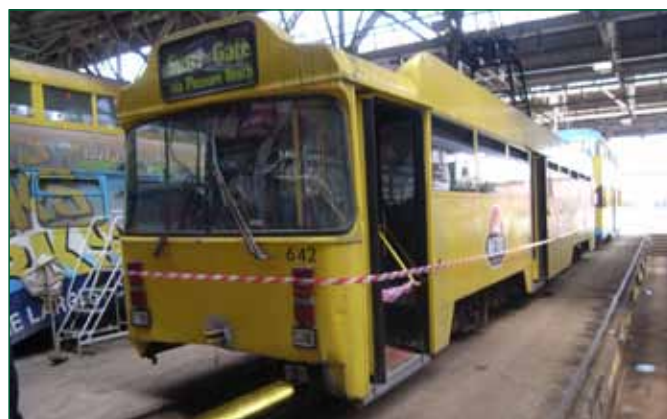
2. The moving tram (Figure 1) was one of a fleet of eight trams constructed between 1984 and 1987. Two other trams of a different fleet type have the same braking system. Three braking systems are fitted:

Figure 1: tram involved in the collision at Starr Gate

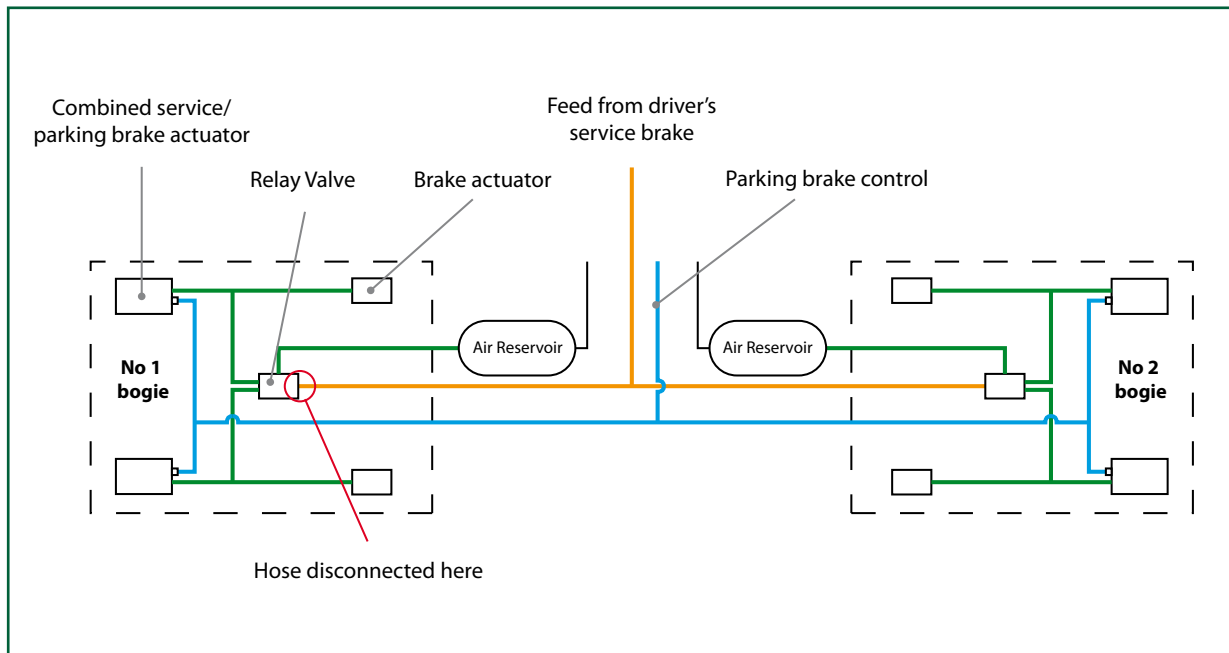
3. The service brake when operated admits air pressure to a relay valve on each bogie (Figure 2). These operate to allow air pressure from each of two air reservoirs to the eight brake actuators. The pressure admitted to the actuators is in proportion to the movement of the service brake handle.

Figure 2: diagram of air system

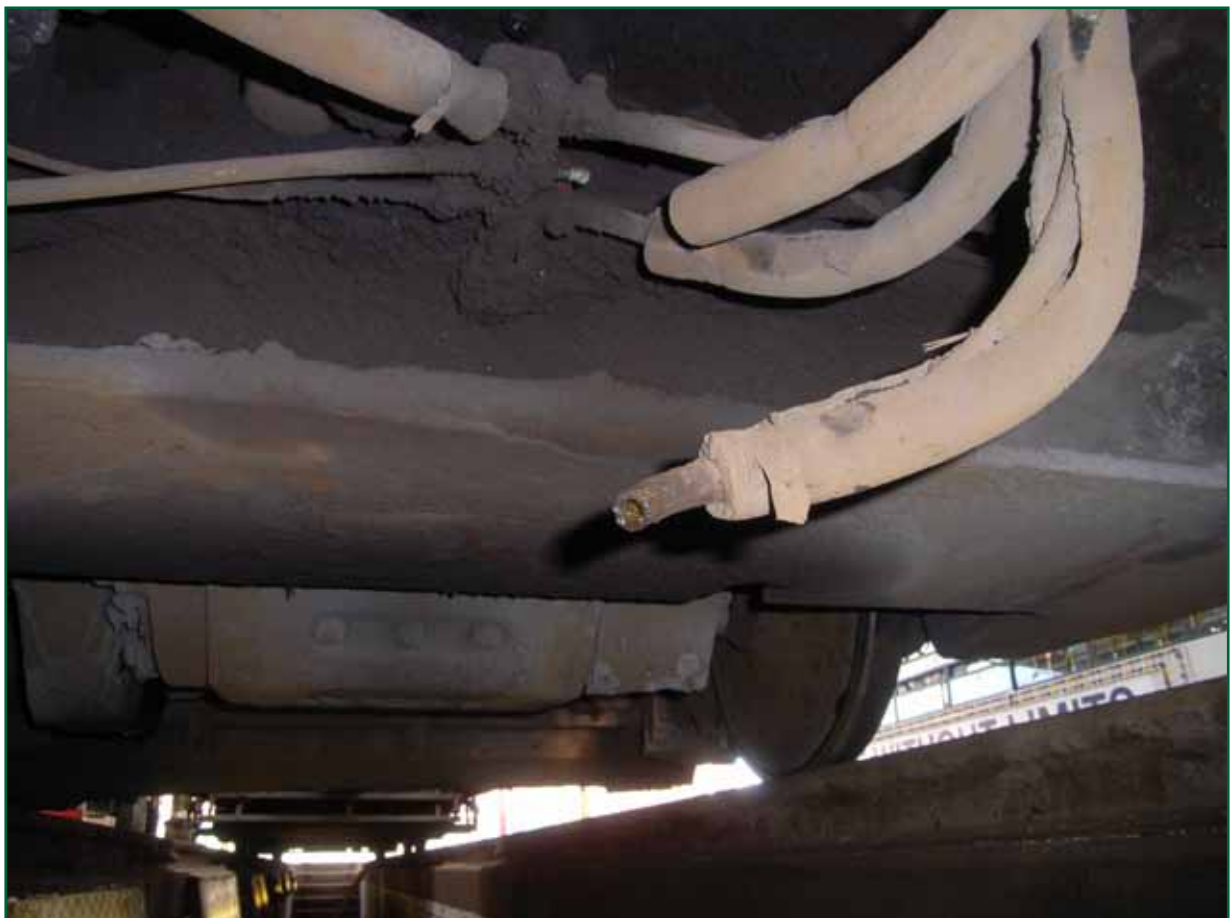
Figure 3: disconnected hose

4. In order to accommodate the rotation of each bogie, the brake system pipework between the underframe and each bogie consists of flexible hoses secured in position by jubilee clips. One of these clips broke and the corresponding flexible hose came apart from its connection to one of the relay valves. The broken clip was found still in situ on the end of the hose. It is likely that the hose became disconnected from its fitting (Figure 3) in the period between the driver's last use of the service brake when it operated normally and his use of it when he attempted to stop just before the collision.

5. Depot tests indicated that with the hose to one of the relay valves disconnected, the service brake was completely ineffective, including to the bogie whose relay valve connections were intact, because there was insufficient air pressure left to operate it. Operation of an emergency brake plunger did provide sufficient air pressure to operate the relay valve whose connections were still intact to apply the brakes on that bogie. The parking brakes on both bogies also applied when an emergency brake plunger was operated.

6. Jubilee clips once fitted were not subject to any maintenance requirement or any consideration as to their serviceable life. The subsequent accumulation of dirt and detritus would also have hidden any failure of a clip which may otherwise have been noticed as part of a general inspection of the tram underframe.

9. The duty holder replaced every jubilee clip on all 11 tram cars with the same sort of braking system fitted to the tram involved in the accident. Efforts were also being made to obtain a better quality fastening.
