RAIB Bulletin 09/2009

Passenger train derailed

The events described took place at Broad Green, Liverpool on 11 June 2009

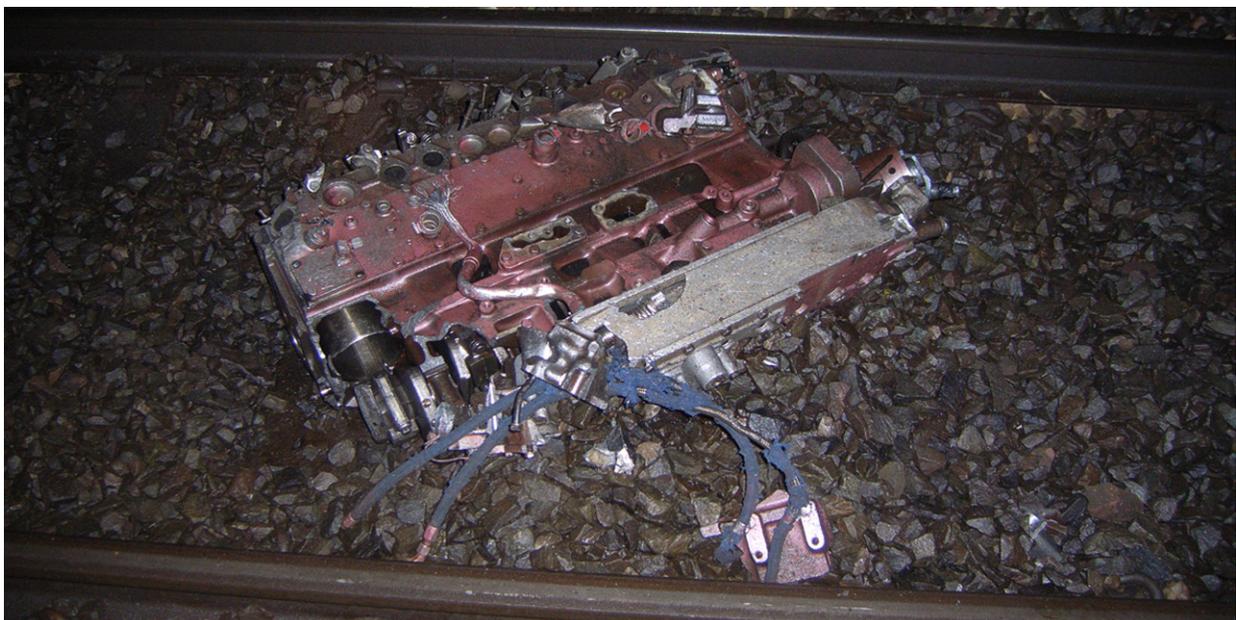
- 1 In June 2009 the rear coach of a two car passenger train derailed as it was running at speed along a double track railway. The train was a class 142 'Pacer' and was carrying 36 passengers and two crew members at the time. The rear axle of the train derailed towards, and the train partially obstructed, the other line.
- 2 Evidence from the train's data recorder showed that the train was travelling at 57 mph (91 km/h) at the time of the derailment and was accelerating on full power away from the previous station stop. The engine mounted under the floor of the second coach became detached and fell to the track, derailing the rear axle as it passed over (Figure 1). The detachment of the engine severed control wires and damaged the braking system causing the brakes to be applied automatically, stopping the train. The engine was still running when it detached from the vehicle.

Figure 1: Detached engine

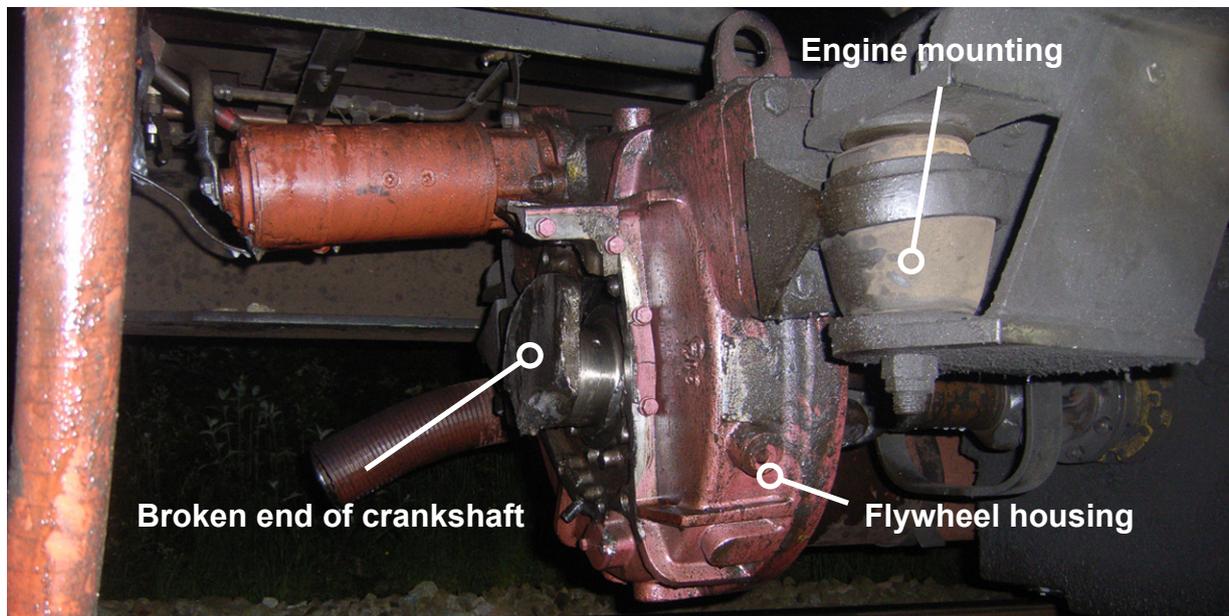
- 4 The engine became detached following the failure of its attachment to the flywheel housing. Two of the three engine mounting points are on the flywheel housing which remained attached to the vehicle (Figure 2).

Figure 2: Flywheel housing and engine mounting points

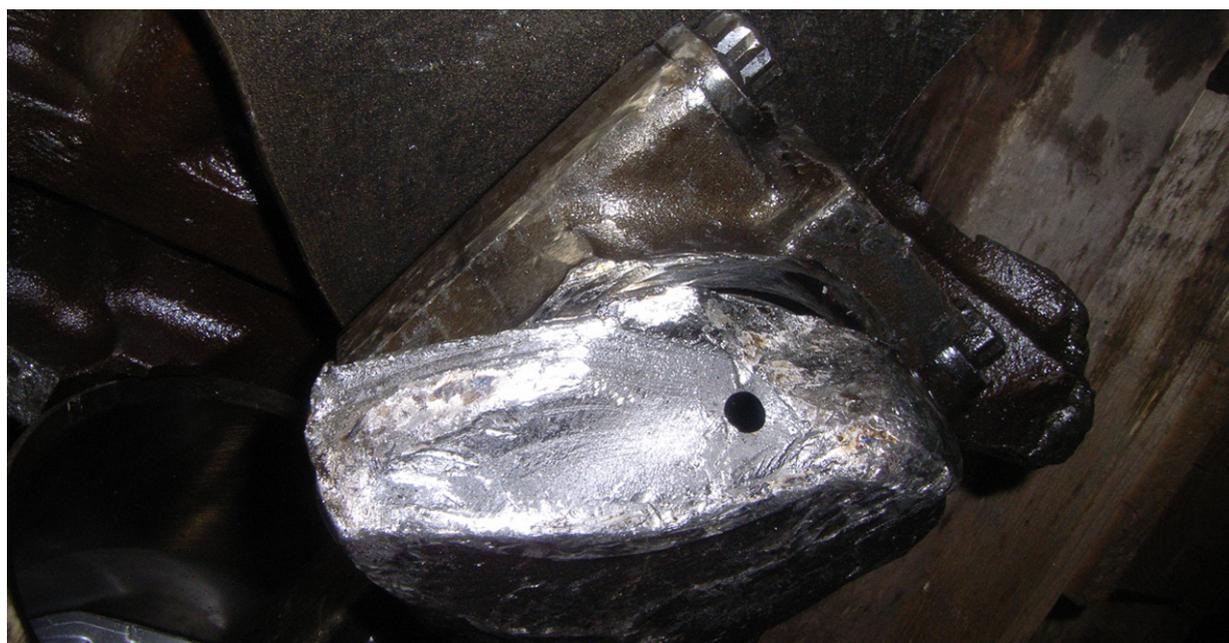
- 5 The engine parts were recovered and taken to the engine overhauler's workshops for supervised examination and dismantling. The bearings and other internal engine parts were found to be well lubricated and there were no signs of overheating or seizure. The engine crankshaft had broken between the big end bearing of the 6th cylinder and the main bearing in the engine casing at the flywheel end. This break exhibited 'beach' marks characteristic of a fatigue failure (Figure 3). The torque load on the crankshaft of an engine on full power is at its maximum between the last cylinder and the flywheel, the location of the fracture.

Figure 3: Crankshaft fracture face

- 8 The engine had been overhauled, and was fitted to the train, in March 2008. The train had covered 114,577 miles (183,323 km) since then. The engine has an interval of 400,000 miles (640,000 km) between overhauls. The crankshaft had been used in two other engines prior to being fitted to this engine. It had been reground and subjected to magnetic particle inspection (MPI) to check for flaws before it was fitted to this engine.

- 9 The MPI process used on this crankshaft was manual and, shortly after this crankshaft was tested, the maintainer had introduced an MPI testing machine, which was able to find smaller flaws.

- 14 The RAIB believes that the learning points from this incident are that owners, operators and maintainers of 'Pacer' trains should:
 - review whether the current system of crankshaft flaw detection can adequately detect precursors of failure with sufficient confidence to assure an engine for a 400,000 mile interval between overhauls;
 - consider if any measures need to be taken to deal with the risks posed by engines of this type already in service; and
 - investigate what precautions can reasonably be taken to mitigate the consequences of catastrophic failure of the engine support.

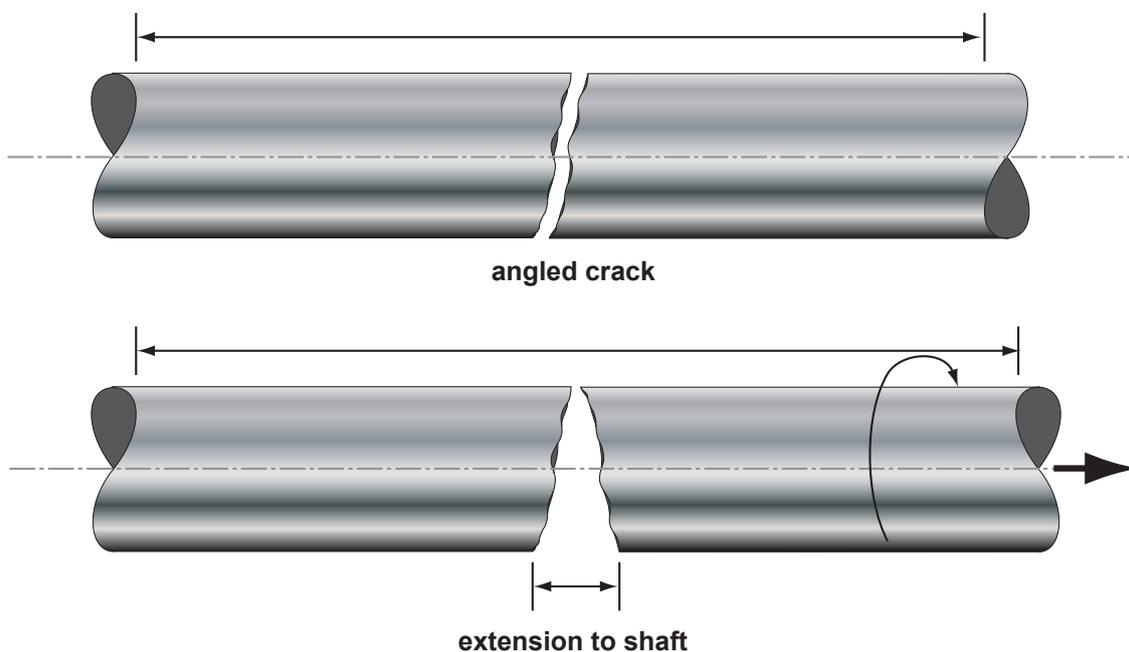
- 6 The crankshaft fracture faces were not perpendicular to the longitudinal axis of the crankshaft and this led to repeated elongation of the crankshaft as the two faces rode over one another with each rotation of the engine (Figure 4). There was bruising on the fracture faces from this overriding.

Figure 4: Diagram showing how fracture lengthened crankshaft

- 7 The longitudinal force generated by the failed crankshaft overriding itself broke the engine casing around the main bearing at the flywheel end and parts of this bearing were found on the track leading up to the point of derailment. A piece of main bearing and its fixing bolt were the first items found in the debris trail towards the derailed train and were found 453 m back from where the train stopped. The engine block was 205 m back from the stopped train.
