Rail Accident Investigation Branch

Rail Accident Report

Fatal accident at Fairfield crossing, Bedwyn, 6 May 2009

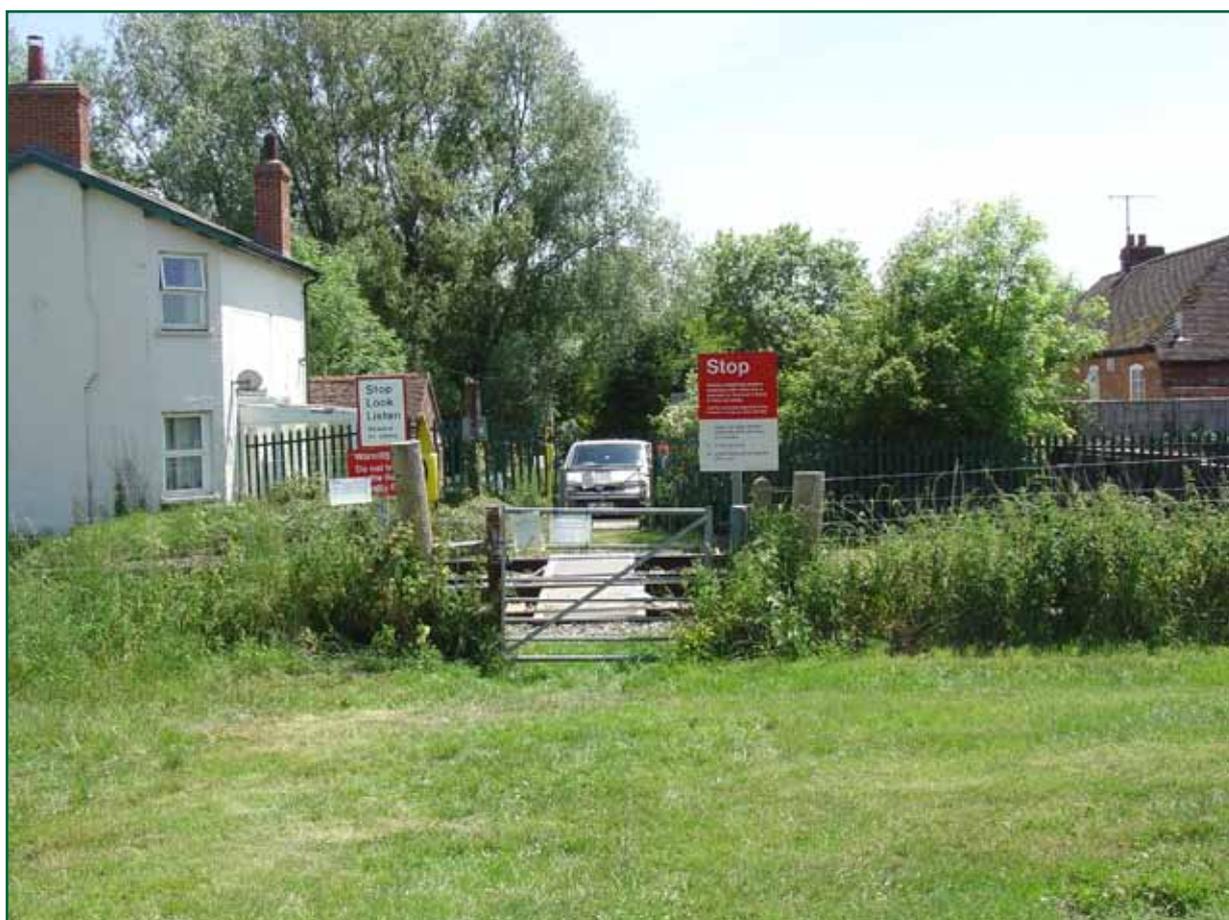
Figure 2: Fairfield level crossing from the north-west

- 12 There are single gates 1.3 metres wide on each side of the crossing, opening away from the railway. At the time of the accident, the crossing had a timber surface over both lines, but the space between the tracks (the six-foot) and the approaches to the crossing were unsurfaced (figure 2).

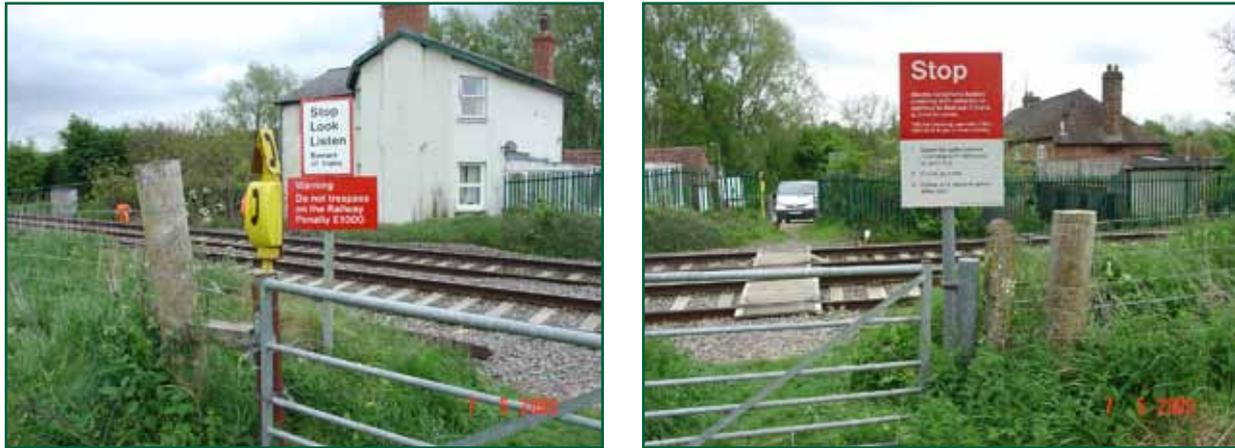
Figure 4: Notices and telephone on the up side at Fairfield crossing

- 32 The gate on the north-west (up) side of the crossing is 5.7 metres from the nearest rail. There is a 'Stop – Look – Listen' notice inside the gate, 4 metres from the nearest rail (figures 3 and 4).

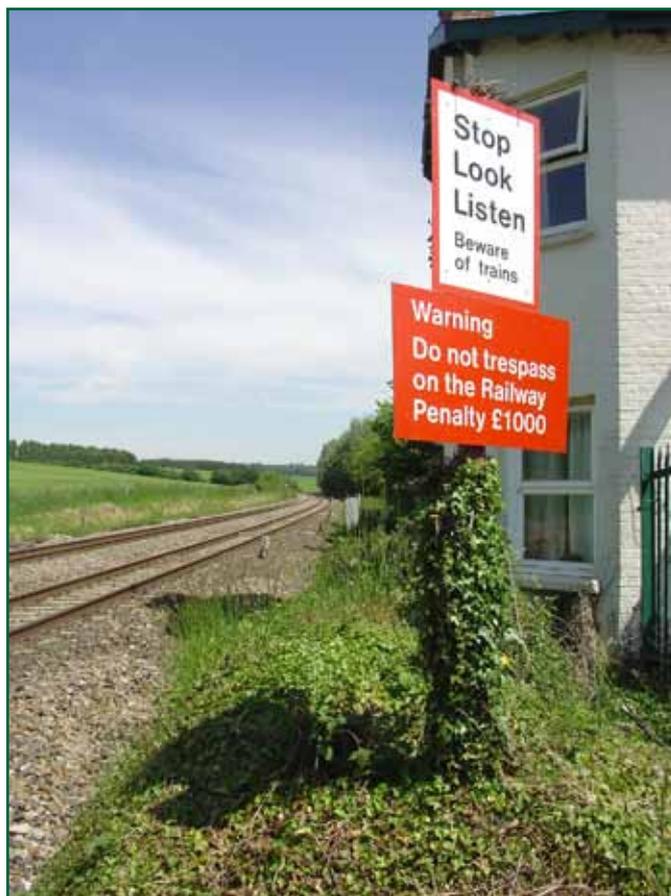
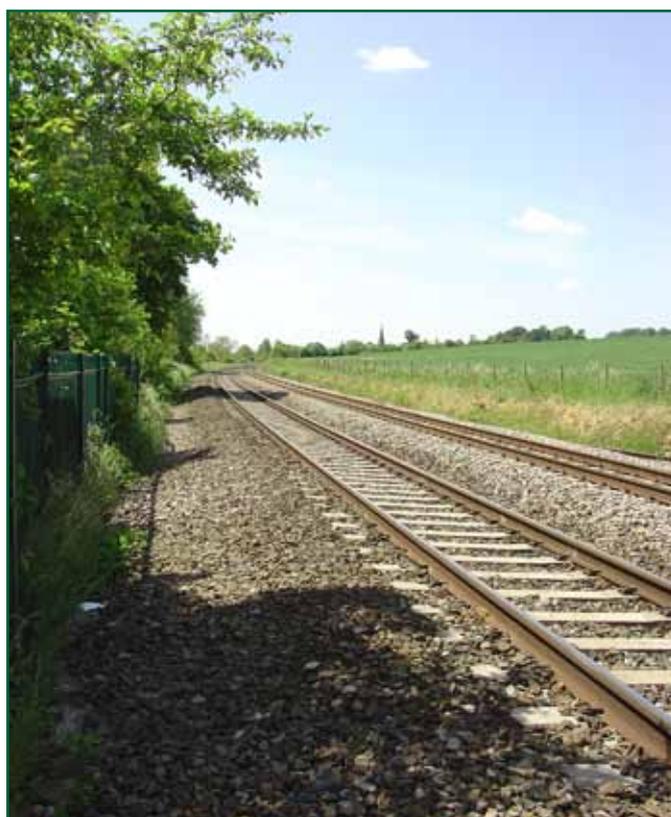
- 36 The visibility of trains approaching Fairfield crossing can vary greatly depending on where the observer is standing and how well the vegetation along the sides of the line on the approaches to the crossing has been cut back. The views from both sides of the line in both directions are shown in figures 5 to 8.

Figure 5: View from down side of crossing looking towards Newbury (View A)

Figure 6: View from down side of crossing looking towards Bedwyn (View B)

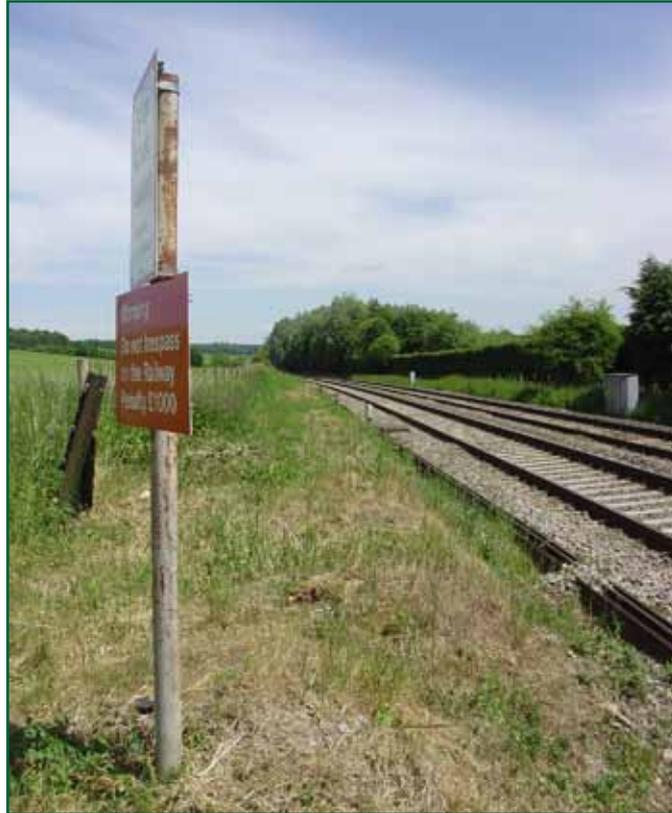
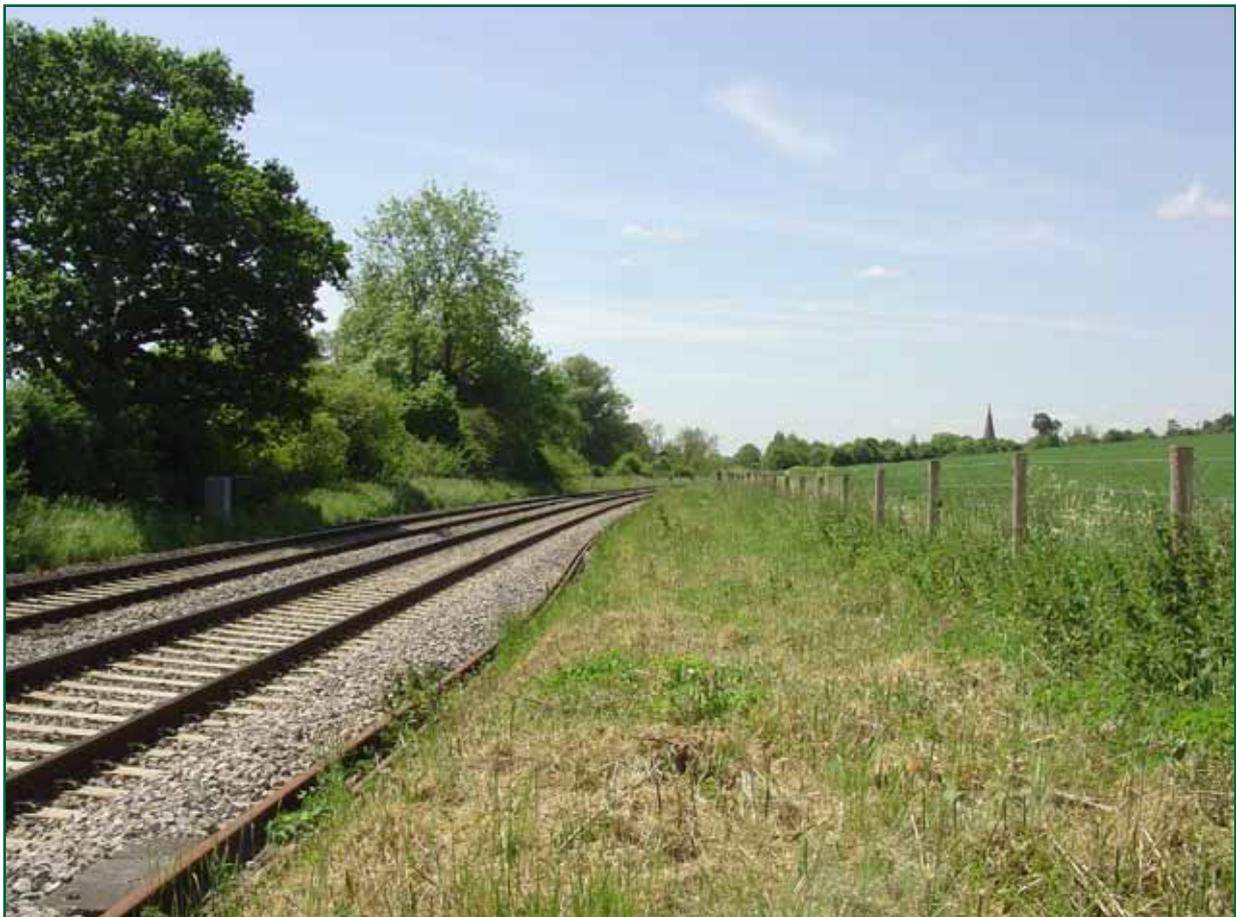
- 37 Figures 7 and 8 show the views that the pedestrian (Mrs Canning) would have had as she approached the crossing from the north-west.
- 38 All of these views show the situation on 7 May, the day after the accident, and the state of the lineside vegetation had not changed since the accident. They are from the viewpoint of an observer standing near the 'Stop – Look – Listen' signs on each side.

Figure 7: View from up side of crossing looking towards Newbury (View C)

Figure 8: View from up side of crossing looking towards Bedwyn (View D)

41 Table 1 shows that there are significantly different sighting distances at Fairfield crossing, particularly from the up side of the line, as measured or estimated at the various inspections and assessments. Inspection of the crossing and photographs taken at different periods show that a lot of this variation is related to vegetation growth: there is a grassy bank on the up side of the line on both sides of the crossing, and long grass on this bank masks the long-range view of approaching trains.

105 The sighting distance from the up side of the crossing for trains approaching in the up direction does not provide adequate warning time (paragraphs 55, 94, **recommendation 1**).

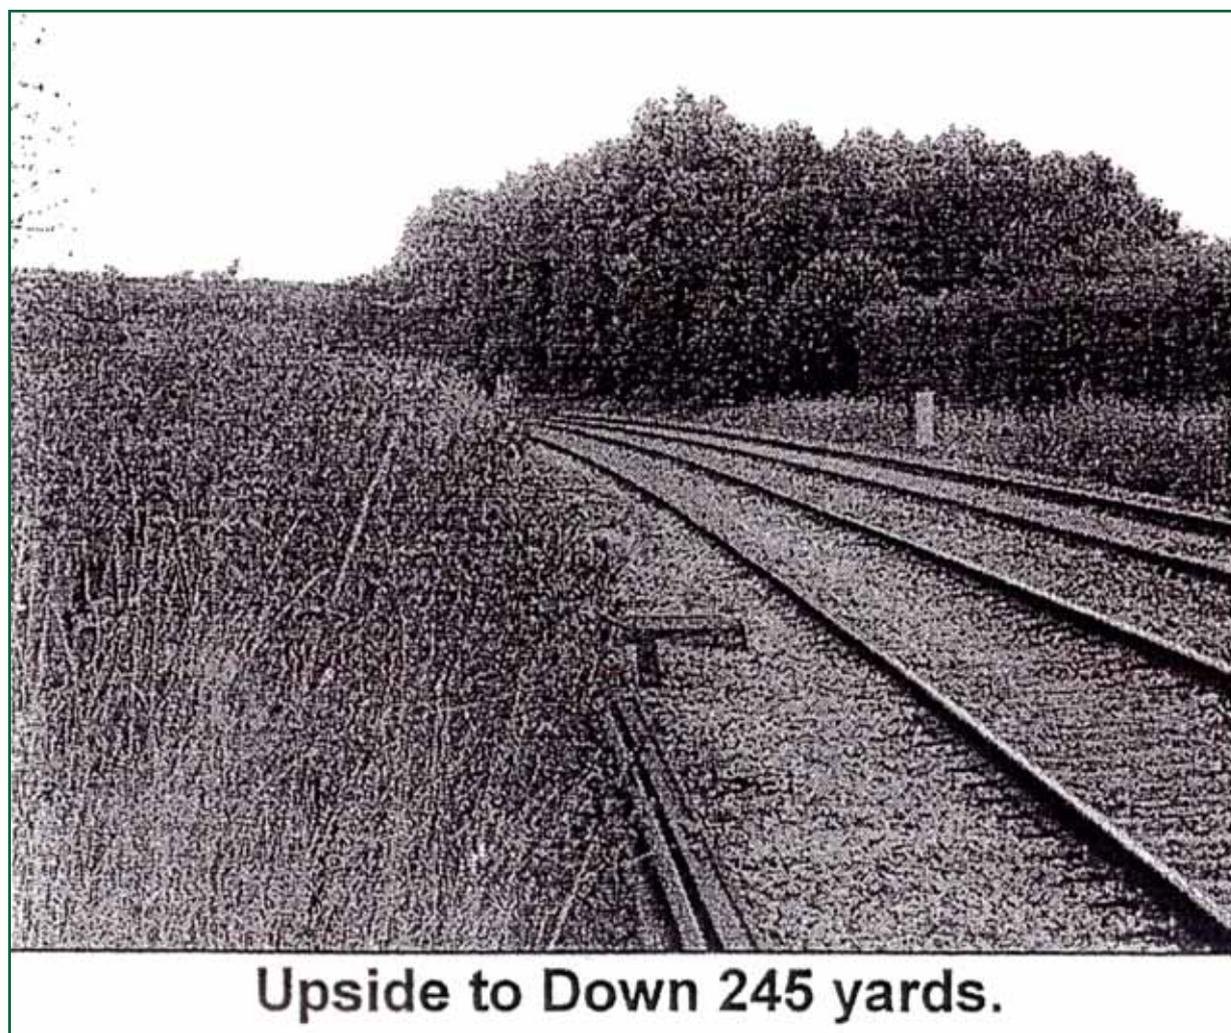
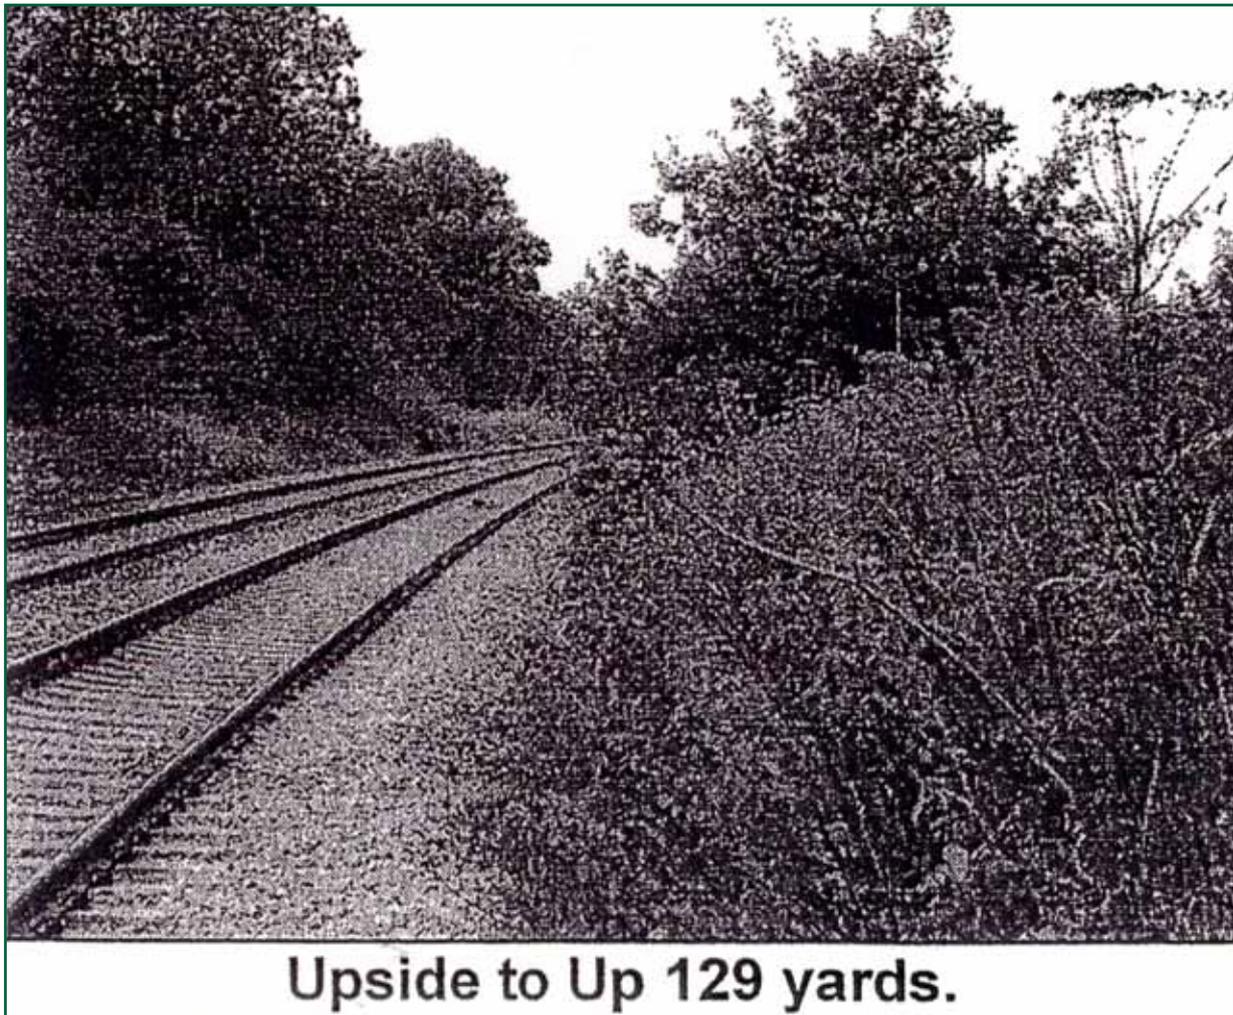
- 45 The MOM took photographs showing the effect which vegetation was having on the sighting distances on the up side (views C and D, figures 9 and 10). He recommended that the vegetation should be cut back. He noted that telephones were available for users, but that the signs did not invite pedestrians to make use of the telephones. He considered that the crossing was safe if the telephones were used, and suggested that signs should invite pedestrians to use the telephones before crossing from the up side. This assessment was not acted upon, possibly because at the time that it was done, an organisational change was taking place in the Western Route, with the central level crossing department for the route being disbanded and responsibility for level crossing management transferring to area level. There was a delay of six to eight weeks in the transfer of records and it seems likely that the report of the assessment was filed without being seen by the level crossing risk control co-ordinator for the area.

Figure 9: View C on 29 July 2006 (Network Rail)

Figure 10: View D on 29 July 2006 (Network Rail)

- 46 Some time after this assessment, Network Rail cut back the vegetation, removing bushes and small trees and cutting the grass on the slope of the shallow cutting on the up side of the line.

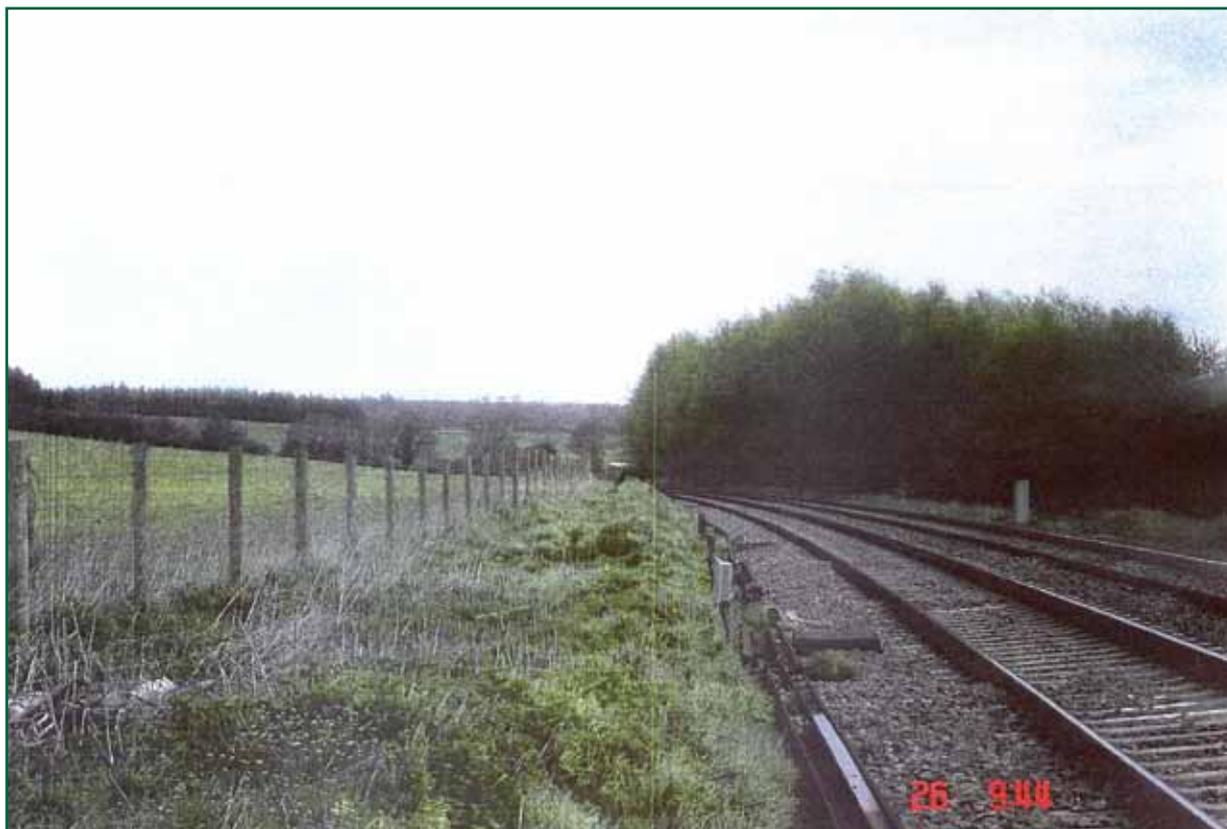
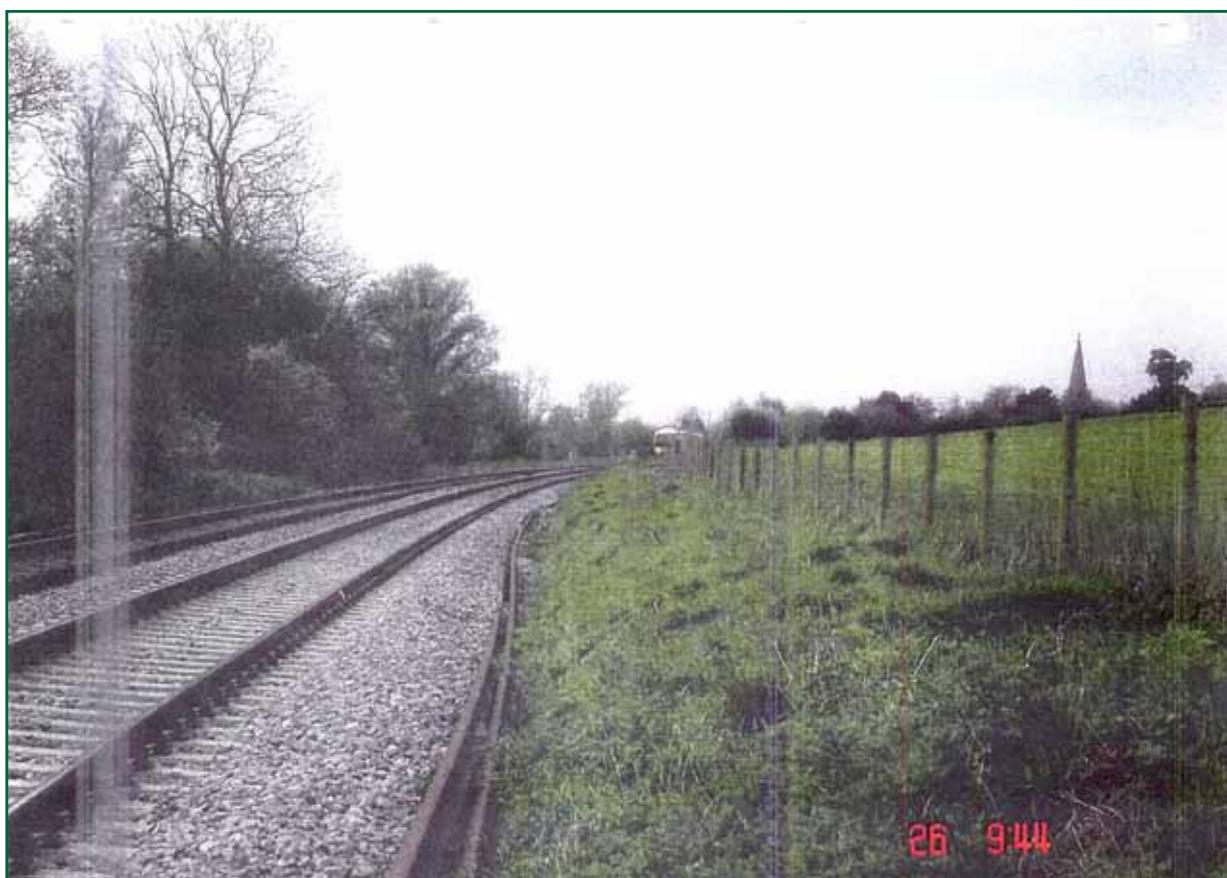
- 47 Fairfield crossing was put forward for risk assessment again in 2008, in the second year of the full ALCRM cycle of risk assessments of footpath crossings. The same MOM carried out another visit to collect data for risk assessment, on 26 May 2008. The pictures of views C and D that he took on this occasion are shown in figures 11 and 12. In both cases an approaching train is shown in the picture. The pictures show that the removal of vegetation has resulted in a considerable increase in sighting distance, as shown in the table.

Figure 11: View C on 26 May 2008 (photograph courtesy of Network Rail)

Figure 12: View D on 26 May 2008 (photograph courtesy of Network Rail)

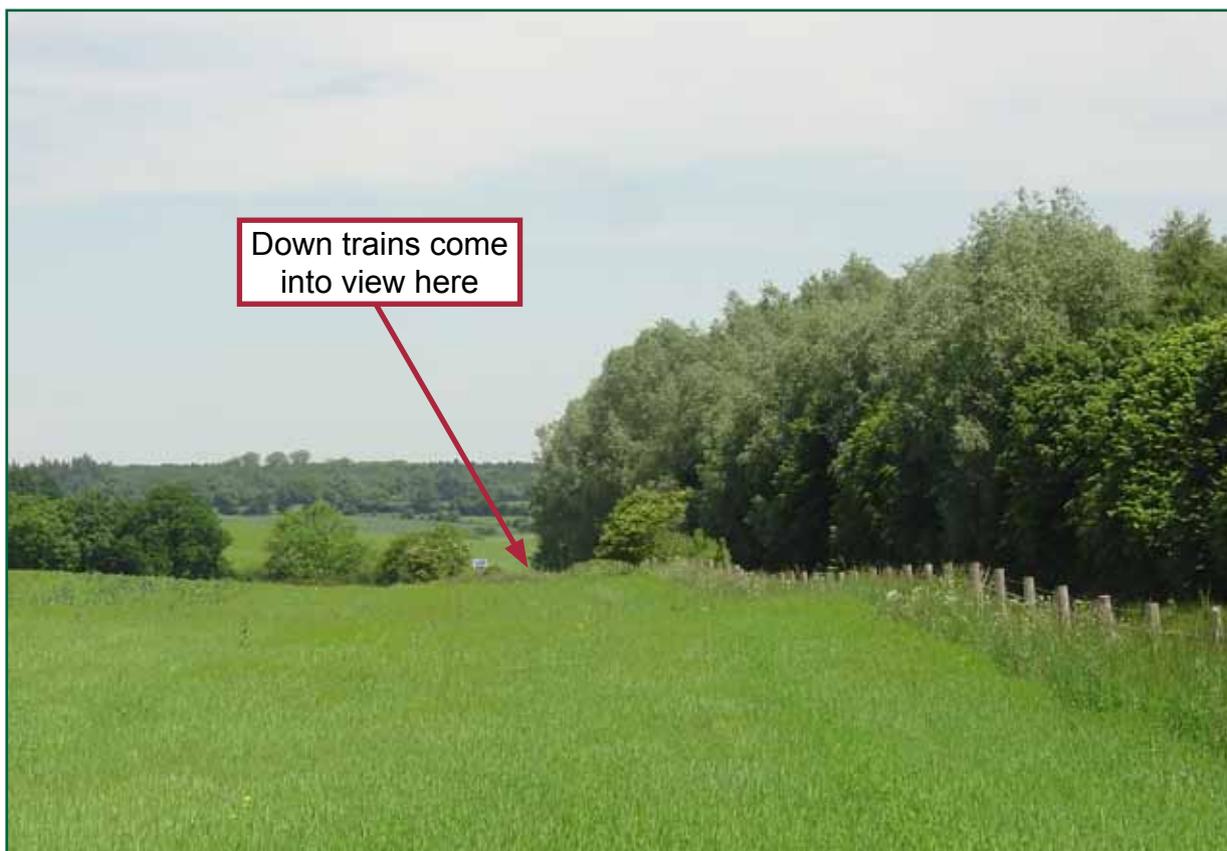
Figure 13: View from up side towards Newbury (view C) from 3 metres back from fence line

- 72 If Mrs Canning had begun to cross at the time the train became visible from a point two metres from the track, she would have been clear of the down line about 3 seconds before the train, travelling at about 69 mph, reached the crossing. The sub-standard sighting time was not a causal factor in this accident. However, if the train had been an express travelling at the permitted line speed of 100 mph, it would have reached the crossing 6.4 seconds after coming into view and there would not have been time for a pedestrian to get clear of the line.
