Rail Accident Investigation Branch

Rail Accident Report

Derailment of a passenger train near Cummersdale, Cumbria 1 June 2009

Report 06/2010
March 2010

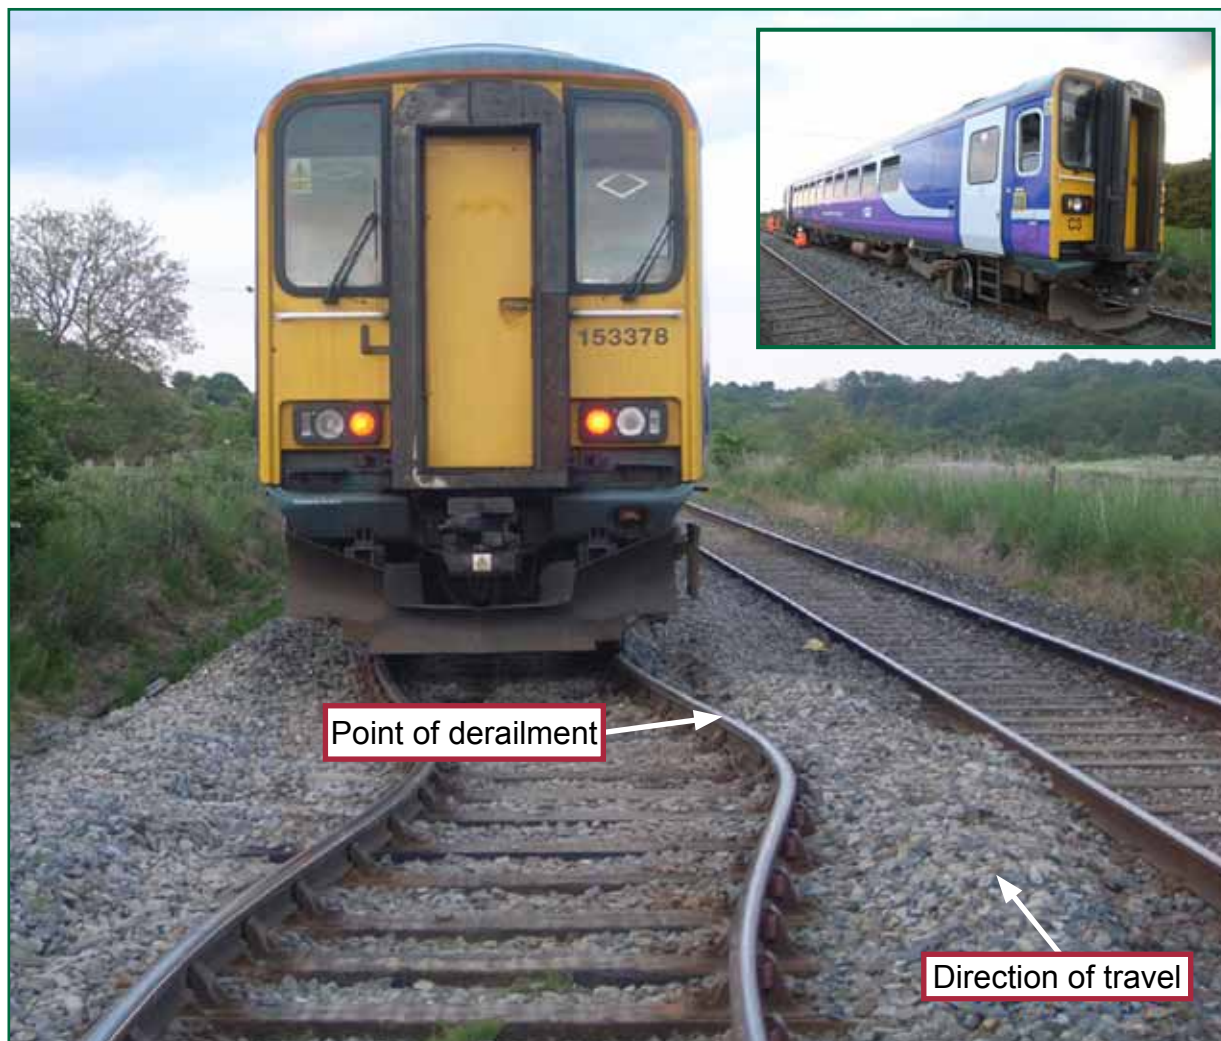
- 6 There were no injuries among the 15 passengers and two crew on board. Damage to the single car train was principally around the leading bogie and surrounding vehicle body. Damage to the track arising directly from the track buckle and derailment was confined to a length of about 30 metres around the point of derailment. However, more extensive repairs to stabilise the track over a distance of approximately 1.6 km were carried out. Figure 2 shows the track buckle and derailed train.

Figure 2: The derailed train showing the track buckle and the rear of the train 2C31 and (inset) the front of the train and derailed leading bogie

- 7 The line was closed until 05:00 hrs on 3 June 2009 when it was initially opened with a temporary speed restriction of 20 mph (32 km/h). Full line speed operation was restored on 10 June 2009, after the track had been *tamped*.

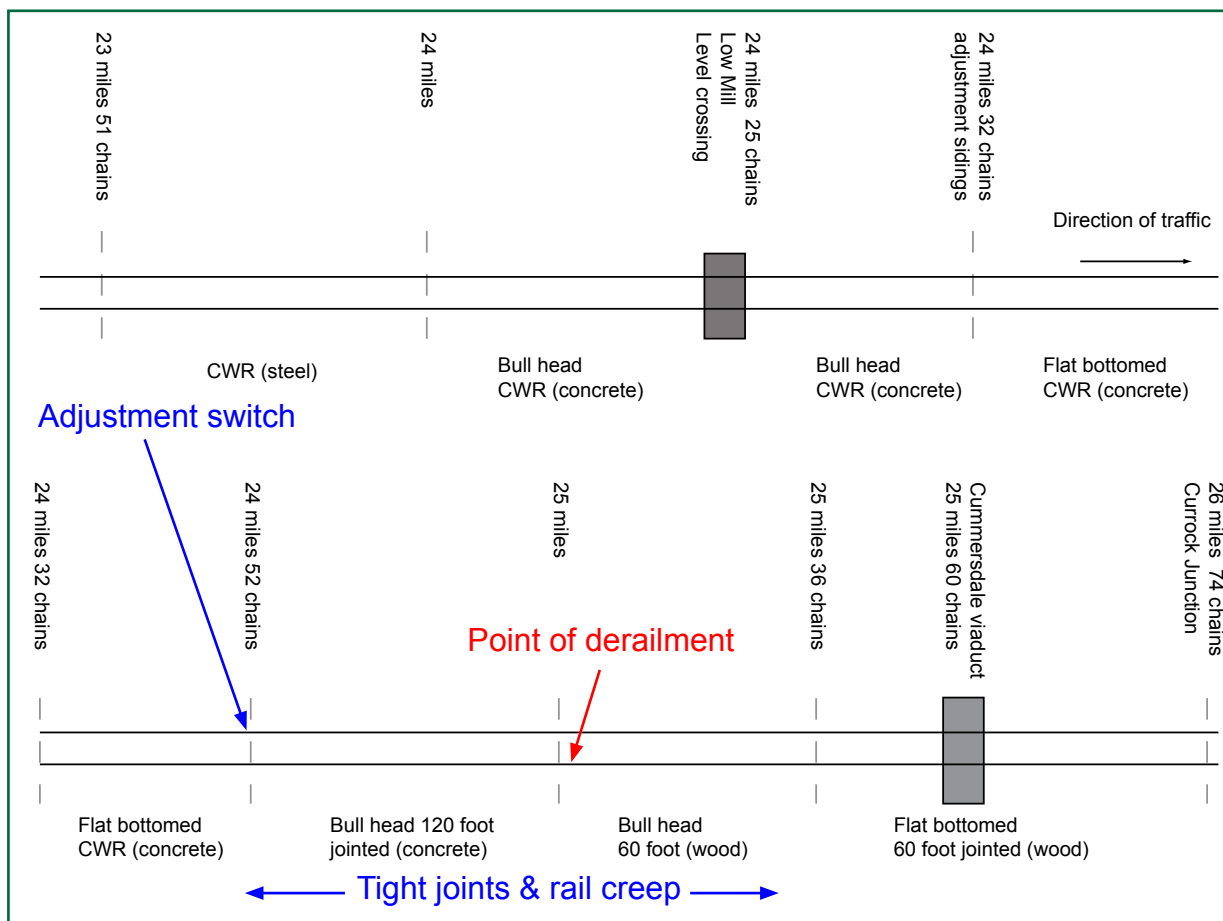
Figure 3: Track schematic showing variation in construction in relation to point of derailment

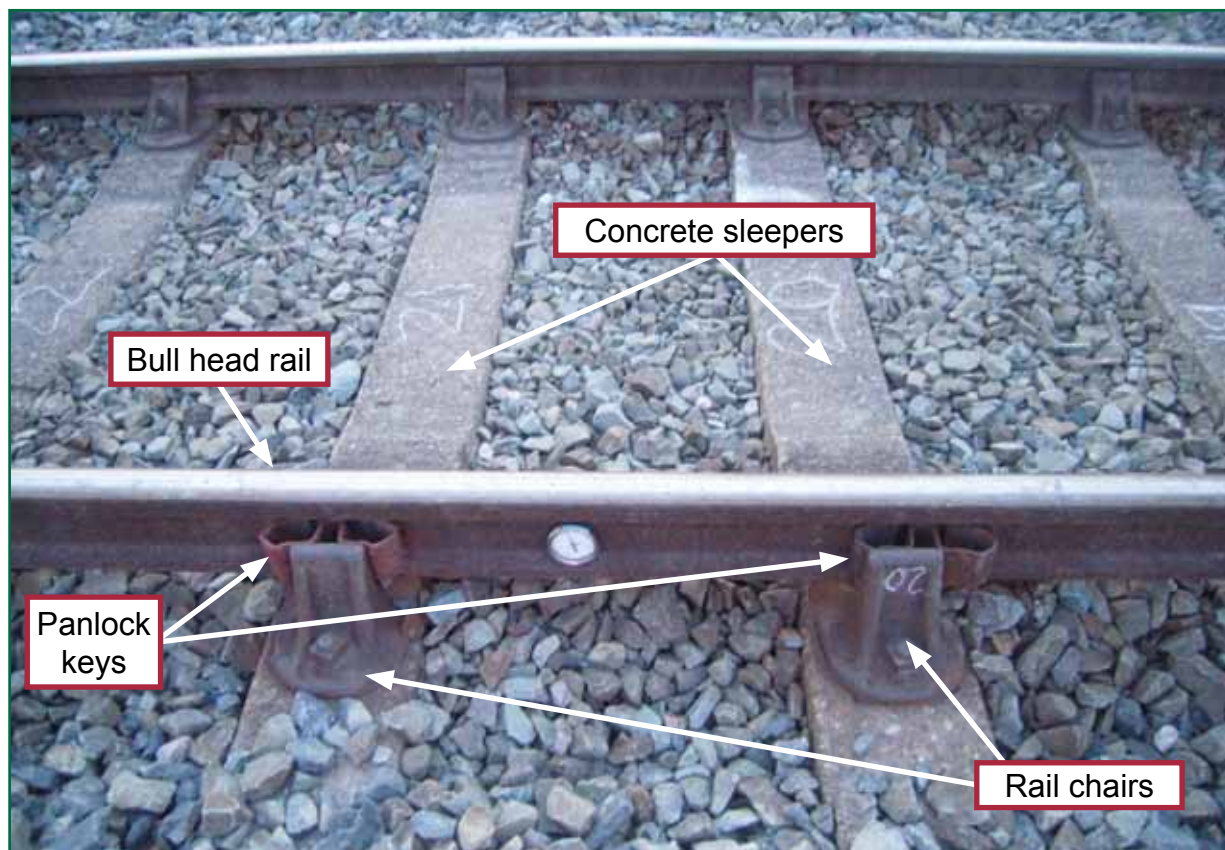
Figure 4: Construction of the down line on approach to the point of derailment

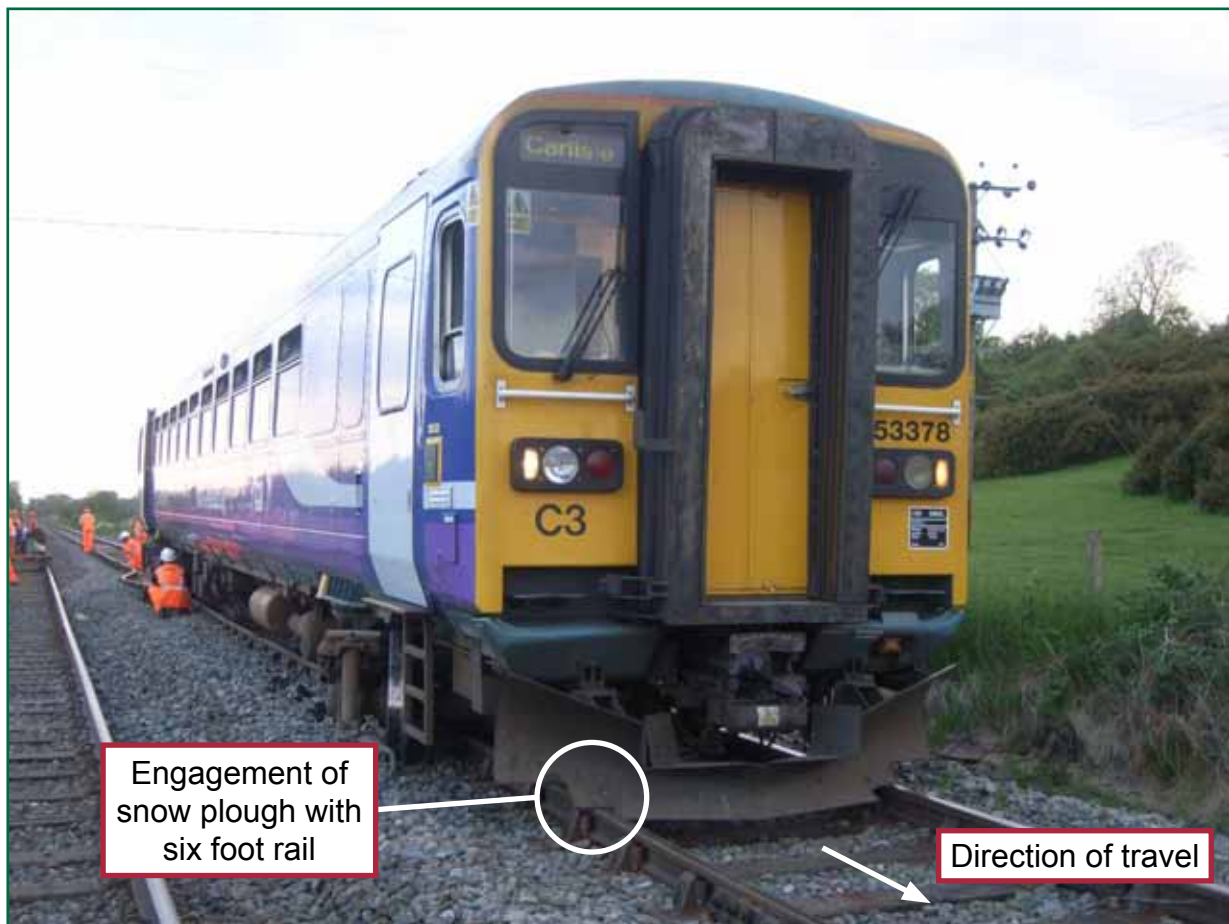
Figure 5: Leading end of unit 153378, showing positions of right-hand wheels and engagement of snow plough with right-hand rail

- The derailed vehicle stayed close to the down line partly because a recess in the lower right-hand edge of the snow plough engaged with the six-foot rail and provided guidance for the leading end of the vehicle. The RAIB has previously made recommendations on examining the practicability of design elements on the bogie which limit the degree of deviation from the track, following other derailments^{9,10}. The RSSB, to which those recommendations were addressed, reported that its conclusion from an initial technical study was that the current risk is as low as reasonably practicable and therefore no changes to vehicle design standards could be recommended; however consideration should be given to providing infrastructure based protection at sensitive locations.

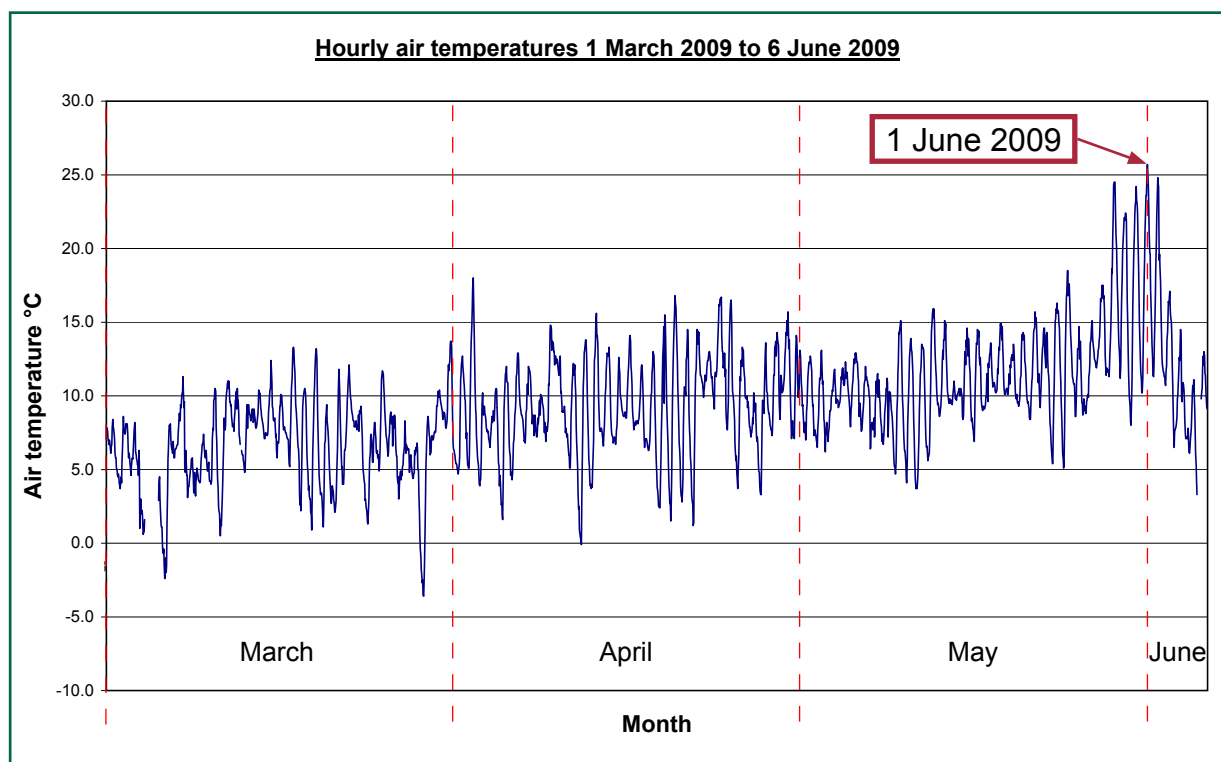
- 41 Air temperature data for the southern Carlisle area shows that during the first half of 2009, the maximum was reached on 1 June 2009, peaking at 25.5°C. This temperature is not abnormal. The variation of temperature between 1 March and 6 June 2009 is shown in figure 6.

Figure 6: Air temperatures for South Carlisle area 1 March - 6 June 2009

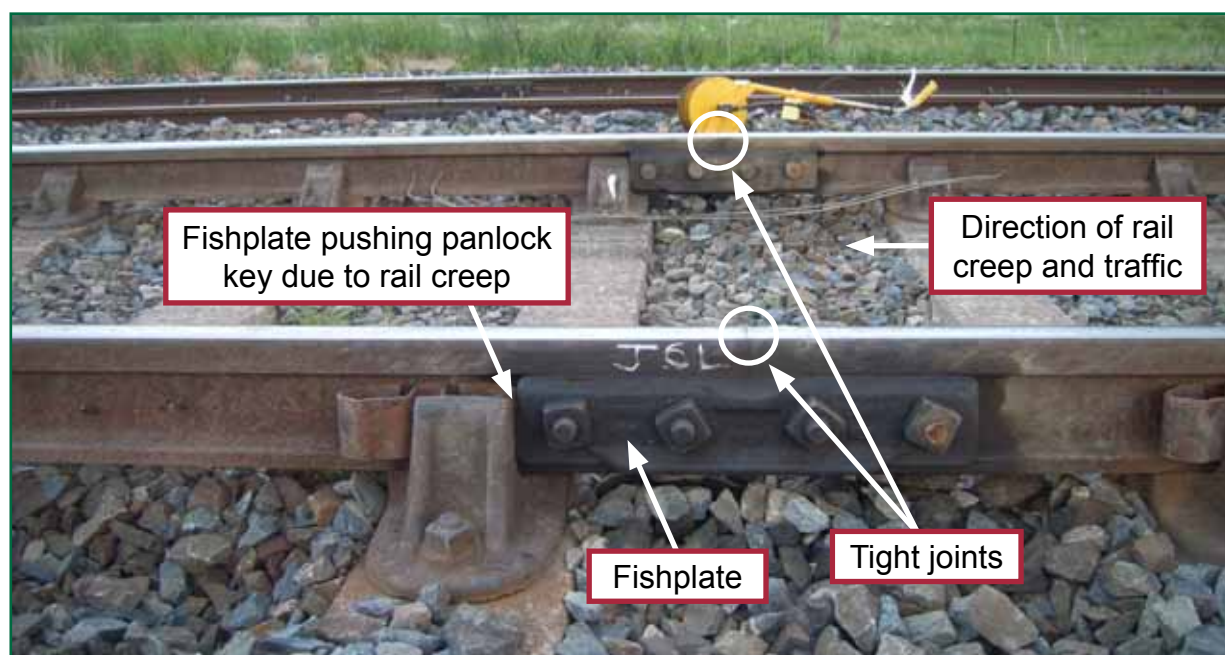
- 50 The control of rail creep at the derailment site had not been effective, resulting in accelerated closure of the installed expansion gaps and this was a causal factor.
- 51 There was clear evidence of extensive rail creep at several joints on the approach to the point of derailment. Figure 7 shows the degree of rail creep at one of these joints on the down line. The rail joint, which should be in the middle of the space between the sleepers, had moved longitudinally in the direction of traffic such that it was bearing on and pushing out the Panlock key. The effect of rail creep could be seen on most of the joints on the approach to the point of derailment, although some of the movement seen after the derailment could have resulted from the formation of the track buckle itself.

Figure 7: Tight joints and rail creep at the Cummersdale site

- 54 Tight joints observed in the vicinity of the derailment site were not reported because patrollers and maintainers were not aware of the sensitivity of this site to joint closure and buckling. Had they been reported, timely remedial action might have been taken and this was a probable causal factor.

- 107 Network Rail repaired the track at the derailment site, carried out rail adjustment, installed additional rail anchors and removed Panlock keys to minimise the risk of further track buckles. It also made organisational changes and carried out briefings to front line staff on relevant track standards.
