Rail Accident Investigation Branch

Rail Accident Report

Derailment of a Docklands Light Railway train near West India Quay station, London, 10 March 2009

Report 03/2010
March 2010

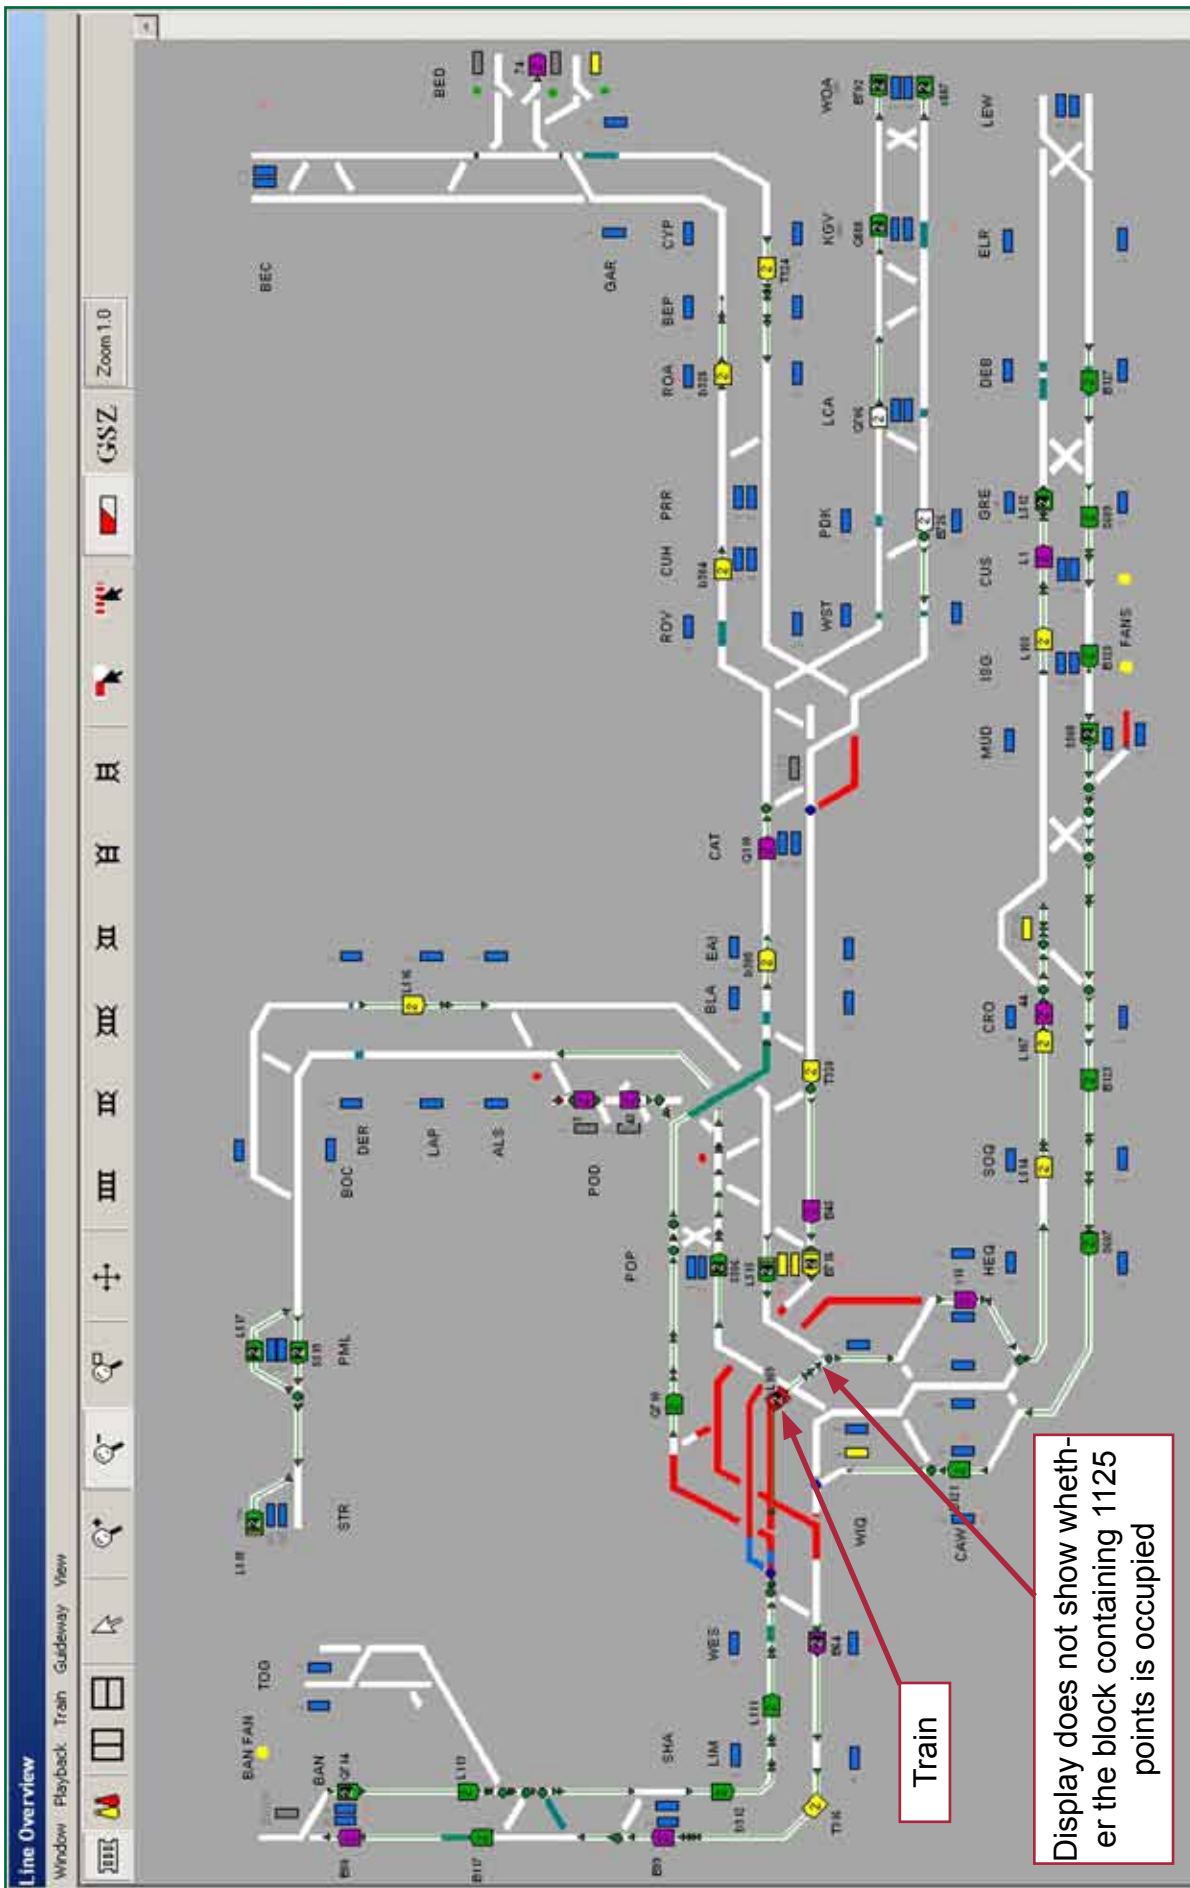
Figure 3: Line overview screen display at 07:42 hrs with the block occupancy turned off

- 76 Figures 3 to 6 show the differences between overview screens with block occupancy turned off and on. They also demonstrate the effect of the position of a train at the delta and how this is displayed to the controller. The delta area shows the closed sections of track (in red) caused by the axle counter block that had become disturbed. These screen displays were obtained from the 'playback' facility of the SMC (for 10 March 2009).

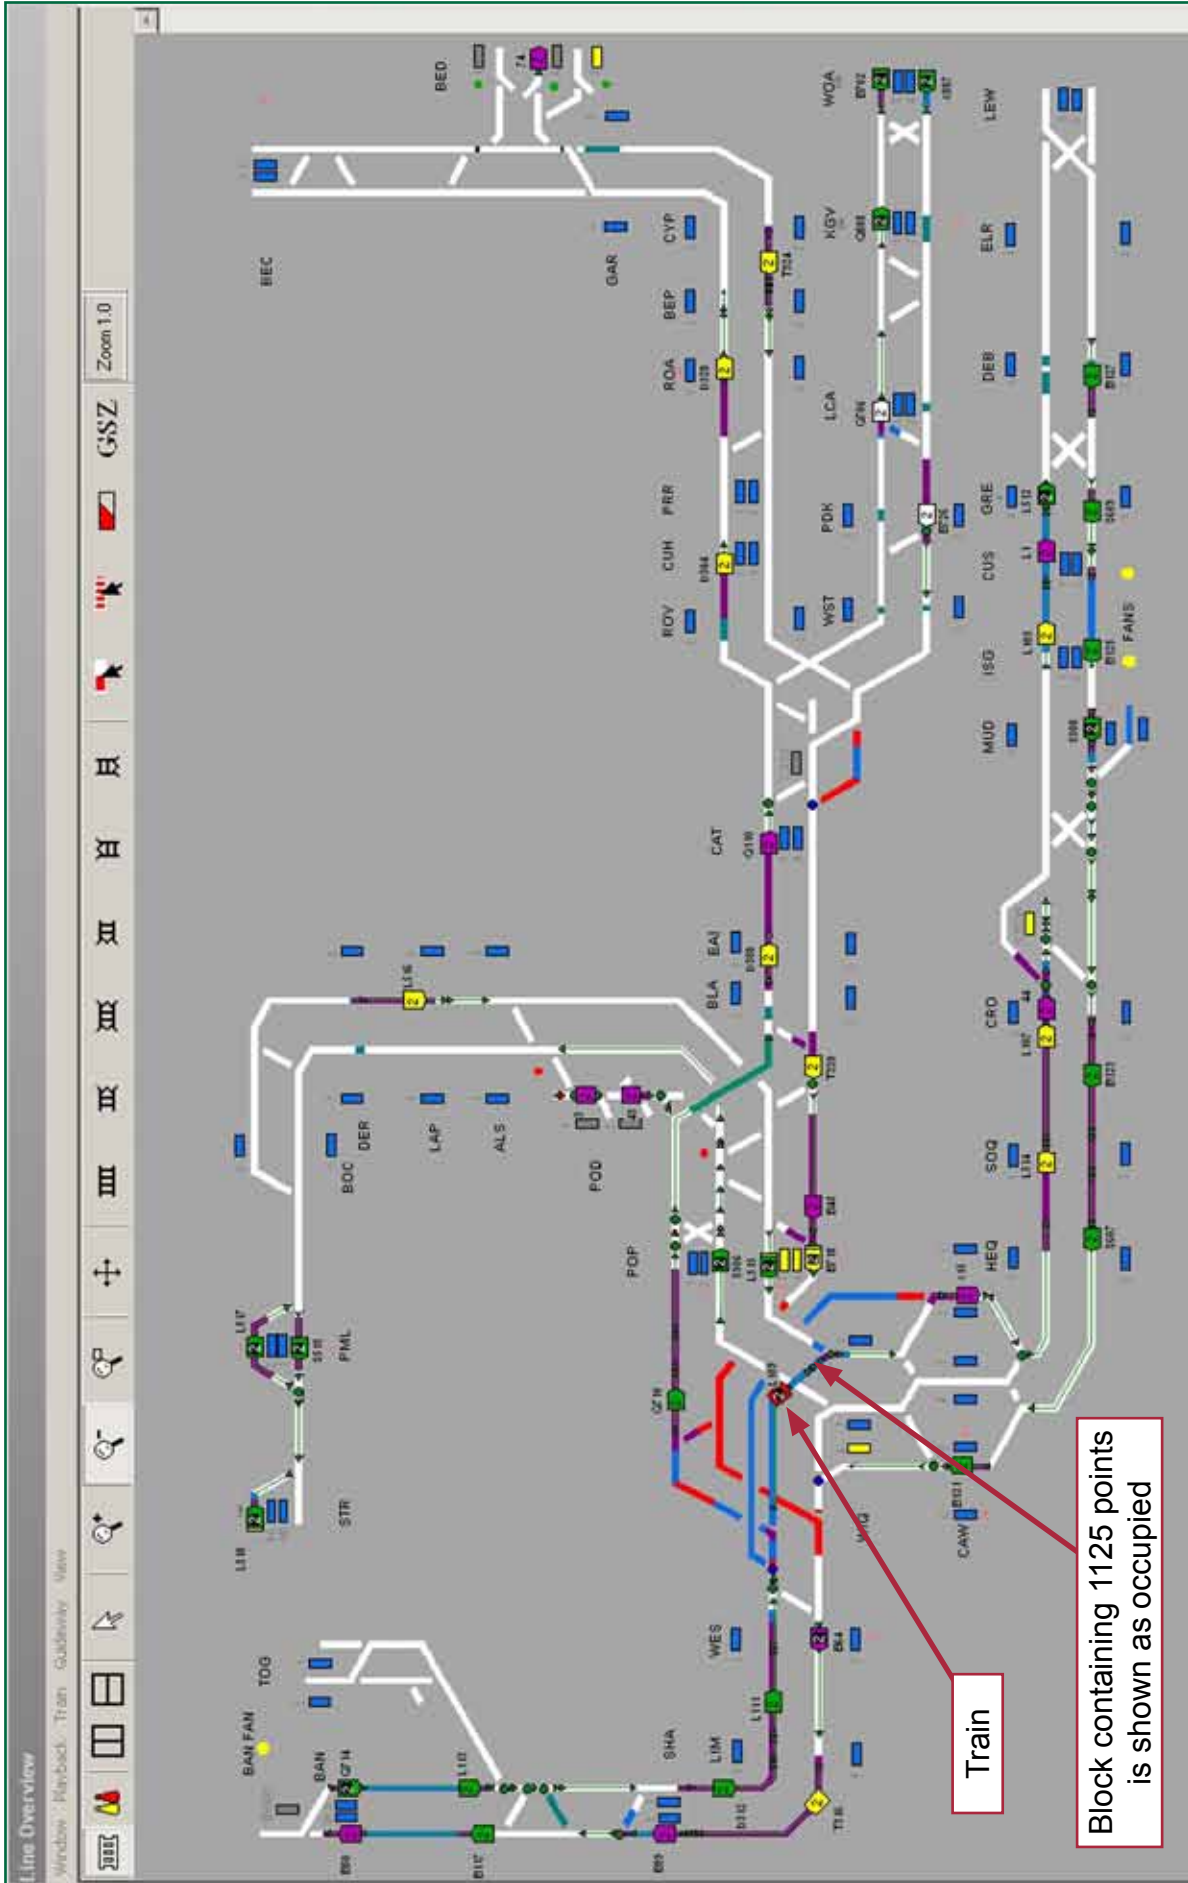
Figure 4: Line overview screen display at 07:42 hrs with the block occupancy turned on

Block containing 1125 points is shown as occupied

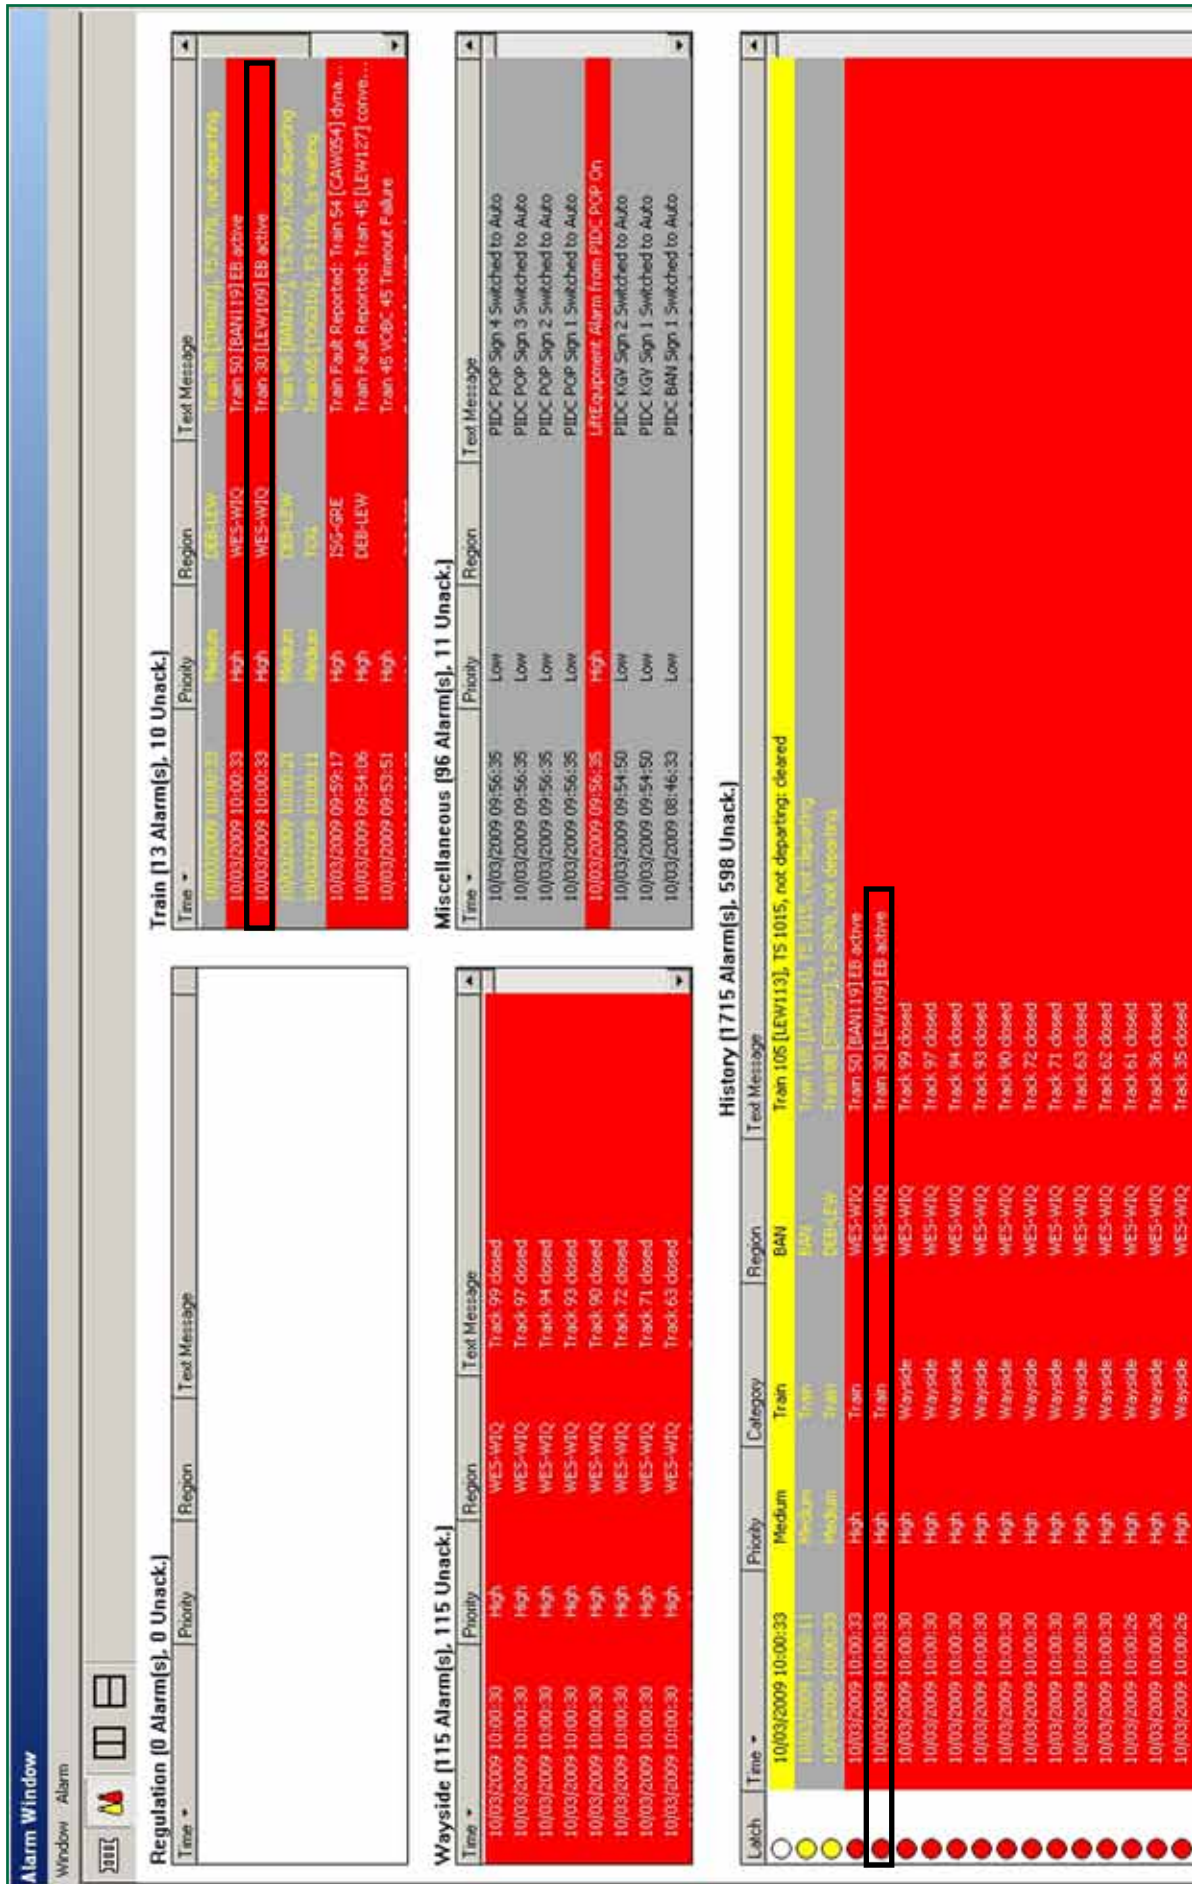
Figure 8: Alarm overview screen at 10:00:33 hrs displaying all alarms

- 85 Figure 8 shows the alarm overview screen that the controller could have seen at 10:00:33 hrs, if the screen had been configured to display all alarms. Train LEW109 emergency brake application (E.B. active) can be seen displayed at 10:00:33 hrs under both the train and history category headings on the screen.

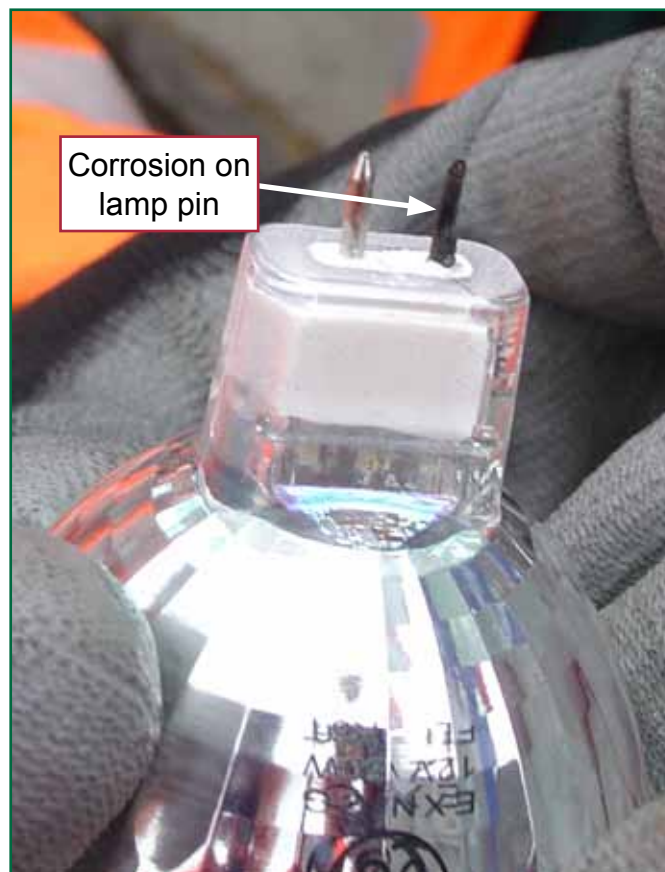
Figure 9a: Lamp from 1125B red bar indicator

117 Following the derailment, the RAIB found that the lamp associated with the illumination of the red bar indication was not functioning because one of its connection pins was corroded (figure 9a).

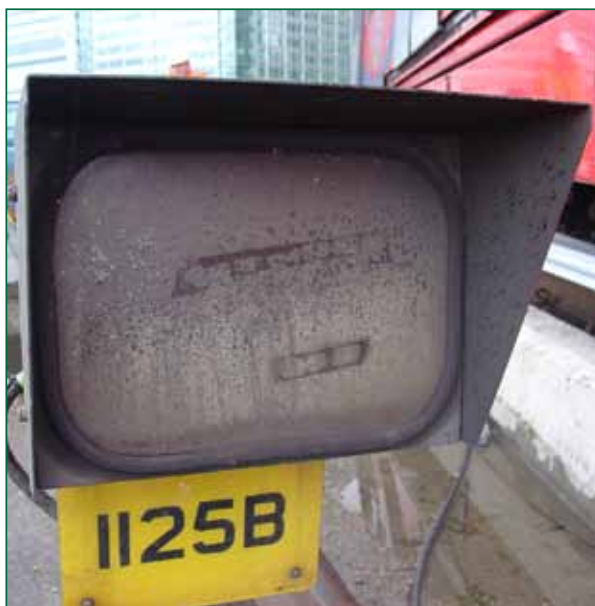
Figure 9b: 1125B point position indicator when unlit

118 Figure 9b shows 1125B point position indicator when unlit. This photograph was taken on 10 March 2009 at 14:15 hrs. The rear of derailed train LEW109 can be seen alongside the indicator.

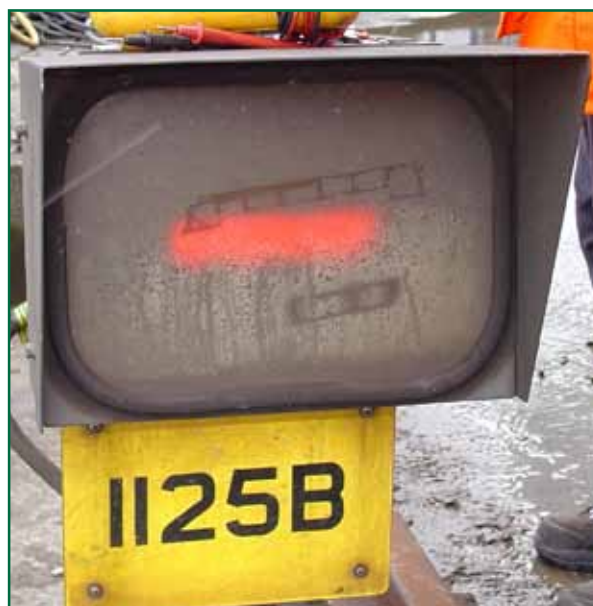
Figure 9c: 1125B point position indicator displaying a red bar

119 Figure 9c shows 1125B point position indicator displaying a red bar. This photograph was taken on 10 March 2009 at 15:20 hrs after the lamp pins had been cleaned and the lamp inserted back into the indicator.

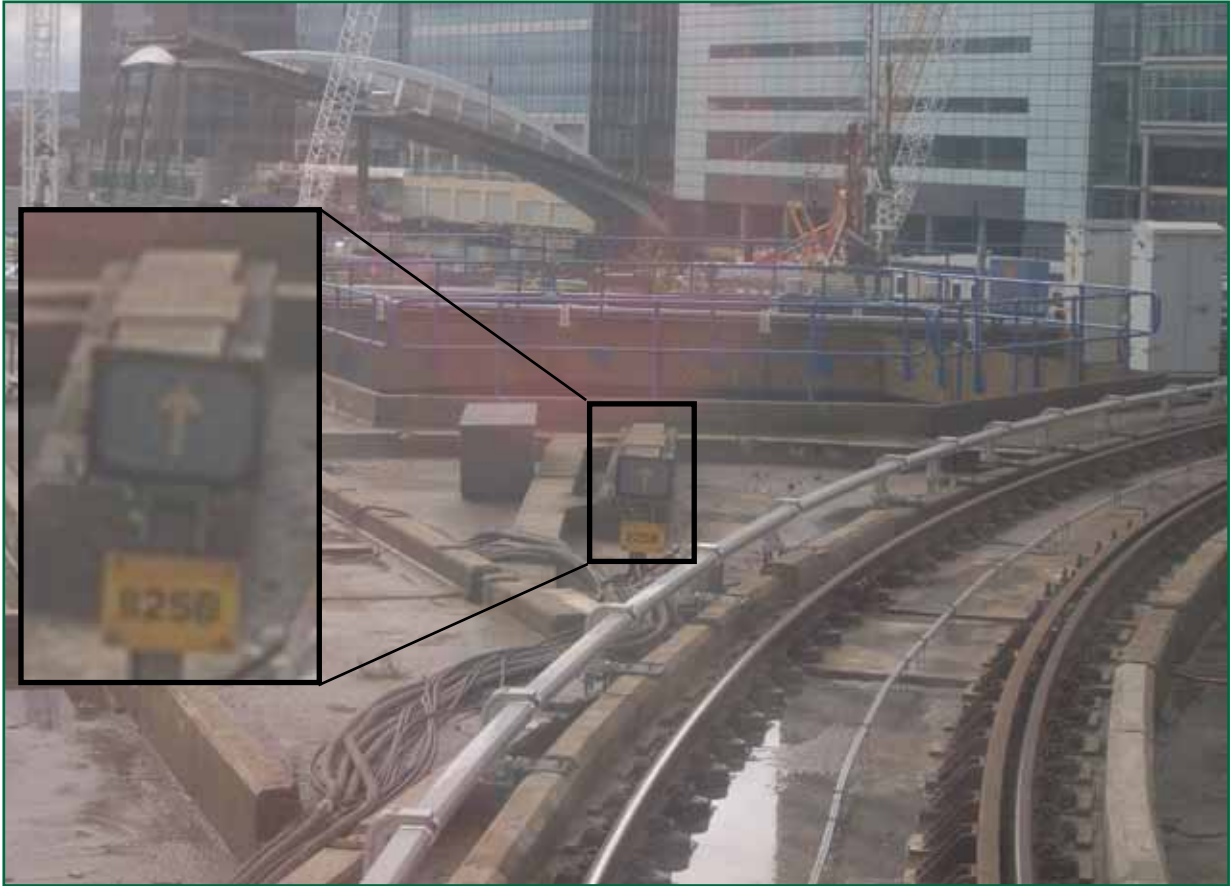
Figure 10: 1125B point position indicator displaying a white arrow and viewed from a stationary train in approximately the same position as train LEW109 was after emergency braking

121 Following the derailment on 10 March, the 1125B point position indicator was removed from site for further testing. A replacement indicator (of the same type) was installed and photographed with a white arrow displayed. Figure 10 shows the 1125B indicator, displaying a white arrow, as viewed from a test train that was located at the approximate position occupied by train LEW109 after the emergency brakes had applied.

123 There is no evidence to suggest that sunlight either behind or reflecting onto the front of 1125B point position indicator could have made the white arrow difficult to see.

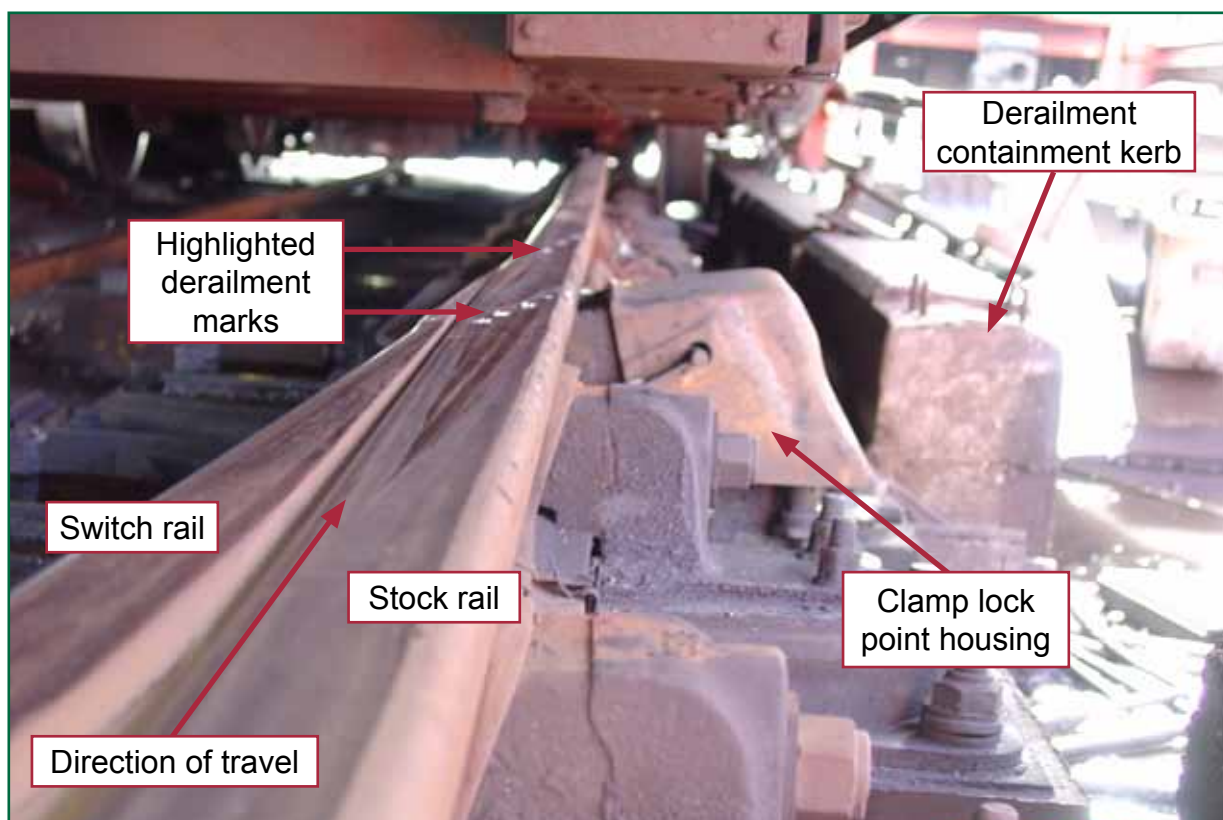
Figure 12: Picture of the derailment path and the derailed bogie of car 86 taken in the direction of travel. Note the highlighted derailment marks on the right-hand stock rail

- 174 As the train approached 1125 points in the trailing direction the flange of the right-hand wheel of the first bogie hit the back of the switch rail where it was hard against the *stock rail*. The flange was unable to 'push through' and split the switch rail from the stock rail because of the light weight of the train in relation to the force exerted by the clamp lock points (3.3 kN). As a result, the flange climbed the rail, rode along the top of the stock rail and dropped off into the gap between the right-hand rail and the derailment containment kerb. Figure 12 shows the derailment path of the two axles across the right-hand stock rail.
