Rail Accident Investigation Branch

Rail Accident Report

Derailment of a freight train near Stewarton, Ayrshire 27 January 2009

Report 02/2010
February 2010

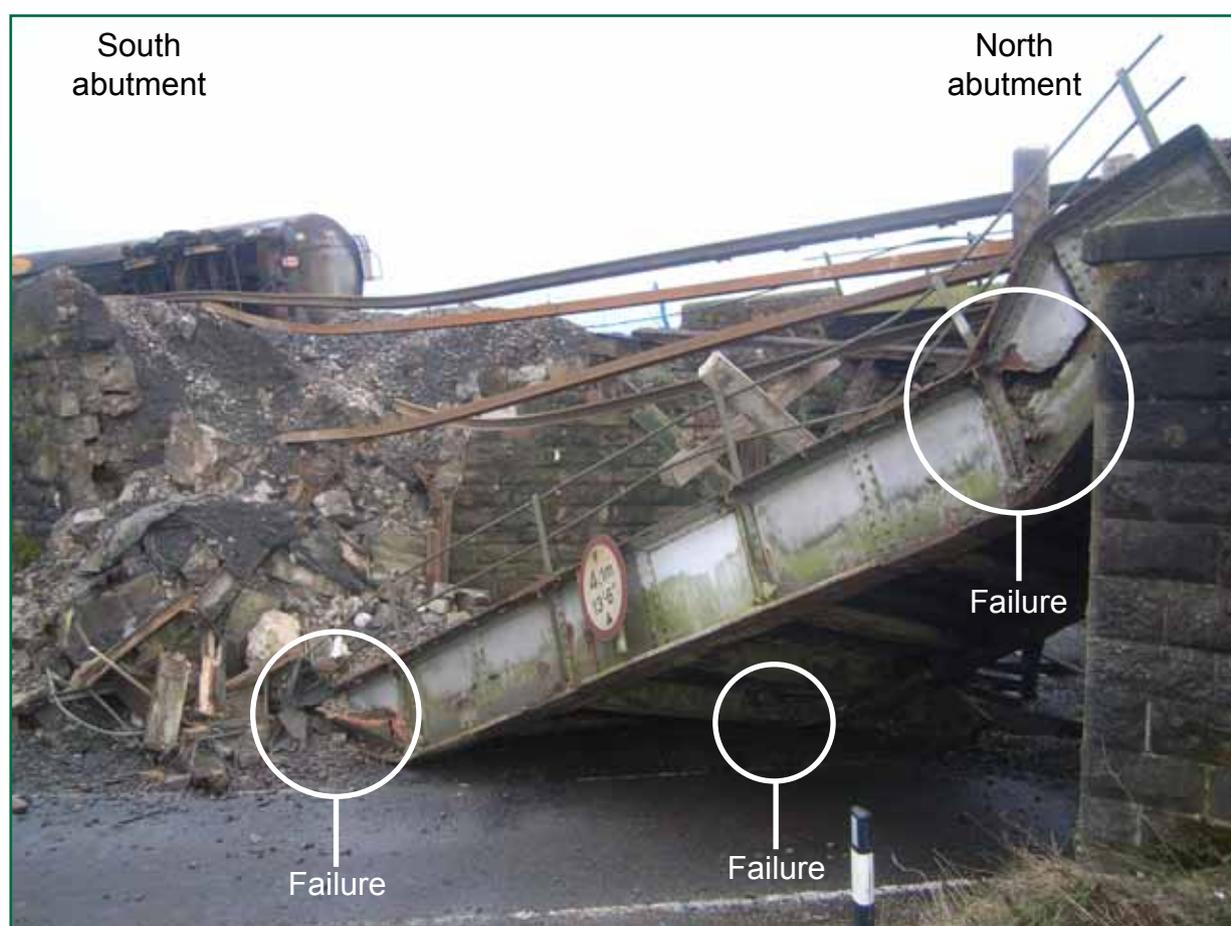
- 13 The main girders that supported the east side of Bridge 88 failed and fell to the A735 road below, together with other debris and masonry from the south *abutment*, a major part of which was destroyed.

Figure 9: Bridge 88 after the derailment - east side (reflective yellow and black hatching road sign has been removed to reveal the condition of the east main girder)

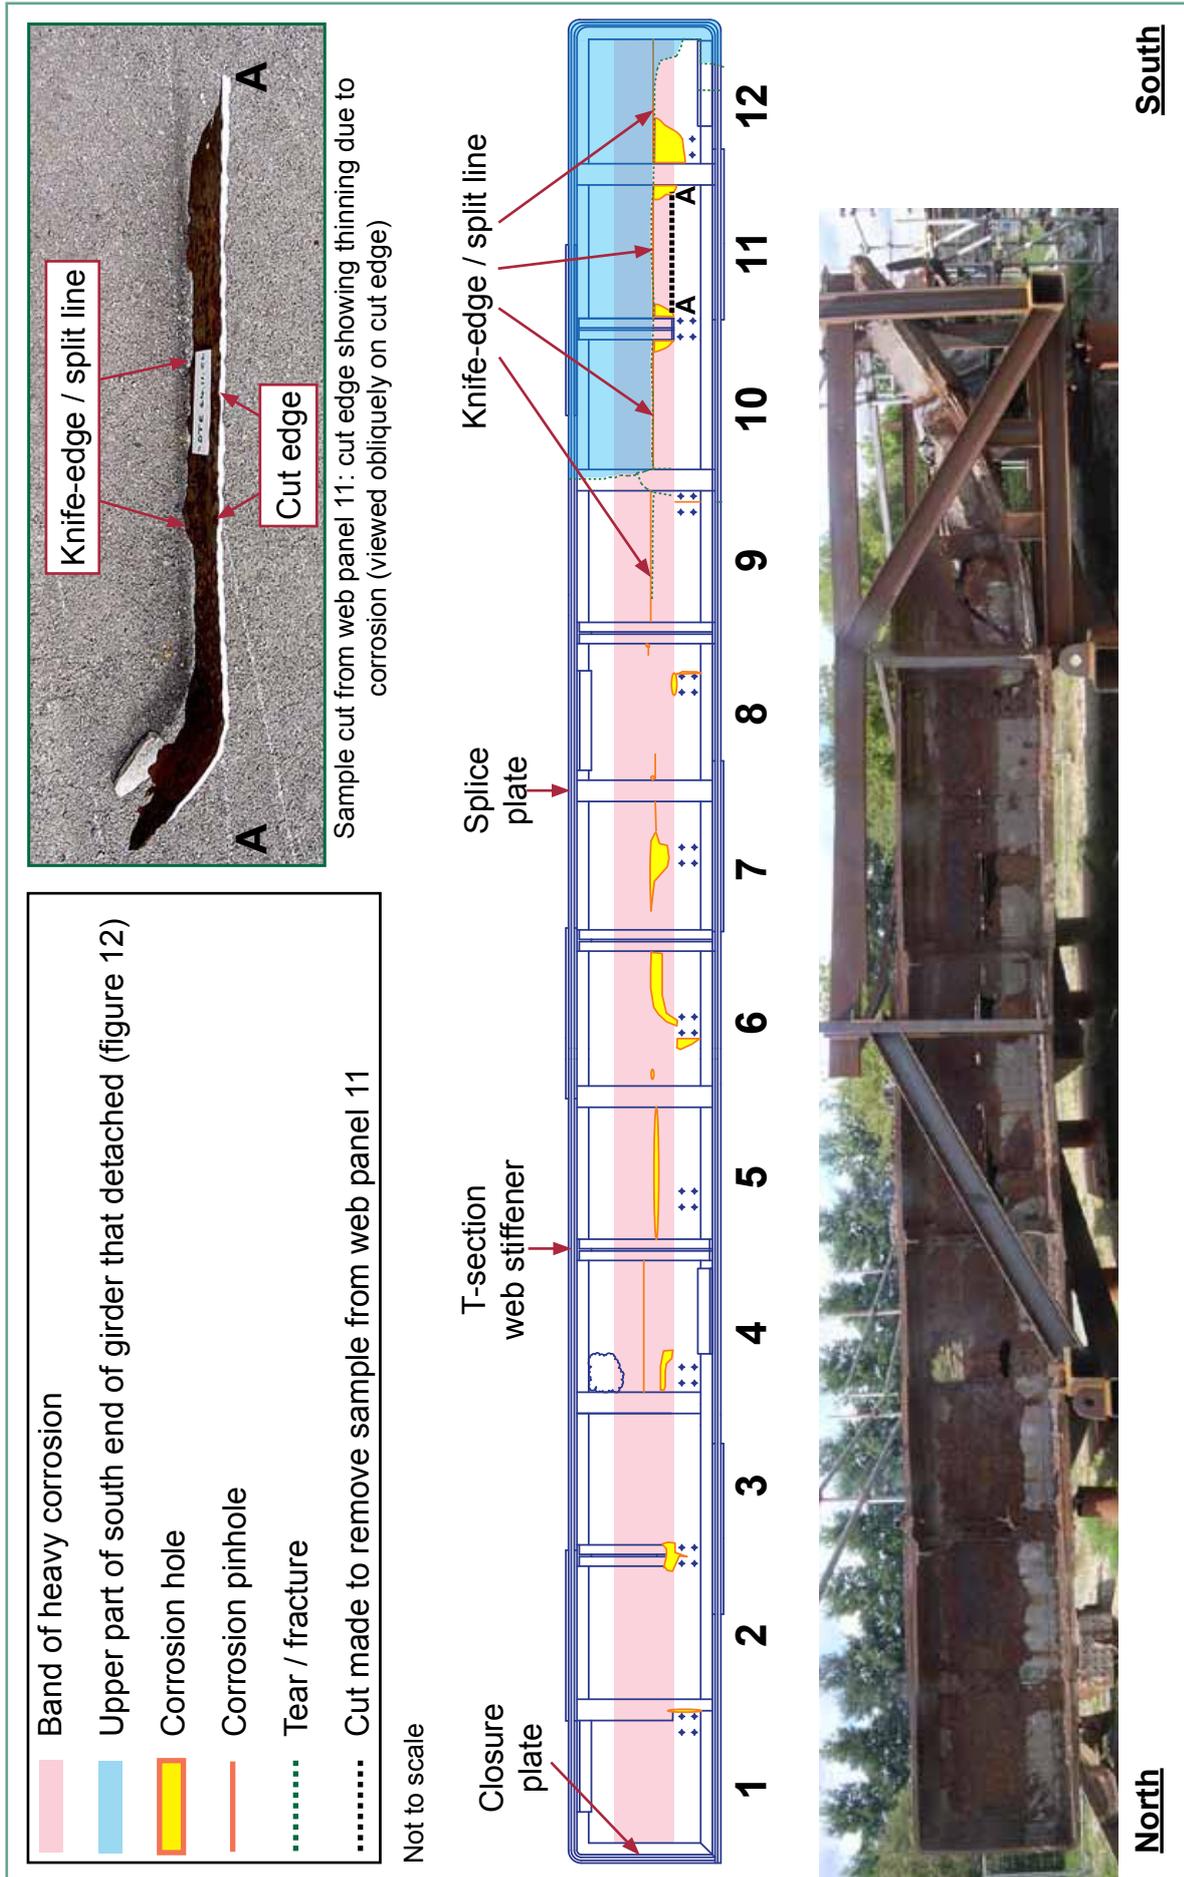
Figure 10: Condition of the centre main girder. Inset shows sample cut from web panel 11 (Note: due to the damage that occurred as a result of the bridge collapse and the limitations in recording the nature of the corrosion, the shape and size of the defects are shown for illustrative purposes only)

- 103 The horizontal band of heavy corrosion affected both surfaces of the centre main girder web plate - there was material loss throughout its length. At mid-span, web panels 4 to 7, the corrosion was so severe that significant holes had formed. At the south end, the web thickness had reduced to a knife-edge that extended along a horizontal line, at mid-height, from the centre of web panel 9 through to panel 12. Pinhole-like perforation had occurred along the knife-edge and both panels 11 and 12 had holes in them. The key features of the centre main girder condition are illustrated in figure 10. The inset shows a sample cut from the web plate at panel 11. It is from just below the horizontal knife-edge line and illustrates the thickness reduction that had occurred.

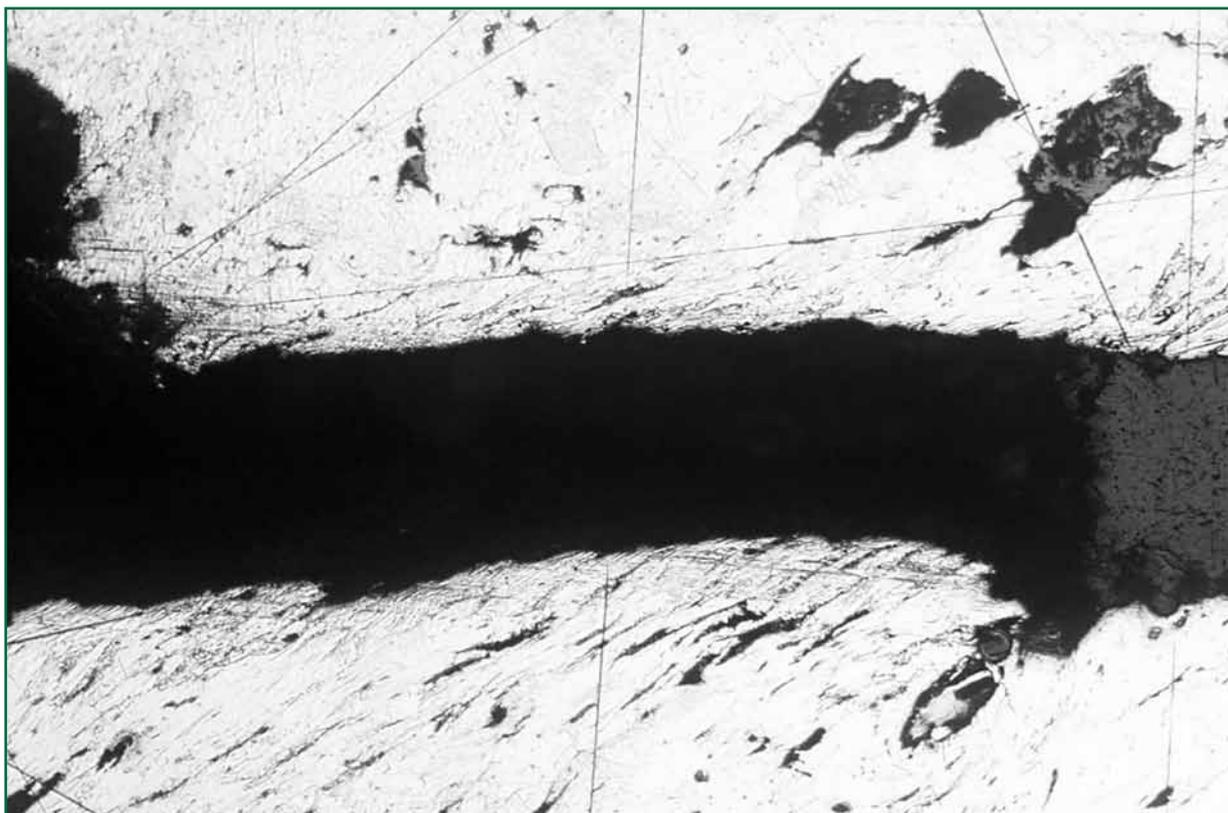
- 107 The failure at the south end of the centre main girder was of particular interest. Here, the girder had split along the horizontal knife-edge line (paragraph 103), and a section, comprising the upper parts of web panels 10 to 12, became detached (figure 10). One of two samples taken from this interface showed evidence of slip, of a microscopic scale, along this line (figure 11). This indicates that horizontal movement had been occurring along the split, and therefore that the web plates were no longer carrying the shear stresses required for the upper and lower parts of the I-beam to work together as a single effective structural member.

Figure 11: Micro-section through the mating surfaces along the knife edge line that had formed on the web plate on the south end of the centre main girder - sample taken from web panel 11

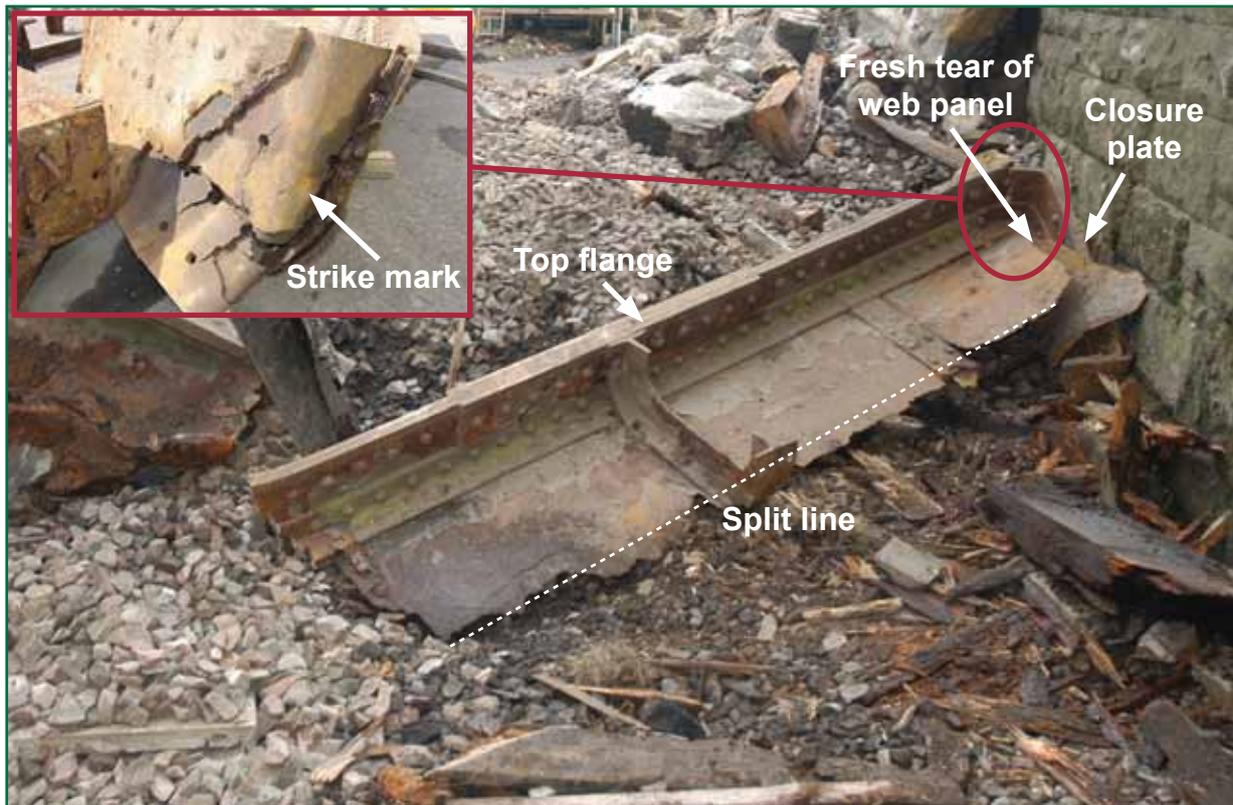
108 On the section that detached, the *closure plate* (the vertical plate at the end of the girder) had folded to form an acute angle with the top flange. To accommodate this, the web tore to the upper corner, and the outer layers¹¹ of the flange fractured and parts broke off (figure 12). There was a strike mark on the flange material freshly exposed by this de-layering that was consistent with impact from the train (figure 12 inset); there was no corresponding mark on the part that broke off. This supports the scenario of the flange fracturing suddenly, and while the girder was still in an elevated position - exposed to the passing train. The folding is therefore unlikely to be a consequence of the girder falling and then hitting the road. It is, however, consistent with upper and lower parts of the beam flexing independently, because the web plate could not carry the required shear stress, and then the flanges, suddenly having too much load transferred to them, fracturing, resulting in catastrophic failure. There was no evidence to indicate failure due to pre-existing fractures on the flanges – for instance, due to *fatigue* crack growth.

Figure 12: Upper part of the south end of the centre main girder showing the horizontal split line, the folded closure plate and fractured flanges (main photograph courtesy of British Transport Police)

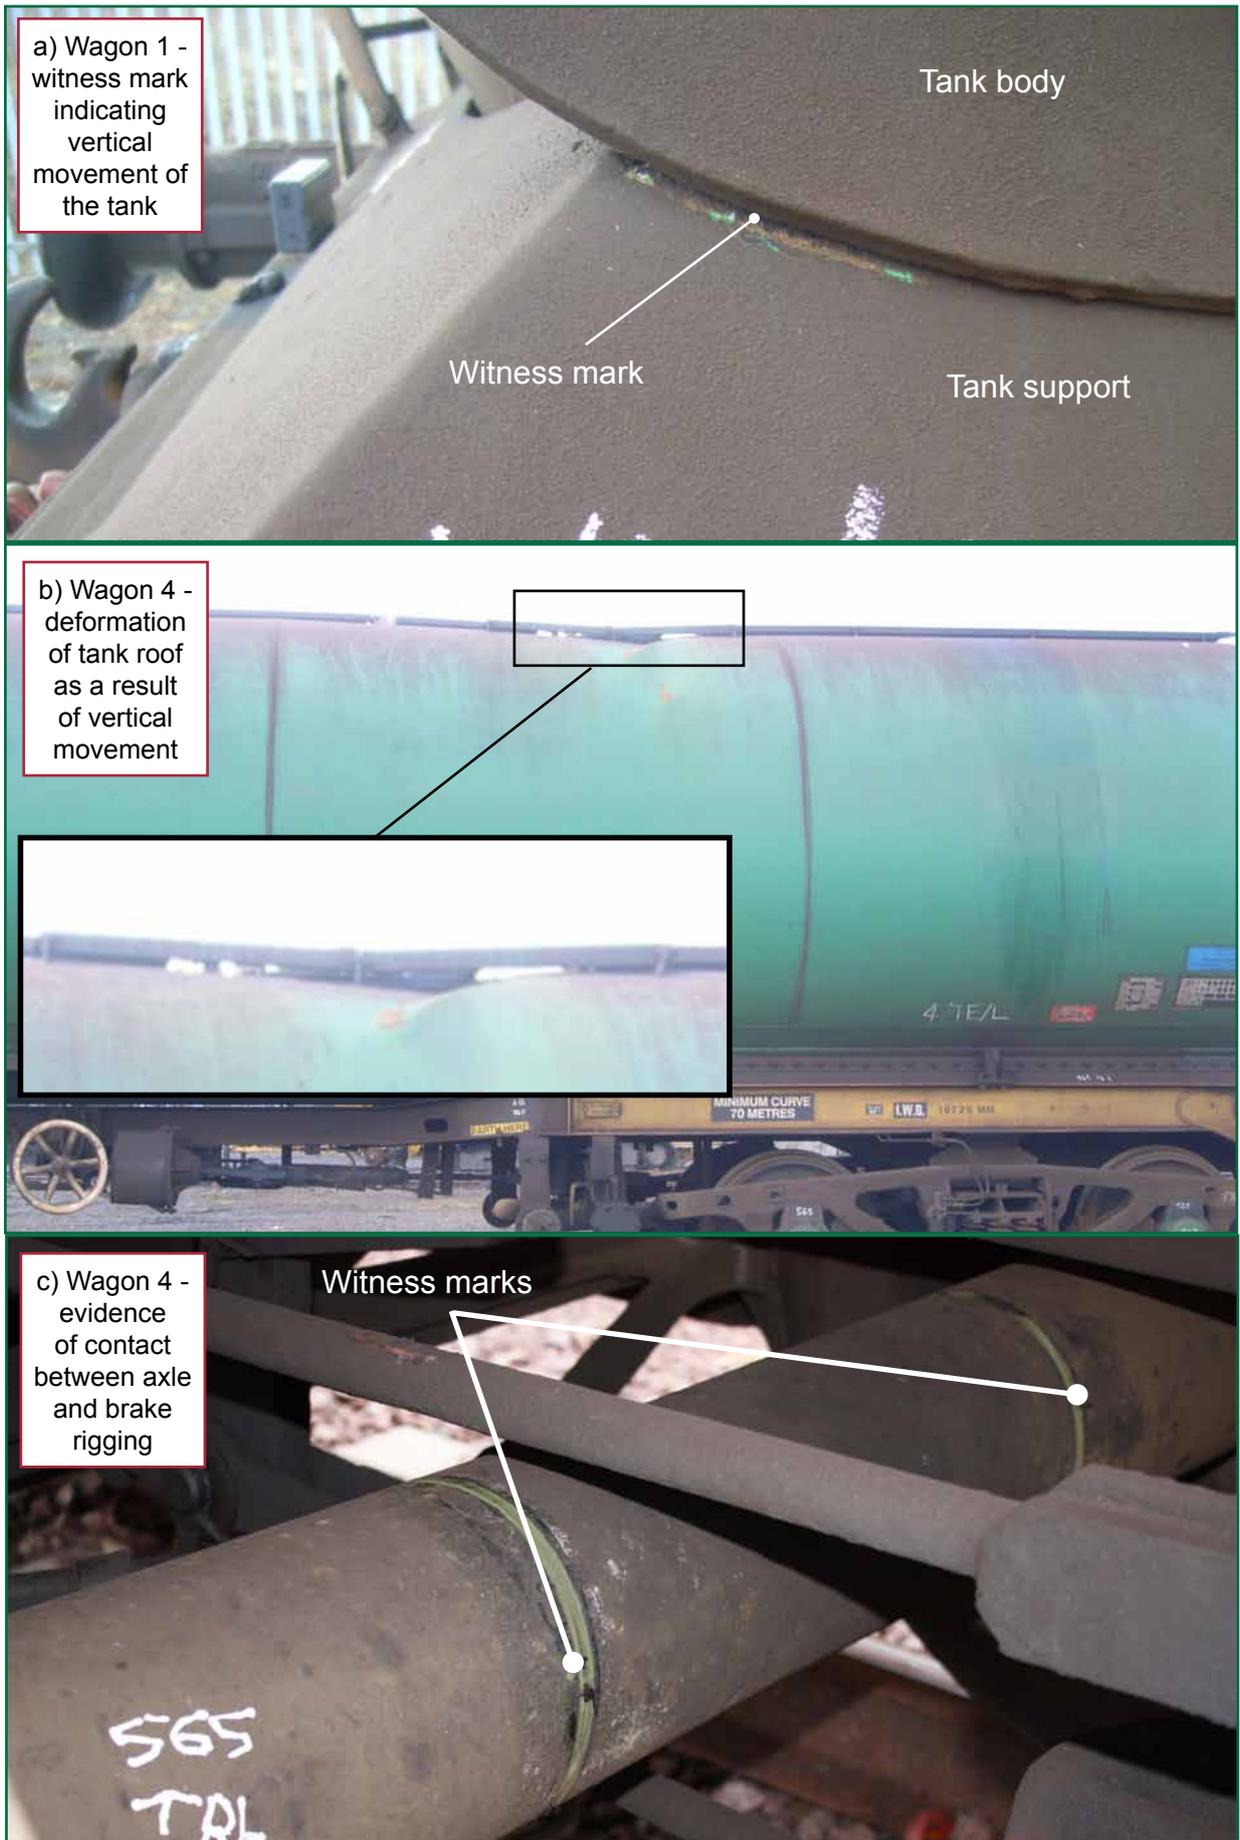
Figure 14: Witness marks and damage on the wagons that did not derail

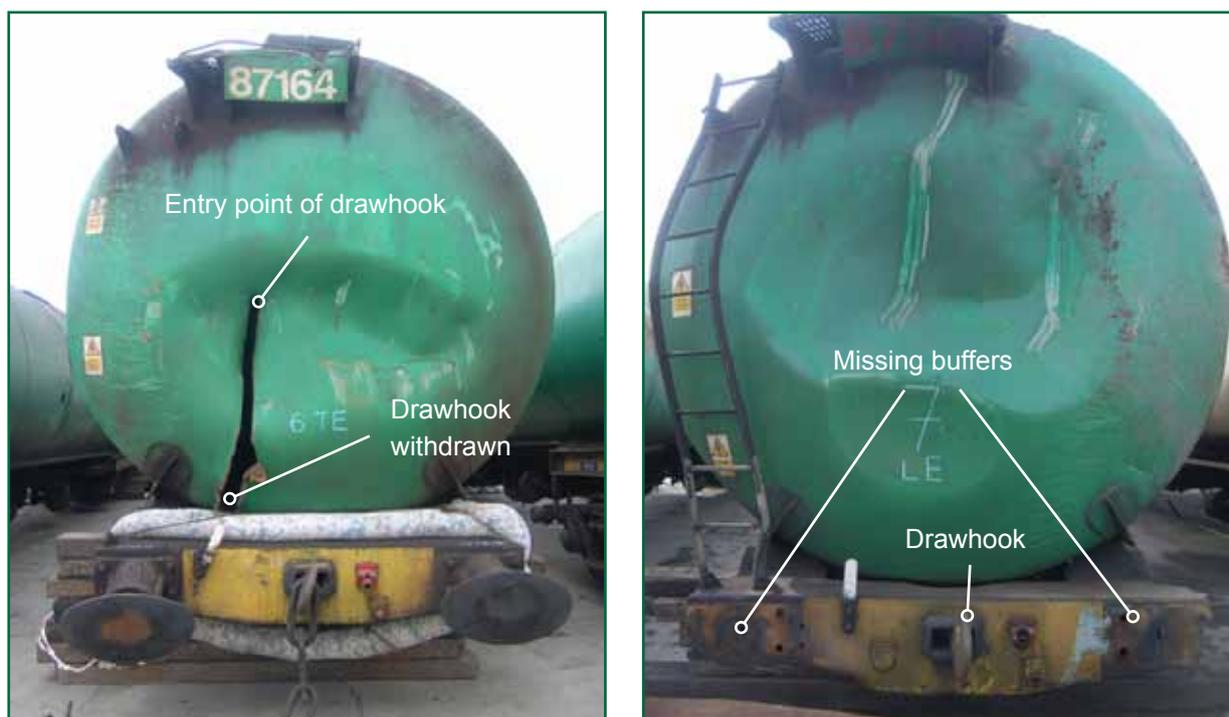
Figure 15: Vertical gash on the tank of wagon 6 (left) caused by the adjacent drawhook on wagon 7 (right)

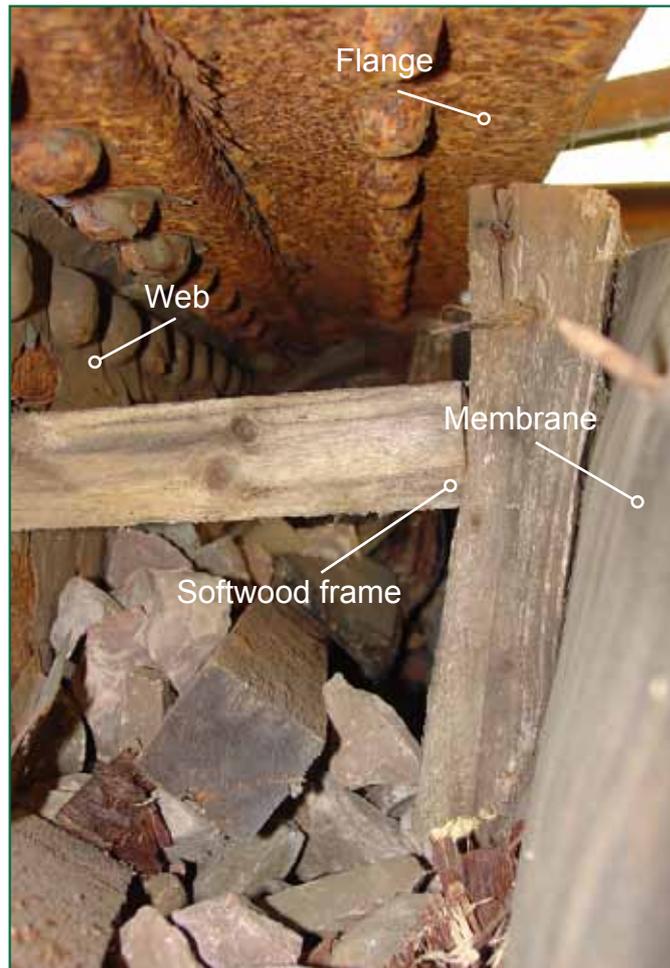
130 The membrane, therefore, effectively sealed in the LMSR timber upstands, the moist debris and the band of heavy corrosion. The photograph in figure 18, taken during dismantling, is a view behind the membrane fitted to the centre main girder – so much ballast had accumulated that the timber upstand is buried. There was no provision in the design or installation of the waterproofing arrangement to facilitate inspection of this critical area.

Figure 18: Accumulated ballast and debris found behind the waterproof membrane of the centre main girder

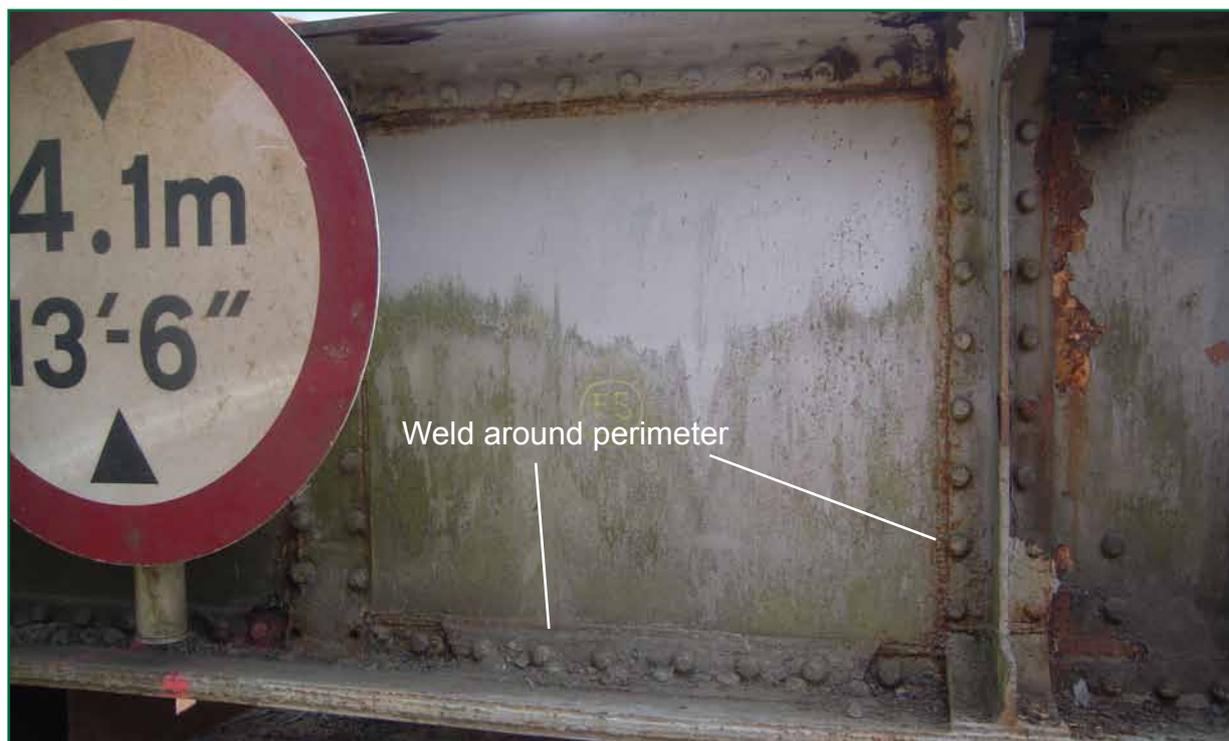
Figure 19: Repair plate welded to web panel 5 of the east main girder

147 The RAIB's survey of Bridge 88 found that web repairs had been considered necessary in the past. Web panels 1, 5, 10 and 12 of the east main girder all had steel repair plates welded to their external surface:

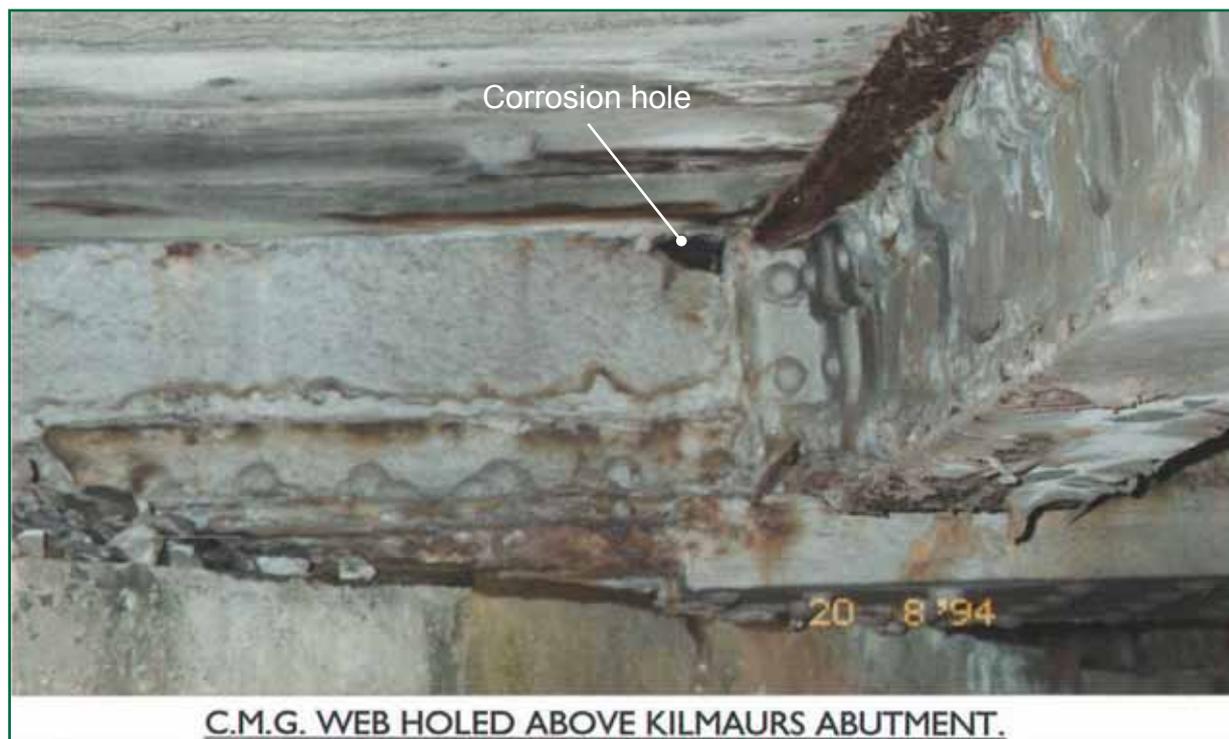
Figure 21: The web plate corrosion hole at the south end of the centre main girder that was illustrated in the 1994 Assessment report (photograph courtesy of Network Rail)

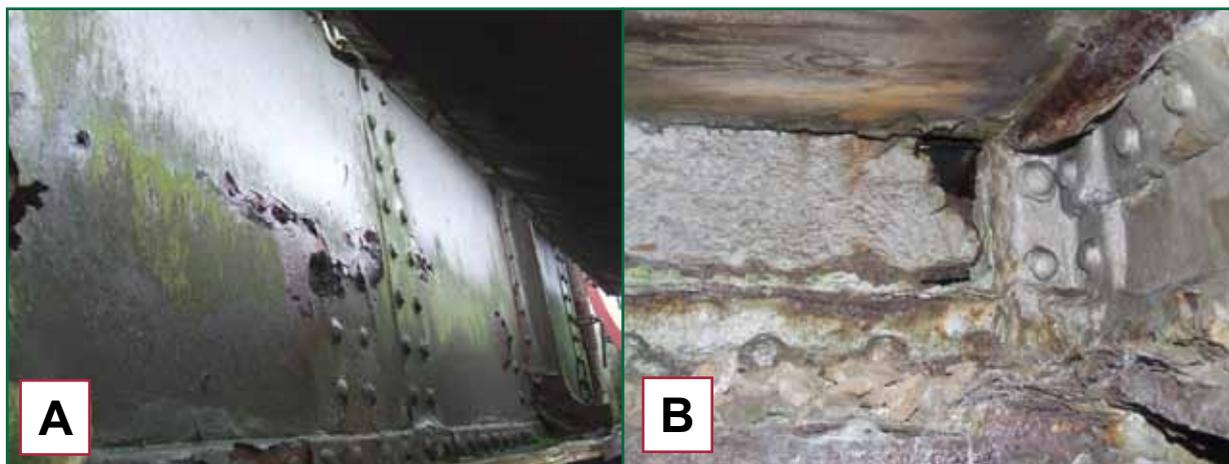
Figure 23: Photographs of web corrosion from the Inspection for Assessment undertaken 27 November 2007 (photographs courtesy of Network Rail)

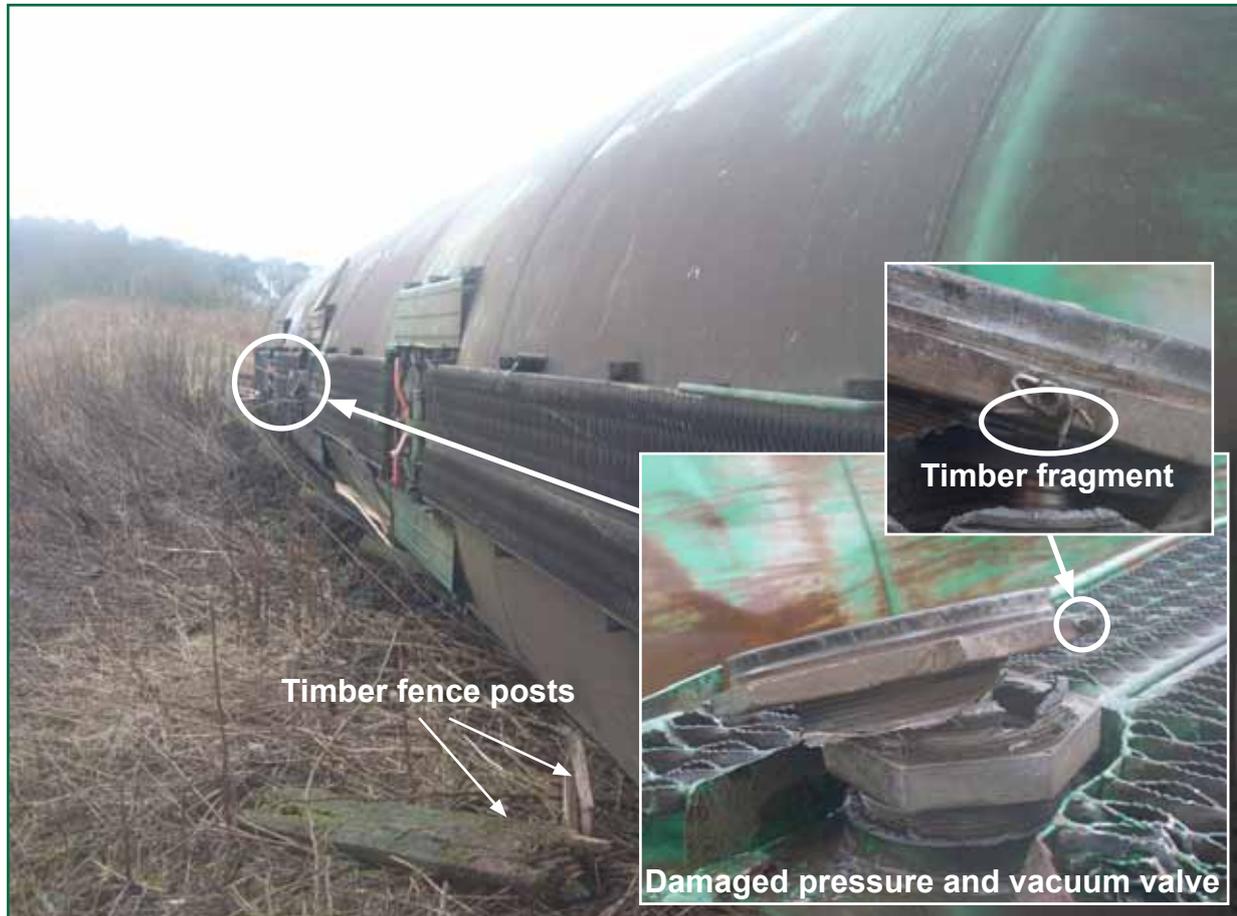
237 Two pressure and vacuum valves are mounted on the top of each wagon, and the rearmost valve on wagon 7, a TEB tank wagon, was severely damaged. The valve's head was pushed back causing the valve body to be torn open around its threaded section. There was evidence that it had struck a timber post from the railway boundary fence (figure 24). All of the fuel lost from wagon 7 leaked from the broken valve.

Figure 24: Damaged pressure and vacuum valve on wagon 7

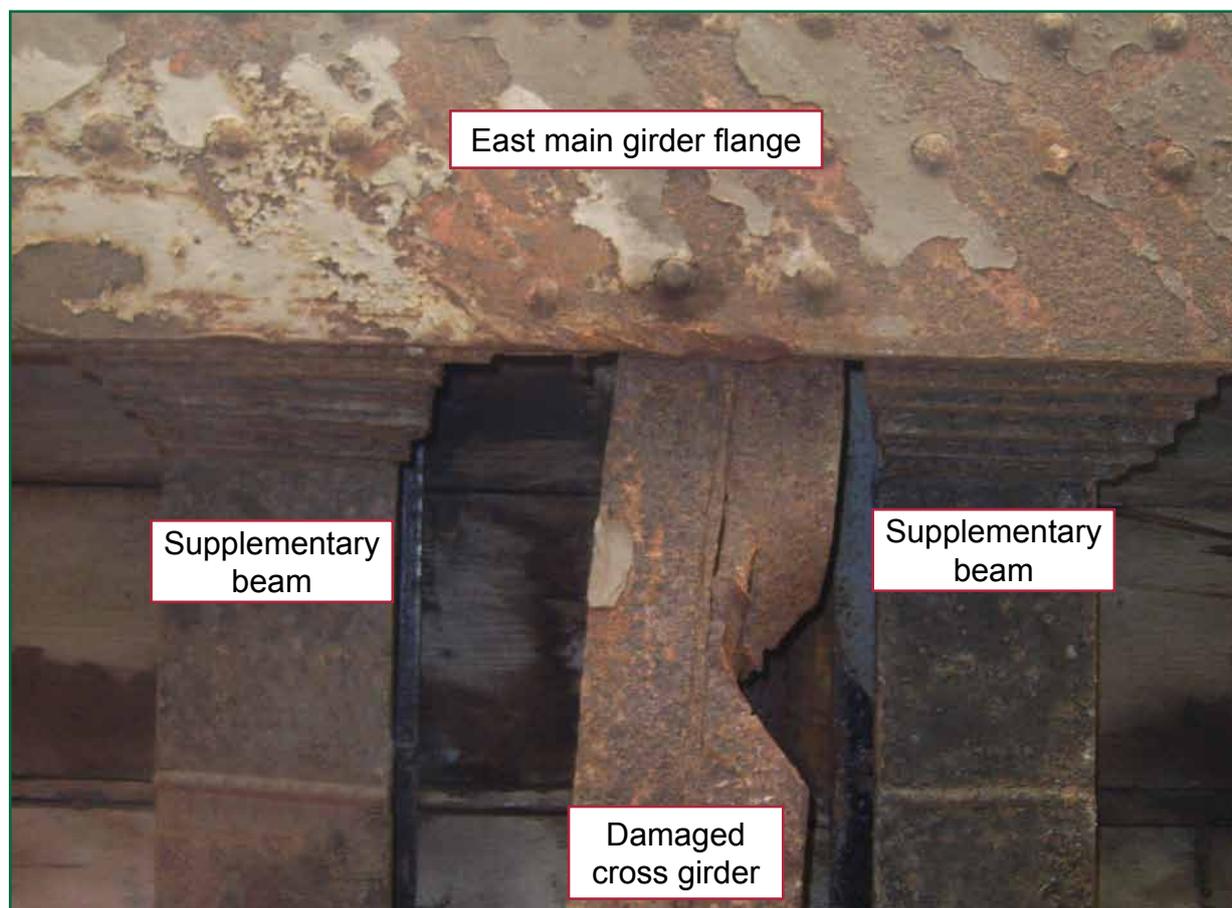
On the east side of the deck, one of the cross girders had been replaced in the past (date not recorded). Two other cross girders on the east side, whose bottom flanges were badly torn by a strike incident, had supplementary steel beams inserted each side of them. Records show the supplementary beams were installed in January 2004, probably in response to recommendations arising from the routine structures management process (paragraph 187) The RAIB found the repair work was intact when it surveyed the bridge (figure F1).

Figure F1: Repair done in 2004 to supplement cross girders damaged by vehicle strikes

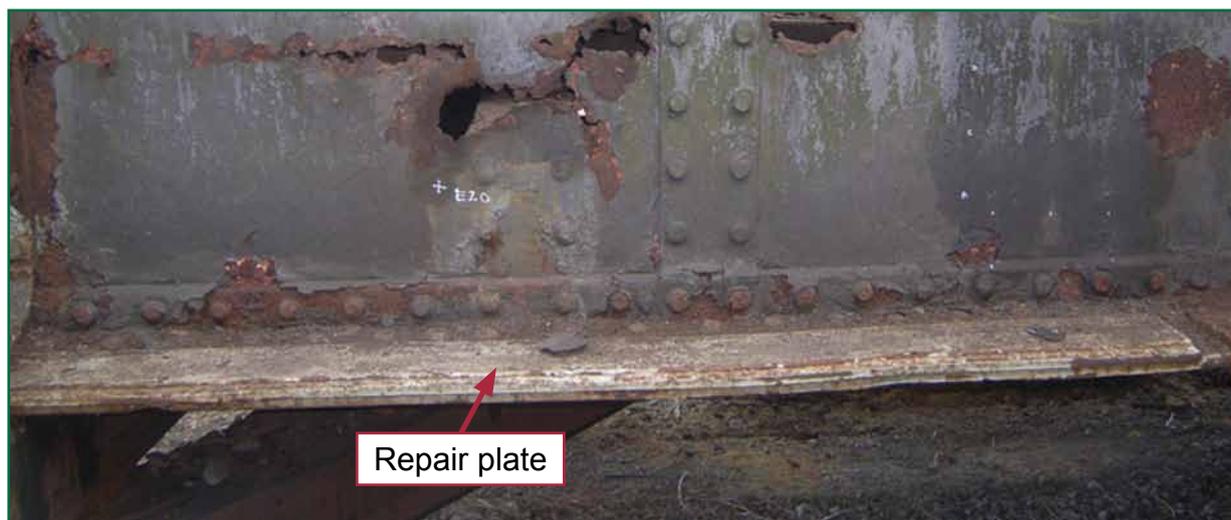
- The damage to the east main girder bottom flange was repaired sometime after the 1994 Assessment report was issued (appendix F and figure F2).
- 64 On 23 March 2007, Jacobs advised Network Rail that it considered that application of the new assessment codes would offer little or no scope for improvement to the RA of this structure. In the light of this, Network Rail considered replacing the superstructure of Bridge 88 and entered a proposal in its business plan. On 19 June 2007, after undertaking an evaluation, Network Rail asked Jacobs to undertake additional assessment work. This included consideration of the load from real trains (using train types defined by Network Rail together with results from the 1994 Assessment) and a new 'further rigorous assessment' of the bridge (the 2007 Assessment). The detailed requirements for the 2007 Assessment were defined on the 'Approval in Principle for Assessment' form, which was agreed later. It stated the assessed capacity of the bridge as 'RA1 at 70 mph' with the critical issue defined as rivet shear stress in the east main girder.

Figure F2: Repair to bottom flange of the east main girder

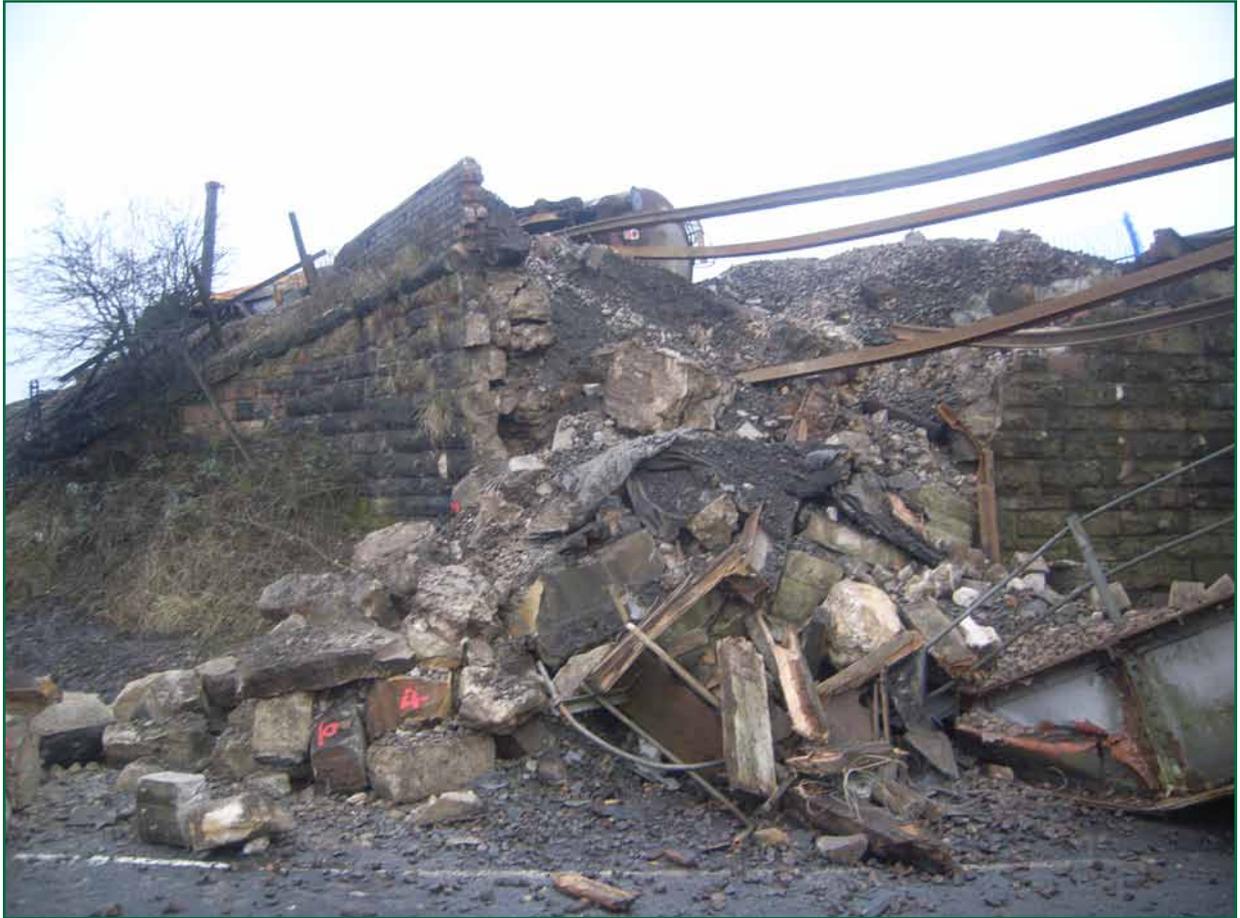
Figure F4: Photograph of debris from failed south abutment

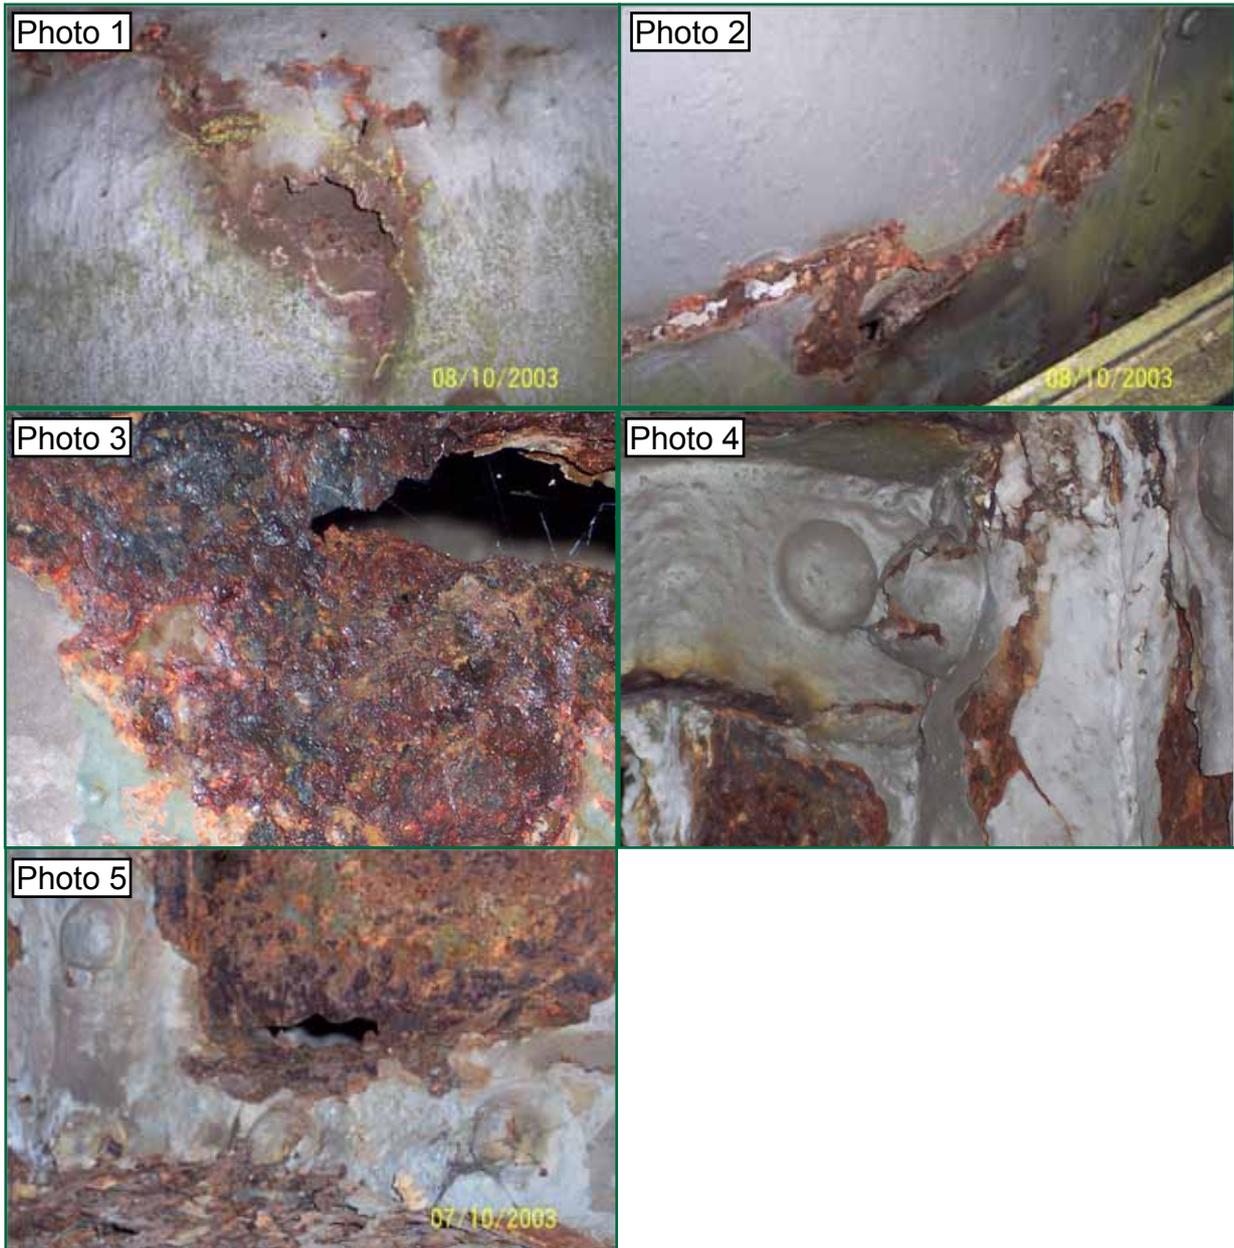
SEVERAL CROSS GIRDERS SHOW ISOLATED HOLES IN WEB AT ENDS NEXT TO CONNECTIONS TO MAIN GIRDERS. PHOTO 3 + 4 + 5.

Figure G1: Photographs from Atkins urgent defect report (photographs courtesy of Network Rail)
