Special Investigation

RAIB review of the railway industry's investigation of an irregular signal sequence at Milton Keynes, 29 December 2008

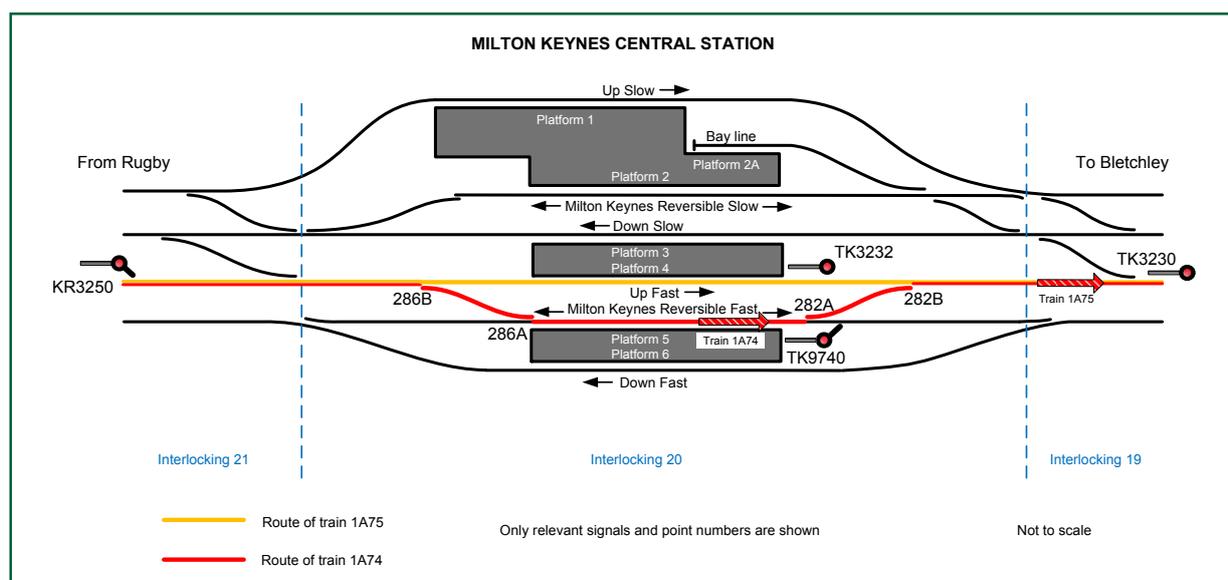
Figure 1: diagram of incident

- 2 When train 1A74 arrived at Milton Keynes, signal TK9740 was displaying a red aspect. A train, 1A75 21:15 hrs Manchester to London Euston, then passed on the Up Fast line. The points leading from the Reversible line to the Up Fast changed, routing 1A74 onto the Up Fast, and signal TK9740 then changed to a green aspect while 1A75 was still visible on the line ahead (figure 1). Shortly afterwards signal TK9740 changed to a single yellow aspect.

- 4 WCRM project staff investigated the reported incident during the night of 29/30 December 2008, and discovered that there was missing data in the cross-boundary interface between two interlockings covering the Milton Keynes station area. The Solid State Interlocking (SSI) data was rectified and tested and the route was brought back into use on 4 January 2009.
