Rail Accident Investigation Branch

Rail Accident Report

Incident involving a container train at Basingstoke station 19 December 2008

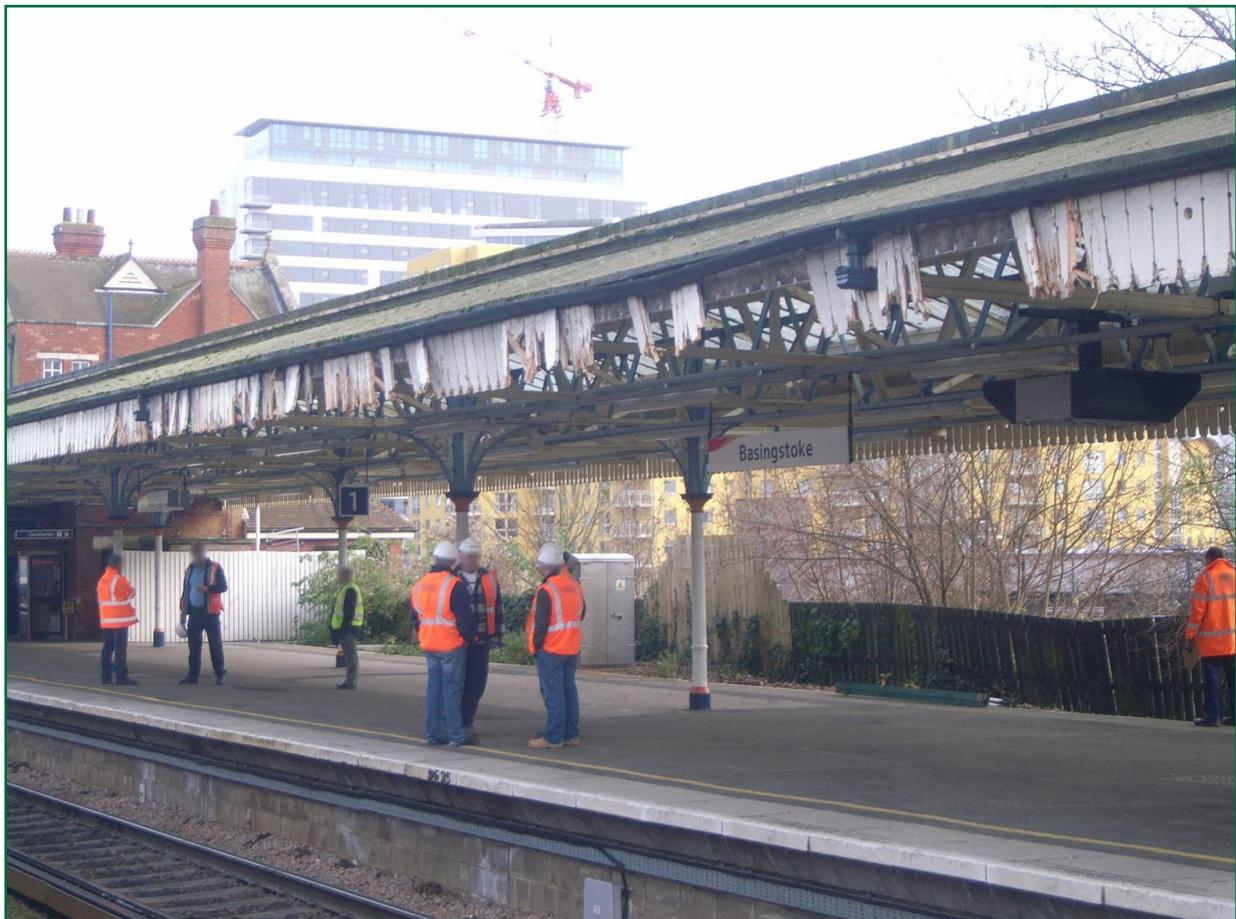
Figure 2: Canopy of platform one, Basingstoke, showing damage

- 40 About 130m of the canopy valance was damaged, with severe damage over about 20m (Figure 2). Debris from the canopy was spread along the platform, and some also lodged on top of the container.
- 41 There were few, if any, people on the platform at the time, and no-one was hurt.
- 42 There was no visible damage to the container.

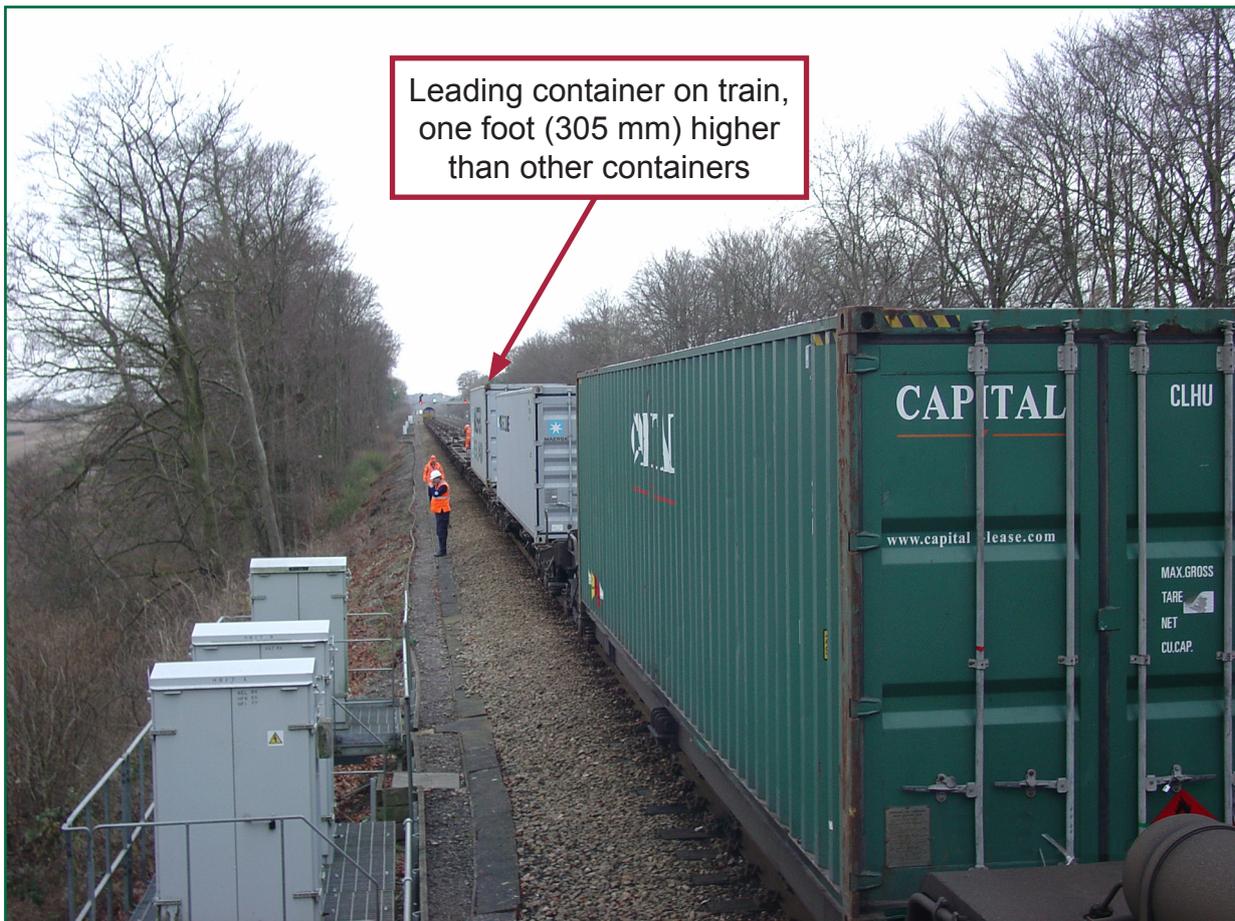
Figure 7: Train at Waller's Ash loop, showing overheight container

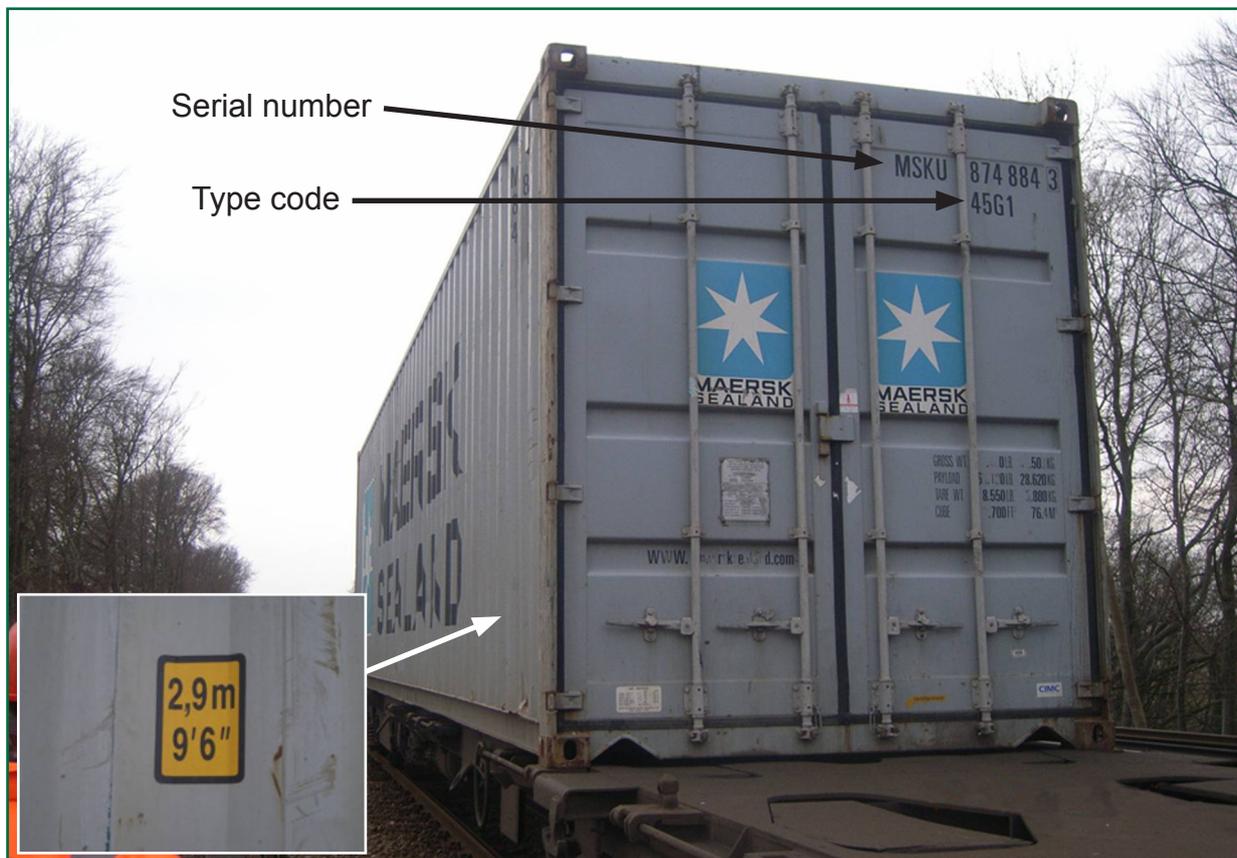
Figure 9: Incident container showing serial number, type code, position of height marking (on sides), and absence of black/yellow stripes

- 132 There were no black/yellow markings on the top corners of this container to indicate that it was a high-cube, although there were small labels (Figure 9), and the 45G1 code below the serial number on the side, which both indicated the height. The height markings were placed lower on the container side than required by ISO 6346, being about 2.5 m from the top, rather than the maximum of 1.2 m specified in the standard. The container is owned and maintained outside the European Union, and it has not been possible to establish the reason for these deficiencies.

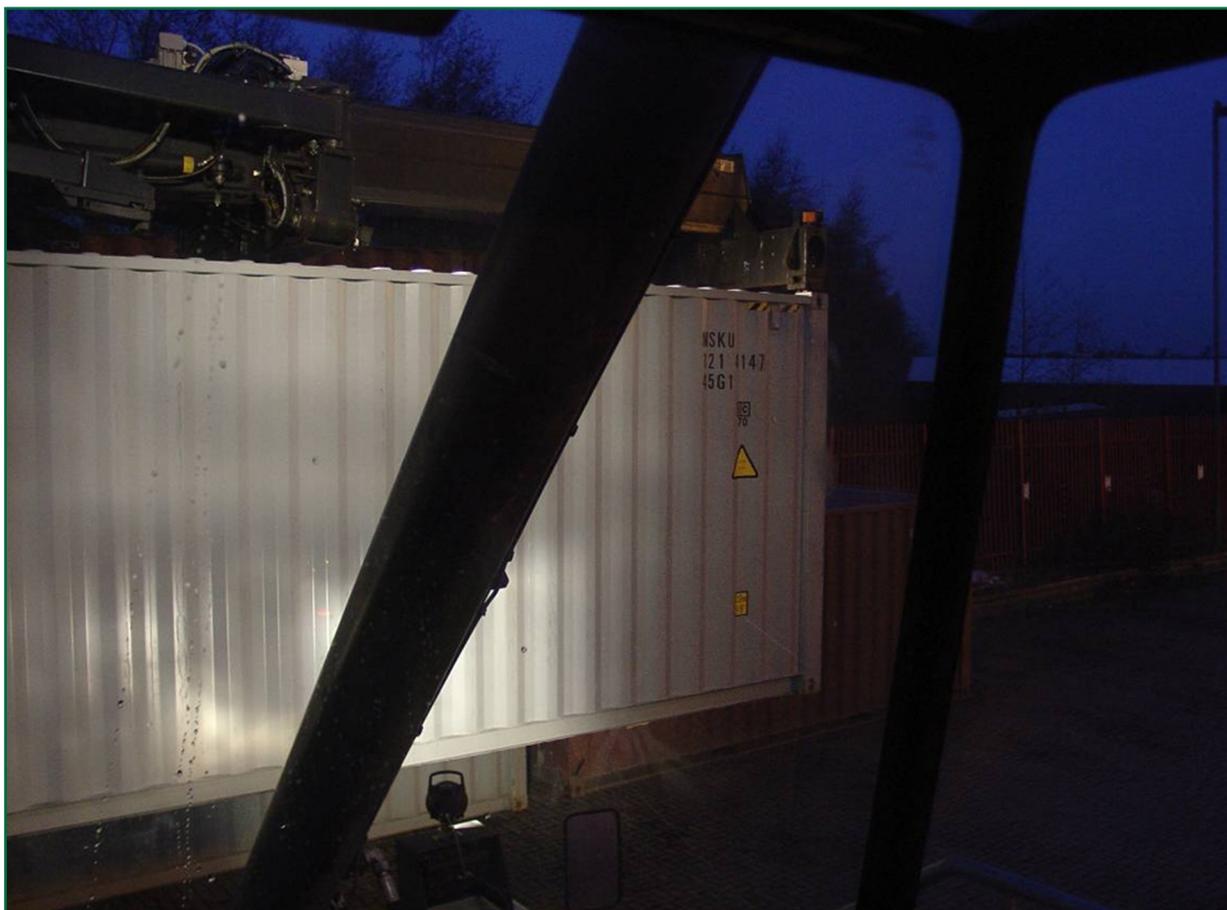
- 135 The reach stacker driver loaded the container onto an FIA type wagon on the train. He loaded a second container onto the same wagon, but did not notice that the two containers were of different heights. The view from the cab of the reach stacker was restricted by the telescopic supports for the lifting arm, the lighting on the machine was directed towards the container being handled, and there was a gap of about 4 m between the two containers on the wagon. The view from the cab is adequate for the task being undertaken, but these factors make it less likely that the driver of the reach stacker would detect a height difference, particularly after dark, and were contributory to the incident (Figure 10).

Figure 10: View from cab of reach stacker showing restricted vision after dark and black/yellow stripes on top corner of high-cube container
