Rail Accident Investigation Branch

Rail Accident Report

**Collision and derailment of a passenger train
at North Rode, between Macclesfield and
Congleton,
18 December 2008**

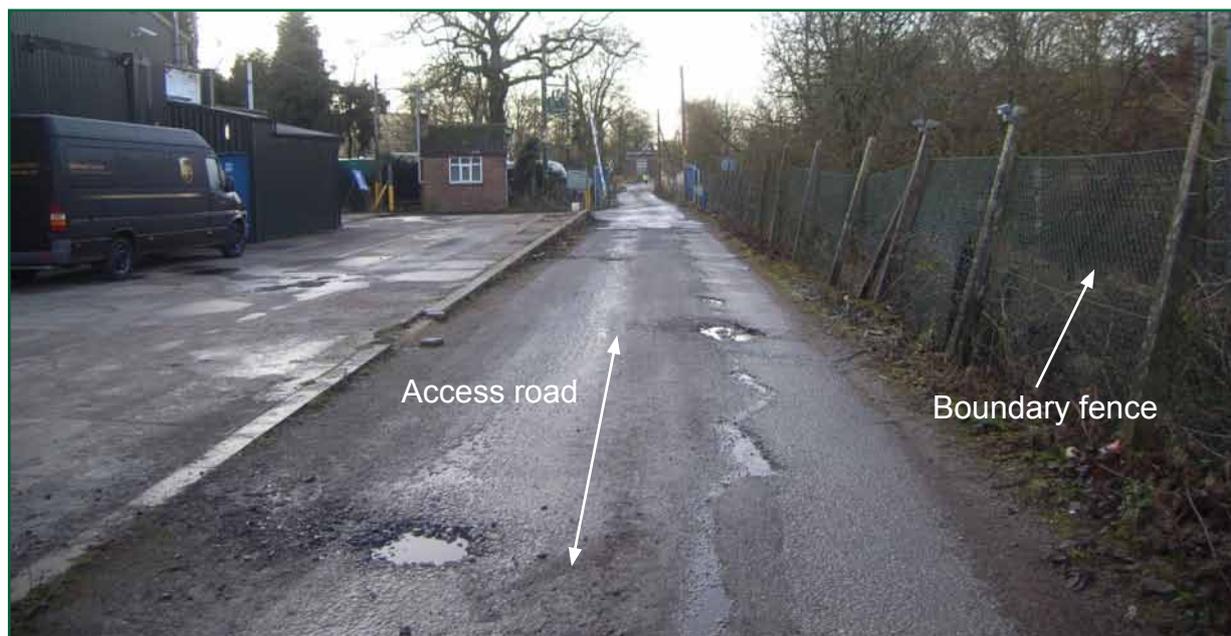
Figure 3: The UPS site looking south

- 48 The car park is bounded by a chain link fence which comprises a plastic coated steel wire mesh secured to concrete posts (Figure 5). Its purpose is to deter trespassers; it was not designed to prevent vehicle incursion onto the railway. At the time of the accident the fence was in a poor state of repair: the mesh steel wire had rusted through, the plastic coating had perished away and the fence leant towards the railway because several of the concrete posts were cracked at their base (Figures 3 and 5).

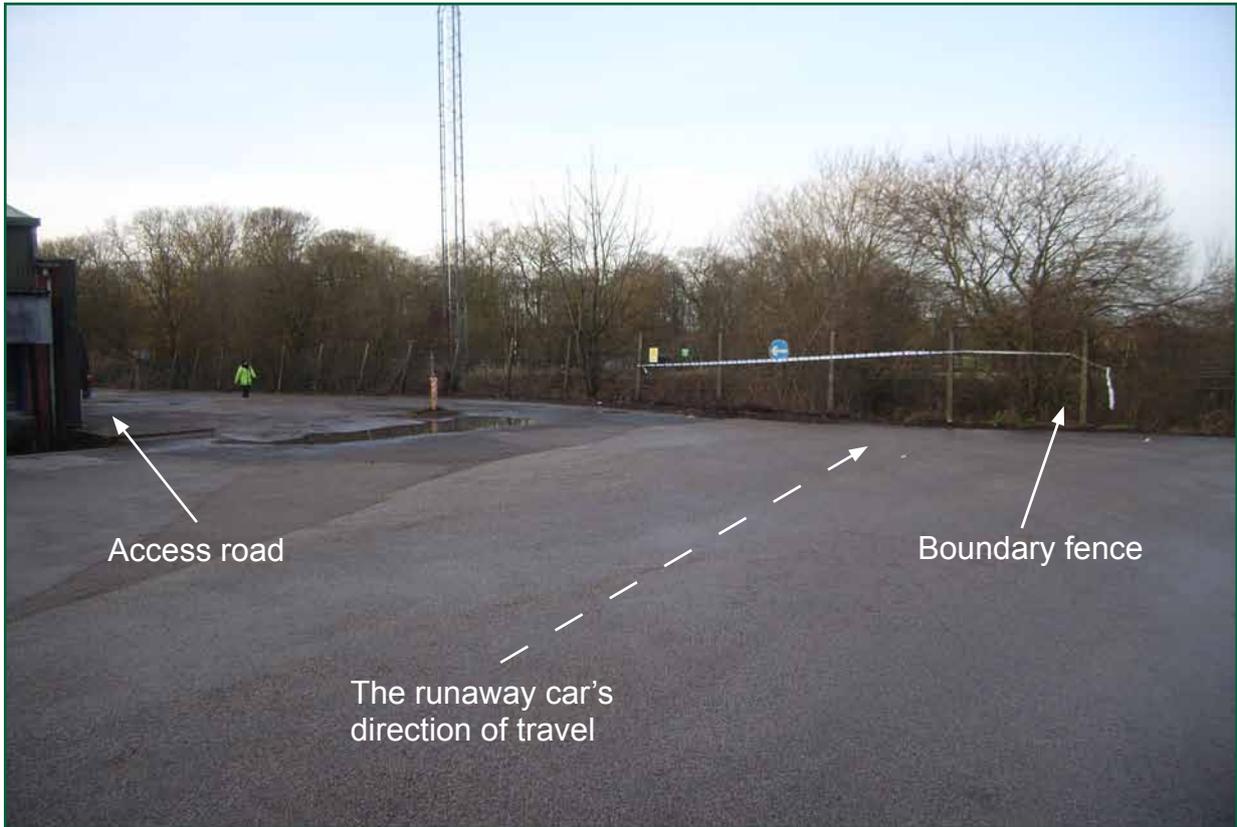
Figure 4: The UPS site looking west towards the railway

- 47 The path of the car across the car park and through the fence is shown in Figure 4. The RAIB surveyed the area and found that the path taken by the car falls towards the railway on a 1 in 36 gradient; to the left of this path and towards the access road, the car park is flat or falls away from the railway.

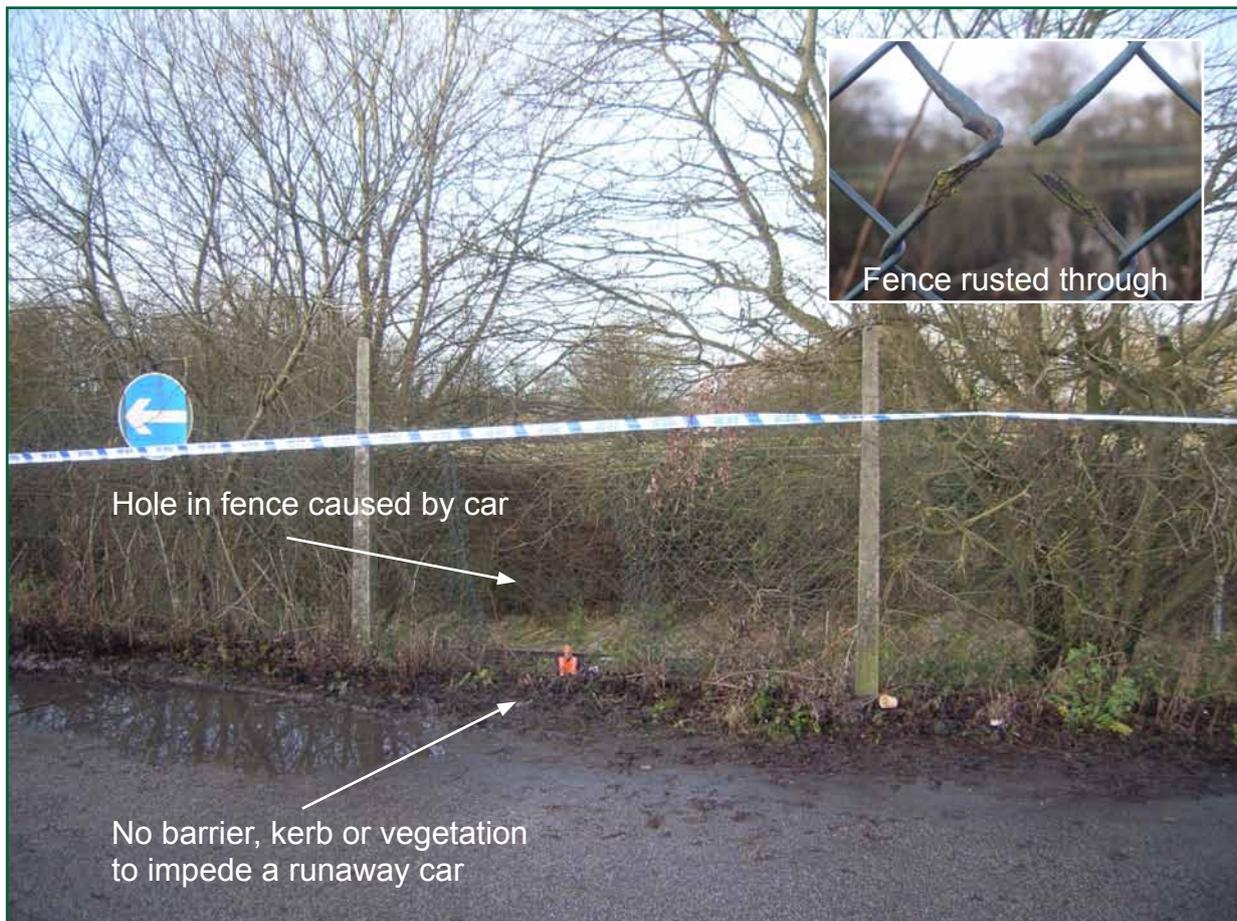
Figure 5: The UPS boundary fence

- 49 Closed circuit television camera footage shows the car passing through the fence without slowing as it tears a hole through the wire mesh. There were no features between the car park and the railway that could contain the car, for example a kerb, a crash barrier, a ditch or a mound (Figure 5).

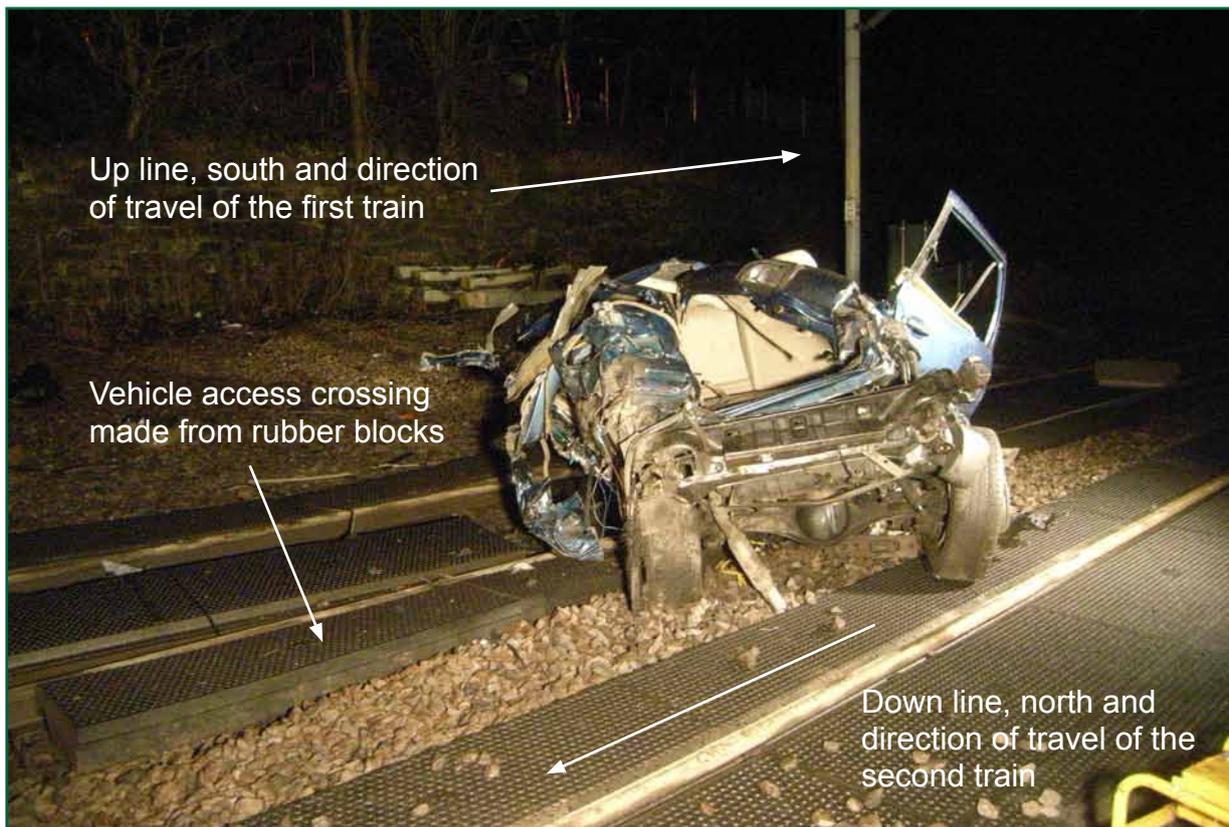
Figure 7: The car on the access crossing

- 17 The southbound train was travelling at 90 mph (145 km/h) when its driver saw the car on the track immediately ahead of him. The train struck the car and in less than a second pushed it 34 metres into the rubber blocks of an access crossing (used by maintenance vehicles to get onto the railway). The rubber blocks between the rails were 1.8 metres long and weighed 0.241 tonnes (Figure 7).

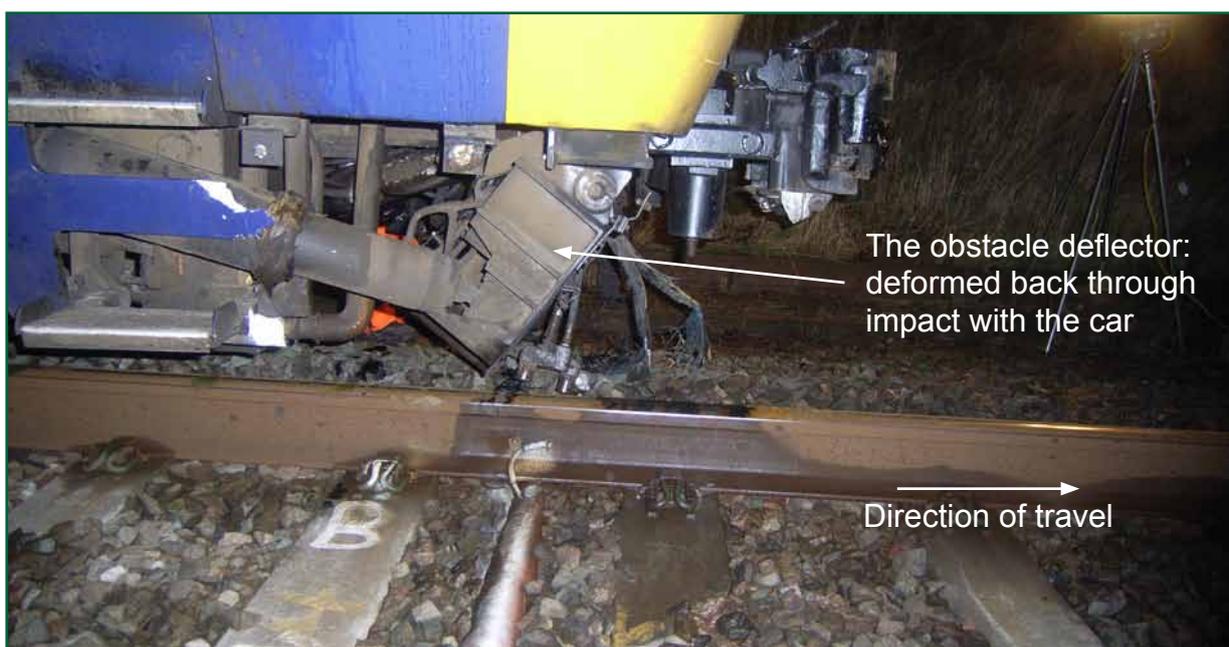
Figure 8: Damage to the southbound train caused by striking the car

18 The collision happened quickly and the driver did not have time to apply the brake before he felt his train lift as its obstacle deflector and lifeguards crushed the car against the access crossing (Figures 8 and 9). The forces generated during the collision ejected the car to the right (Figure 7), tore four large rubber blocks out of the access crossing and derailed the train's leading four wheels to the left. Damage to the train's braking and electrical systems caused the emergency brake to apply automatically.

- 62 During the collision, the train's obstacle deflector and lifeguards performed as designed: they deformed to absorb energy and prevented large debris from going under the train (Figures 8 and 9). As a result, only the leading four wheels derailed; the leading vehicle ran upright and to the left of the track as its leading right-hand wheel was restrained by the left-hand rail (Figure 9).
- 63 The severity of consequences may have been different if the train had derailed further to the left and struck the bridge, jack-knifed, or if the train had derailed to the right and moved into the path of the northbound train.

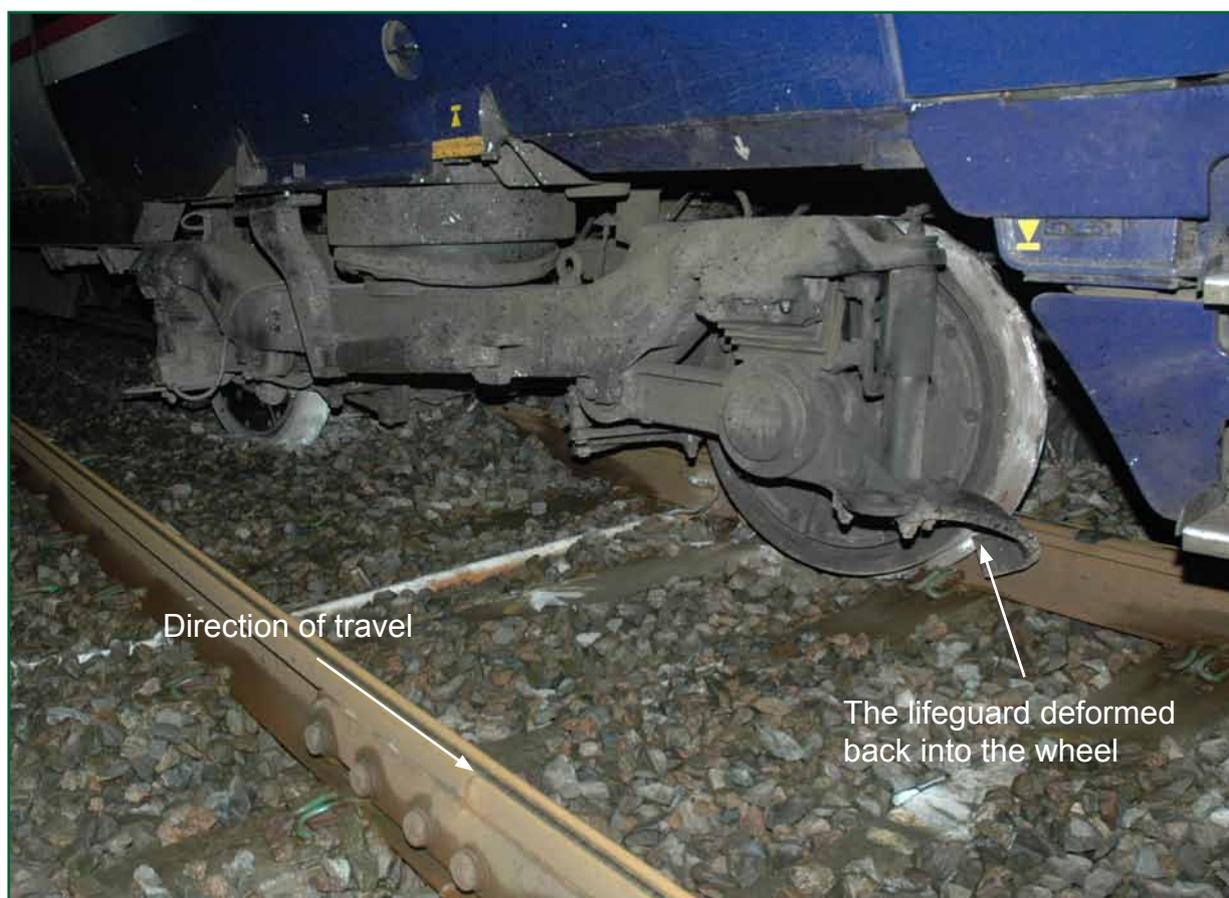
Figure 9: The leading right-hand wheel, bearing against the left-hand rail (photograph courtesy of British Transport Police)

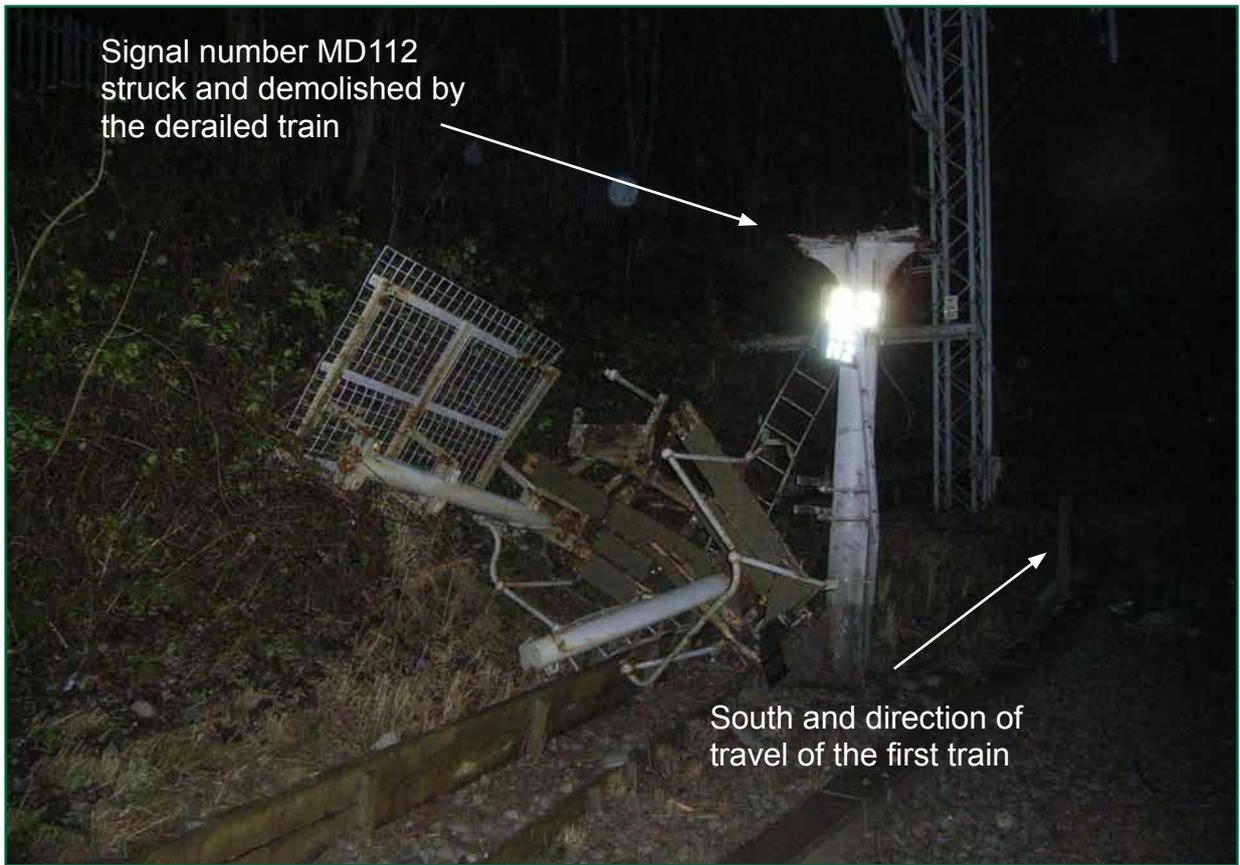
Figure 10: Signal number MD112

- 19 The leading vehicle continued to run derailed, upright, and to the left of the track as it collided with a railway signal (Figure 10) and a footpath handrail that damaged the cab (Figure 11), and tore off its door (Figure 12). The leading two vehicles passed through a road bridge 250 metres from the crossing before coming to a stop 362 metres from where the car had rolled onto the track.

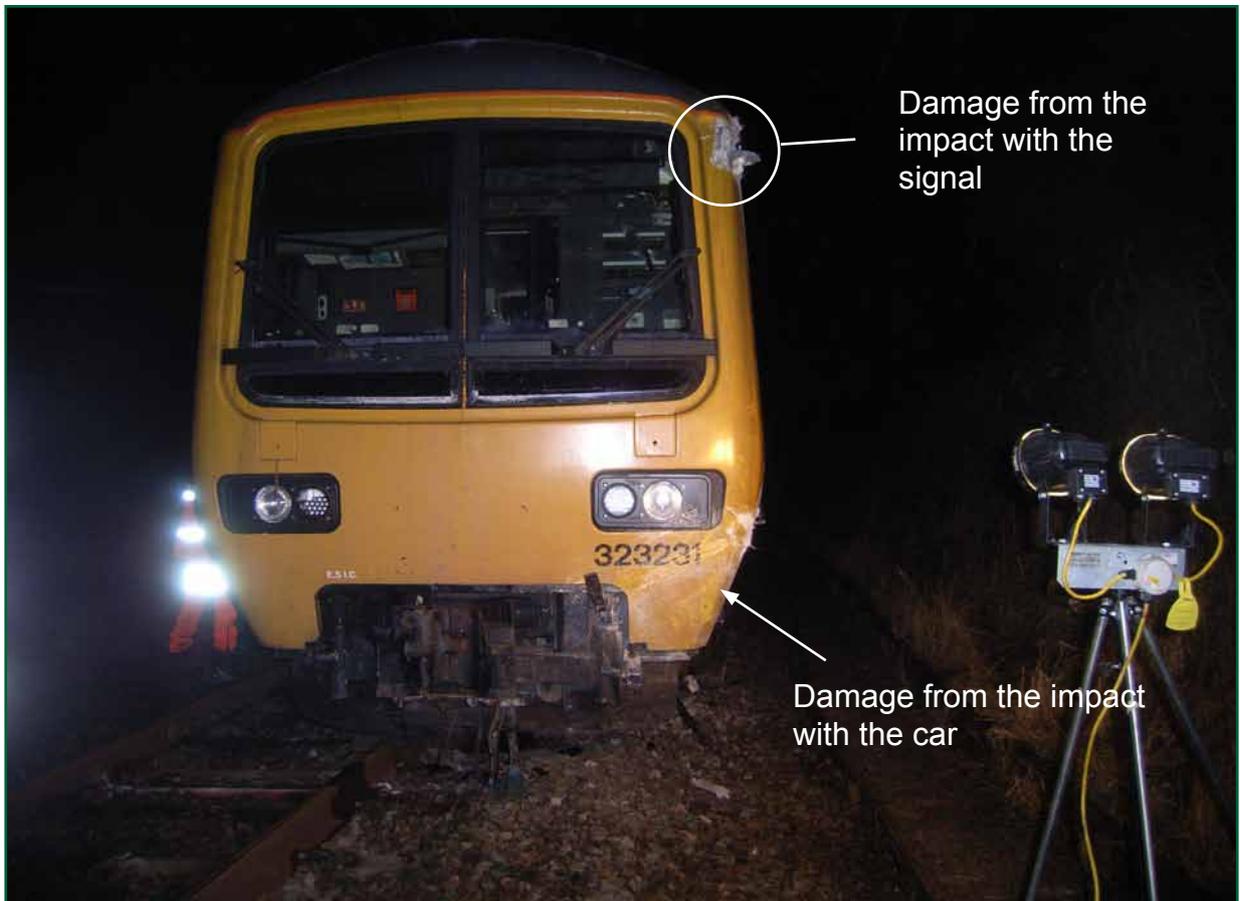
Figure 11: The driving cab of the southbound train

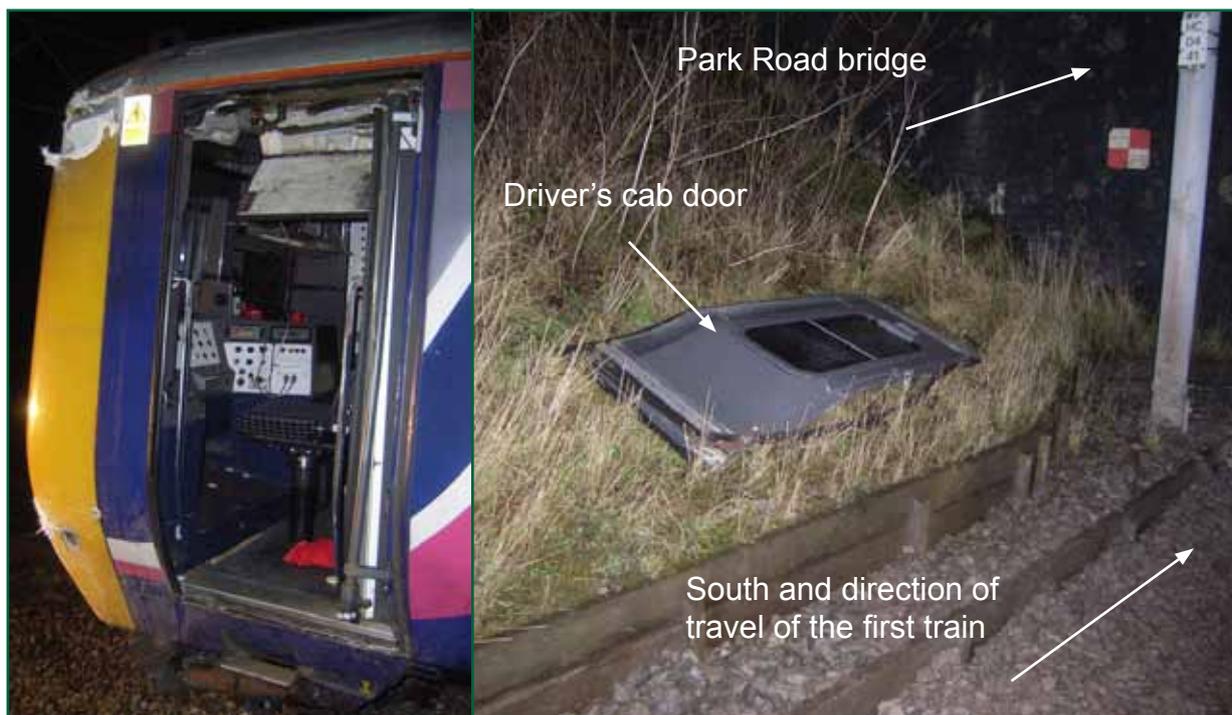
Figure 12: Damage to the southbound train

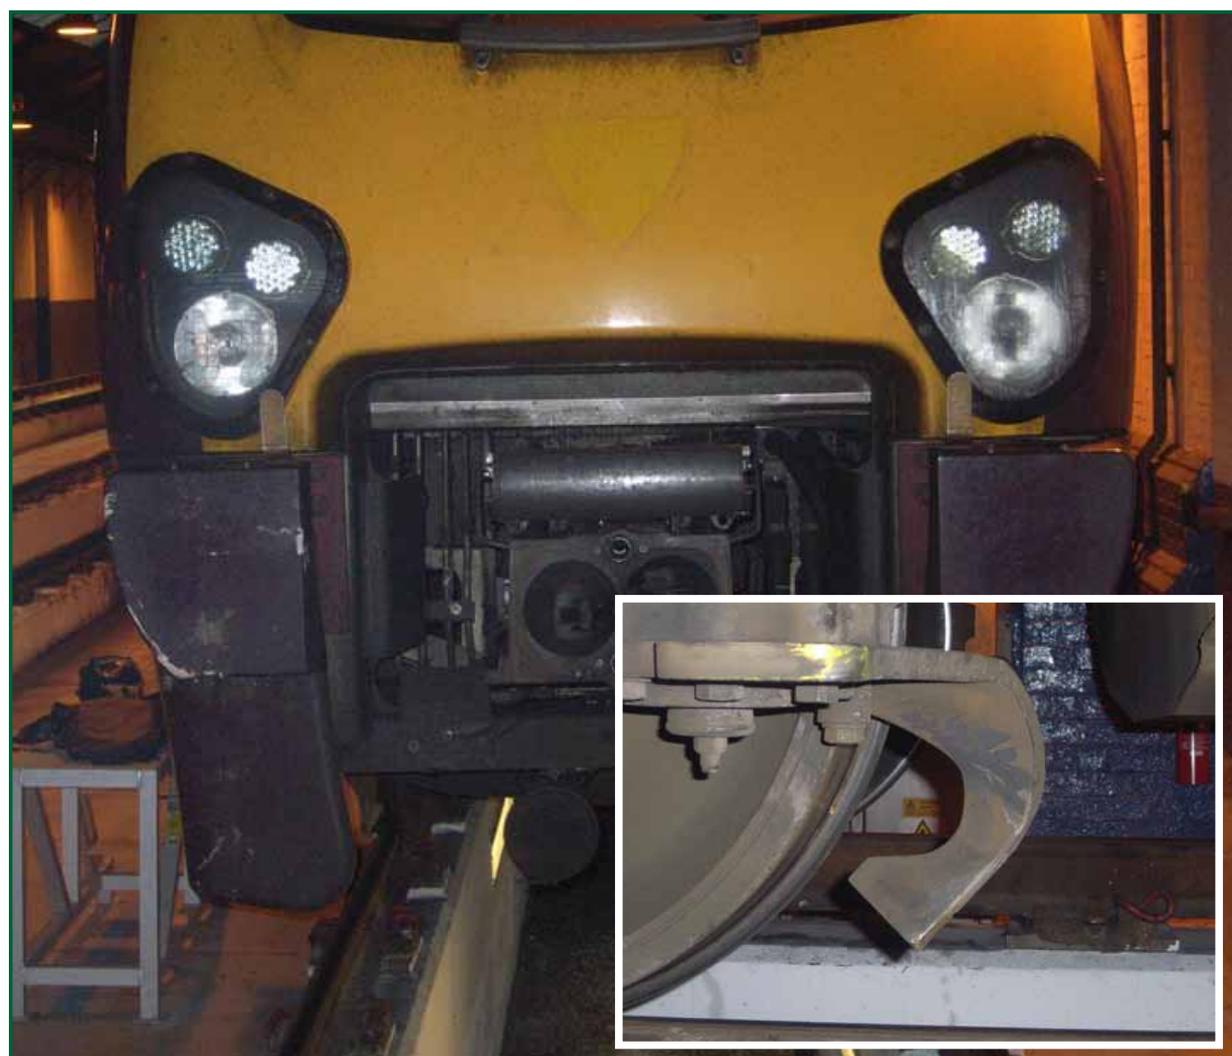
- 21 The train's leading right-hand lifeguard struck one of the large rubber blocks and pushed it along the track until a section of the block was torn off and both parts were ejected to the track side, 88 metres back from the access crossing (Figures 13 and 14). The train came to a stop 714 metres from where the car had entered the railway (Figure 15).

Figure 13: The driving cab of the northbound train and (inset) damage to the right-hand lifeguard

- 64 The train's lifeguard performed as designed as it struck the rubber block and pushed it along the track; the lifeguard deformed to absorb energy and prevented the block from coming between the wheel and rail until a section of the block was torn off and both parts were ejected to the track side (Figures 13 and 14). The severity of consequences may have been different had the rubber block caused the train to derail, as happened in the September 2006 derailment at Croxton. This accident resulted in a train running foul of an adjacent line at speed, causing damage to itself and the infrastructure (see RAIB report 11/2008).

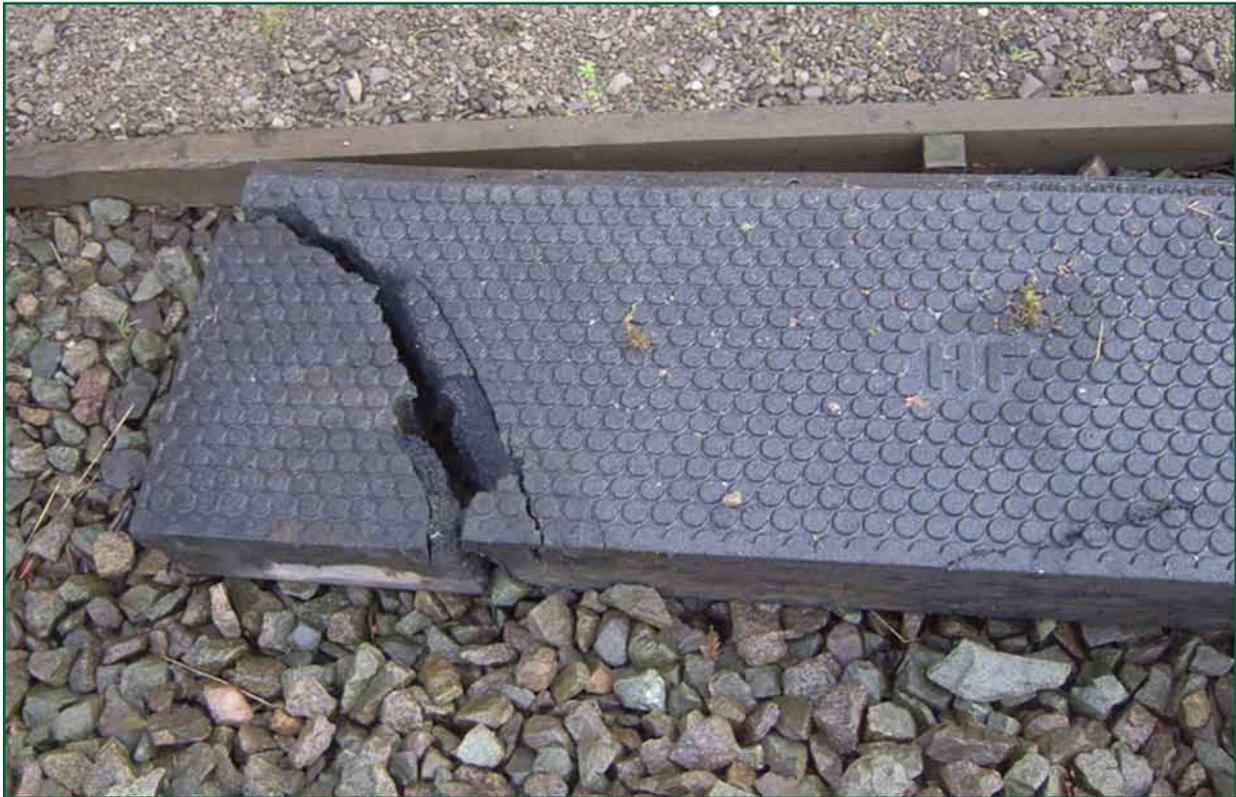
Figure 14: The rubber block damaged by the northbound train (the pieces were placed together for the image)

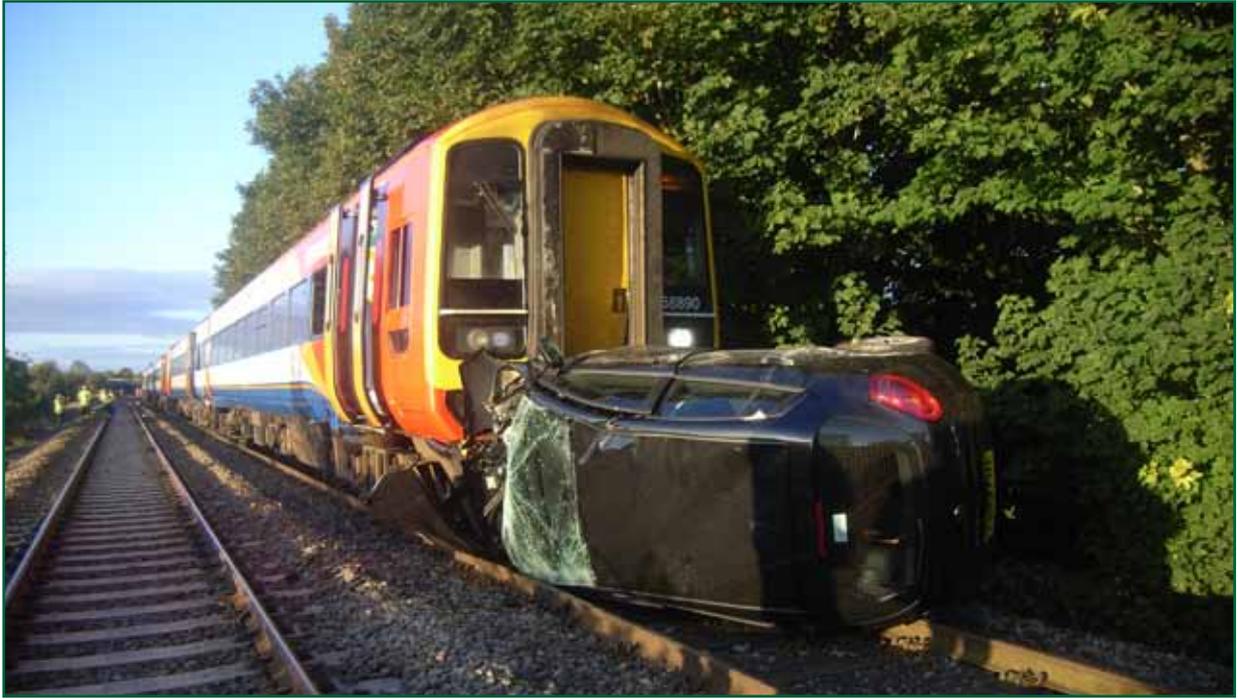
- 28 Broken Cross near Salisbury, Tuesday 22 September 2009: a car ran down a bank and onto the railway. The driver abandoned his car before it was struck by a train (Figure 16). The RAIB conducted a preliminary examination of this accident and did not investigate further, as there were no issues beyond those identified in this report and the report into the collision and derailment at Great Heck in 2001. Another similar accident occurred at Broken Cross in 2003 (Figure 17).

Figure 16: The accident at Broken Cross, near Salisbury, 2009

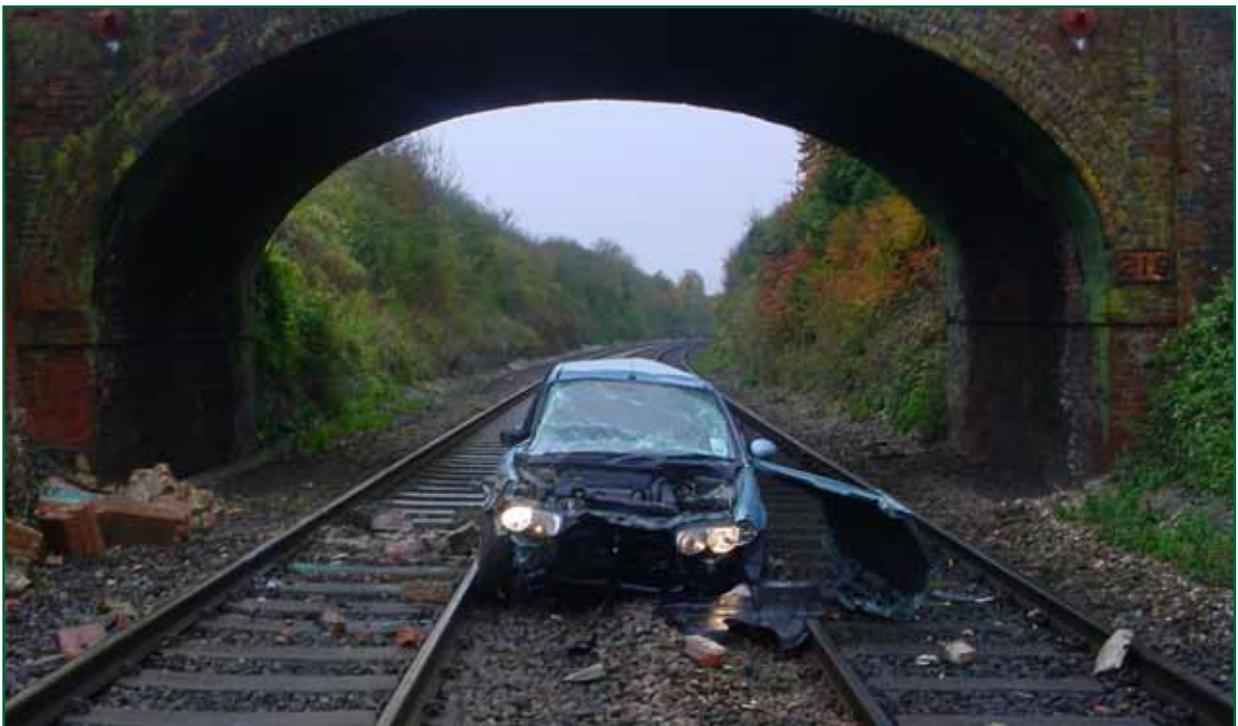
Figure 17: The accident at Broken Cross, near Salisbury, 2003

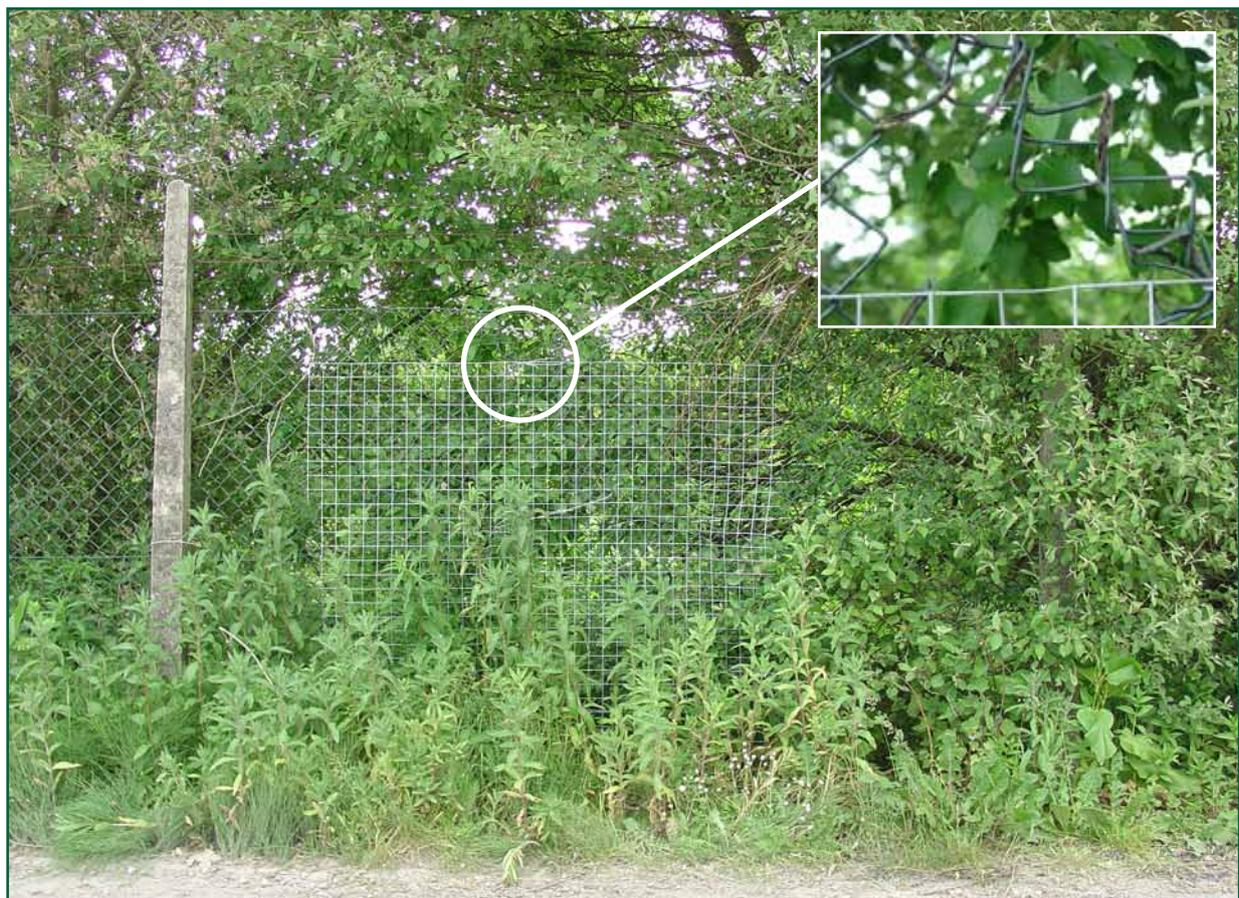
- 71 UPS repaired the hole in the fence; however, the repaired fence has little more resistance to a runaway vehicle than the original one. See Figure 19.

Figure 19: The repair to the hole in the fence

- 1 Network Rail should advise UPS of the arrangements to inform it immediately a road vehicle enters the railway from the depot (paragraph 66c).
- 2 UPS should assess the risk of vehicle incursion from the depot onto the railway and make arrangements so that:
 - a) those risks are eliminated or reduced, by placing a barrier at the railway boundary that is sufficient to prevent vehicle incursion onto the track, or other equally effective measures (paragraph 66d); and
 - b) its emergency procedures require its staff to inform Network Rail immediately a road vehicle enters the railway (paragraph 66c).
