RAIB Bulletin 04/2009

Passenger train derailed in November 2008

Description of the accident and findings of the RAIB

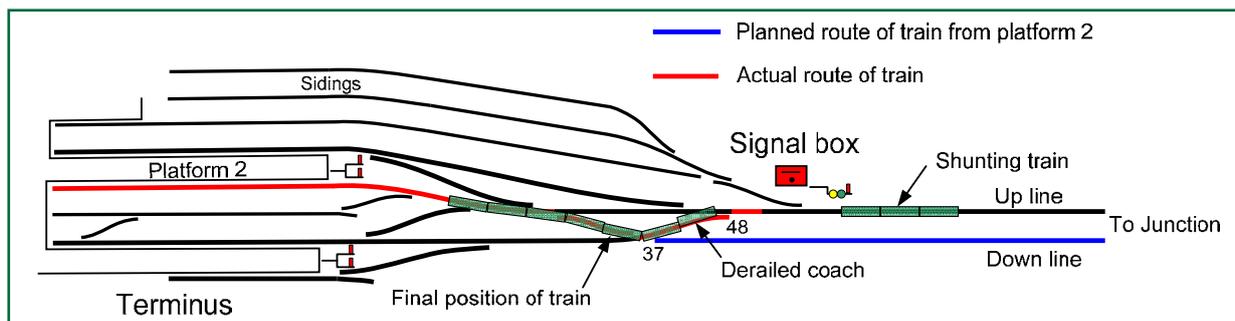
Figure 1: Route of train and position of trains after derailment

7. The signaller then instructed the driver to return the passenger train to the station, intending to then reset the route correctly and send the train out again. Another driver, who had been travelling as a passenger, agreed to go to the rear end of the train and drive it back to the platform. He set off, but after moving about 27 m the train stopped with all wheels of the leading bogie of the last coach derailed to the right, in the position shown in Figure 1.

8. When the surrounding tracks had been made safe, the passengers were evacuated from the last coach via a ladder and walked back to the station.
9. After the train was diverted through facing points 37, it had then run through trailing points 48 which were in the normal position. On moving back towards the station, what was now the trailing bogie of the train was diverted to the right at 48 points and dragged the leading bogie of that coach into derailment.

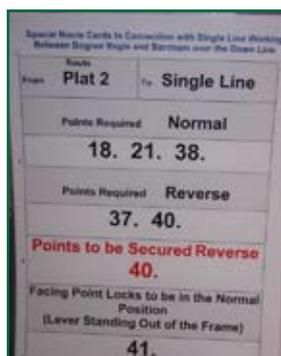
3. There are four platforms and several sidings at the terminus, which is controlled from a mechanical signal box (Figure 1). During the period of single line working, which lasted for a week, trains leaving the terminus had to travel from the platforms to the down line over routes for which none of the signals at the station could be cleared. The interlocking was not disconnected, and all other moves at the station were being signalled normally. The signallers had been issued with route cards setting out the lever positions required to set the route for trains starting from each platform and travelling over the down line in the up direction (Figure 2).

Figure 2: Route card prepared for use during single line working
