Rail Accident Investigation Branch

Rail Accident Report

**Fatal accident at Wraysholme crossing,
Flookburgh, Cumbria
3 November 2008**

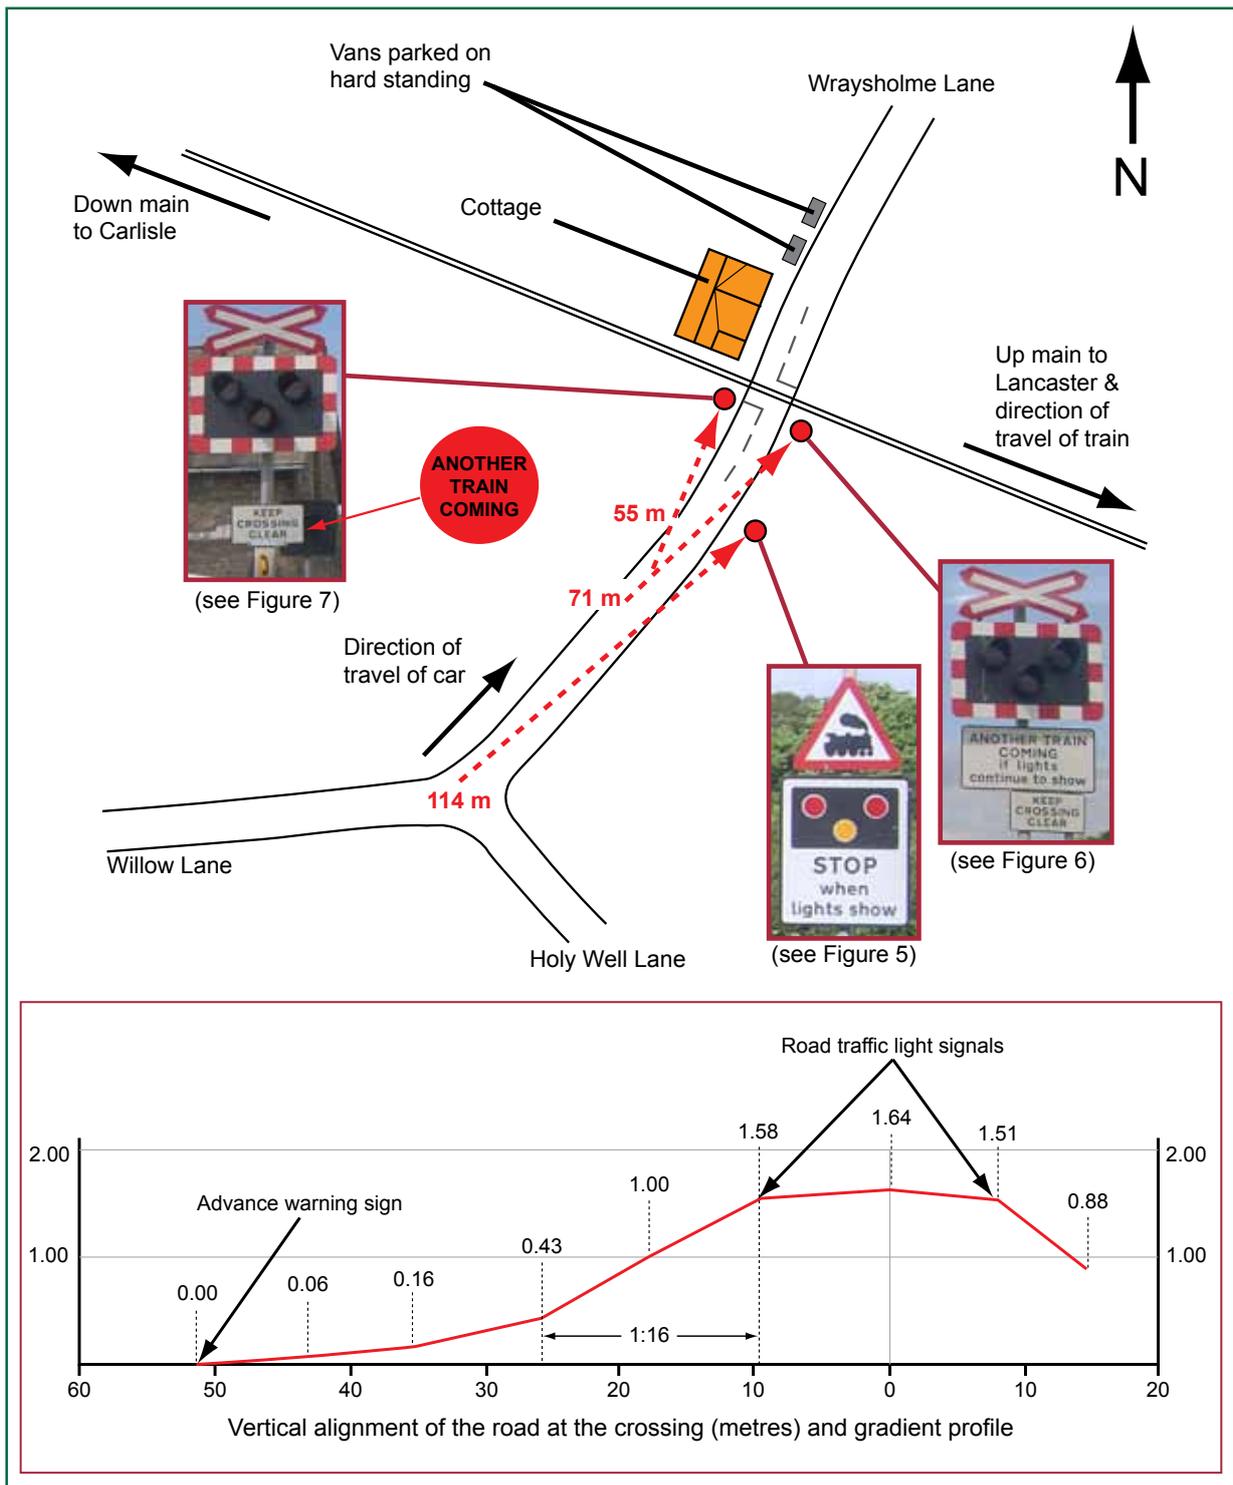
- 22 Advance warning signs on the road indicate the presence of the crossing and read 'STOP when lights show'. At the crossing, signs read 'KEEP CROSSING CLEAR' and 'ANOTHER TRAIN COMING if lights continue to show'. A solid white stop line and the 'STOP' road marking are painted on the road adjacent to the crossing (Figure 3).

Figure 3: The crossing, its warning signs and road traffic signals

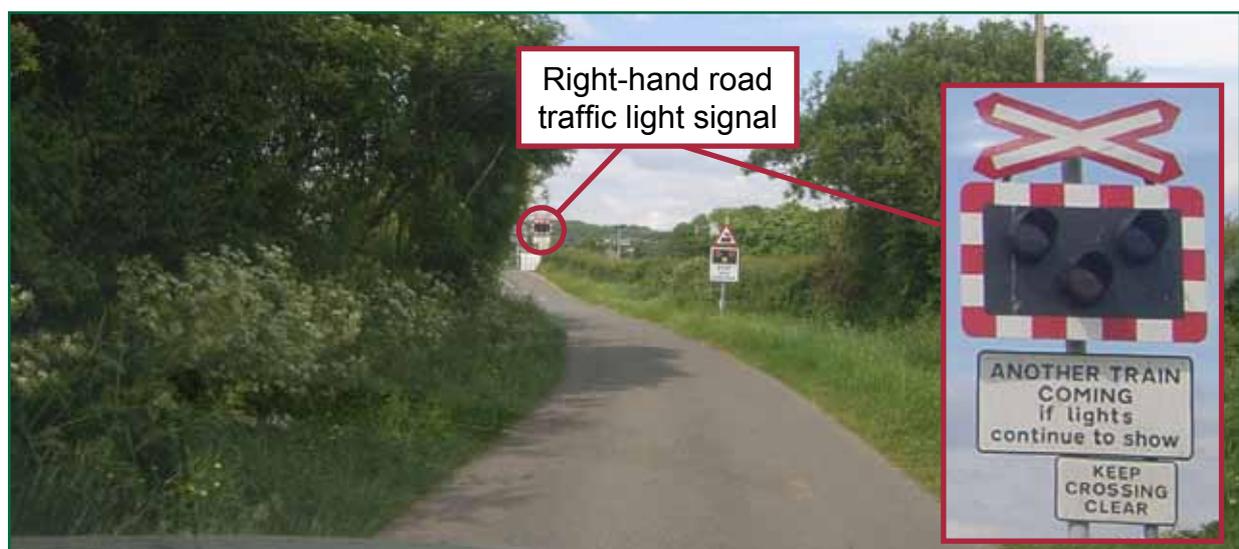
Figure 6: The right-hand signal

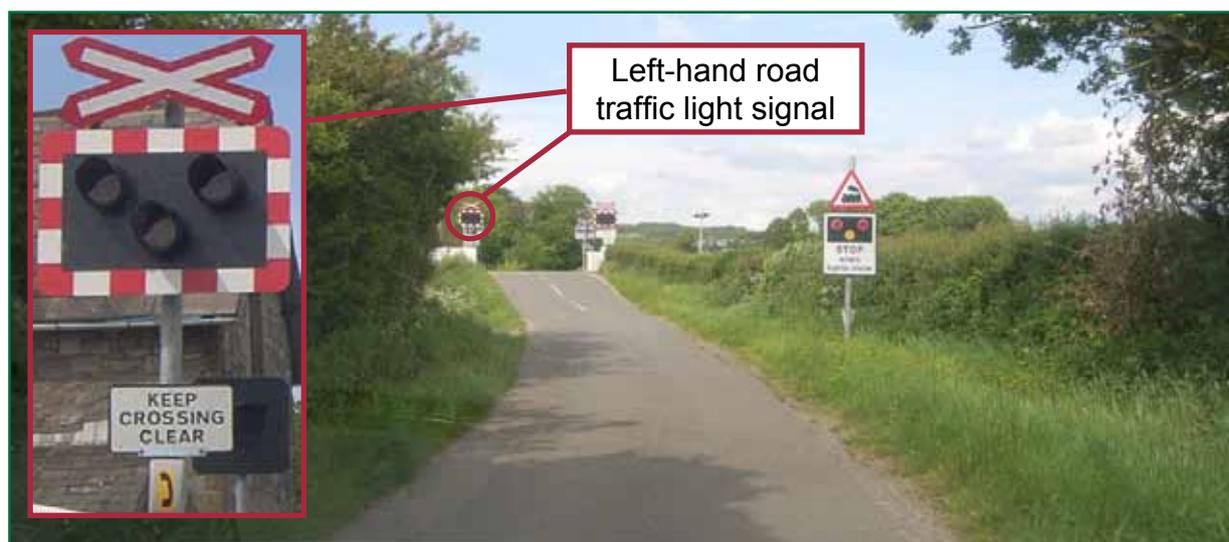
Figure 7: The left-hand signal

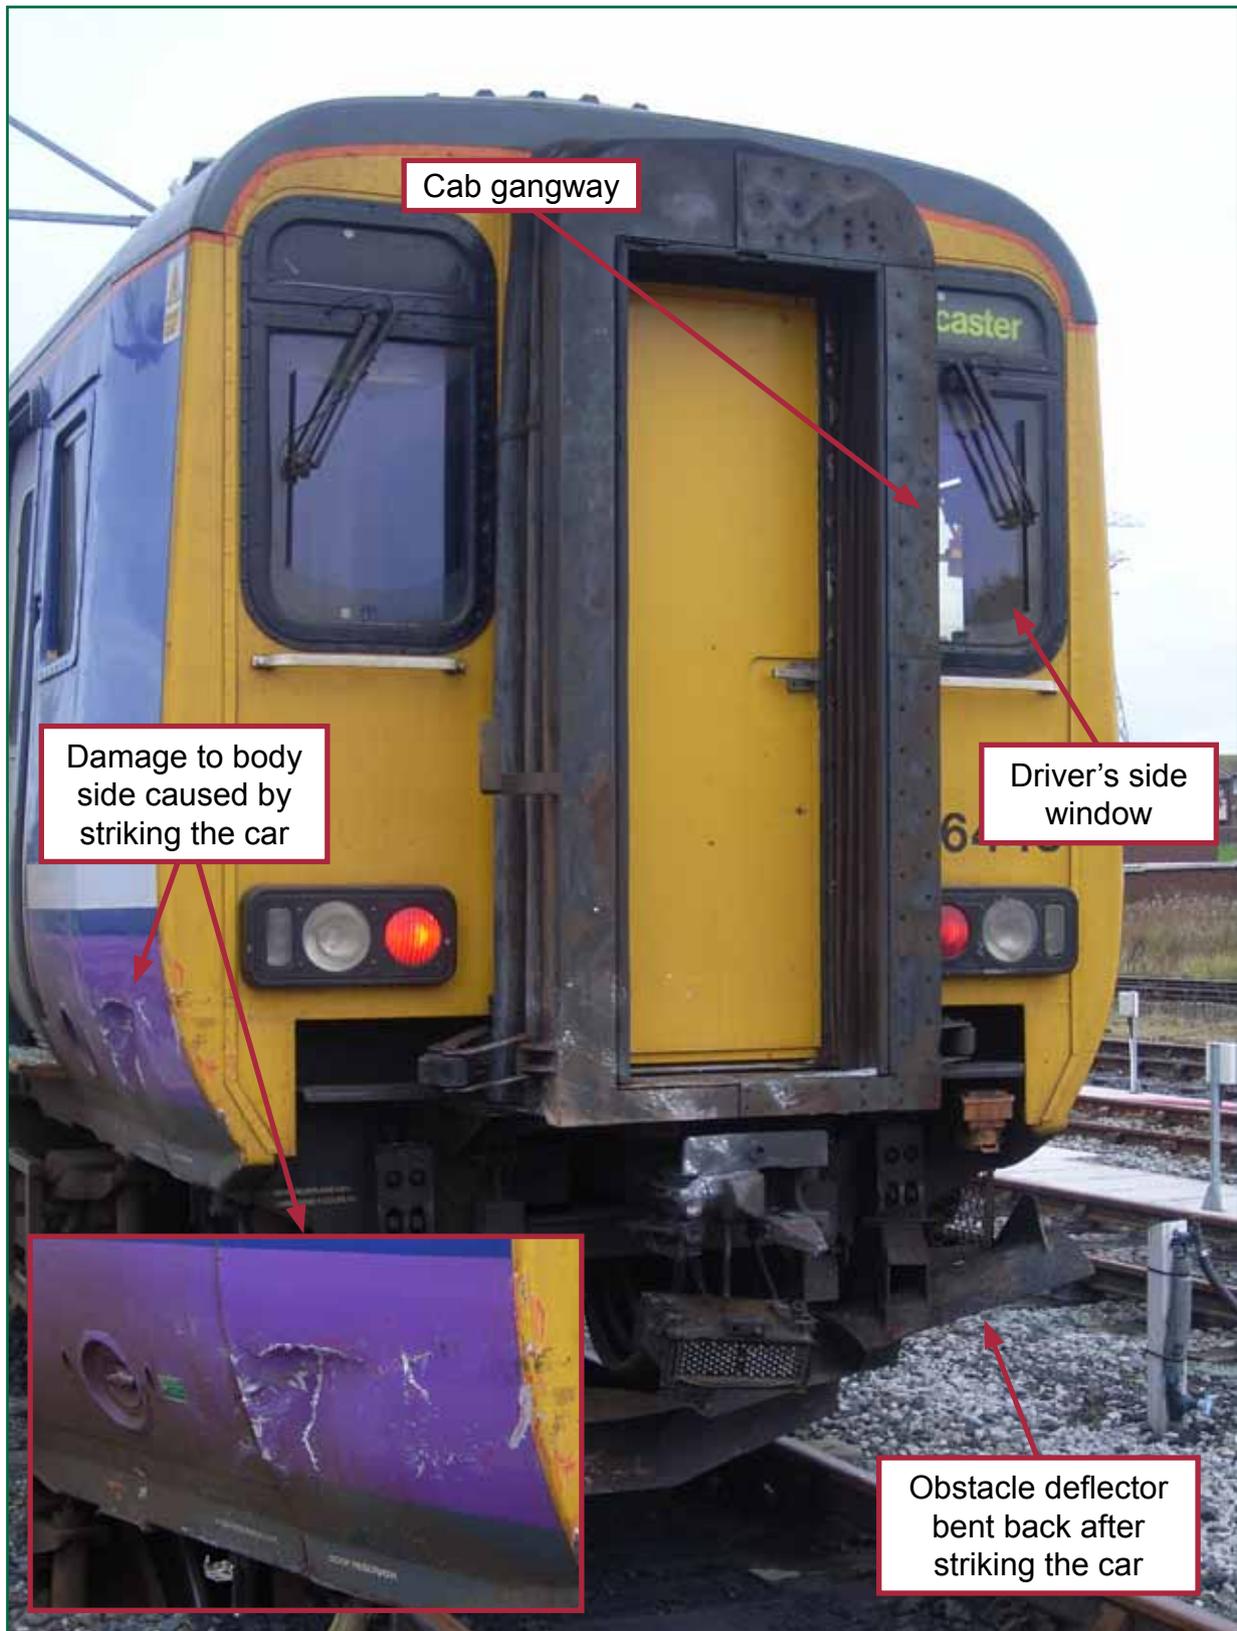
- 36 The car driver suffered immediately fatal injuries and his car sustained damage to its front left-hand side. The driver's two dogs were travelling in the car's boot at the time of the accident and survived the collision. The train sustained damage to its bodyside and obstacle deflector (Figure 8).

Figure 8: The train and its leading cab

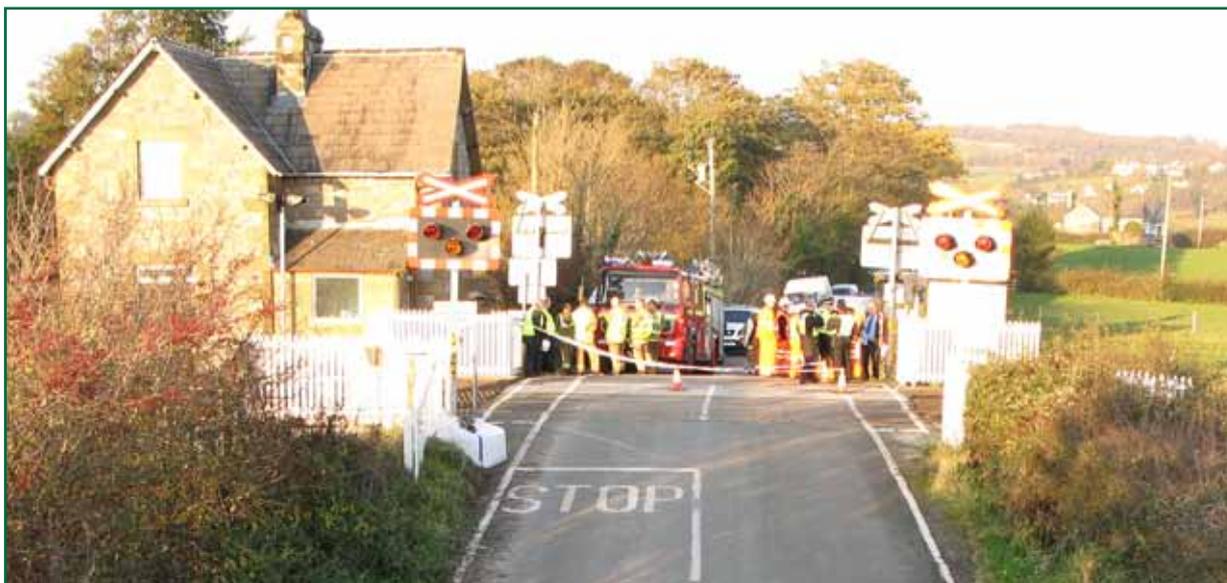
Figure 9: Sunlight reflected off the right-hand signal backboard and warning signs (photograph courtesy of Cumbria Constabulary)

102 However, because the signals were affected by substandard brightness, colour, misalignment and sunlight, the car driver may not have discerned them until he was close to the crossing. He may then have ignored them, believing that it was safer to continue in an attempt to clear the crossing rather than to attempt to stop.

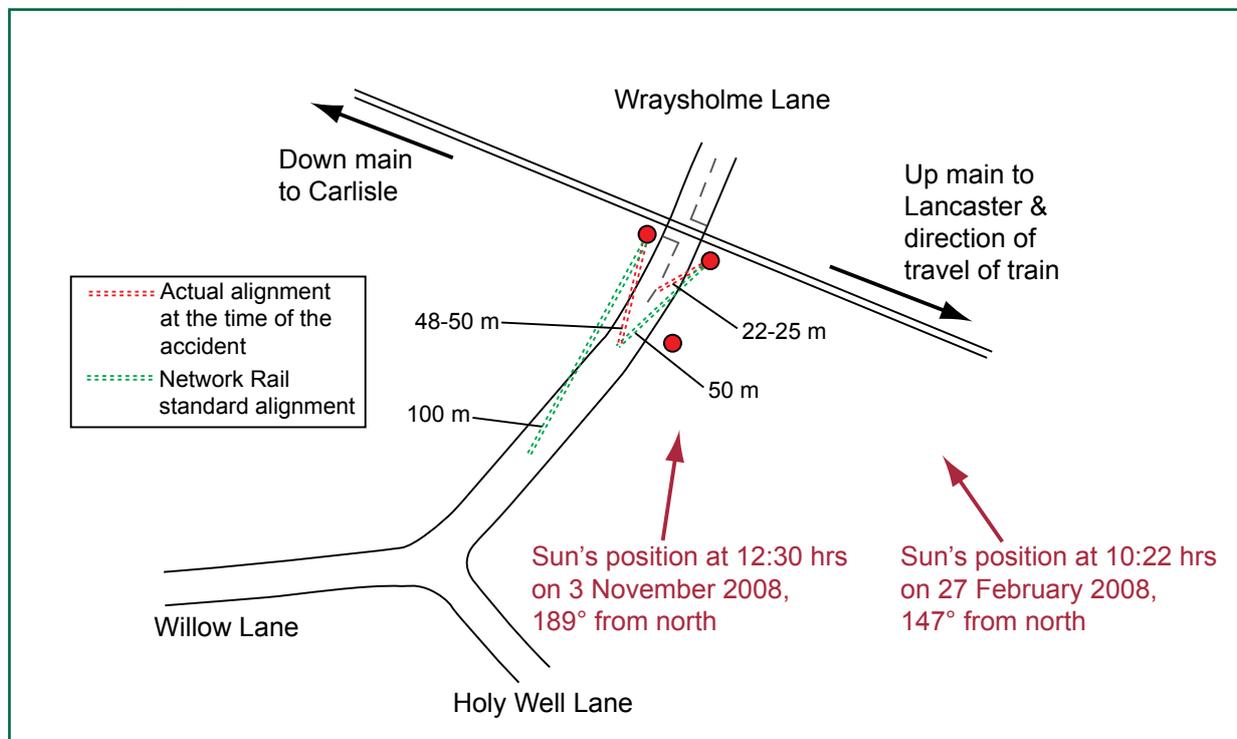
- 92 Network Rail could not position the Wraysholme signals to its standard alignment; if it had, the left-hand signal would align behind vegetation in the field to the left of the road because of the bend on Wraysholme Lane (Figures 7 and 11). At the time of the accident, Network Rail had no procedure for optimising signal alignment so it aligned left and right-hand signals at 48 - 50 metres and 22 - 25 metres from the stop line respectively, and did not record their alignments on the ground plan as required.

Figure 11: The standard and actual alignment of signals at Wraysholme crossing on 3 November 2008

118 Network Rail inspected the crossing 30 minutes before the accident; at this time and in accordance with past practice, the inspector noted that the left-hand signal was misaligned due to the bend in the road and did not raise the matter as a defect.

- 147 On 21 November 2008, the Office of Rail Regulation issued an improvement notice for Wraysholme crossing; it required Network Rail to (a) correctly align the wig wag lamps; (b) fit longer hoods; and (c) replace the existing signal lamps with LED (light emitting diode) lamps.
