Rail Accident Investigation Branch

Rail Accident Report

Derailment of two locomotives at East Somerset Junction 10 November 2008

Report 28/2009
November 2009

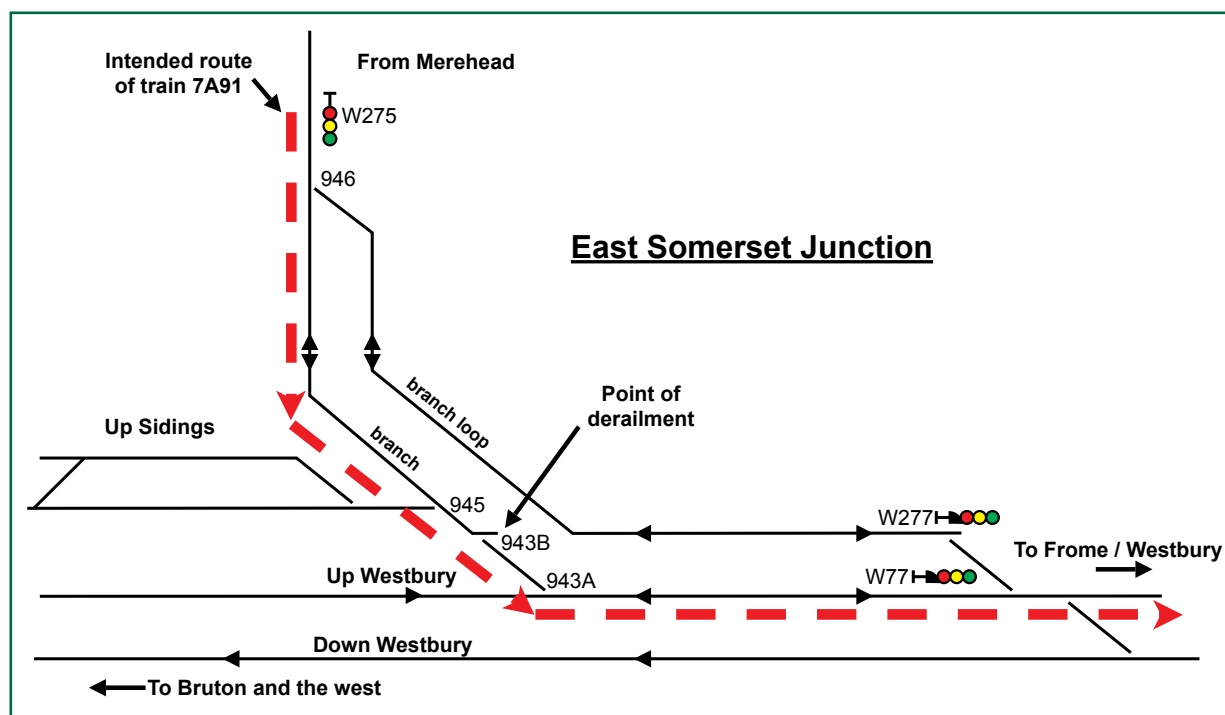
Figure 2: Track layout at East Somerset Junction

- 11 The immediate cause of the accident was that the signaller did not operate a set of points (943 points) to the correct position for the safe movement of train 7A91 (Figure 2).

- 35 At 00:25 hrs, the signalling fault team restored normal signalling arrangements to the Up and Down Westbury lines by replacing a blown fuse in Witham Friary relay room. The area affected by the failure was then confined to the Merehead Quarry branch alone, up to and including 946 points (Figure 2).

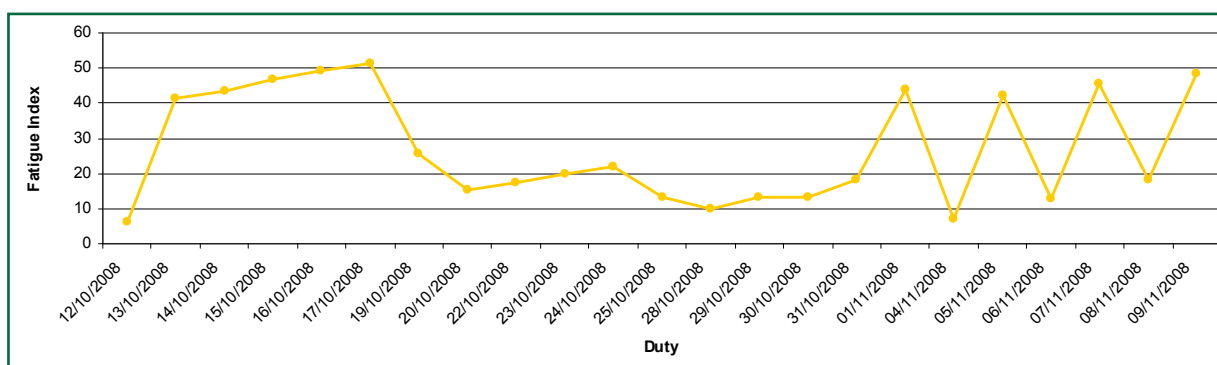
Figure 4: Fatigue index for the shifts worked by the signaller in the four weeks leading up to the accident

107 Paragraph 106 and Figures 4 and 5 indicate that it was probable that the signaller involved in the accident at East Somerset Junction was suffering from fatigue at the time.
